**118 Priory Street,  
Corsham, SN13 0AY**

**Preliminary Roost Assessment**

**Luscinia Ecology**  
On behalf of  
**Rob Shillaker**

LUS26034

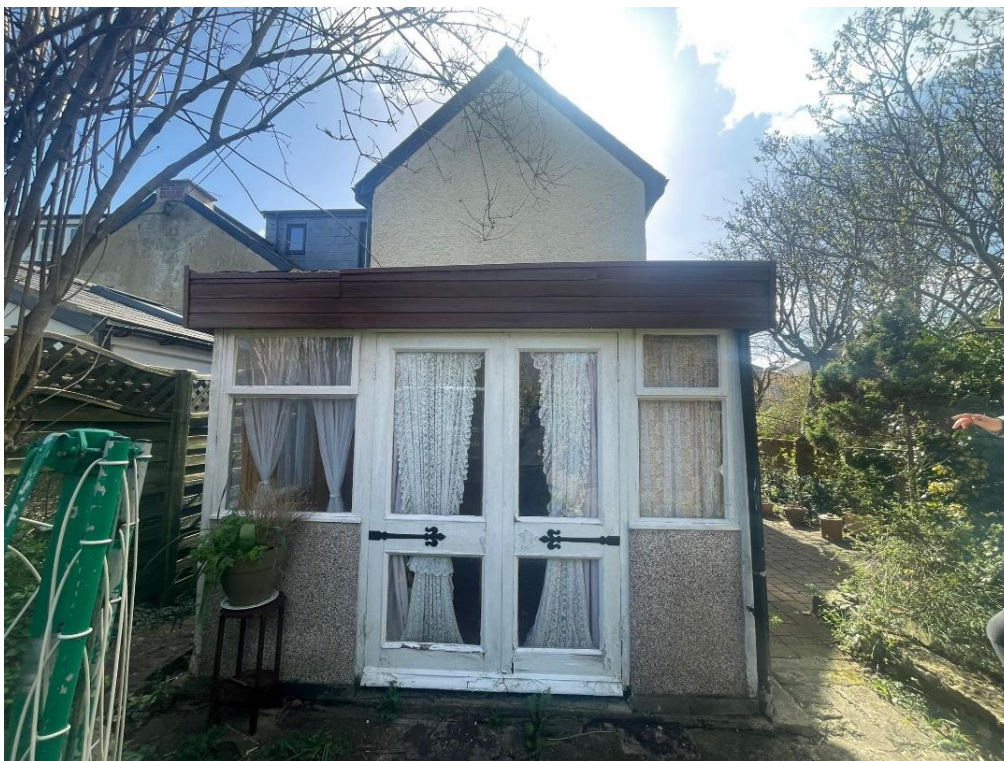
- 1.17 A single-storey conservatory is attached to the rear of the property (**Photographs 1 and 2**). The structure is constructed of blockwork with pebble dash render, with timber-framed single-glazed windows from approximately two metres above ground level and timber-framed glazed double doors opening onto the garden. A small hole associated with localised timber rot was recorded within the soffit on the eastern elevation (**Photograph 3**), along with a minor gap between two soffit sections adjacent to the double doors (**Photograph 4**). These features are exposed, shallow, and likely to be subject to light, draughts, and fluctuating temperatures. As such, they do not provide suitable roosting conditions and were therefore assessed as having negligible potential to support roosting bats, in accordance with best practice guidance. No further bat survey effort is considered necessary in relation to these features.

**Photograph 1: Rear conservatory northern elevation**

- 1.21 As a precautionary measure, Reasonable Avoidance Measures (RAMs) are recommended immediately prior to the removal of the conservatory. This should comprise a brief visual inspection of all accessible features by a suitably experienced ecologist to check for the presence of bats. Should a bat be encountered at any stage of the works, all works must cease immediately, and advice sought from a suitably qualified ecologist.
- 1.22 We trust the above information is in good order. However, should you have any comments or queries on any of the above, please do not hesitate to contact us.

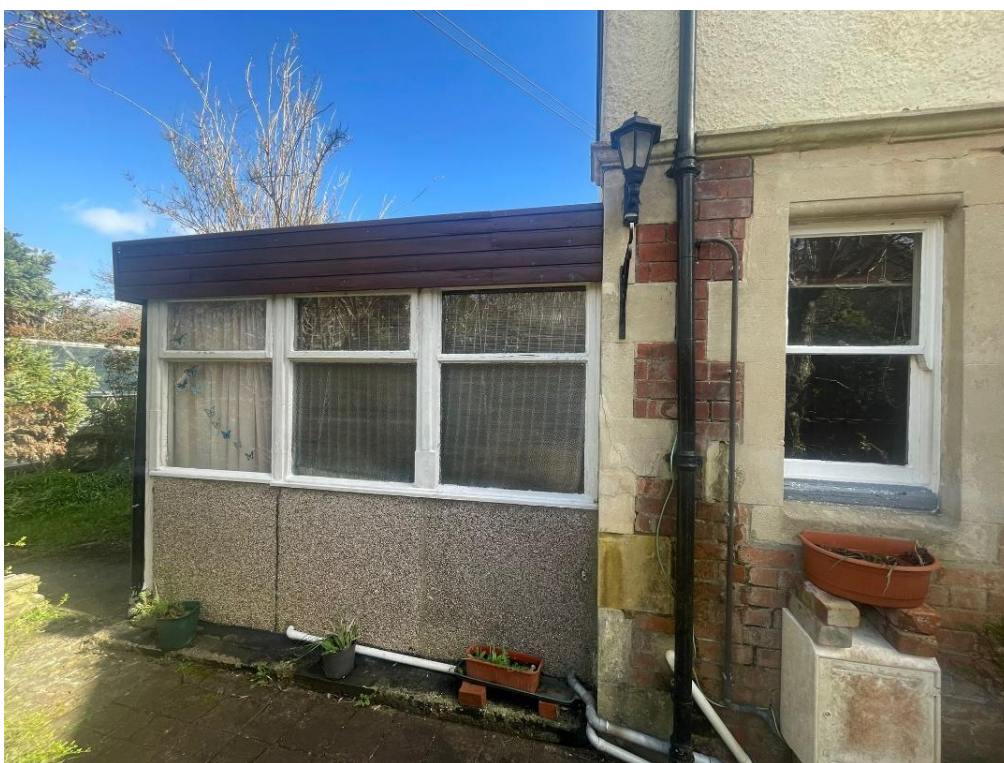
**Photograph 2: Rear conservatory western elevation**

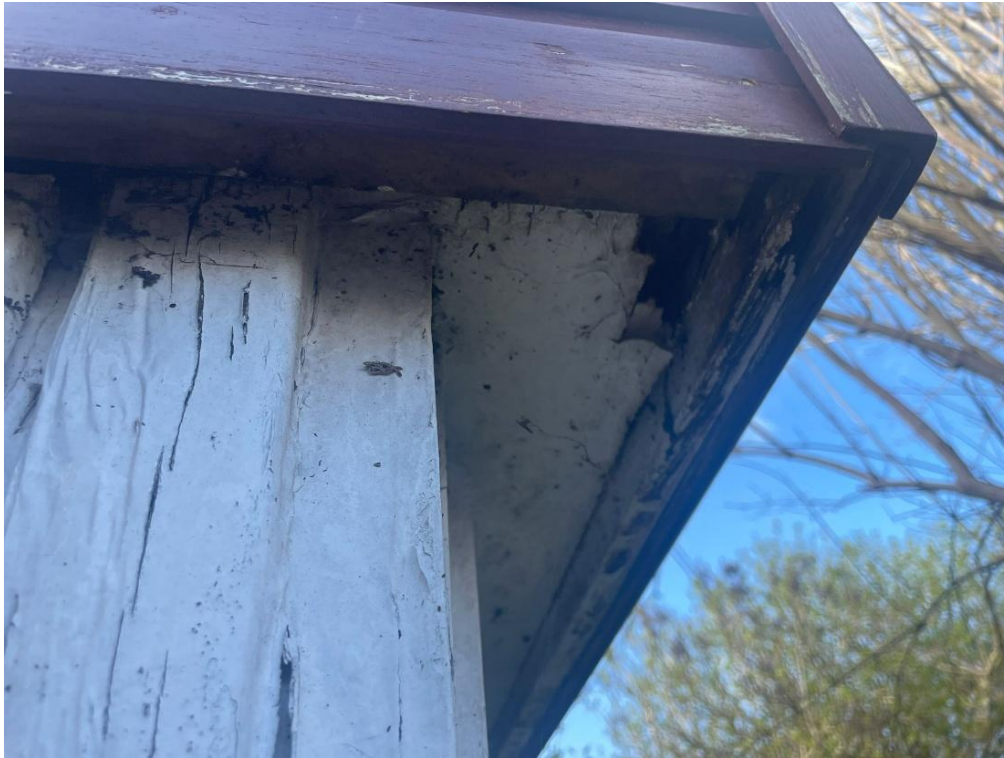
**Photograph 3: Timber rot within soffit on eastern elevation**

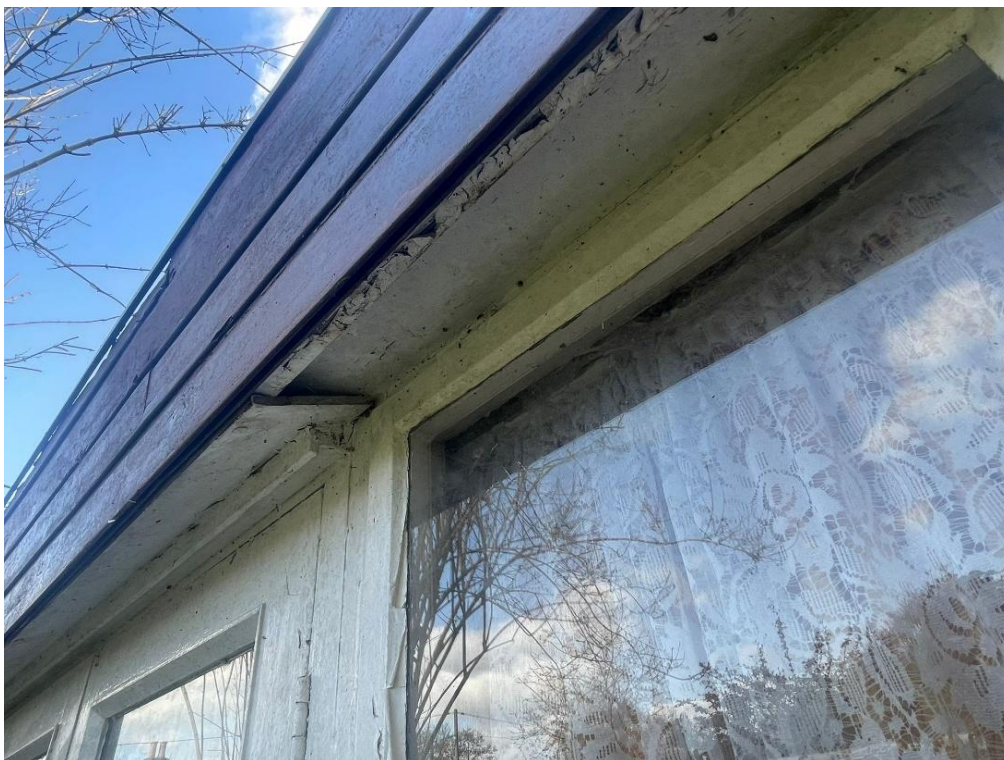
**Photograph 4: Gap between soffit sections**

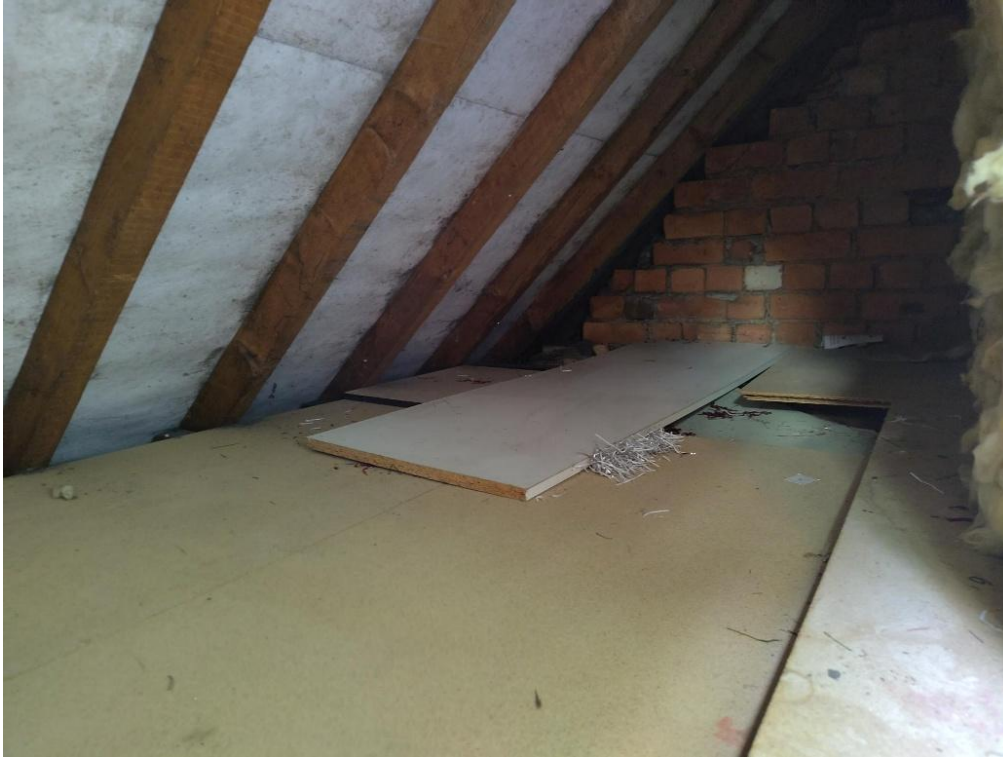
- 1.18 The internal roof space was inspected. The front section of the property has been previously converted into an additional room, with the eastern eaves accessible via cupboard doors. Inspection of these eaves identified no evidence of bat use (**Photographs 5 and 6**).

**Photograph 5: Eaves at front section of property**

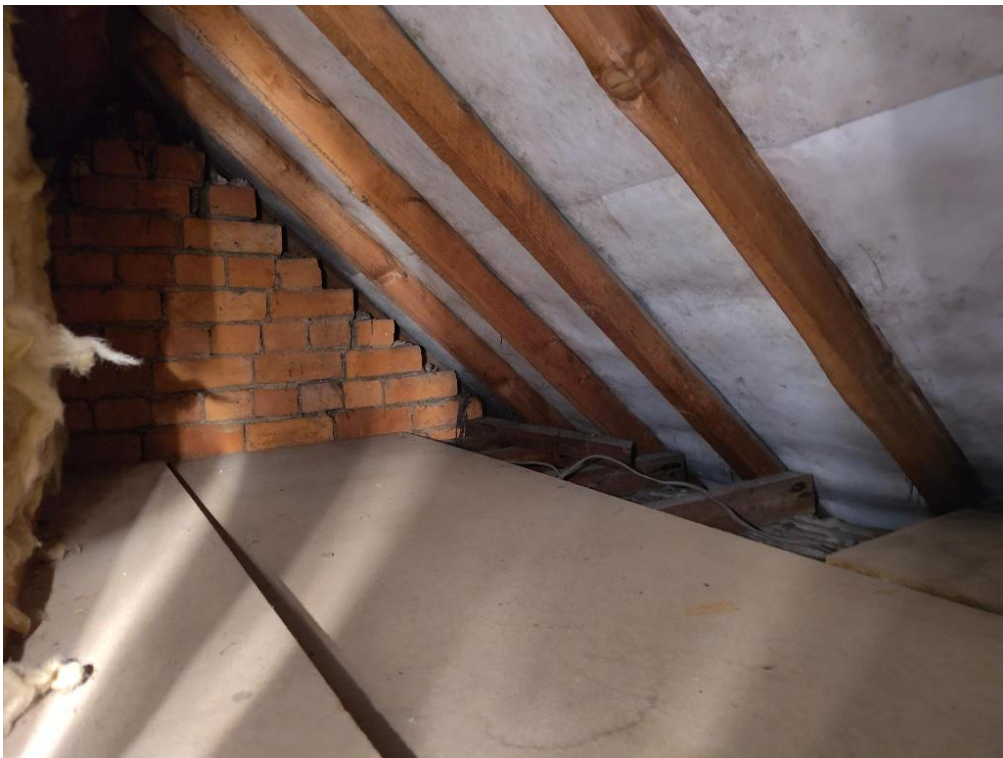
**Photograph 6: Eaves at front section of property**

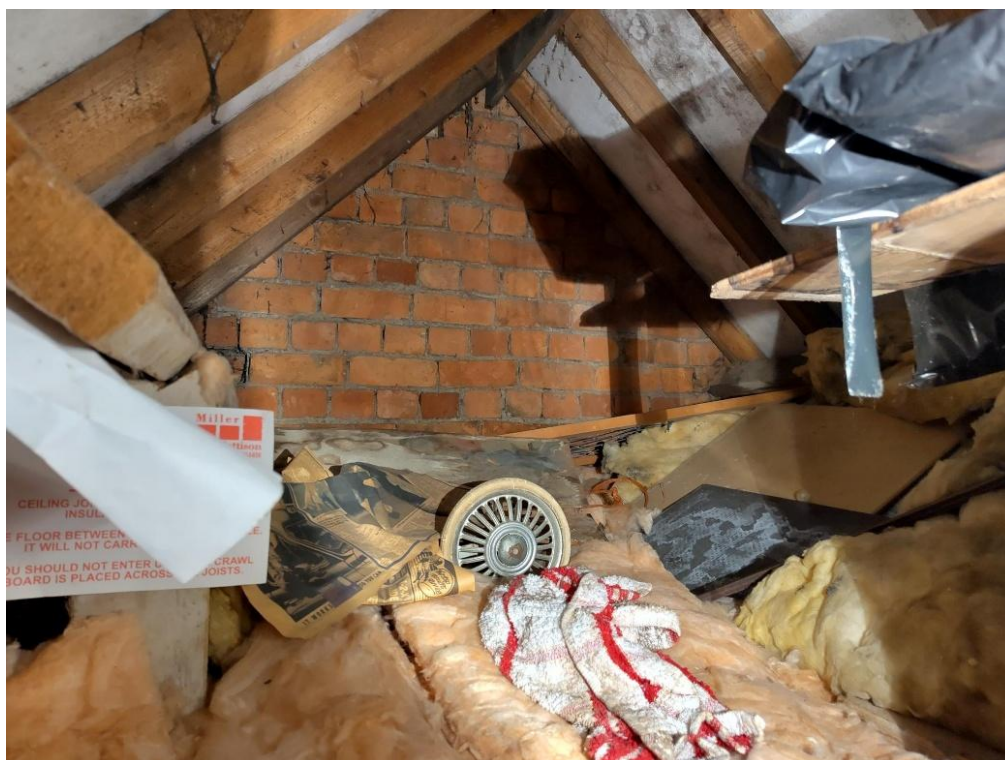
- 1.19 The rear loft space comprised exposed timber beams, brickwork and blanket insulation, with a small amount of detritus present (**Photographs 7 – 8**). No evidence of roosting bats was recorded during the inspection.

Photograph 7: Loft space at rear section of property

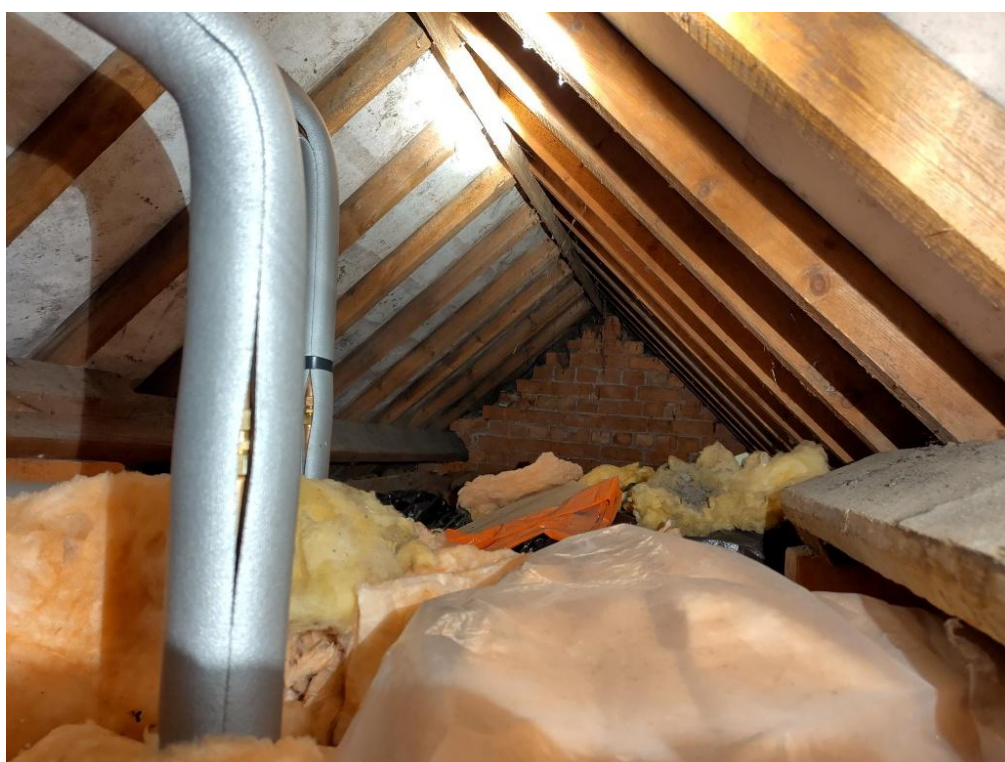
Photograph 8: Loft space at rear section of property
