# RAMSBURY MANOR HOUSE INTERIORS

FURTHER OPENING UP, LIFTING OF ALL FLOORBOARDS, FURTHER TRIAL HOLES,  
AND ASBESTOS REMOVAL

Design & Access Statement  
April 2026

PEREGRINE BRYANT ARCHITECTS

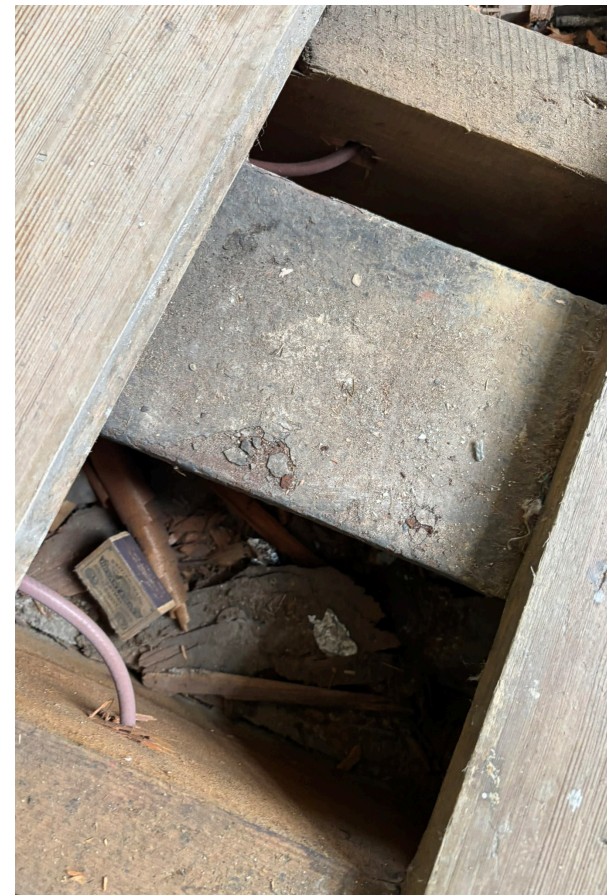
Steel beam (First Floor)

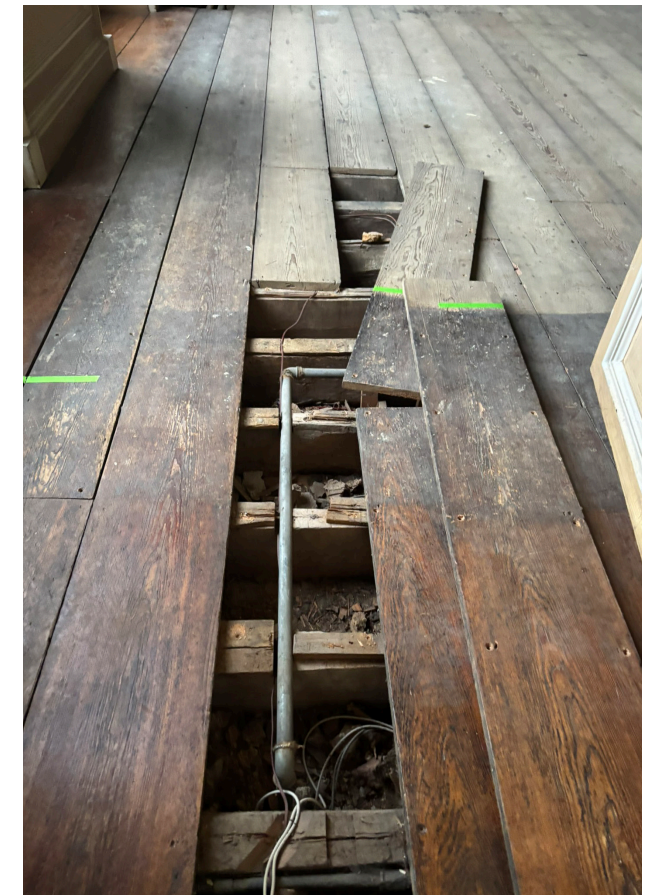
Furrings to level out floor (Ground Floor)

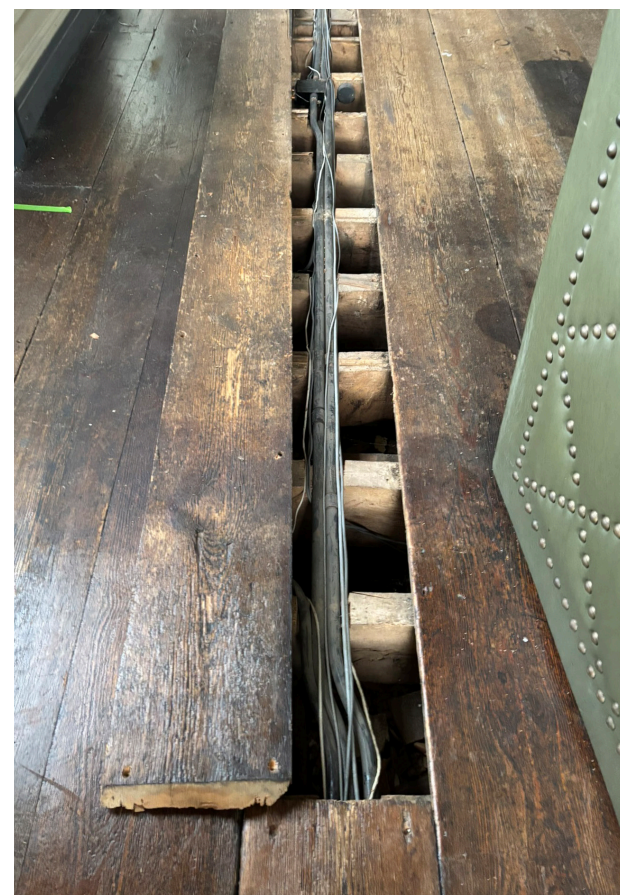
Extensive services (Ground Floor)

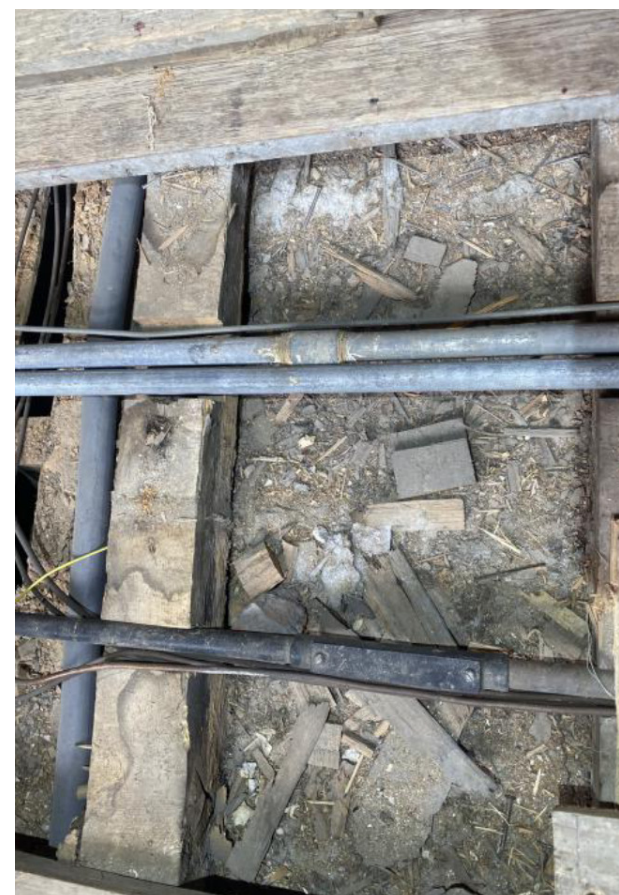
Concealed dropped ceiling void below the ceiling void (First Floor)

It was noticed from taking floor-to-ceiling heights that the Saloon and Hall differed compared to other rooms on the ground floor. The limited opening up revealed that there are false ceilings below the floor voids above these spaces. Limitations on opening-up mean we are unable to interpret why this is so or the condition of these ceilings, their structure, or any chandelier pattresses/support structure. To allow access to these voids to test for asbestos and to understand their purpose and significance, the laths and plaster to the ceiling separating the voids will need to be cut away locally. The minimum number of holes will be made and it is anticipated that holes will be no larger than the spacing of the joists.

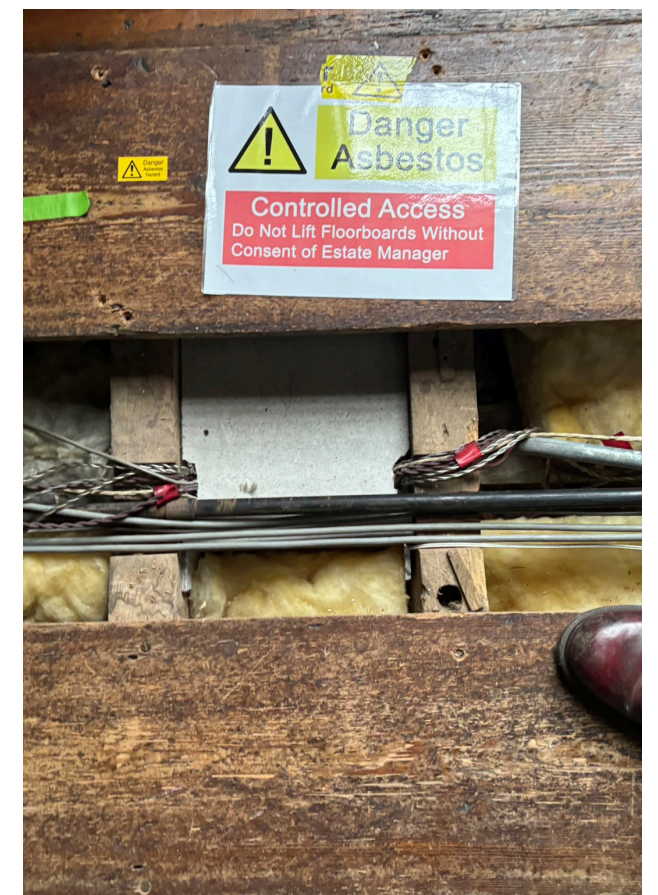
Lining panels containing asbestos (Ground Floor)

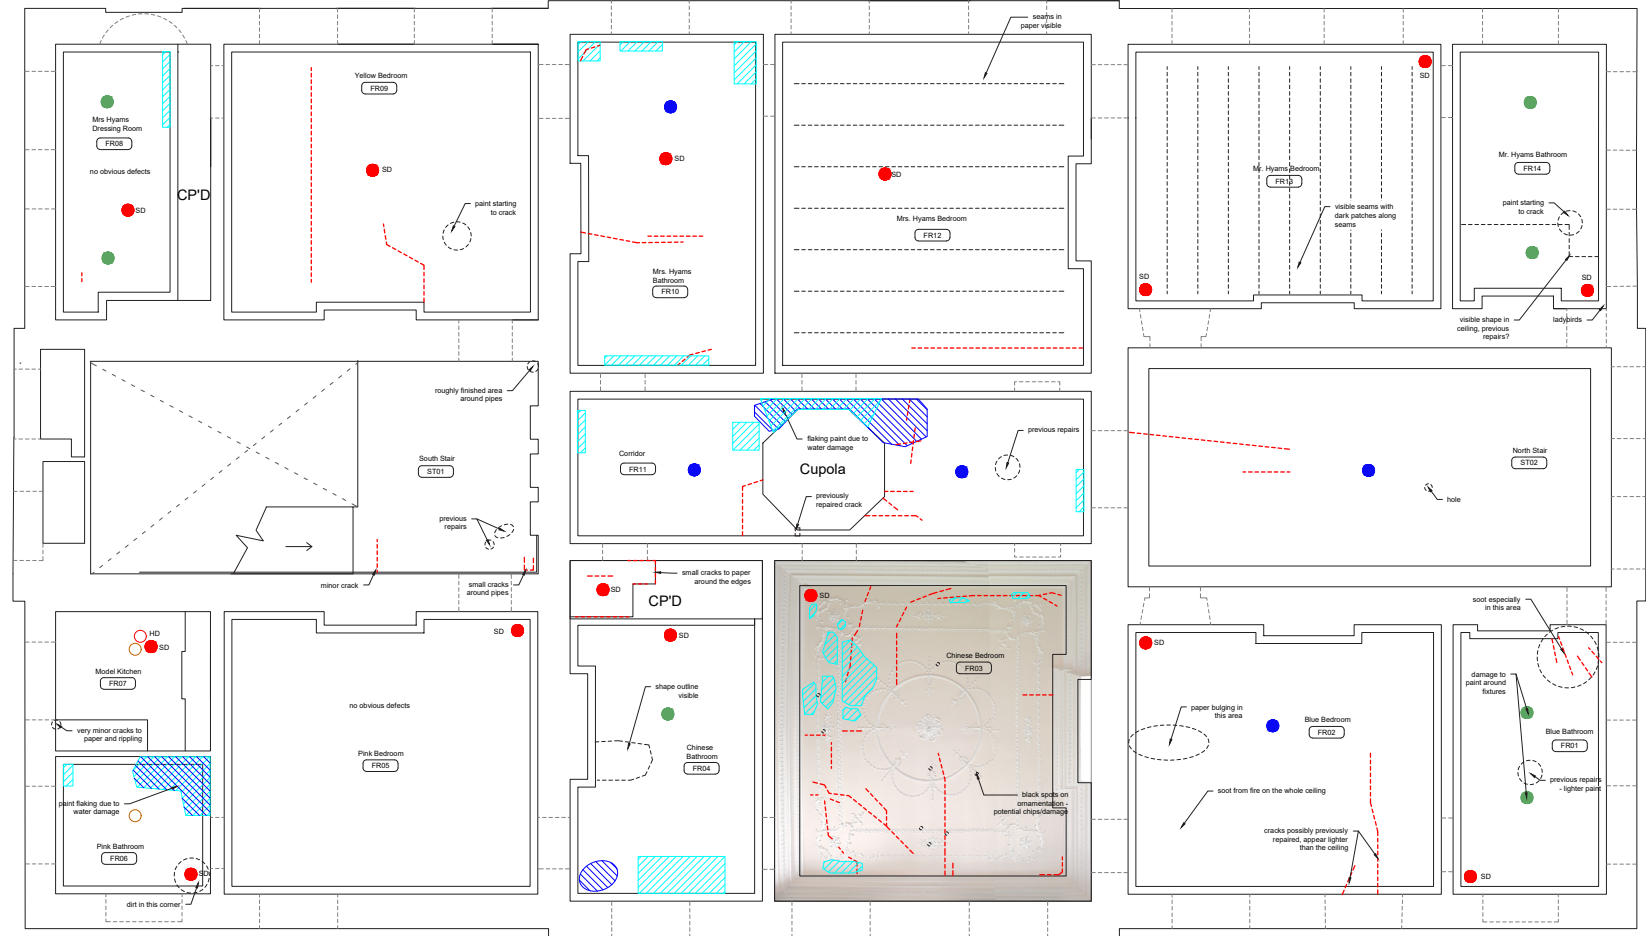
First Floor Reflected Ceiling Plan Showing Condition

Further inspection of the condition of the building has also highlighted water staining, flaking paint and cracking of plaster to a number of ceilings below where bathrooms are located. Opening up has currently limited the ability to inspect the condition of these areas further to understand the true extent of this water damage and condition of the plaster ceilings themselves.

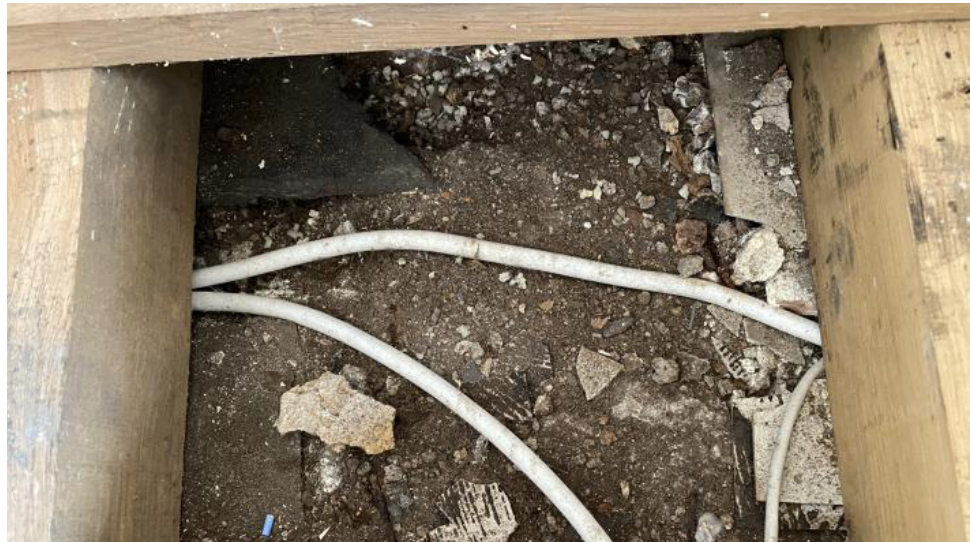
Asbestos containing tile used as packers below floor joists

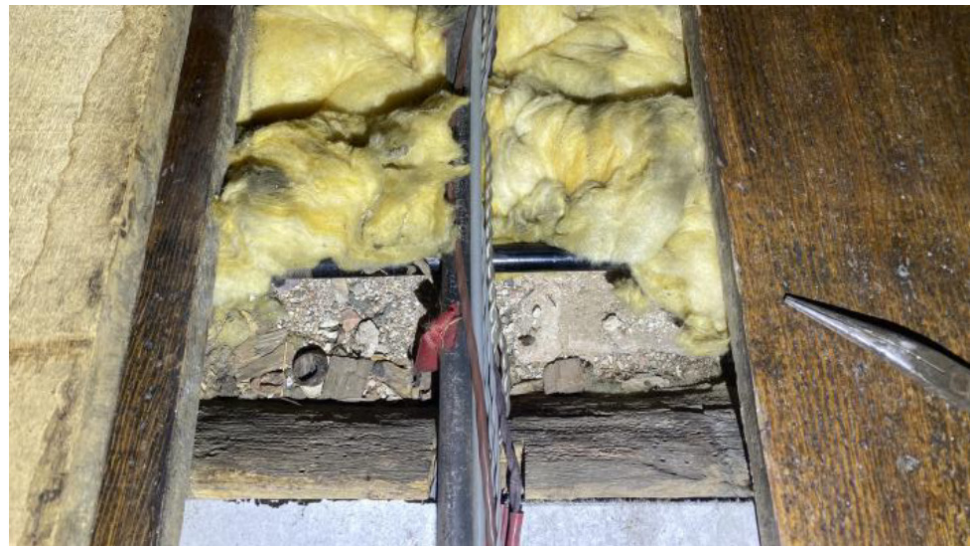
Board dust/debris containing asbestos

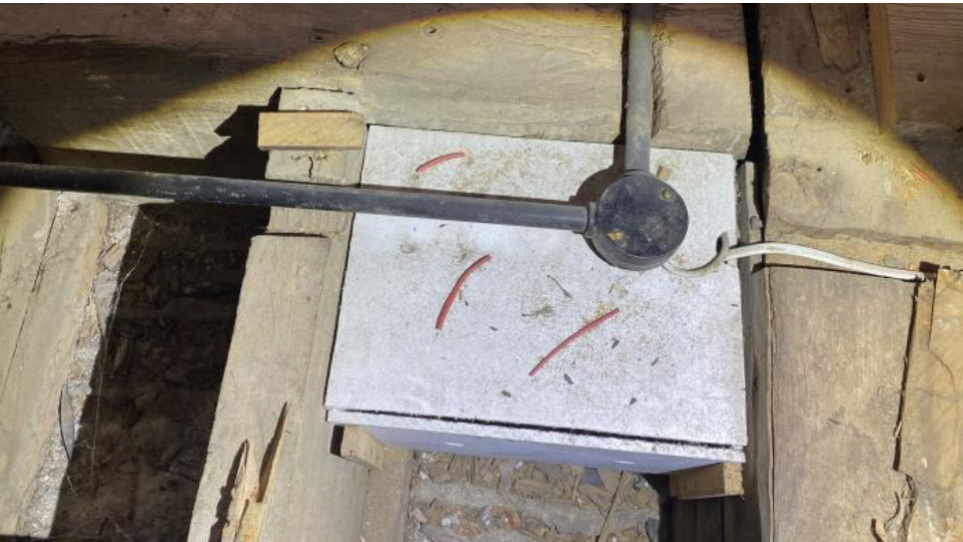
Lining panels containing asbestos used for boxing

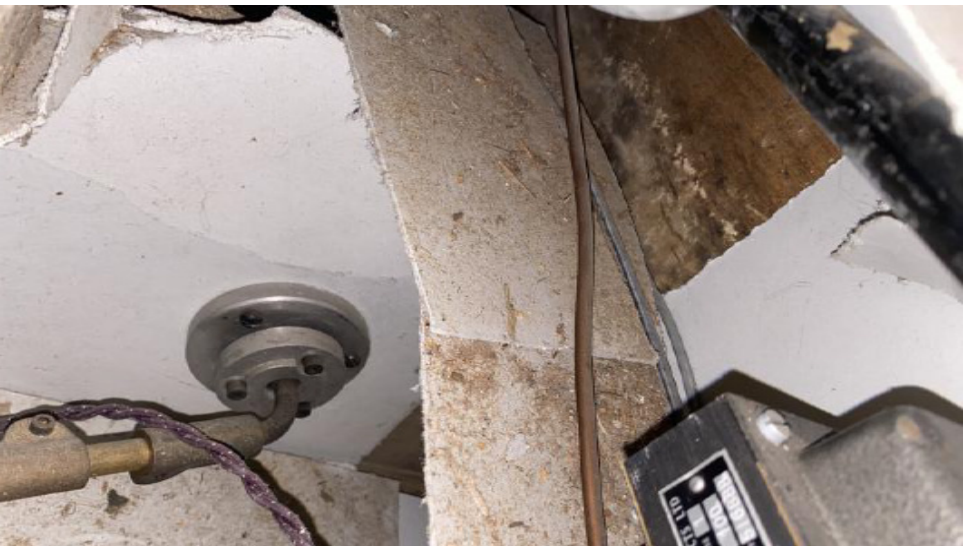
Damaged textile paper to boxing, joist cladding & top of dropped ceiling to Salon
