Asbestos Management Survey

INTERIM REPORT TO MANOR HOUSE ONLY

Ramsbury Manor  
Ramsbury  
Marlborough  
Wiltshire  
SN8 2RG

25/12866

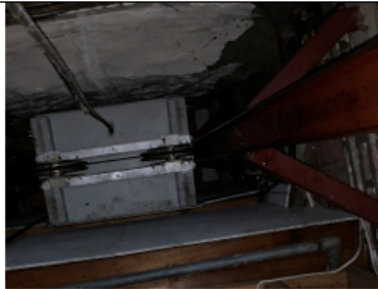
Figure 1.

| <b>Sample Reference:</b> | Refer to S06 | | | |
| <b>Extent of damage:</b> | Medium | 2 | <b>Material assessment score:</b> | 8 |

| <b>Not accessible 2025 (access unsafe) – Recommended management action</b> <ul style="list-style-type: none"> <li>• Restrict all access at all times to all personnel; label the access points to highlight the risk.</li> <li>• We recommend removal by a licensed asbestos removal contractor.</li> <li>• Manage risk until removed, due to no access, condition presumed as previously reported.</li> </ul> | | | | |

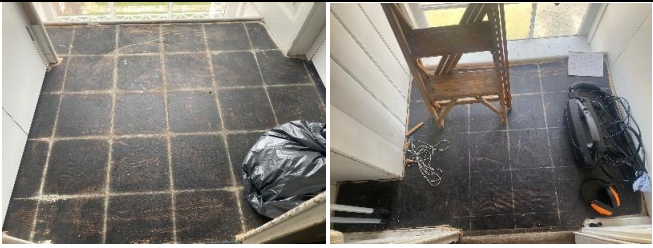
| Name/use & level of room | Ref No. | Ceiling | Walls | Floor | Noted additional features |
|---|---|---|---|---|---|
| Back stairs ½ landing cleaners cupboard (LHS) | 26 | T | T/PB+CWT | T | Note: Refer to (25/12823) S04 - 6m2 asbestos bituminous adhesive residue to floor of cleaner cupboards 26 & 27 - noted in existing register. |

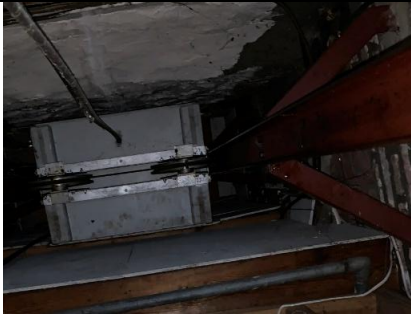
| Hoist | 45a | T | B/T/AIB | N/A | Note: Refer to (19/9725) S06 - <10m2 damaged asbestos insulation board linings inside hoist from ground floor to basement level with debris to the floor of main kitchen hoist (59a) - noted in existing register. |

| <b>Not accessible 2025 (access unsafe) – Recommended management action</b> <ul style="list-style-type: none"> <li>• Restrict all access at all times to all personnel; label the access points to highlight the risk.</li> <li>• We recommend removal by a licensed asbestos removal contractor.</li> <li>• Manage risk until removed.</li> <li>• Due to no access, condition presumed as previously reported.</li> </ul> | | | | |

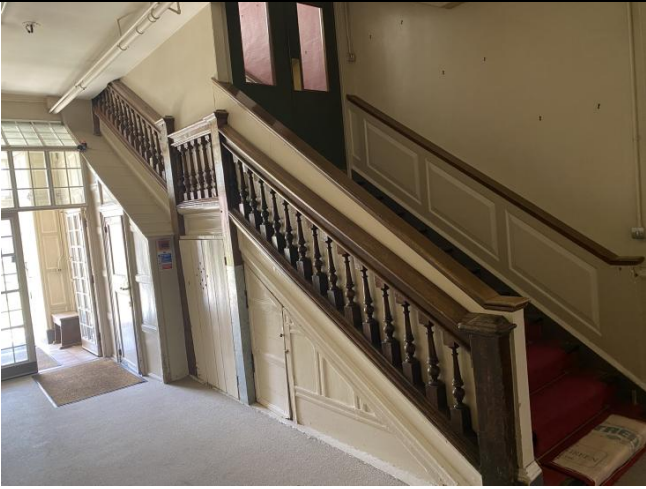
| <b>Other Recommended Action:</b> | | Staircase side of balustrade is timber panelled | | |

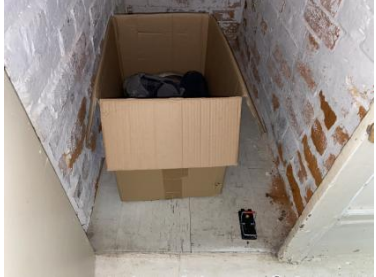
| <b>Sample Location:</b> | Basement back stairs, 2 No. cupboard beneath staircase | | | |

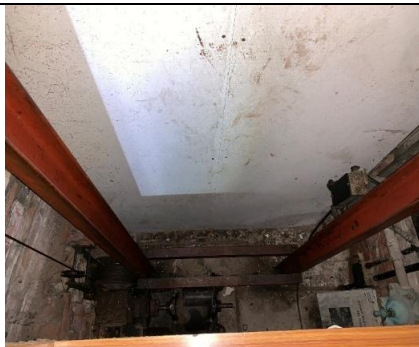
| Main kitchen hoist | 59a | N/A | B/T/AIB | C | Note: Refer to (19/9725) S06 - <10m2 damaged asbestos insulation board linings inside hoist from ground floor to basement level with debris to the floor of main kitchen hoist (59a) - noted in existing register. |

| <ul style="list-style-type: none"><li>• Restrict all access at all times to all personnel; label the access points to highlight the risk.</li><li>• We recommend removal by a licensed asbestos removal contractor.</li><li>• Manage risk until removed, due to no access, condition presumed as previously reported.</li></ul> | | | | |

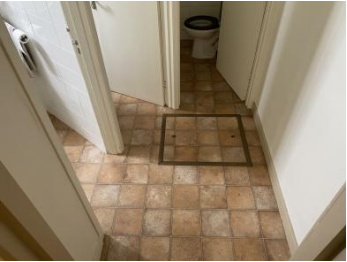
| <b>Sample Location:</b> | Basement cloak room | | | | |

| <b>Accessible 2025 – Recommended management action</b> <ul style="list-style-type: none"> <li>We recommend removal by a licensed asbestos removal contractor if door to be replaced.</li> <li>Manage risk.</li> <li>Reinspect annually to update register.</li> </ul> | | | | |
