West Barn Farmhouse – Internal and External Alterations  
Materials Assessment Ground Floor

West Barn Farmhouse – Internal and External Alterations  
Materials Assessment First Floor

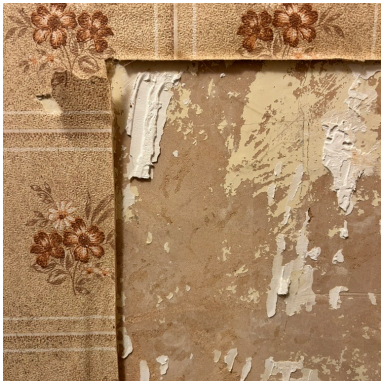
| GF001 | Concrete blockwork with gypsum plaster | These were installed in 1990's and serve no heritage value | These will be removed to allow for a more sympathetic structure to heritage asset. The dividing partition wall will be clad in the timbers that are currently on the mezzanine. |

GF001 – Wall

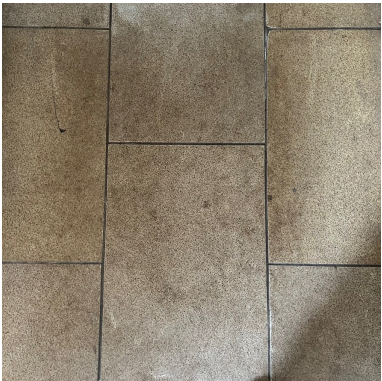
| GF002 | Concrete with various vinyl floor coverings | The floor in the office, would probably been of laid onto of an existing stone floor, it is unclear what condition these may be in. | If flags are present, these will be carefully re-used. A limecrete subfloor, and either polished or finished with existing limestone flags. The limecrete floor will improve breathability. Underfloor heating, and foamed glass insulation will be installed. |

GF002 – Floor

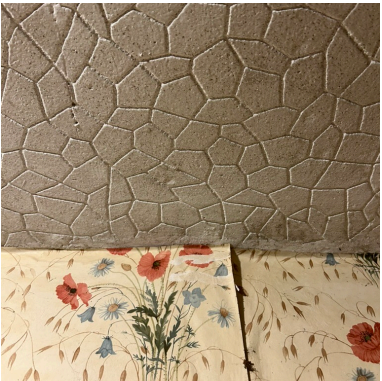
| GP003 | Polystyrene tiles | No heritage value and provides a fire risk. | These will be removed. The new ceiling will be supported by the mezzanine and will be clad in Savolit wood wool boards and birch ply as a finished material. |

GF003 Ceiling

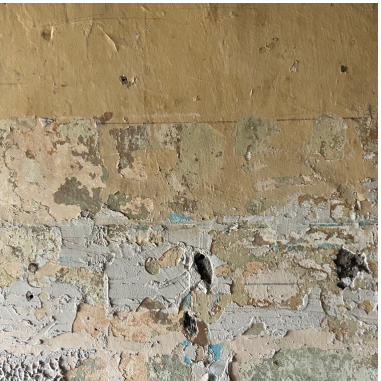
| GP004 | Gypsum plaster | No heritage value and provides poor breathability. | The plaster will be stripped, and walls will be repaired with lime mortar and finished with Seciltek isovit silicate paint. |

GF004 – Wall

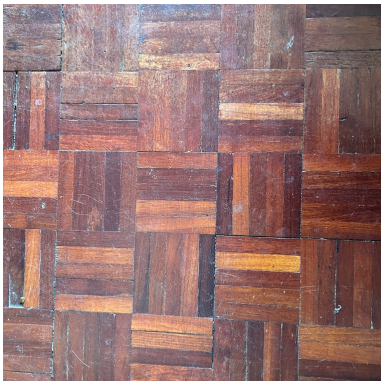
| GF005 | Concrete with timber floor | The concrete floor is offering poor breathability. It is unknown if the original flagstone remain. The timber floor laid is off herringbone probably laid in the 1990's. | The concrete floor will be removed and replaced with a limecrete subfloor with limestone flags. Insulation will be provided in the subfloor in the form of foamed glass to provide breathability. Underfloor heating will be installed to enable a heat pump to provide heating. |

GF005 Floor

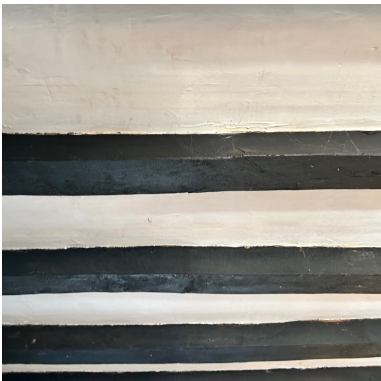
| GF008 | Lime plaster on sawn lath | The ceilings are lime plaster on sawn lath, probably dating from the 19 <sup>th</sup> century. | These are to be retained, and repaired where required. |

GF008 Ceiling

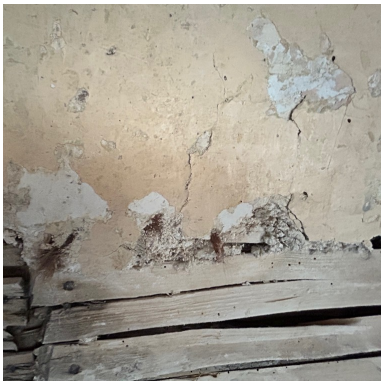
| GF009 | Lime plaster on riven lath | This wall is likely to be from 1616, it is comprised hand split oak lath, with lime plaster with horsehair. The lower portion of the wall has suffered damp, and the timbers have decayed. | The decayed timbers will be replaced, and oak riven lath will be used to restore this wall. Lime plaster will be used to restore the wall. |

GF009 Wall

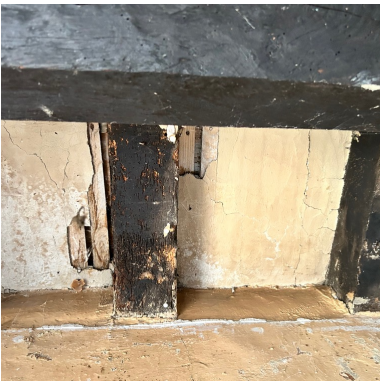
GF004 – Wall

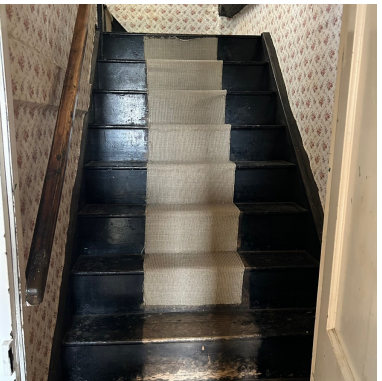
| GF007 | Lime plaster with vinyl wallpepr | The walls are mainly of lime plaster, various coverings mainly vinyl wallpaper exist. The wallpaper is modern, while the lime plaster is not. | The wall coverings will be removed and lime plaster repaired appropriately with lime based plasters. |

GF007 Staircase wall

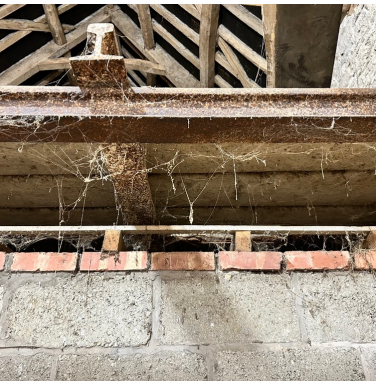
GF – Concrete blockwork and railway line mezzanine.

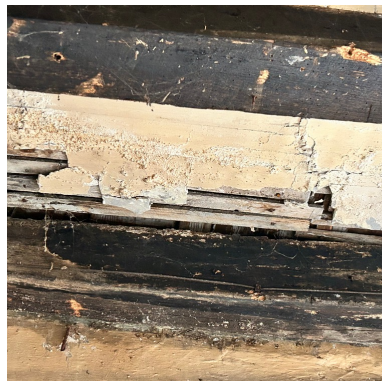
GF – Beams showing sign of decay

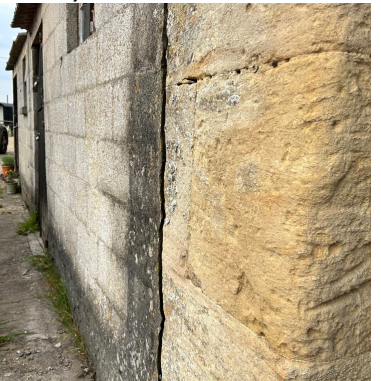
| | Roofing Everite cement roofing | There is no heritage value. It is in poor condition and poses a health risk. | The stables are to be carefully demolished to return the footprint to the 1740's floorplan. |

GF011 – Stables cement abutment to 1740'S barn

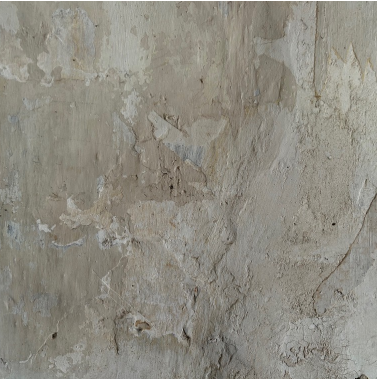
| FF001 | Lime plaster | The walls here are lime plaster, with repairs in places. | The exterior facing wall will receive 40mm of wood wool insulation, and lime plaster applied. |

FF001 – Wall lime plaster

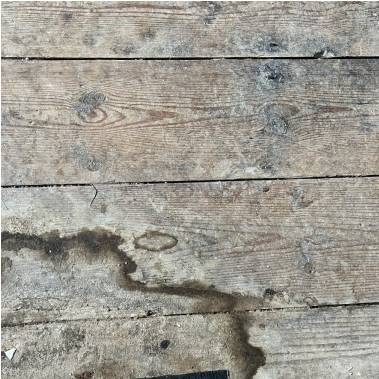
| FF002 | Pine boards | Pine boards here are recent addition, probably added when the original floor was decayed. | The floor will be replaced with oak or elm timber boards to match existing floor elsewhere on the first floor. |

FF02 – floor / pine showing sign of decay

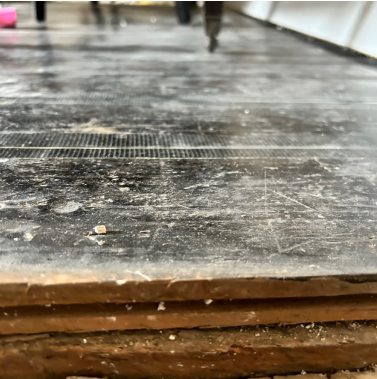
FF02 – Showing edge on view of floor

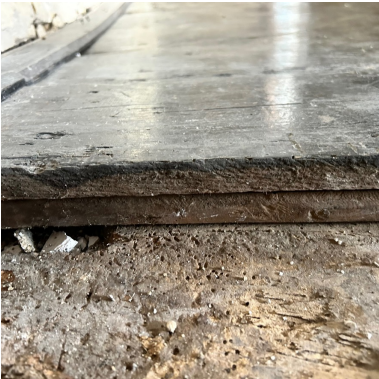
| FF004 | Oak boards | These oak boards have been laid onto of existing elm planks. This was probably done when a ceiling was added, possibly 1800's. | The floor will be retained - any attempt to remove boards will cause significant harm to the fabric. The staircase opening will be re-filled with oak beams and flooring to match. |

FF004 – Floor section showing newer floor laid on 16<sup>th</sup> century boards

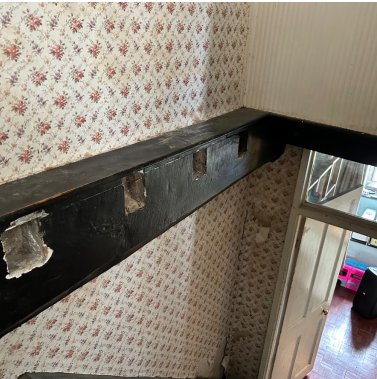
FF005 – Showing beams cut for opening

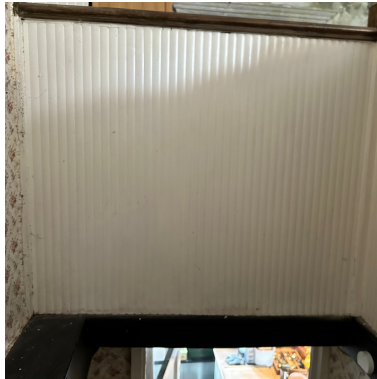
| FF005 | Pine | The staircase looks to be of pine, and built around 1950's. | This will be removed, any timber retained for use elsewhere. |

FF005 – Mid century stair balustrade

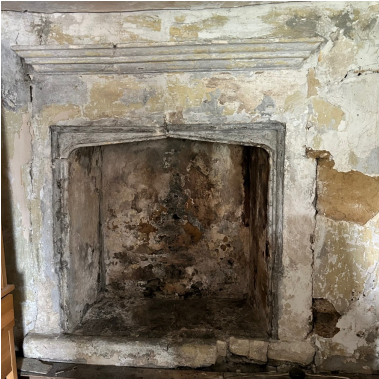
| FF007 | Fireplace | The fireplace is carved from bath stone and probably dates to 1616 or prior to that date. | The fireplace ledge is to be repaired, as previous unsympathetic plumbing cut through the fireplace. |

FF007 - Fireplace

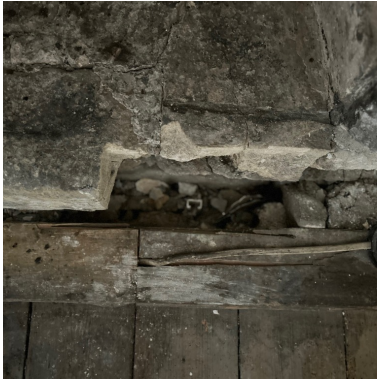
FF007 – Fireplace ledge

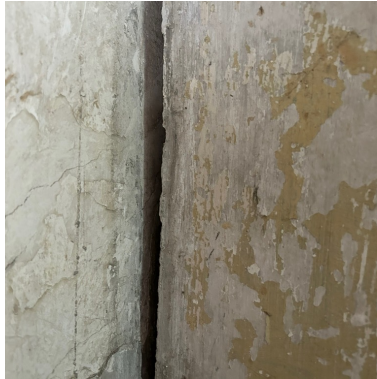
| FF008 | Rubble | Rubble stone wall looks to be a mix of lime, cement and other materials. This would probably off been added when an interior bathroom was installed in early 20 <sup>th</sup> century. | This is to be removed, the walls structural integrity is poor, it has become detached from the exterior wall. The abutment to the exterior wall will be repaired with lime. |

FF008 – Wall detached from exterior

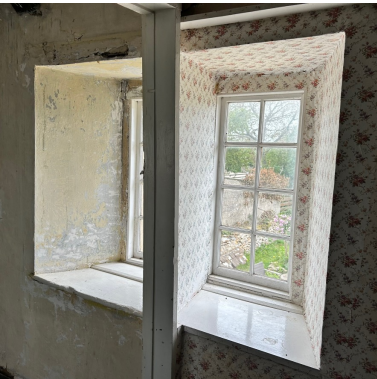
| FF009 | Window | There is a partition in the window, the windows themselves look to be relatively modern. | The partition is to be removed, and the ledge, surrounding plasterwork will be repaired. |

FF009 – Window with partition

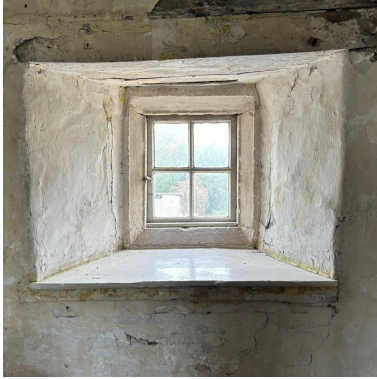
| FF010 | Window | A small leaded window, likely to be a stairwell window, when a staircase might off existed in the 1600's | This will be retained and allow ventilation to the proposed bathroom. |

FF010 – Small leaded light

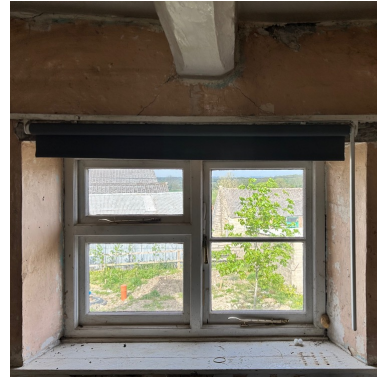
| FF011 | Window | The opening, ledge, and lintel looks to be mid 20 <sup>th</sup> century. | This window is to be infilled, partly to support the timber beam above, and to make space for a new opening into the proposed staircase. This will be filled in with lime mortar and rubble stone to match existing elevation. |

FF011 – 20<sup>th</sup> century opening / window

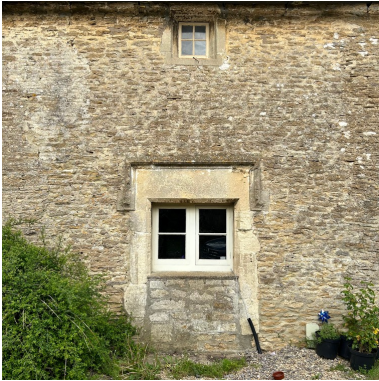
IMG001 – Front doorway infill

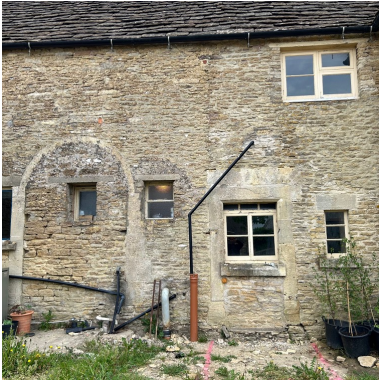
IMG004 – rear elevation / 20<sup>th</sup> century opening and infill

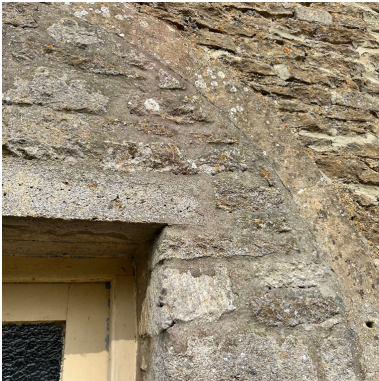
IMG006 – Stone archway with concrete / stone infill

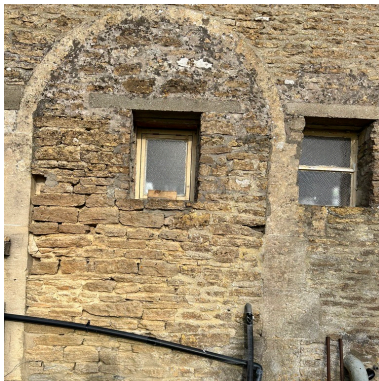
IMG013 – Rear archway infill

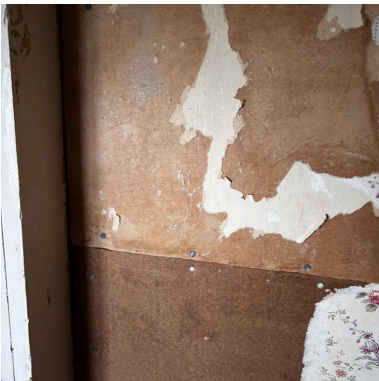
| FF013 | Celotex fibre board | This looks to be added in the 1950's, the partition is made from hardboard and serves not heritage value. | The hardboard will be removed. A modern stud wall will the divide the spaces into bathroom and bedroom. This will also enable all services, heating and electricity installed into this partition wall. |

IMG015 – Hardboard partition
