An Arboricultural Report on Trees at

Neston Primary School  
Church Rise  
Neston  
Wiltshire  
SN13 9SX

26<sup>th</sup> March 2026

Prepared by Mark Sharples BSc, Tech Cert (Arbor.A.), Dip Arb (RFS), MArborA.

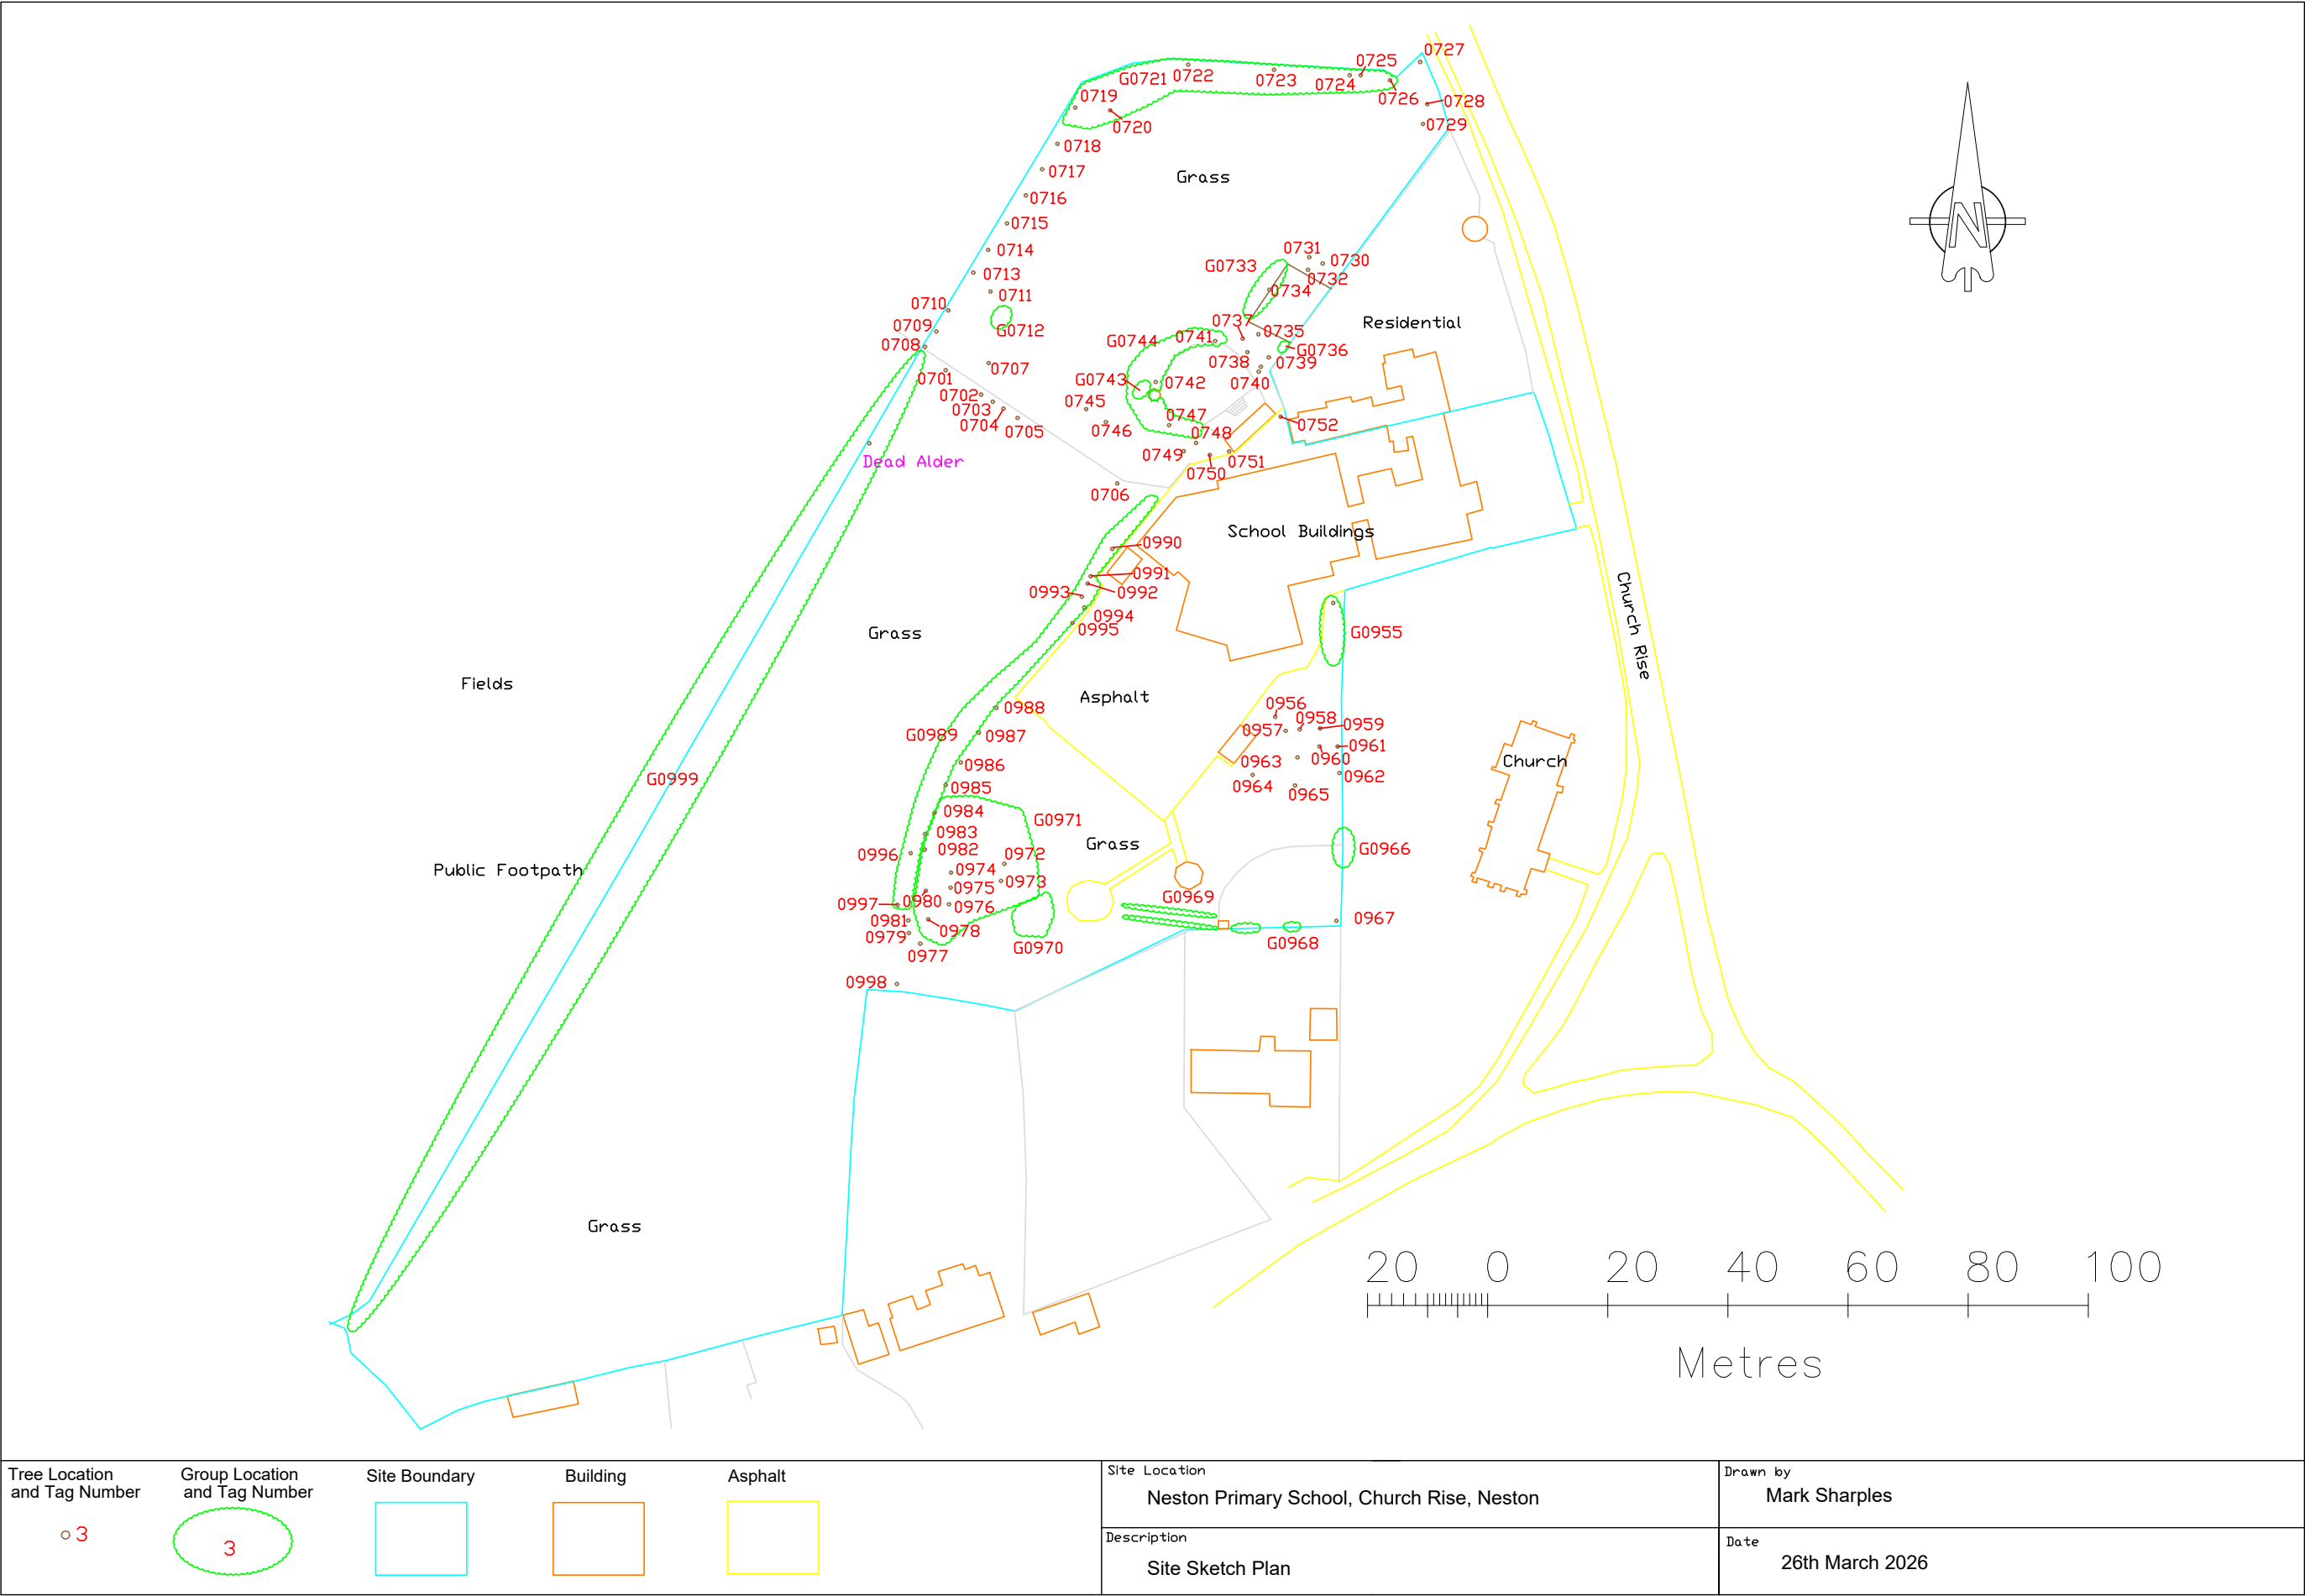
FIGURE 1  
Site Sketch Plan

- 2.4 Location of the Trees:** I have illustrated the approximate locations of the significant trees on the Site Sketch Plan included as Figure 1. The plan is for illustrative purposes only and it should not be used for directly scaling measurements. All the relevant information is contained within this report and the provided documents.
