# Current Structural Condition Report

Dutch Barn At  
Barrow Street Farm,  
Barrow Street,  
Mere, Wiltshire,  
BA12 6AB

| Project title | Barn At Barrow Street Farm, Barrow Street, Mere, Wiltshire BA12 6AB |
| Document title | Current Structural Condition Report |

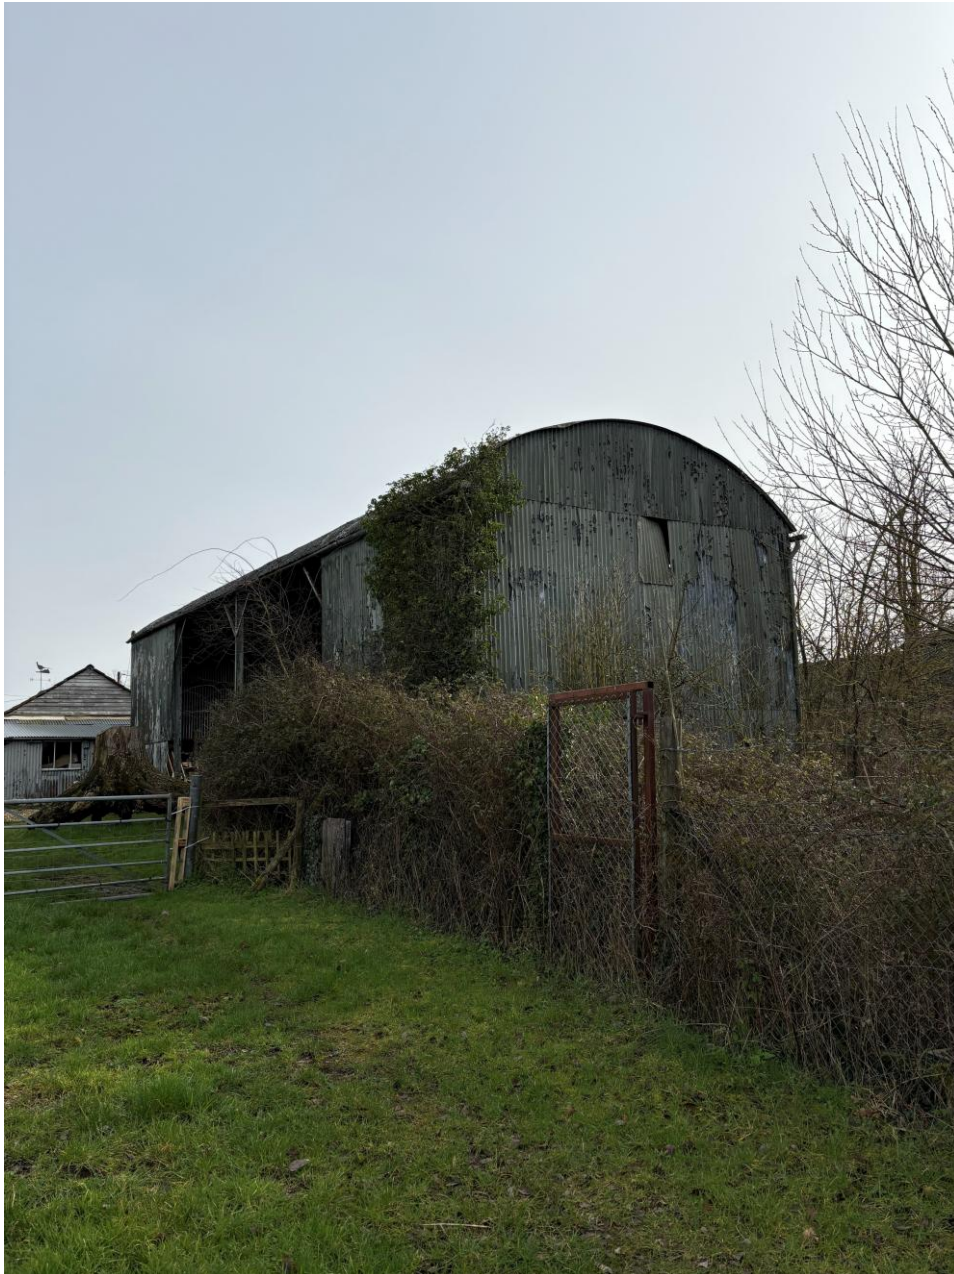
The building is of rectangular shape in plan, the structure is of steel framing to roof and side walls, and of curved roof form.

**General View of Building West Elevation**

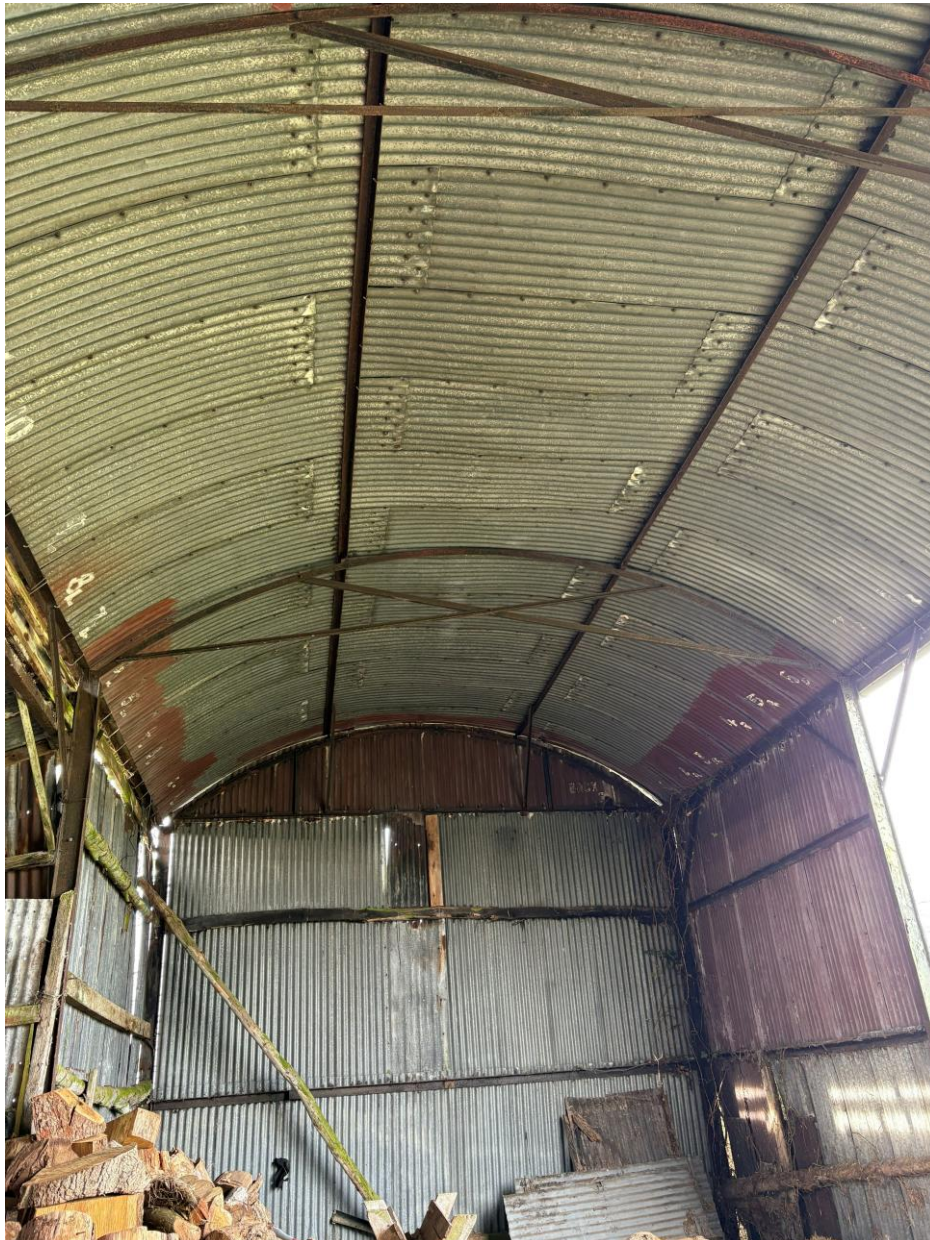
The roof of the building is of curved corrugated steel sheets, resting on steel angle purlins, which span lengthways along the building, between and are supported by steel cross scissor trusses, which run front to back.

**General View of Roof Structure**

The steel columns are knee braced at the top o provide stability to the building.

The roof structure is in reasonable condition.

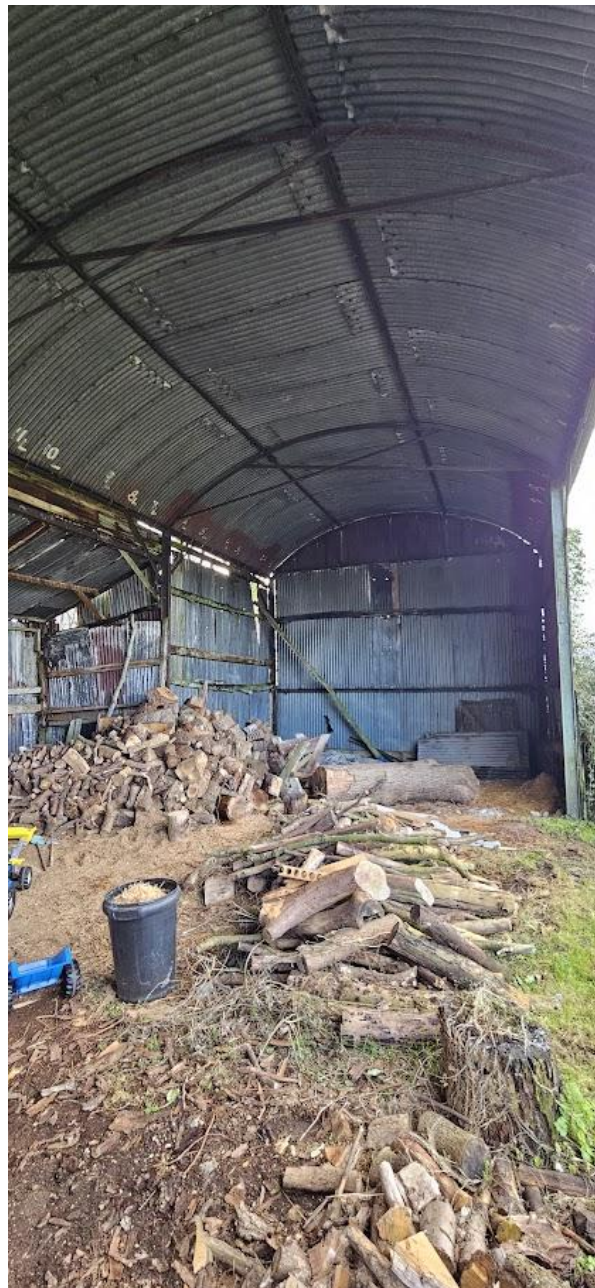
The general wall corrugated sheeting is due for an overhaul.

**General View of End Wall and Floor**

The floor of the building is of rammed earth, stone and chalk typical for the nature of the use of barns of this type and age.

Upgrading of this floor will be required with insertion of a damp proof membrane, insulation and a concrete slab, to provide a floor in accordance with the Building Regulations.
