**TREES AT LAND ADJ TO TUDOR COTTAGE, PARK LANE, CHERHILL, CALNE, SN11 8QN.**

**Brief:**

Survey trees that have a potential impact on the proposed development at Land Adj to Tudor Cottage, Cherhill, SN11 8QN from the plans provided. Comment upon their condition, suitability for retention and the impact they may have upon the proposed development.

**Date of Inspection:** 09.07.25

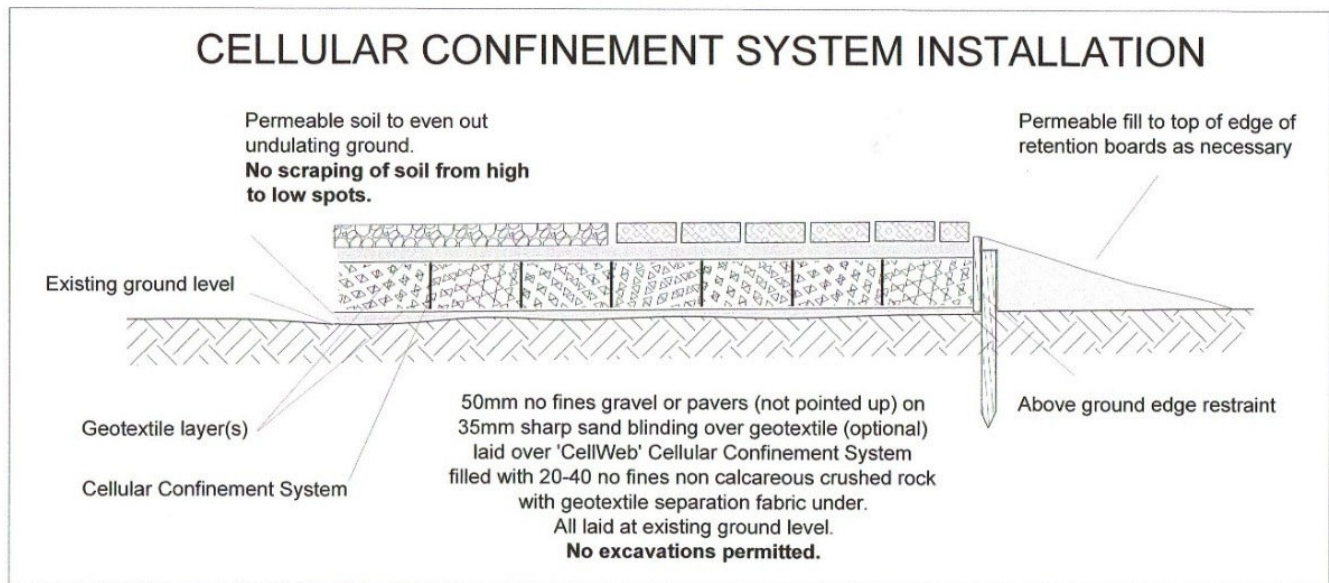
Diagram 1

Currently the site has a shared access with Tudor Cottage. In the plans provided there is a proposal for the site to have its own access driveway. The route of the driveway would be through part of the RPAs of T4, T14 and T15. To mitigate any impact on the trees from the proposed driveway there are a number of things that can be done to maintain the circumstances that the trees are currently used to. Firstly, we would state that the driveway cannot be constructed within 1 metre of the trunk of a tree. This protects the structural buttress roots of a tree and prevents damage to the driveway. If structures are constructed too close to trees as they grow and develop, the tree will exert pressure on the structure and deform it over time. The maximum changes in soil depth within the RPA are to be 100mm excavation or 150mm increase. 100mm would remove the top layer of turf without disturbing the tree's root system. 150mm increase would not detrimentally impact the penetration of moisture and gases to the tree's rooting system. Finally, a cellular confinement system, as shown in diagram 1, should be used. This type of cellular confinement system has been used for more than 20 years for the protection of tree roots. There are hundreds and thousands of examples where this system has been used and the trees have continued to be successful. We believe this can also be the case on this site. This method of protecting roots has been very successful because of its ability to spread load and protect against compaction within the rooting zones and when constructed with permeable materials the water that would normally be intercepted by the grass or other competitors is able to permeate down to the roots of the tree. As this water percolates through the cellular confinement system, it draws oxygen down with it making it available to the roots of the tree. This system also has the benefit of

being able to store water on a short-term basis, slowing down runoff and helping to prevent the drains being swamped. The wearing layer and sub-base layers will need to be permeable to enable moisture, nutrients and gases to be accessible for the roots and from a non-marine source. The permeable wearing layer will need to be constructed of a material that promotes easy maintenance. Being able to clear up easily the detritus that falls from a tree will promote a positive relationship between the trees and the residents of the proposed development.
