# Structural chimney appraisal

17 The Close, Salisbury

| Document ref. | 14781.1 |

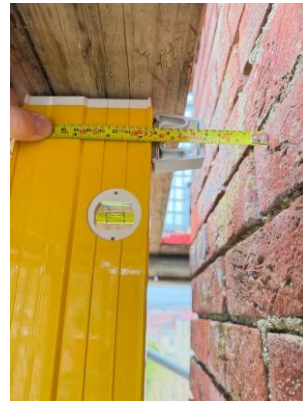
- Plan dimensions = 580mm x 1280mm
- Maximum exposed height (from lowest roof tile) = circa 3.5 metres
- Verticality check
  - South elevation = plumb over 3.15m height
  - West elevation = chimney leaning 50mm east at top over 2.23m height (2.3mm lean per 100mm height)
  - *Measurement of the south elevation is from the u/s of the cap corbel, and the west is from the u/s of the top scaffold lift.*

Figure 12 – West verticality check

- **Option A** - Dismantle and rebuild chimney stacks
- **Option B** – Install Helibar around full perimeter at every third course and repoint in lime. Monitor within touching distance yearly.
- Install cowls onto pots which prevents water ingress but permits air flow.

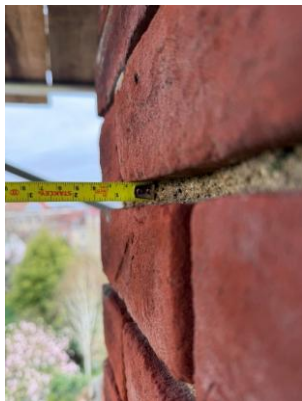
The stack is partially built into the north west gable. There is a visible change in brick and pointing quality from the adjacent window head upwards. The stack contains three grouped flues. The brick is laid in stretcher bond. No headers were noted and it is assumed that the withes (brick flue divider), which can be seen when looking down the pot, are not bonded to the outer stack masonry. The flaunching has cracked and 15mm loss of pointing is typical across the elevations.

Figure 13 – Typical depth of pointing loss

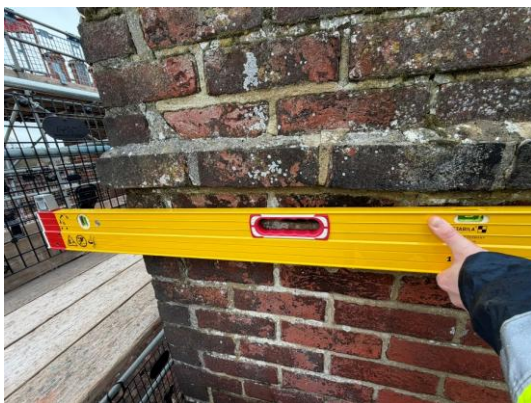
- Plan dimensions = 580mm x 1280mm
- Maximum exposed height (from lowest roof tile) = circa 4.5 metres
- Verticality check
  - South elevation = stack leaning 30mm north at top over 2.03m height (1.5mm lean per 100mm height)
  - East elevation = plumb over 3.15m height
  - *Measurement of the south elevation is from the u/s of the top scaffold lift., and the west is from u/s of the cap corbel*
- Level check
  - East elevation string course = 50mm lower at north end

Figure 22 – 55mm string course dip at north

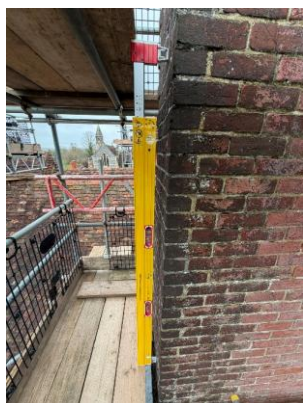
Figure 24 – South verticality check

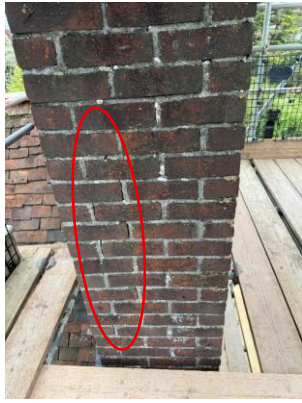
The stack is partially built into the north east gable. As per chimney A, the stack contains three grouped flues and the brick is laid in stretcher bond. The north and east elevations appear to have been previously repointed in lime but are now failing. A separation crack is present in the south elevation, suggesting that the east and west elevations are moving apart, possibly as a deformation/tension effect on the side away from the lean.

Figure 26 – Separation cracks at south elevation

Chimney B is plumb in the minor axis but has a significant lean in the major axis. Although the stability of the stack is less concerning here, the stress concentrations in the masonry below are likely to be high. The separation cracks noted are an indication that the lean may be causing some tensile related deformation on the opposite side.

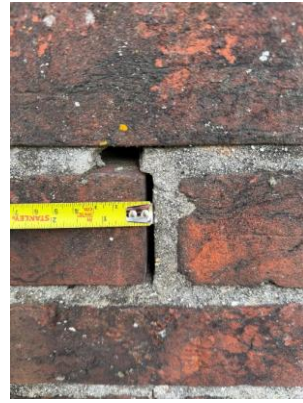
Figure 27 – Close view of typical south elevation separation crack

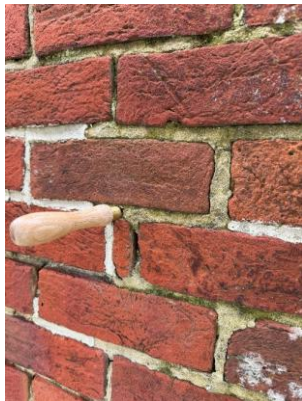
Figure 28 – Soft pointing on east elevation

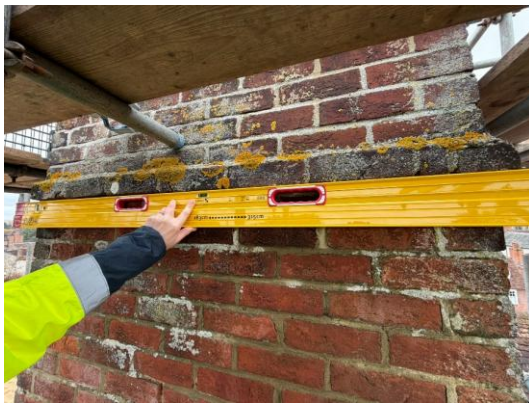
Figure 37 – 10mm string course dip at west

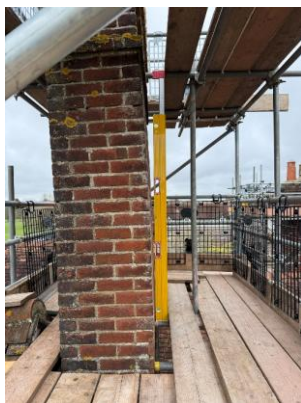
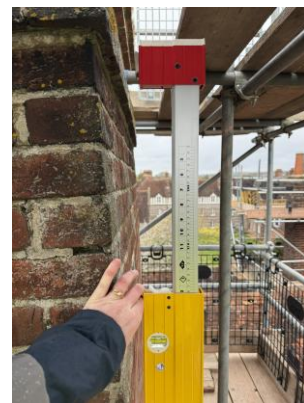
- Plan dimensions = 580mm x 1525mm
- Maximum exposed height (from lowest roof tile) = circa 4.5 metres
- Verticality check – *measurements are from u/s cap corbel*
  - North elevation = chimney leaning 78mm south at top over 2.3m height (3.4mm lean per 100mm height)
- Level check
  - North elevation string course = 10mm lower at west end
- Individual flue plan opening size = 1.5 brick square

Figure 39 – North verticality check

- Chimney A = 50mm toward east (circa 2.3mm lean per 100mm height)
- Chimney B = Plumb
- Chimney C = 78mm toward south (circa 3.4mm lean per 100mm height)
- Chimney D = ~50mm toward east (circa 1.6mm lean per 100mm height)

- Dismantle and rebuild chimney stack
- Install cowls for ventilation

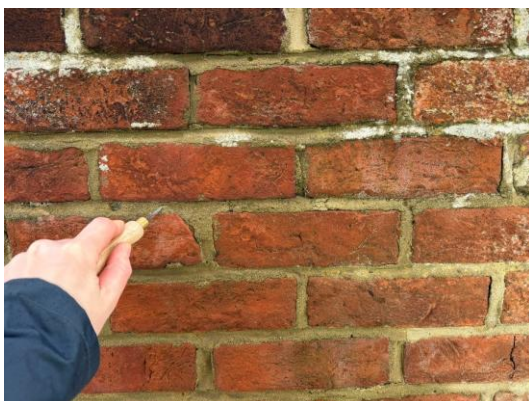
Figure 41 – Cement pointing at north

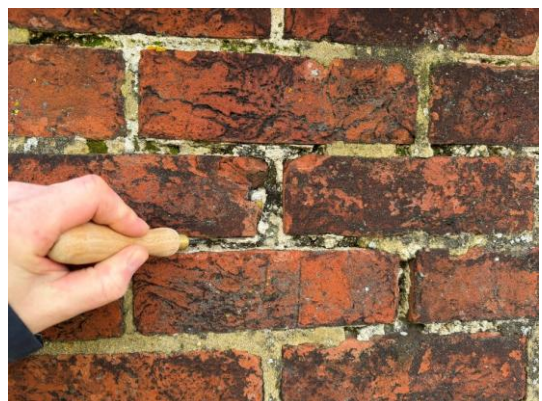
Figure 42 – Soft pointing at south

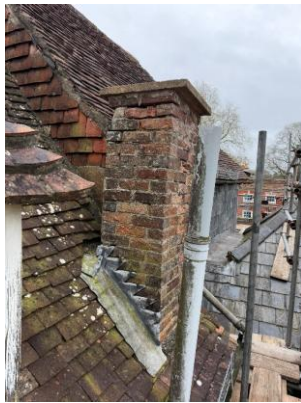
The chimney is located on the west side of the house. Is it a single flue stack, much shorter than the others. The brickwork is in poor condition toward the top and the flue has been capped with a concrete slab. The leadwork at the roof interface is in poor condition.

Figure 49 – North elevation

- Rebuild top courses of stack
- Repoint in lime
- Install cowl for ventilation
