# SALISBURY CATHEDRAL

**CLOSE WALL REPAIR**

17 AND 18 THE CLOSE

**DESIGN & ACCESS STATEMENT**  
**HERITAGE STATEMENT**  
**HERITAGE IMPACT ASSESSMENT**

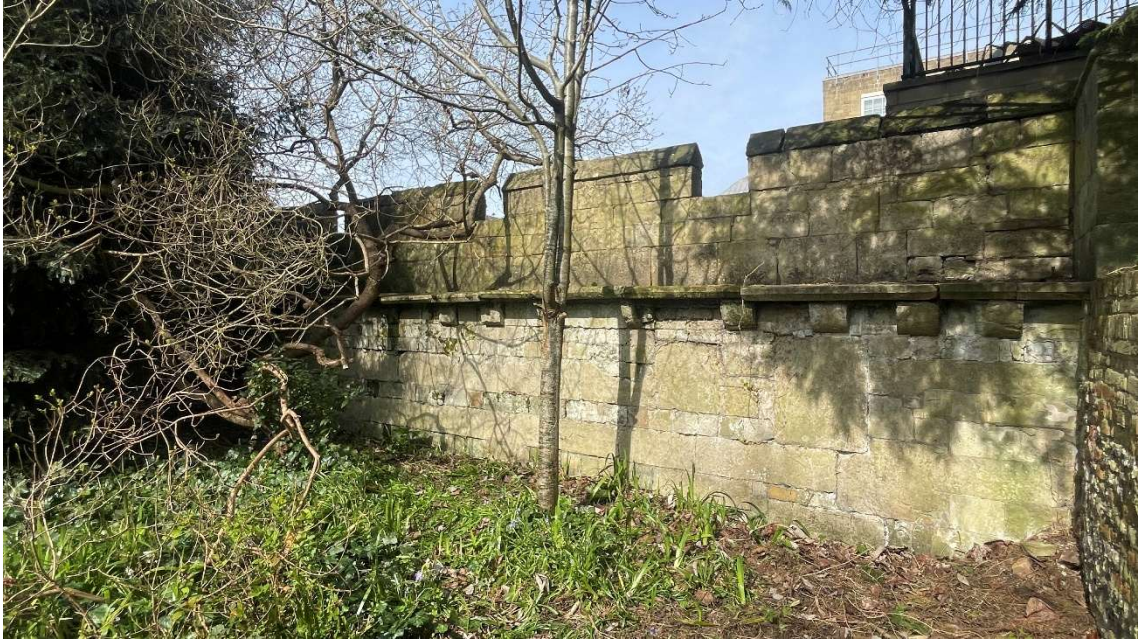
- 1.5 The outer section of wall between no. 18 The Close and no. 1 New Street (the Wig and Quill Public House) is in poor condition and has an alarming lean to the north side. The wall section north of no. 17 The Close is in better condition, but current repair works being undertaken to no. 17 provide access to the wall for generational maintenance and repair.

Figure 1.5a: The wall in the garden of no. 18 The Close

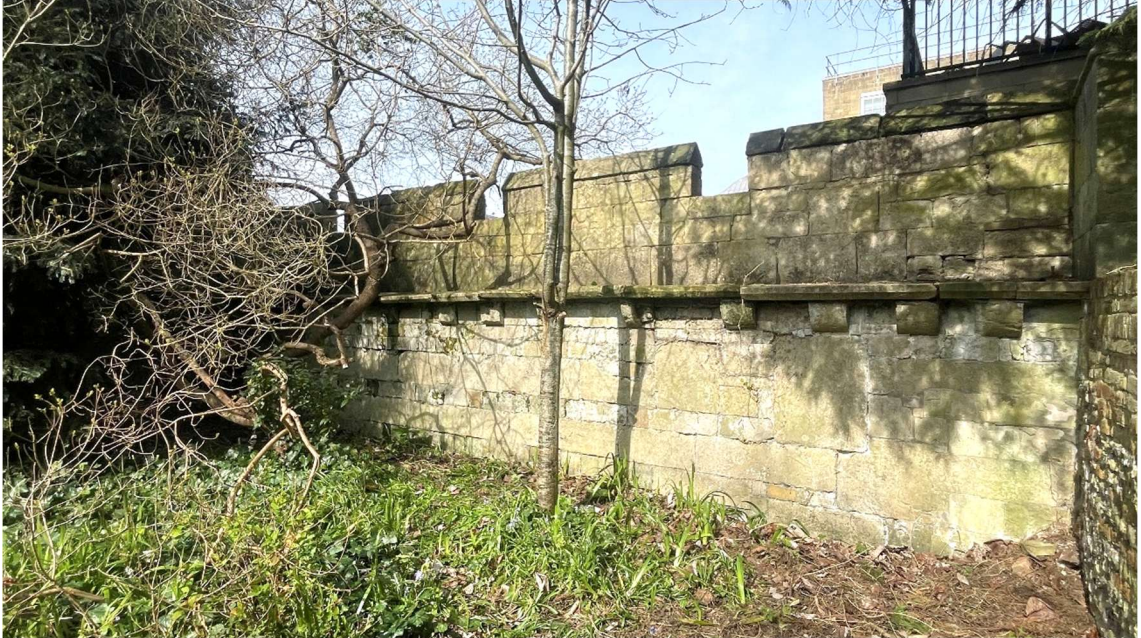
Figure 3.1: The south face of the wall to the end of the garden of No. 17 The Close

- 3.1 This section of wall is approximately 12m long by 2.8m high. It is generally in good condition but the wall walk paving needs attention; individual stones in areas need replacement; and pointing is deteriorating. Proposed repairs are shown on drawing **1207 (CW) P-06**.
- 3.2 The south face of the wall was covered by extensive vegetation recently, which was removed in 2025. The branch of a tree has been growing into the wall walk and has now been removed. There has been root penetration between the wall walk and the parapet section. There is a gap between the wall and paving, and stone pavers have been dislodged towards the south. Isolated sections of wall are leaning but the wall is generally plumb. There is a 50mm outward bulge to the centre of the wall to the south but there are no signs of problems arising from this.

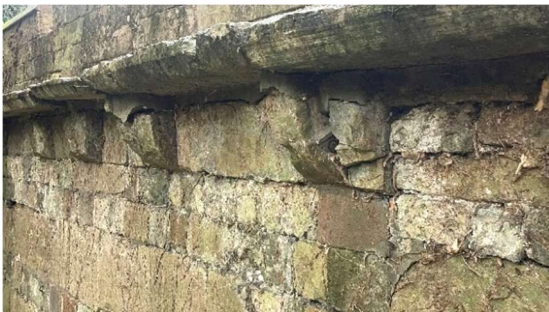
Figure 3.2a: Stone corbels supporting the wall walk

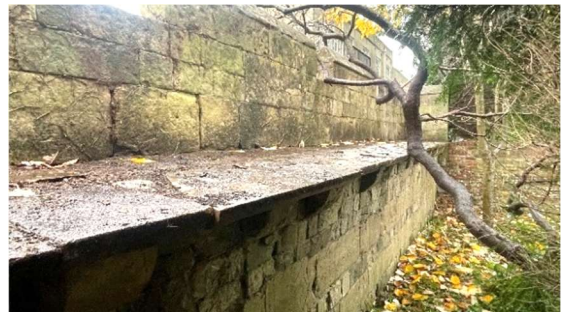
Figure 3.2b: The wall walk

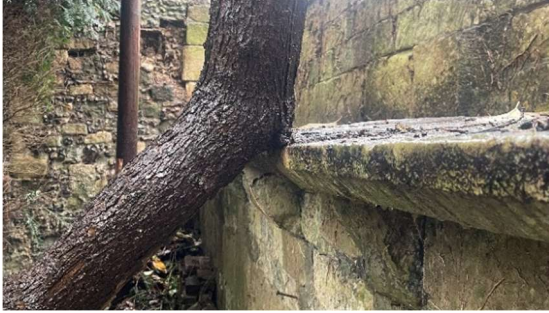
Figure 3.2c: Branch growing into the wall walk

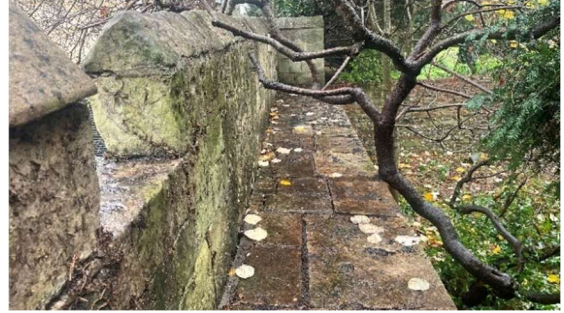
Figure 3.2d: Wall walk looking east

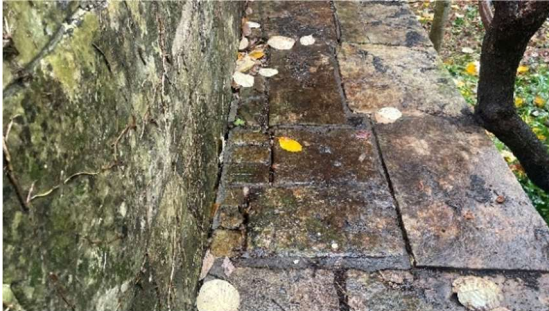
Figure 3.2e: Wall walk paving

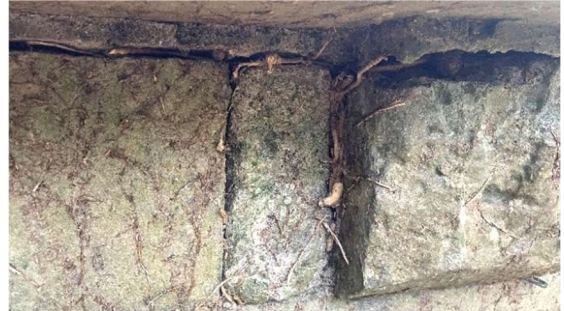
Figure 3.2f: Dislodged stonework

- 3.5 Around half-a-dozen stones are shattered or very friable and are proposed for replacement.
- 3.6 There is a return section of wall running to the south between the gardens of nos. 18 and 17. This wall appears to be a later addition, containing random ashlar blocks and a lot of flint facing bedded in hard cement mortar. There has been extensive root penetration in the wall and the wall head is loose and does not protect the wall from water penetration. It is proposed to re-bed the wall head and relay the flint facing to the north, as application drawing **1207 (CW) P-08**. The cement mortar matrix for the small un-knapped flint stones mean that they will need to be taken out and re-laid; it is not possible to rake out so much cement mortar without the small flints falling out.

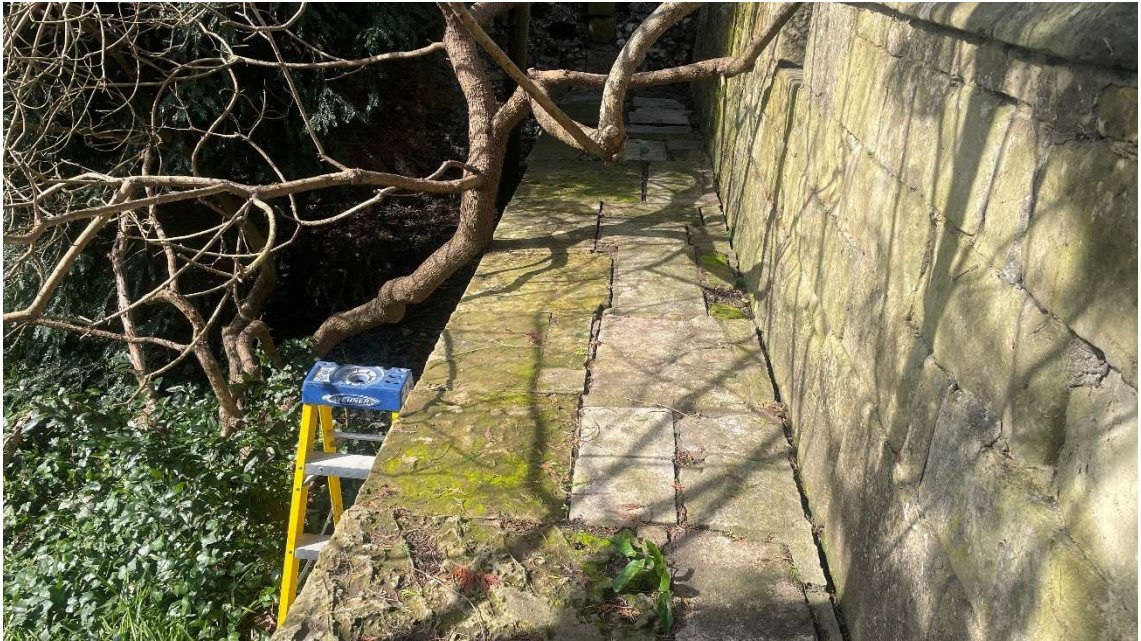
- 3.4 The smaller pieced-in stones and the gap against the parapet are problematic as root penetration at this point has caused structural problems to many sections of wall. The ability of the upward-facing paving to deflect water from penetrating the wall core is vital, and the wall walk paving must be in good condition with mortar joints minimised in order to protect the entire wall. As such it is proposed to remove the pavers to allow removal of embedded root systems below and to re-set the paving that has been forced upwards by vegetation, and to replace the smaller stones against the parapet with larger Chicksgrove stone slabs with much tighter joints. Ensuring the wall walk paving is intact and can shed water, much like the roof of an historic building, is an established methodology for repair and protection of the crenellated sections of Close Wall, as recently undertaken to crenellated wall section in the Bishop Wordsworth School (application PL/2022/03615).

Figure 3.4a: The wall walk paving

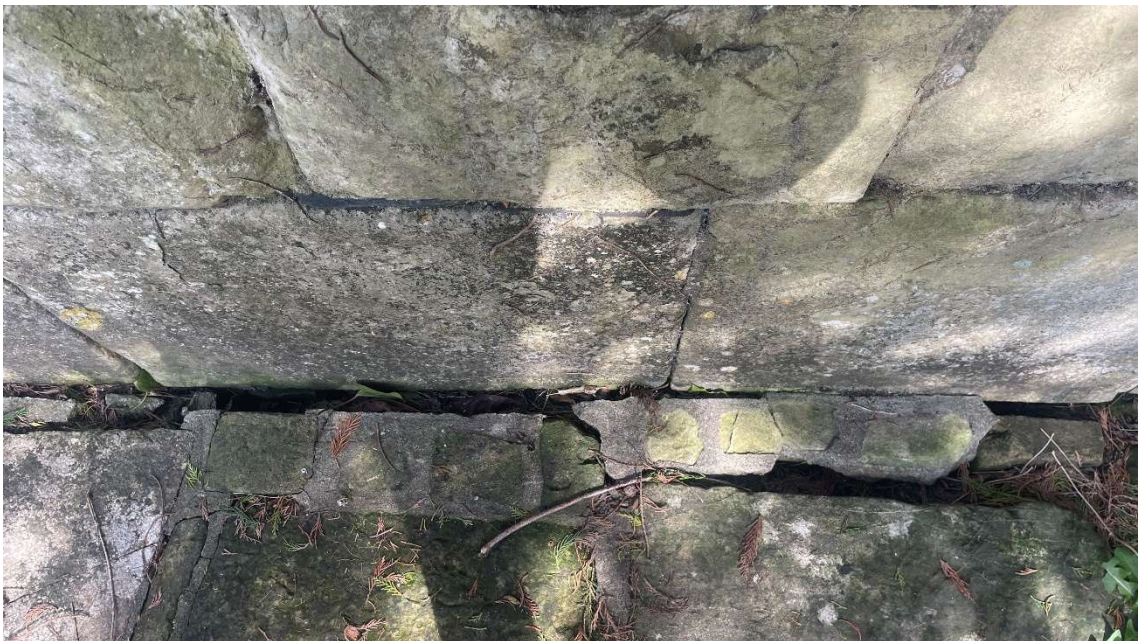
Figure 3.4b: Gaps between the wall walk and crenellated parapet section allowing water and root penetration

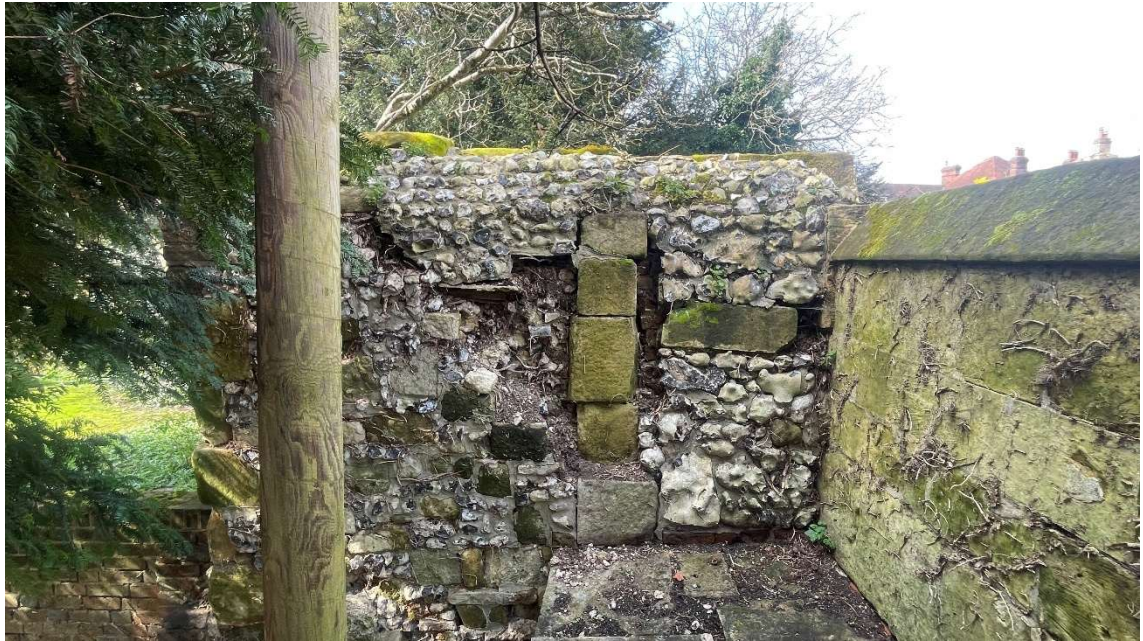
Figure 3.6a: The south return wall between nos 18 and 17 from the east

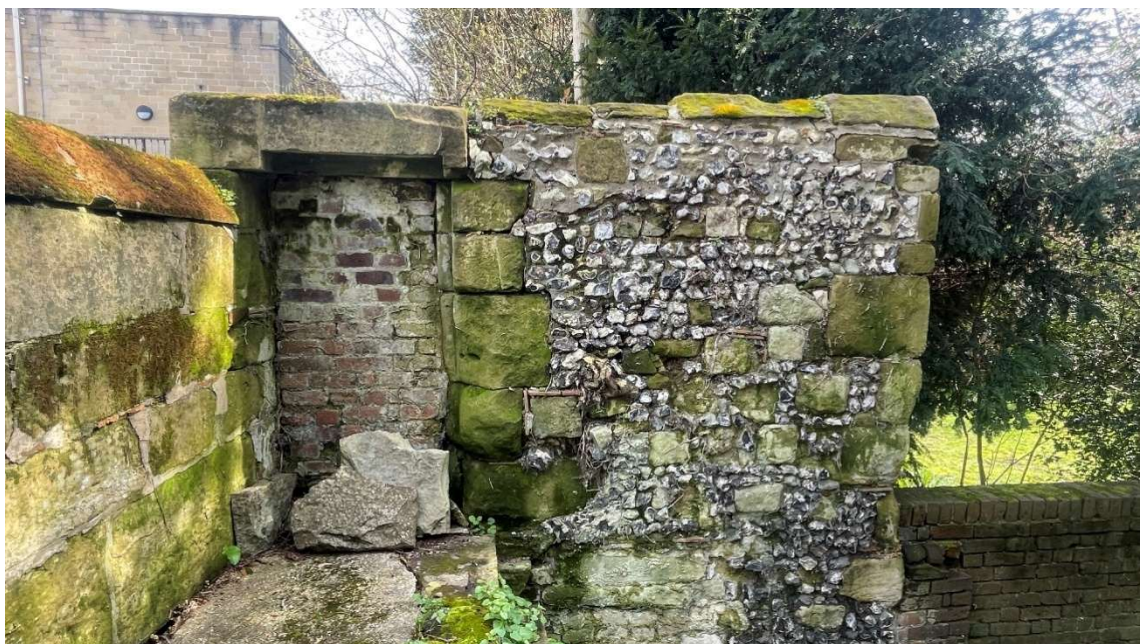
Figure 3.6b: The south return wall from the west

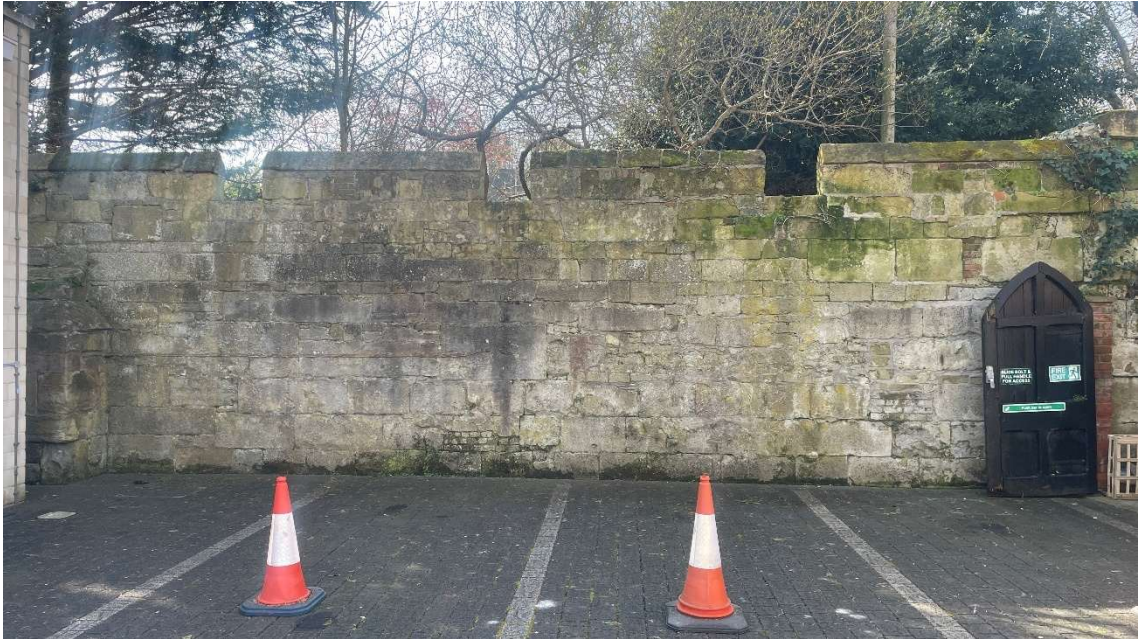
Figure 3.7a: The north face of the wall from the car park of Alexandra House

- 3.7 The north face of the wall to no. 17 is within the car park of Alexandra House on New Street. The wall is plumb and is generally in good condition.
- 3.8 Proposed repairs are shown on drawing **1207 (CW) P-07**. Around half-a-dozen stones to the west have no faces and are friable and are proposed for replacement. A similar number require mortar repairs. An allowance has been made to repoint 50% of the wall, which will be reviewed on site.

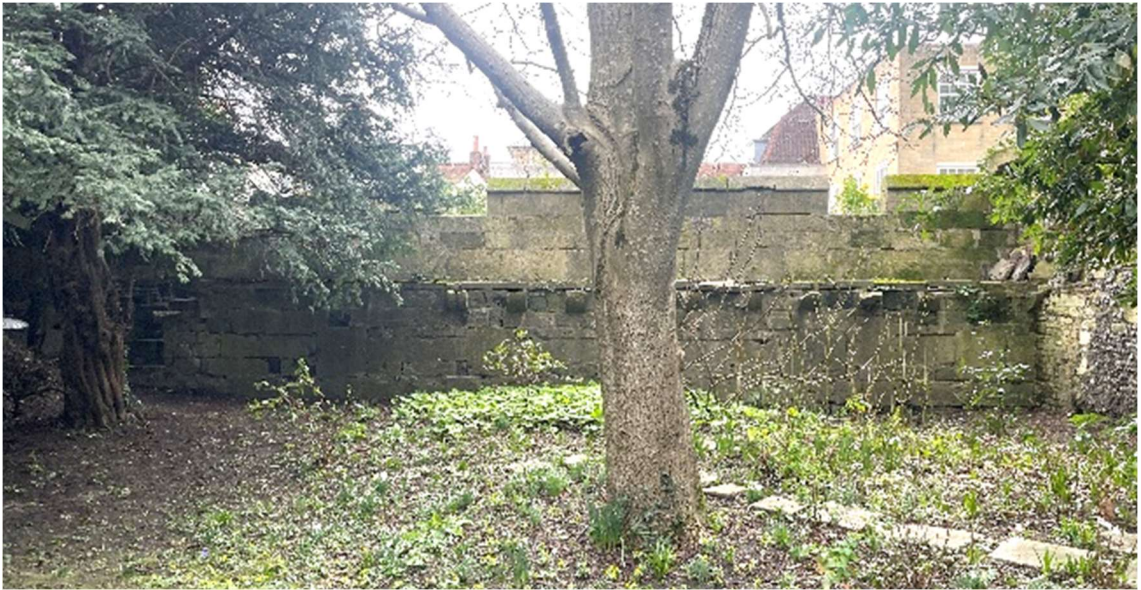
Figure 3.9: The south face of wall in the garden of no. 18 The Close

- 3.9 This face of wall is in poor condition. It is relatively plumb. The wall walk has a concrete capping with a large gap to the crenellated parapet wall which has caused a lot of water ingress and vegetation growth. This has pushed the top of the wider wall walk section of wall nearly 200mm northwards into the garden of the Wig and Quill (the entire parapet wall length has bent 200mm to the north while remaining intact and upright – see figure 3.9i). The outer 300mm edge of the wall walk has narrow strips of stone which are collapsing. A section of wall to the west corresponding to no. 3 New Street has had the embattlements removed and merlons loosely rested on top; the wall walk is missing here and there are ad-hoc stone steps indicating a later rebuild. There is little surface ivy but the remains of large root systems are embedded in the wall, including a large buddleia stump, indicating the cause of the structural damage now very much in evidence to the north side of the wall.

- 3.10 Proposed repairs are shown on drawing **1207 (CW) P-04**. The merlons across the entire wall length are loose and need to be re-bedded. The wall walk concrete capping and paving need to be removed to extract the embedded root systems within the wall core and to fit the proposed anchor rods (see below) into the wall core. To ensure the wall head drains and to minimise the chance of root penetration it is proposed to lay new, larger Chicksgrove stone pavers to the wall walk to replace the concrete and narrow strips of outer stone. The paving will be laid to fall to the south to throw water as quickly as possible.
- 3.11 Some of the supporting corbel stones are fractured. These are structurally important to support the original detail of the cantilevered chamfer paving (which will be reinstated to both wall lengths).

- 3.12 In order to arrest the alarming outwards hinging of the north face of wall the cathedral engineer has proposed four tie rods through the wall with pattress plate anchors on each side. The wall work masonry below parapet level is thick and tying the north face to this bulk of masonry will anchor the wall. The pattress plates will be visible on the south wall face; these are proposed in cast iron to match the Chilmark stone colour.

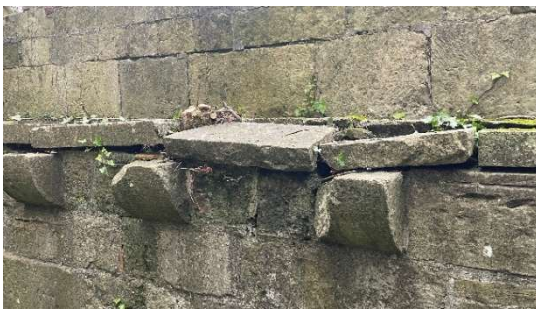
Figure 3.9a: The wall walk paving collapsing locally

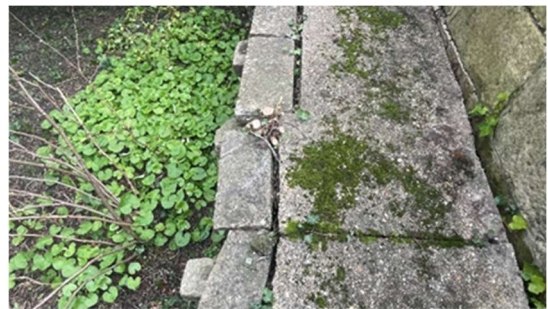
Figure 3.9b: The wall walk showing concrete capping

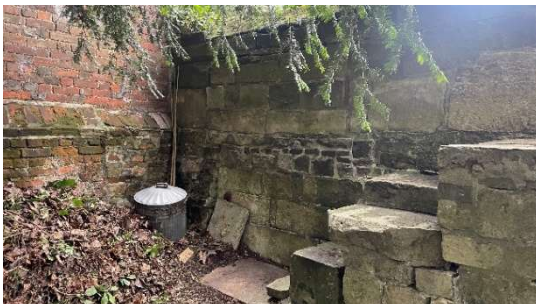
Figure 3.9c: The west end of the wall

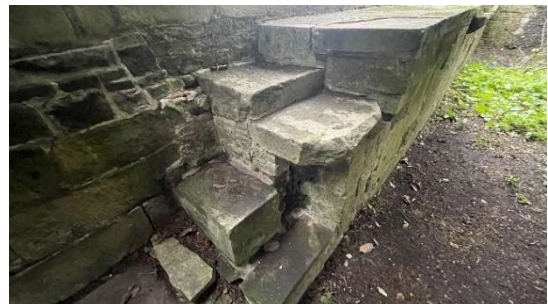
Figure 3.9d: Ad-hoc steps (non-original)

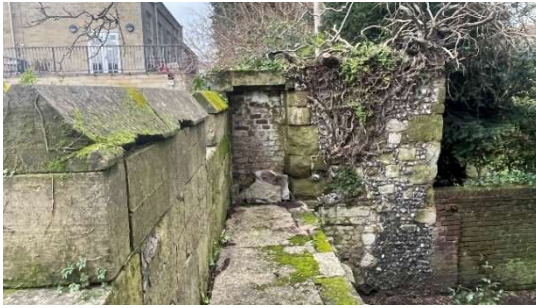
Figure 3.9e: The wall walk looking east

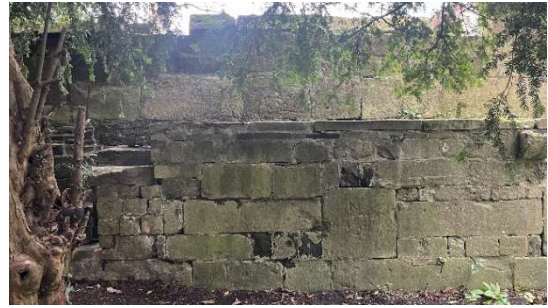
Figure 3.9f: Lower wall facing

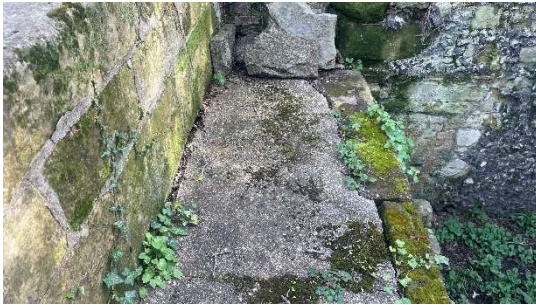
Figure 3.9g: Wall walk concrete capping

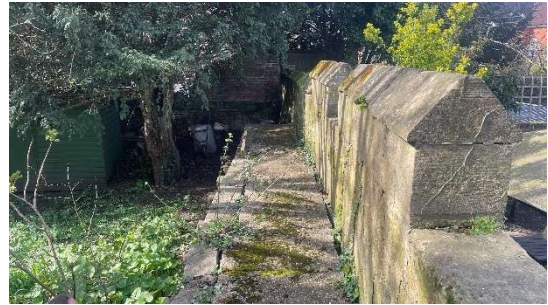
Figure 3.9h: The crenellated parapet

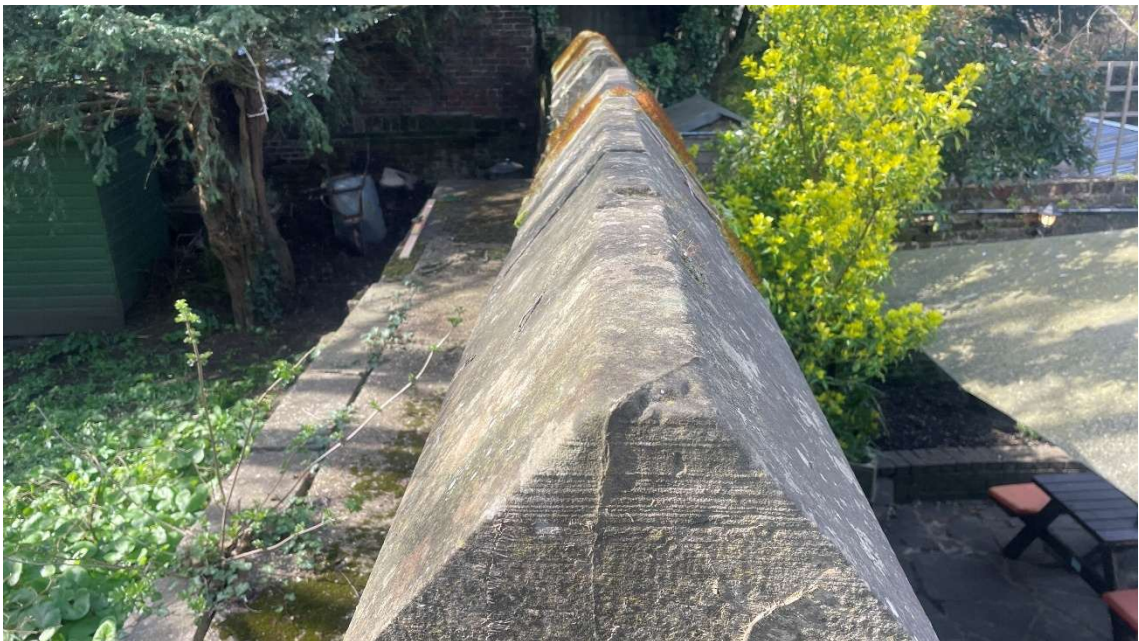
Figure 3.9i: Deviation in the wall head indicating the northwards movement of the wall

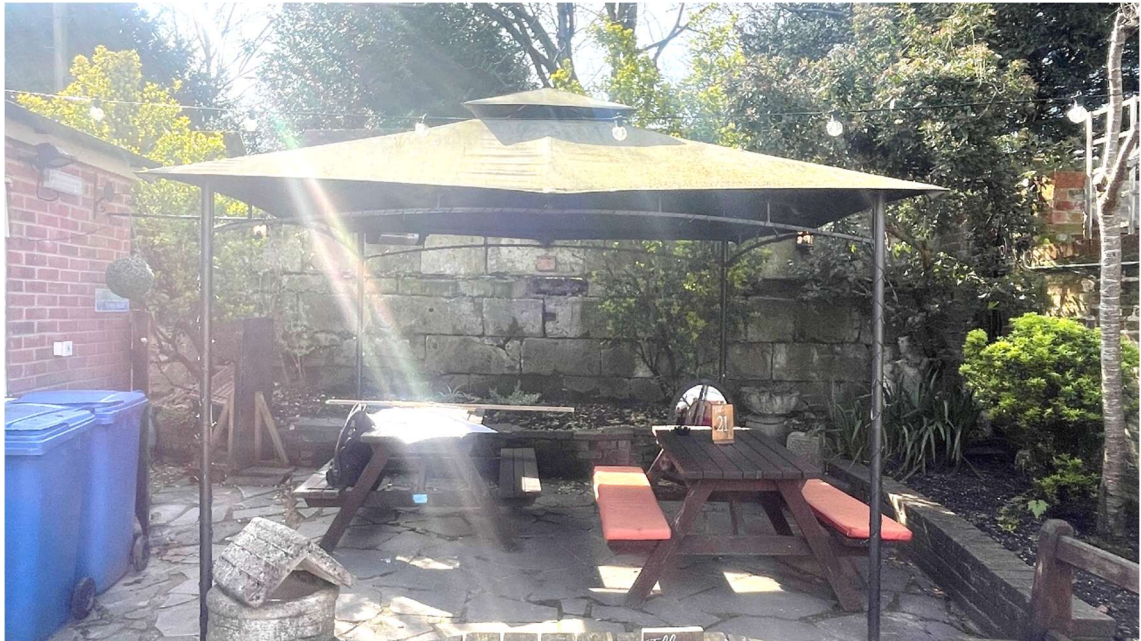
Figure 3.13a: The wall within the garden of the Wig and Quill Pub (no. 1 New Street)

- 3.13 The wall on the pub garden side bulges and hinges to the south at the point of the wall walk. There are missing stones. The wall hinges considerably to the north – it leans out 220mm to the midpoint, where a course of stone is missing, then leans back in 60mm to the embrasure point – see figure 3.13.

- 3.14 Proposed repairs are shown on drawing **1207 (CW) P-05**. The large gap of missing stonework at the hinge point is to be pointed with a tile creasing course to help pack the deep joint, with some adjacent stone replacement and infill of missing stones. The merlons need to be re-bedded. Ivy roots are to be removed. The hinging lower section of wall is to be restrained with four tie rods through the wall which will need to be cored through stones on this face. These will be tied by cast iron pattress plates, painted to match the Chilmark stone colour. The wall will be fully repointed.

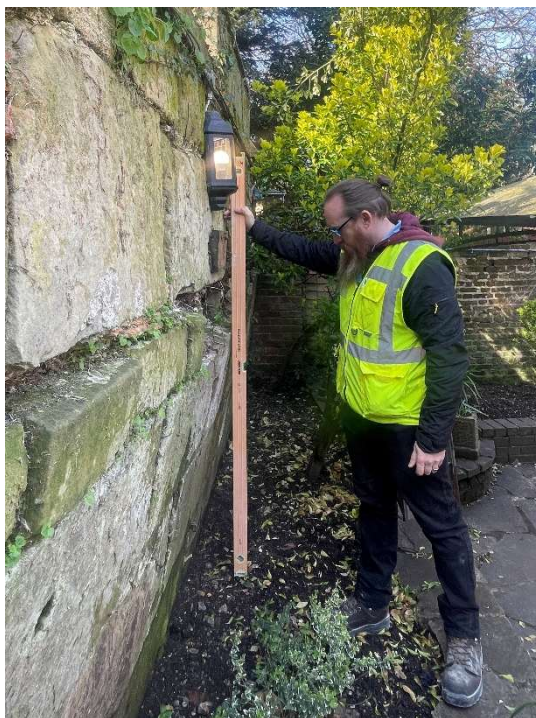
Figure 3.13b: The extent of lean to the north is alarming

The lower section of wall leans some 220mm to the north below a clear 'hinge line' some 1.3m above ground level on the northern side. This line is clearly visible and has been periodically repaired and infilled, using both stone and mortar.

The movement is clearly historic, but it is difficult to judge whether movement is progressive; however, any active movement does not appear to be at a rapid rate. The movement is probably due to a combination of settlement of the wall foundation and lateral movement of the northern skin due to settlement of the core of the wall. The walkway is 'concrete' capped and in apparently reasonable order, though ivy has clearly penetrated the wall from the southern side. This ivy has probably, over the years, contributed to movement of the wall.

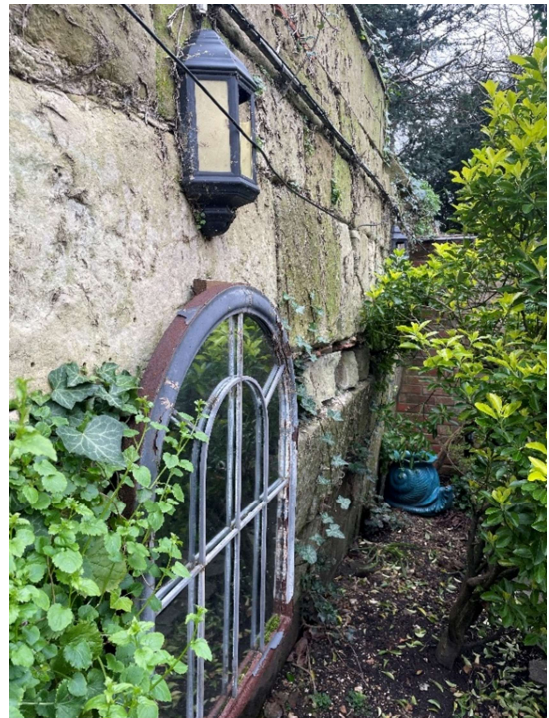
Figure 3.13c: Loose stonework is evident at low level

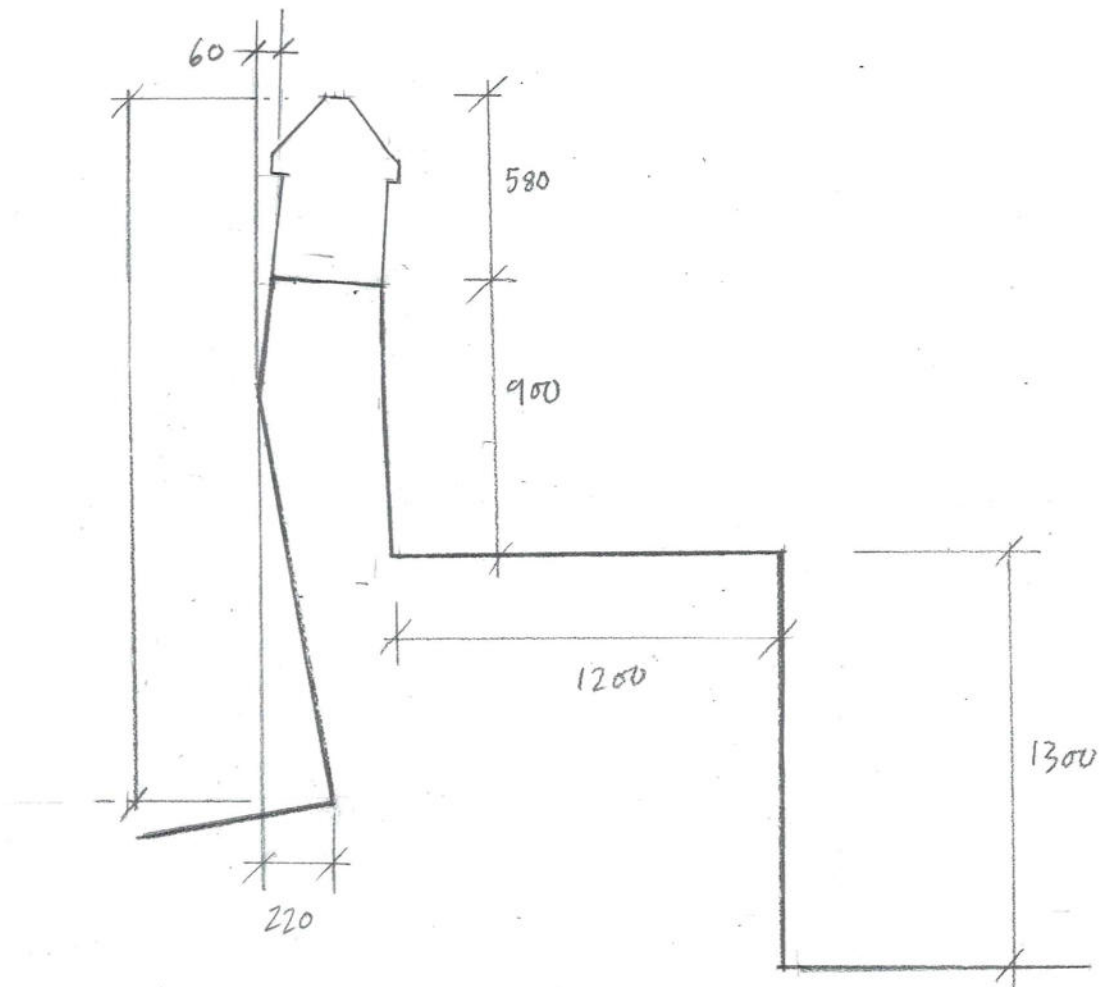
Figure 3.13d: Section through the wall looking east showing the hinging to the north

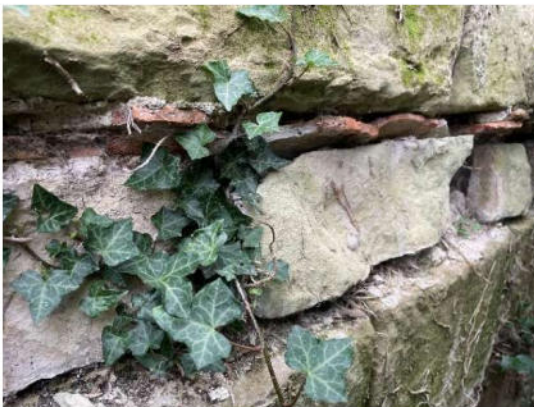
Figure 3.14a: Loose stonework in the wall

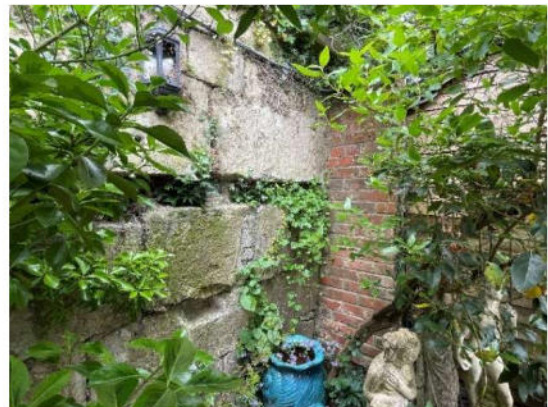
Figure 3.14b: Junction with Party wall to west of No. 1

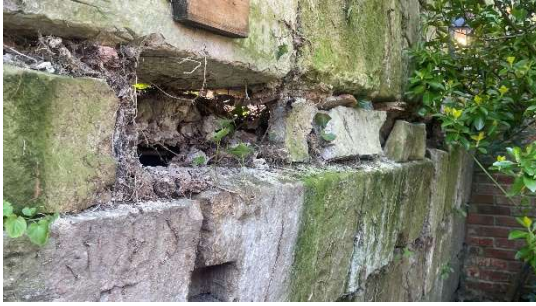
Figure 3.14c: Missing stonework in the wall

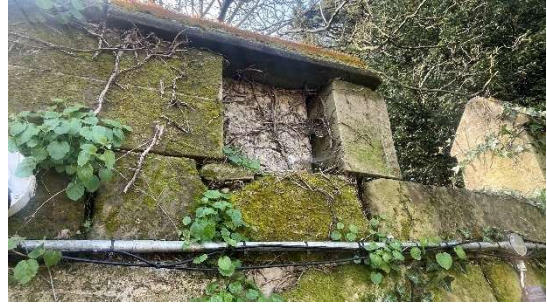
Figure 3.14d: Missing stonework at crenellation level

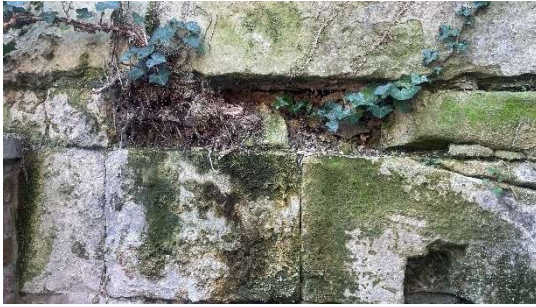
Figure 3.14e: Ivy growing from the wall

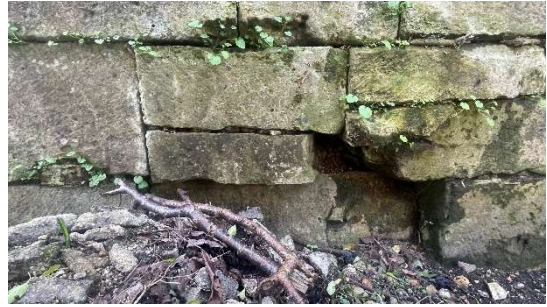
Figure 3.14f: Missing stonework at low level

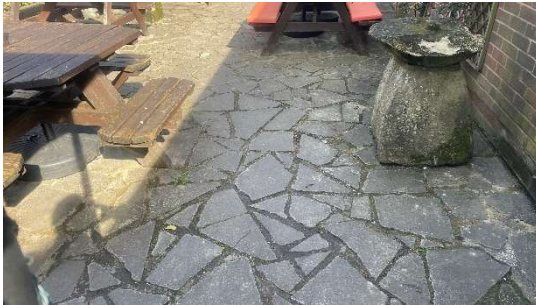
Figure 3.15a: Crazy paving landscaping

- 3.15 It is proposed that a small section of crazy paving to the east end of the wall is lowered by approximately 400mm to provide a level egress route from the pub for escape and refuse (to avoid bins toppling over and damaging the wall). A new small length of low Chicks Grove stone-clad retaining wall is proposed to address the change in level to the existing raised planting bed.

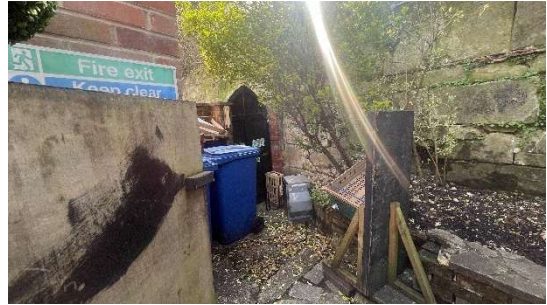
Figure 3.15b: The area to be lowered (under the crate)

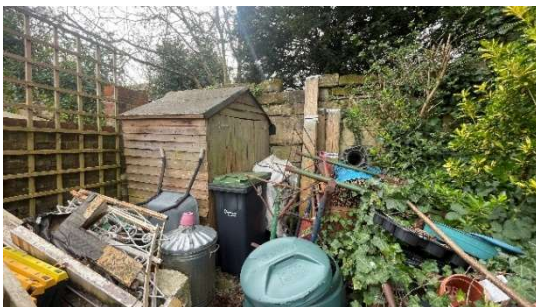
- 3.16 The west section of wall lies within the garden of no. 3/5 New Street (united for many years as a single property). There are a shed and garden walls built hard up against the wall (the shed is to be removed). The wall head here has been lowered. The merlons are loose and need to be rebedded; one large stone needs to be re-set, and the wall has little pointing and needs a full deep-pack repoint.

Figure 3.16a: The wall to no. 3/5 is difficult to access

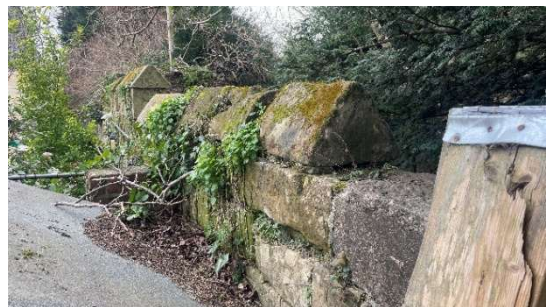
Figure 3.16b: The lower parapet facing no. 3/5

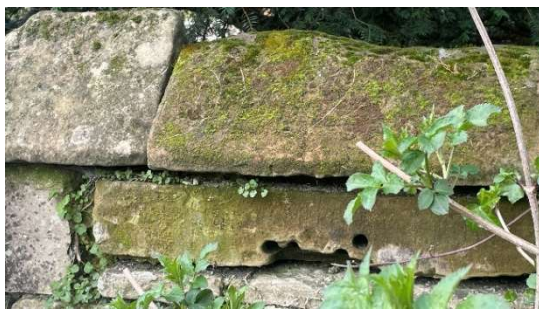
Figure 3.16c: Missing pointing

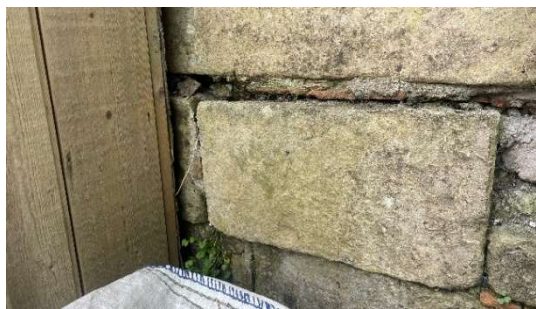
Figure 3.16d: Stone to be re-set

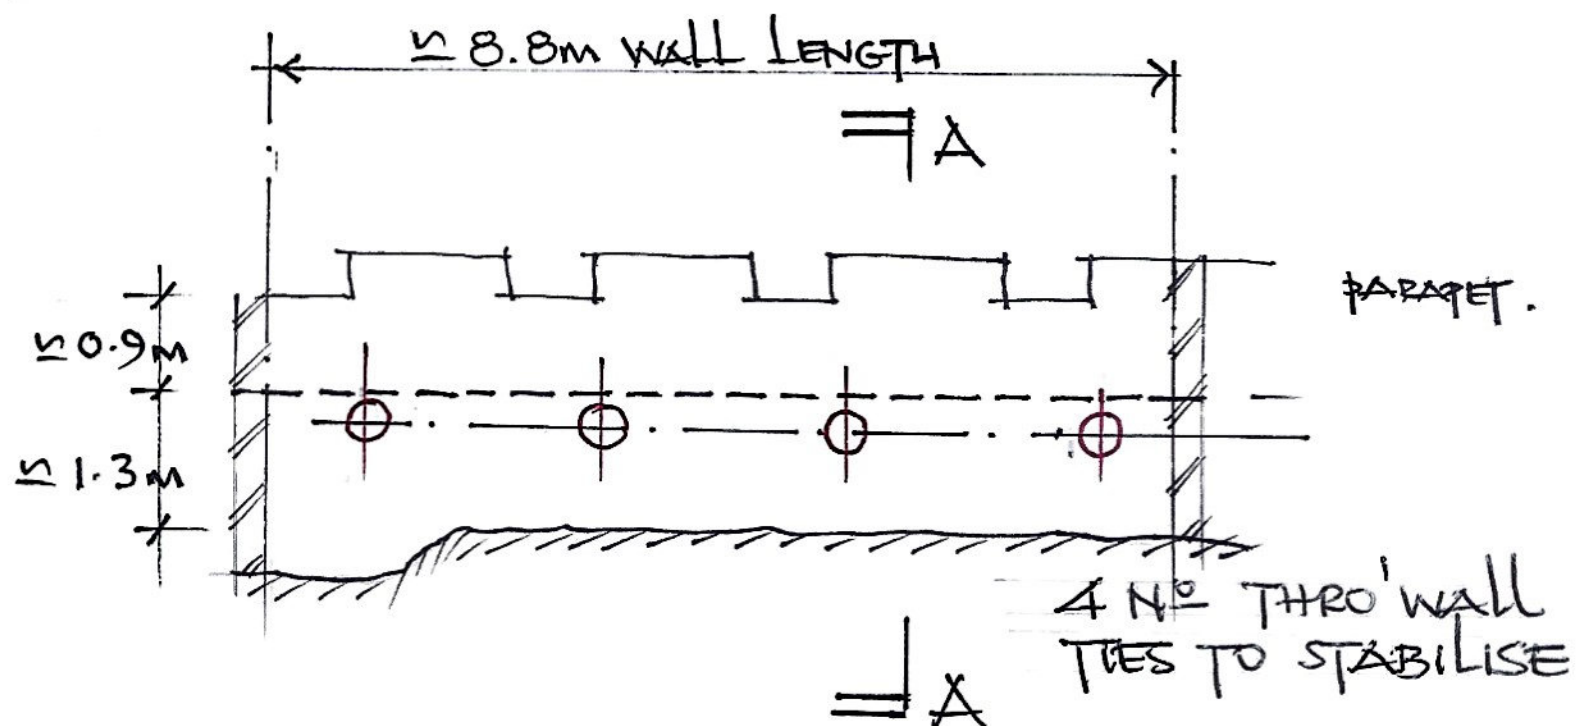
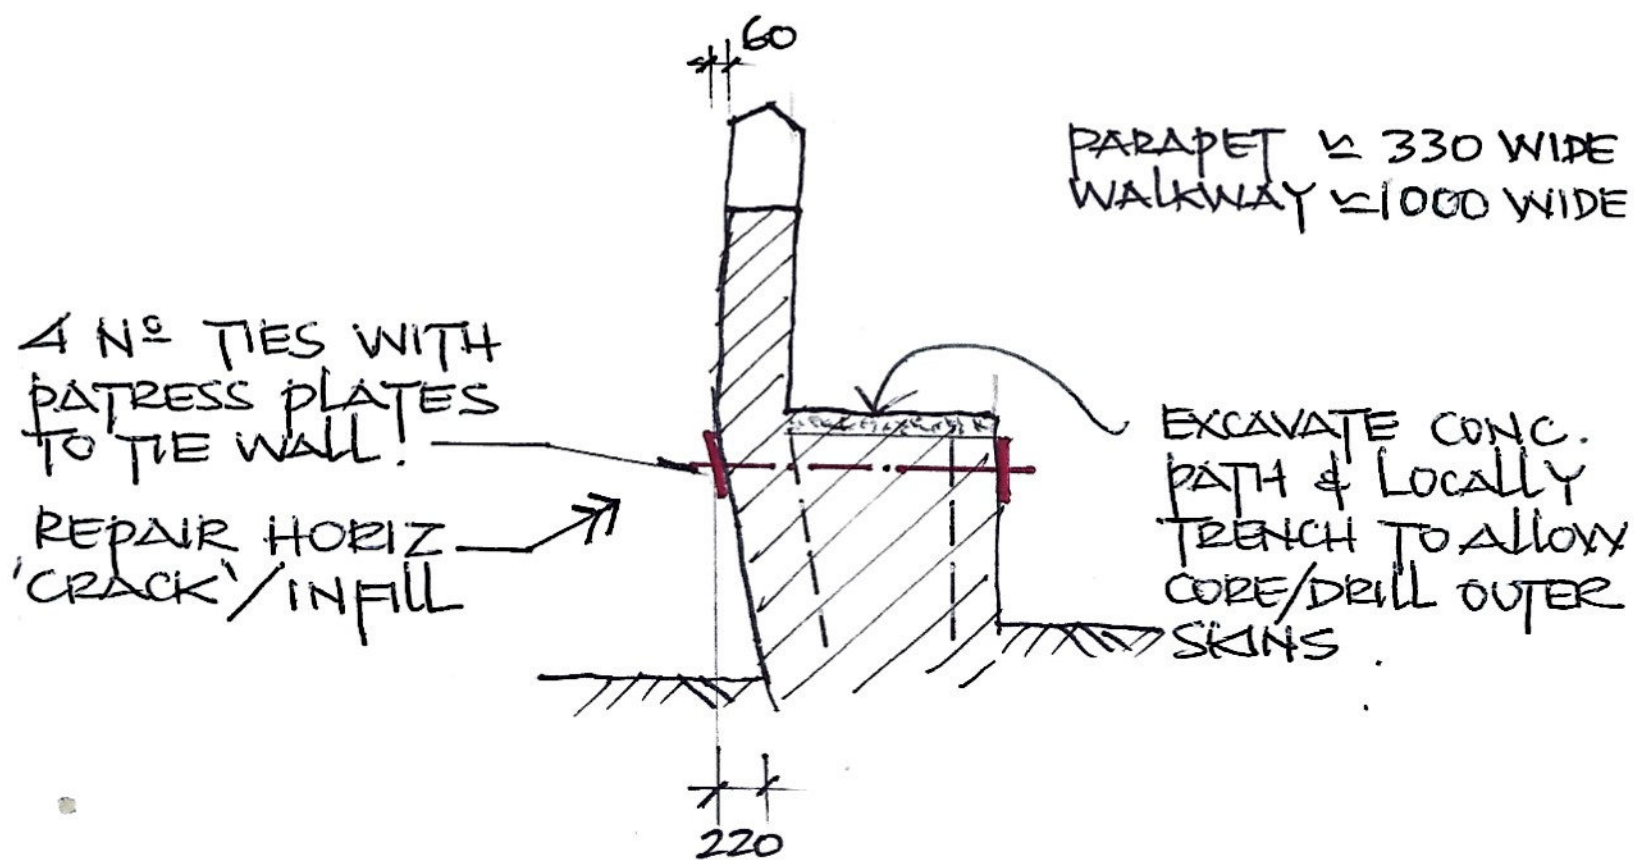
656.CW.S01

Above this level the parapet leans to the south by approximately 60mm.

Clearly, it would be preferable to retain the wall rather than rebuild it and this is possible. I attach my sketch showing a possible solution using through-ties and pattress plates on each face, in four locations. These ties can, with advantage, be installed from the southern side. The walkway concrete path should be removed, and some fill locally removed to allow holes to be drilled in each face. This will avoid the need to core drill the full width of the wall from one side. The wall core can be cleared of ivy roots and any voids locally grouted to stabilise the wall core. The 'hinge line' would need repair with new stone pieced in as appropriate.
