Our Ref: 25-043-P2

Home Farm, Swan Lane, Leigh, SN6 6RD

## Structural Report in support of Class Q permitted development

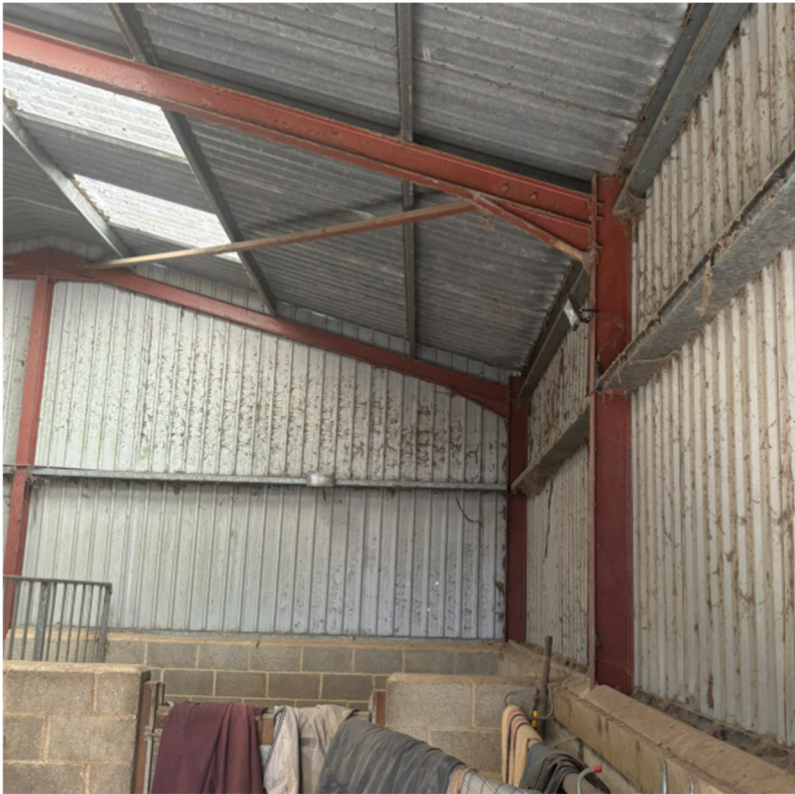
- Minor surface corrosion of steel brackets above the walls (which can be dealt with by re-coating as part of any conversion works).
- Settlement of the slab below the north elevation (most likely due to local washing out of soils from the central drainage outlet and run-off from the cladding). This can be remedied by local underpinning of the slab and re-direction of the drainage away from the building. Both of which would form part of any conversion works.

*Figure 1. Typical portal frame junction at eaves level. Note cold-formed steel cladding rails and eaves member.*

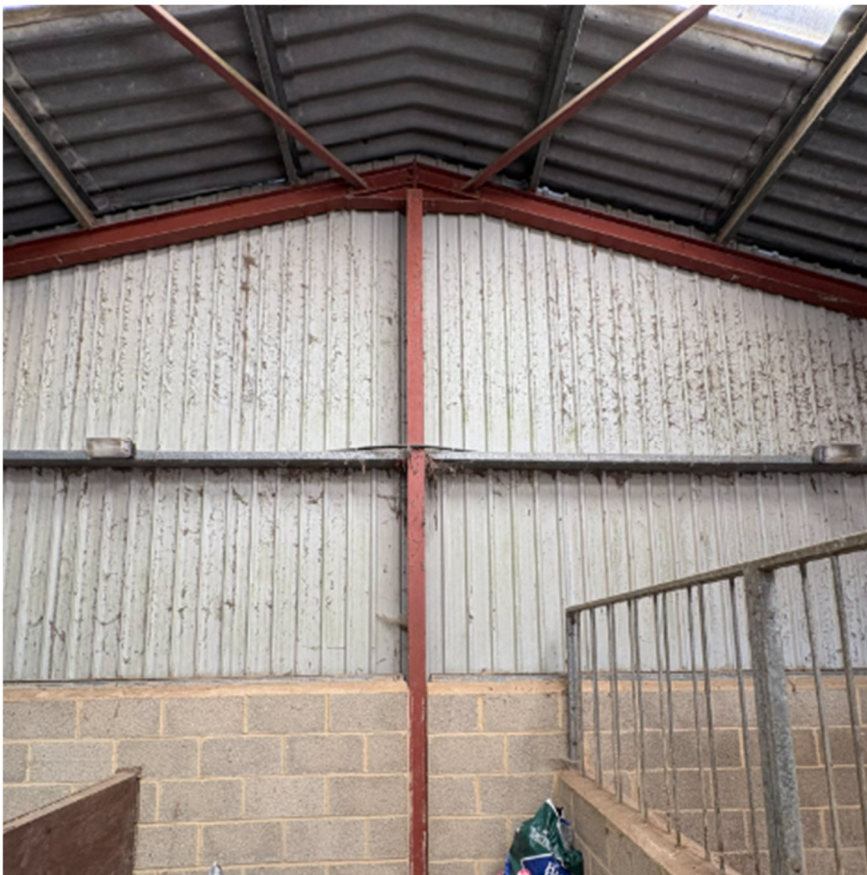
*Figure 2. internal view of North gable showing central wind-post and roof bracing.*

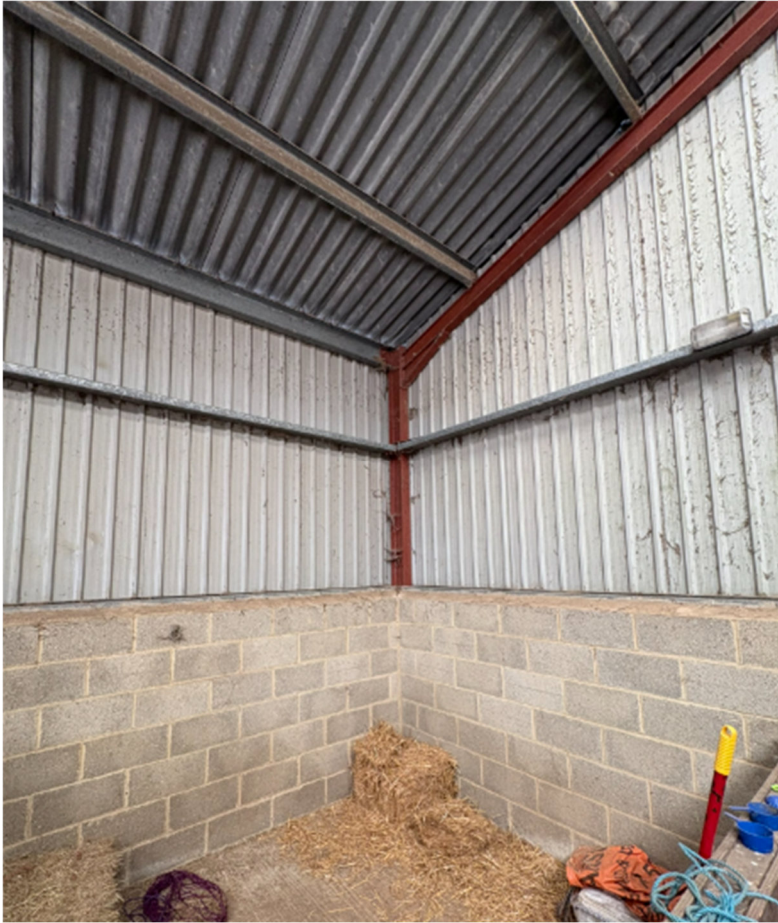
*Figure 3. Northwest corner showing cladding rails and blockwork built tight into steel posts.*

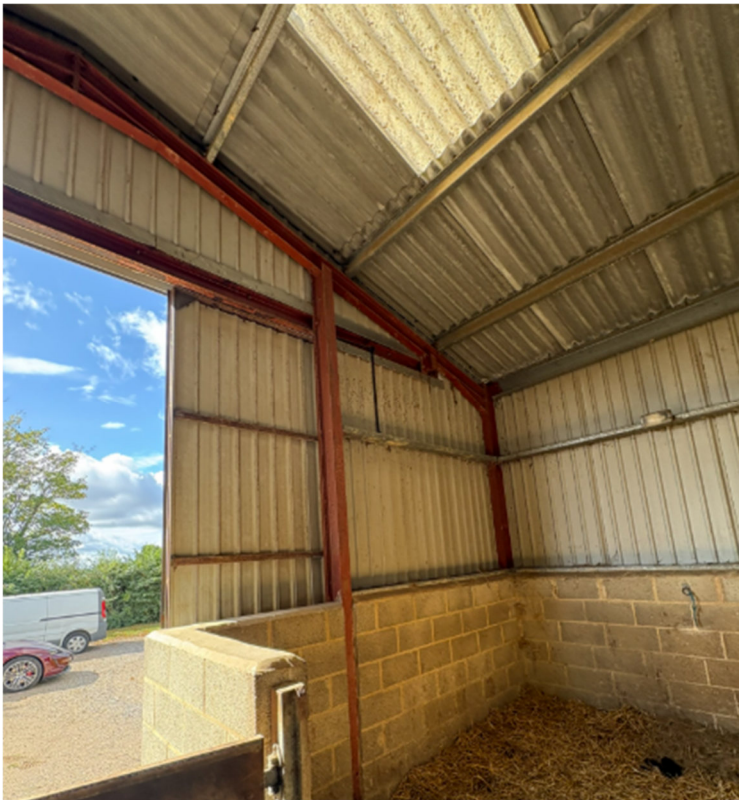
*Figure 4. Front entrance on south elevation showing sliding doors and trimming steelwork around opening.*

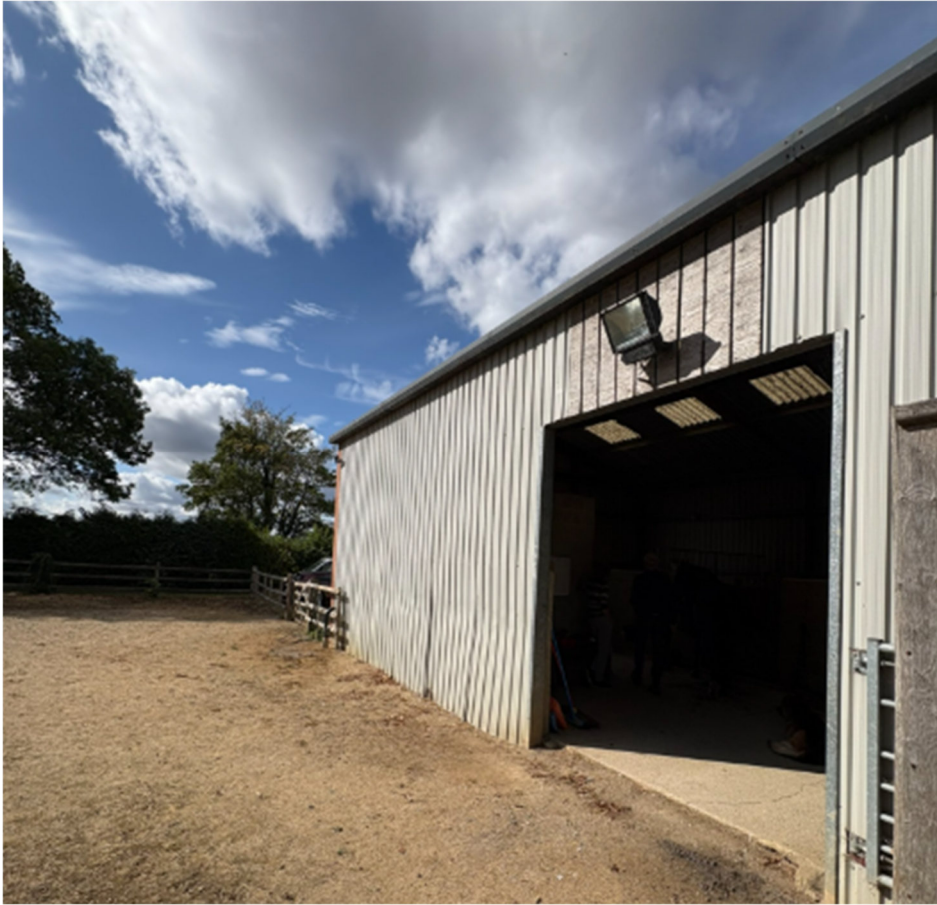
*Figure 5. East elevation opening.*

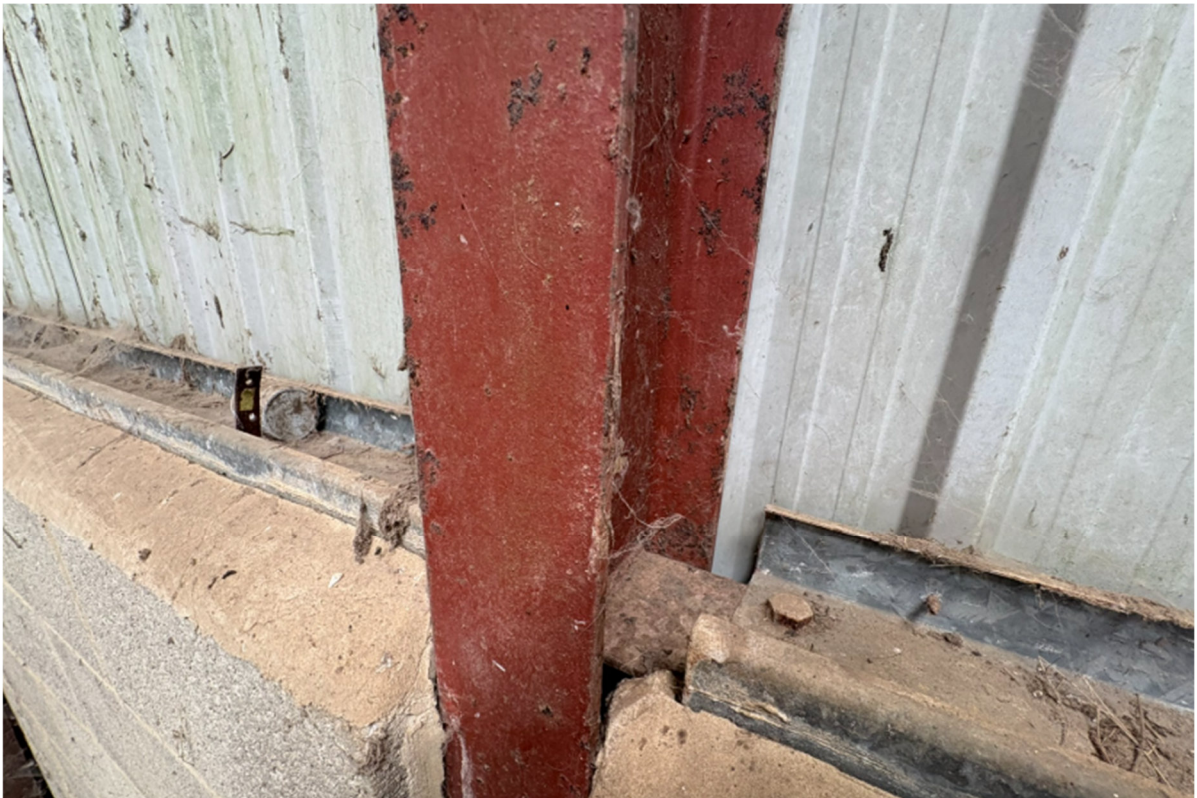
*Figure 6. Typical cladding rail connection to main stanchion.*

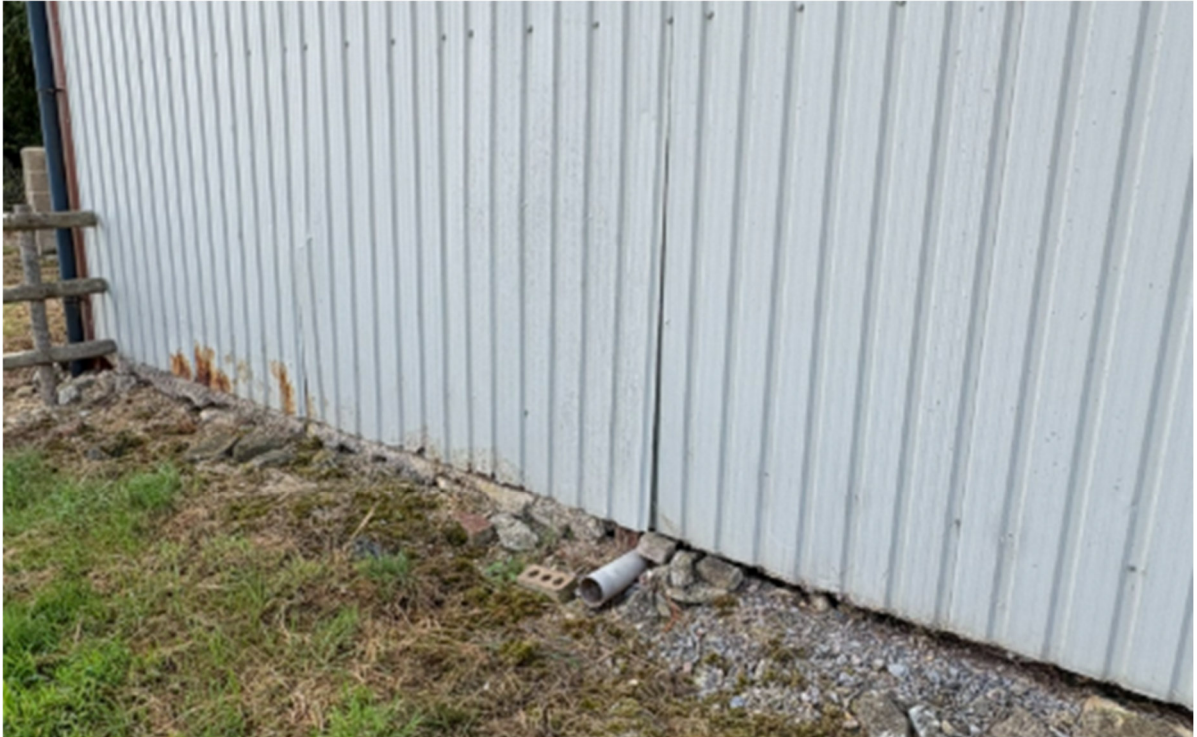
*Figure 7. North elevation showing drainage pipe from central slab channel and local washing out of soil beneath slab edge.*

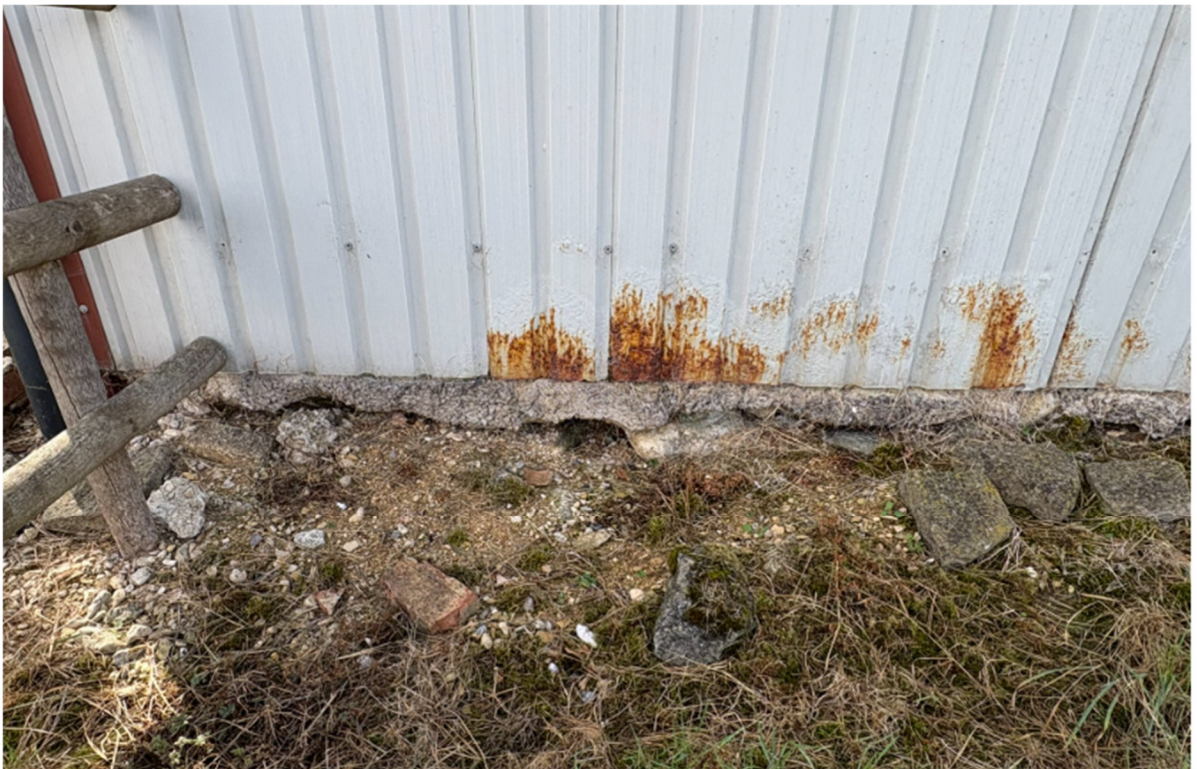
*Figure 8. Close-up detail of the same. Slab will require underpinning as part of the conversion works.*
