# Arboricultural Consultancy for Aviva

| Insured | Mr & Mrs Rod & Barbara Pudduck | Address | ARB LAST REPORT - Jones House, Bradford-on-Avon, BA15 2EE | | |
| ES Ref | SA-250103 | Consultant | Giles Mercer | Contact No. | 0330 380 1036 |
| Report Date | 23/08/2022 | | | | |

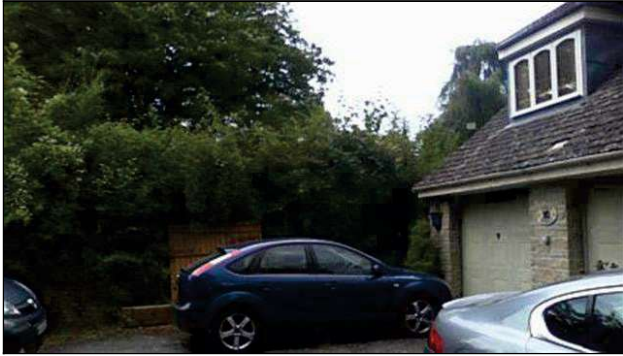
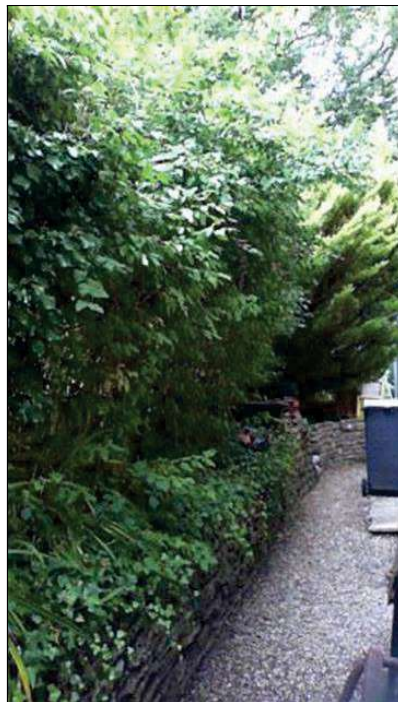
Our survey of the site identified the Cypress (T1), Oaks (TG1), Sycamore (T8) and Mixed Species Hedge (H1) given their position relative to the damage it is our opinion that the roots identified in TP/BH2, TP/BH3 and TP/BH4 will emanate from this vegetation.

H1 - Mixed species hedge

| Tree No. | Species | Age Cat | Approx. Height (m) | Distance to Building (m) * | Ownership | Action | Requirement |
|---|---|---|---|---|---|---|---|
| H1 | Mixed Species Hedge: including Hawthorn, Ivy and Forsythia, | 1 | 2.5 | 2.4 | C - Insured | Maintain as detailed | Remove section of hedge to achieve 3.5m of clearance to the subject property; do not treat stumps due to translocation risk. Where such a risk exists, we advise that any emergent regrowth is removed annually. Maintain retained section(s) at broadly current dimensions by way of regular pruning. |

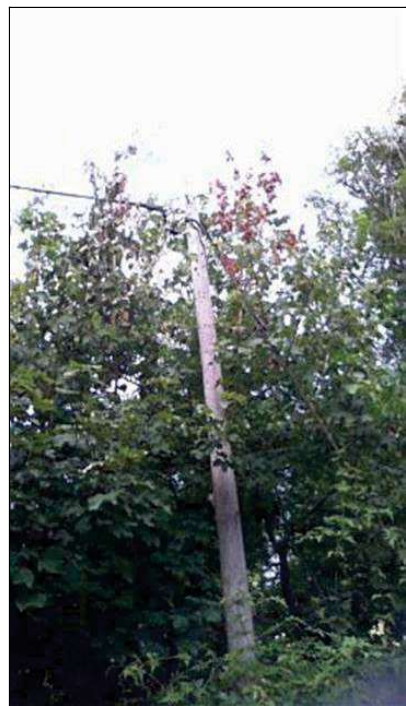
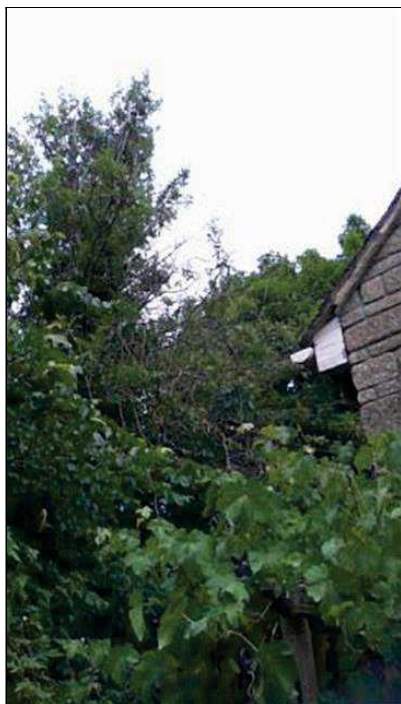
With regards to the roots recovered within TP/BH1, given the variable nature of the soils on site, the extent of the movement / damage, and the size of the trees in question, the Ash trees (T3 & T4) and Apple (T6) are also judged to be rooting below the advised area of damage and therefore are also likely to be exerting a contributory influence.

T3 - Ash

| Tree No. | Species | Age Cat | Approx. Height (m) | Distance to Building (m) * | Ownership | Action | Requirement |
|---|---|---|---|---|---|---|---|
| T3 | Ash | 1 | 15 | 7.4 | A - Third Party | Remove | Remove close to ground level and treat stump to inhibit regrowth. |

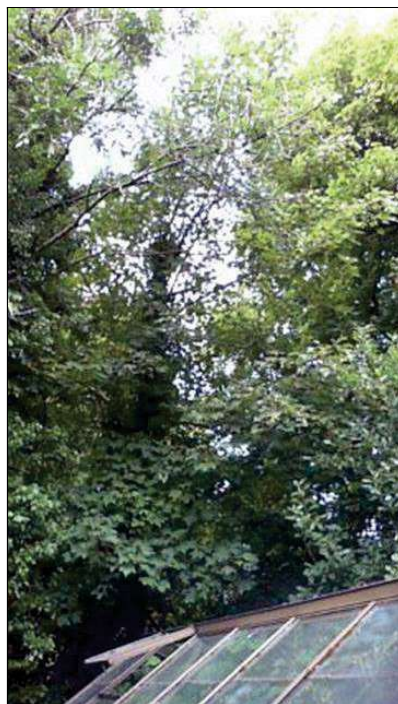
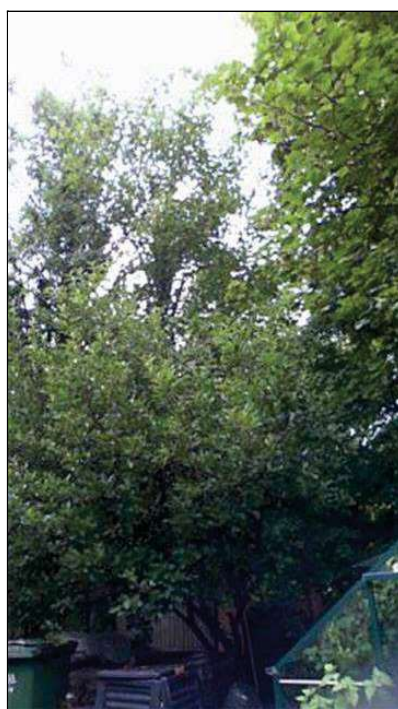
Whilst not positively implicated by root analysis, the Sycamore (T5) and Cypress (T7) are also considered to retain a contributory influence, albeit in a limited / secondary capacity when compared to the primary causal vegetation.

T5 - Sycamore

| Tree No. | Species | Age Cat | Approx. Height (m) | Distance to Building (m) * | Ownership | Action | Requirement |
|---|---|---|---|---|---|---|---|
| T5 | Sycamore | 1 | 16 | 7.8 | A - Third Party | Remove | Remove close to ground level and treat stump to inhibit regrowth. |

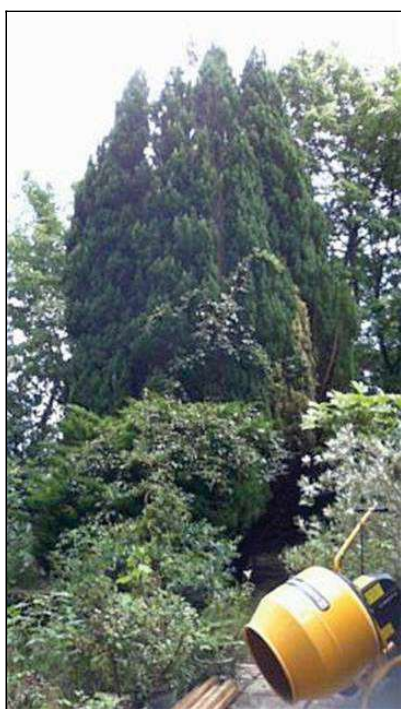
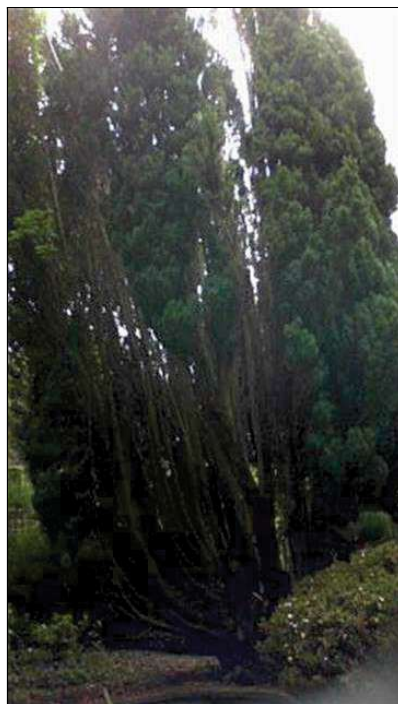
T7 - Cypress

| Tree No. | Species | Age Cat | Approx. Height (m) | Distance to Building (m) * | Ownership | Action | Requirement |
|---|---|---|---|---|---|---|---|
| T7 | Cypress | 1 | 12 | 7.85 | C - Insured | Remove | Remove close to ground level. |

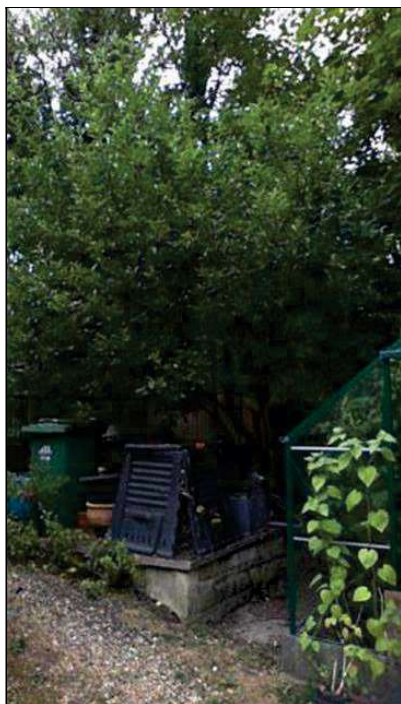
T6 - Apple

| Tree No. | Species | Age Cat | Approx. Height (m) | Distance to Building (m) * | Ownership | Action | Requirement |
|---|---|---|---|---|---|---|---|
| T6 | Apple | 1 | 5 | 5.1 | C - Insured | Remove | Remove close to ground level and treat stump to inhibit regrowth. |

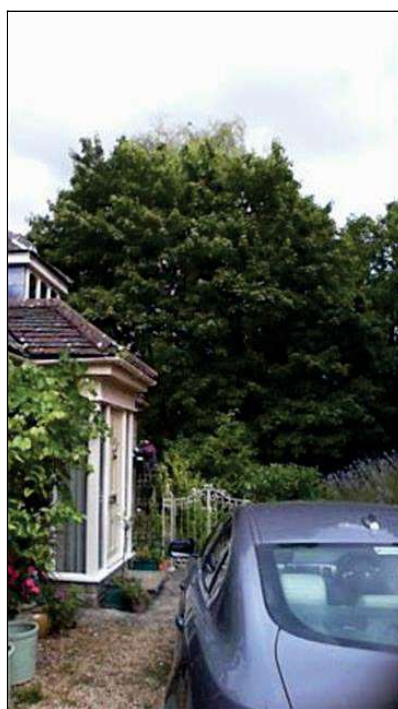
T8 - Acer

Consequently, complete removal of T1, TG1, T3, T4, T6, T7 & T8 along with the management (to include partial removal) of H1 (as detailed) will offer the most certain arboricultural solution likely to restore long-term stability.

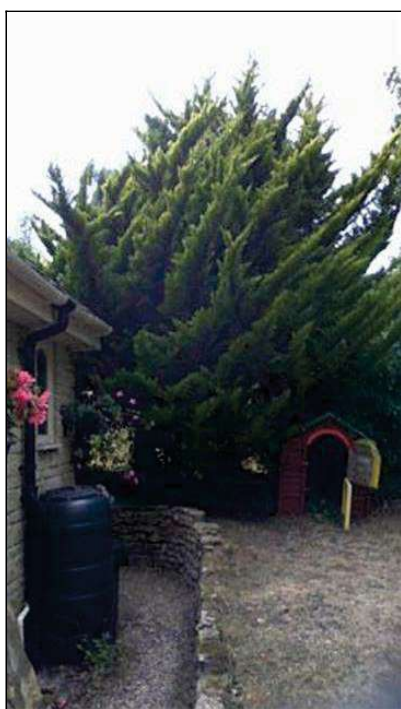
T1 - Cypress

| Tree No. | Species | Age Cat | Approx. Height (m) | Distance to Building (m) * | Ownership | Action | Requirement |
|---|---|---|---|---|---|---|---|
| T1 | Cypress | 1 | 5.6 | 2.2 | C - Insured | Remove | Remove close to ground level. |

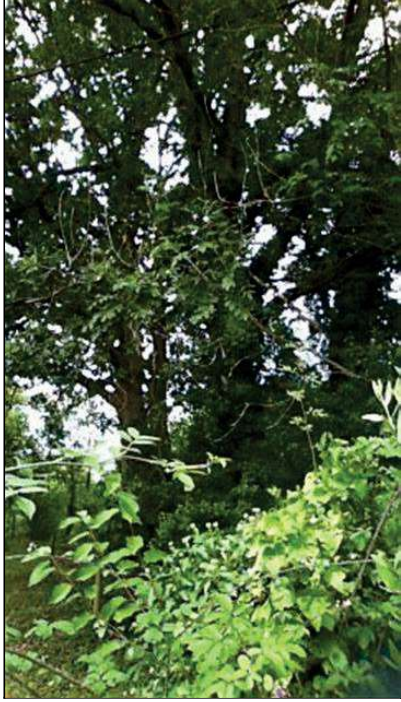
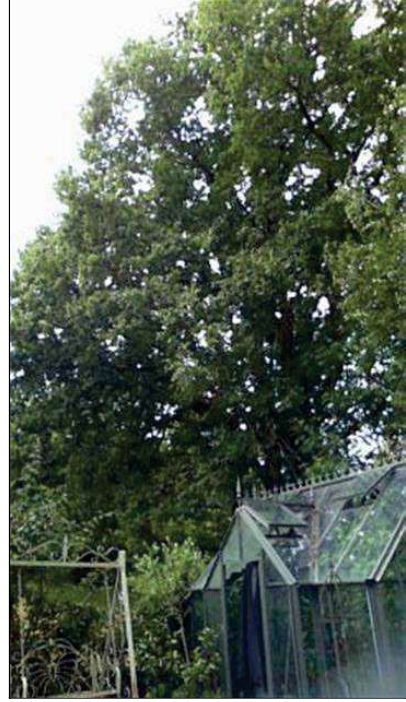
TG1 - Oak

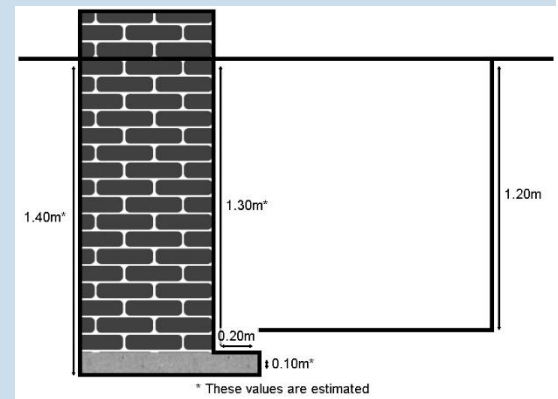
## TP/BH1 Foundation Detail and Borehole Log

House foundation comprised of brick wall to 1300mm bgl, bearing on concrete to an estimated depth of 1400mm bgl, with a total projection of 200mm from the elevation. Underside of foundation (USF) was estimated by pushing a probe, back from the face of the foundation, at an angle with no apparent contact with the face of the foundation beyond the estimated depth.

| WS | Samples | | Tests | | Legend | Stratum Description and Observations |
|---|---|---|---|---|---|---|
| | | | | | 1.5 | Hard brown slightly clayey ROCK.<br>...at 1.20m bgl base of hand excavated trial pit.<br>...at 1.40m to 1.70m bgl numerous roots of live appearance encountered and sampled.<br>...at 1.40m bgl ESTIMATED UNDERSIDE OF HOUSE FOUNDATION.<br>...at 1.70m bgl unable to retrieve further sample due to rock preventing sample recovery. |

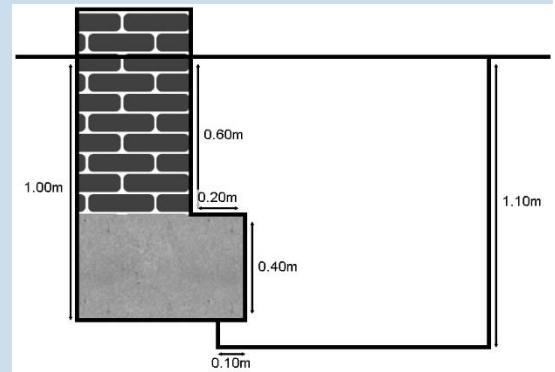
## TP/BH3 Foundation Detail and Borehole Log

Garage foundation comprised of brick wall to 600mm bgl, bearing on concrete to 1000mm bgl with a total projection of 200mm from the elevation. Underside of foundation (USF) was exposed to 100mm back from the face of the foundation and probed 450mm back from the face of the foundation.

| WS | Samples | | Tests | | Legend | Stratum Description and Observations |
|---|---|---|---|---|---|---|
| | R | 1.00 - 2.00 | PEN | 1.00 | | ...at 1.00m bgl UNDERSIDE OF GARAGE FOUNDATION. |

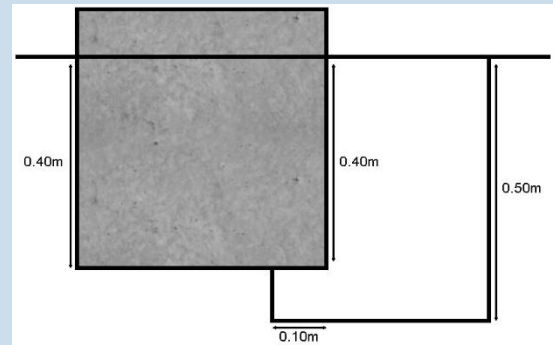
## TP/BH4 Foundation Detail and Borehole Log

Garage foundation comprised of a concrete slab to 400mm bgl with no projection from the elevation. Underside of slab (USS) was exposed to 100mm back from the exposed face of the slab and probed 450mm back from the exposed face of the slab.

| WS | Samples | | Tests | | Legend | Stratum Description and Observations |
|---|---|---|---|---|---|---|
| | | | | | 0.5 | Hard brown CLAY.<br>...at 0.40m bgl UNDERSIDE OF GARAGE FOUNDATION.<br>...at 0.40m to 1.40m bgl numerous roots of live appearance encountered and sampled.<br>...at 0.50m bgl base of hand excavated trial pit. |
