# STRUCTURAL APPRAISAL REPORT [REV 1]

ON BEHALF OF: Carter Jonas, Taunton

BARN AT  
HIGHWAY FARM  
CALNE  
SN11 8SR

DATE OF ISSUE: 11<sup>TH</sup> MAY 2026

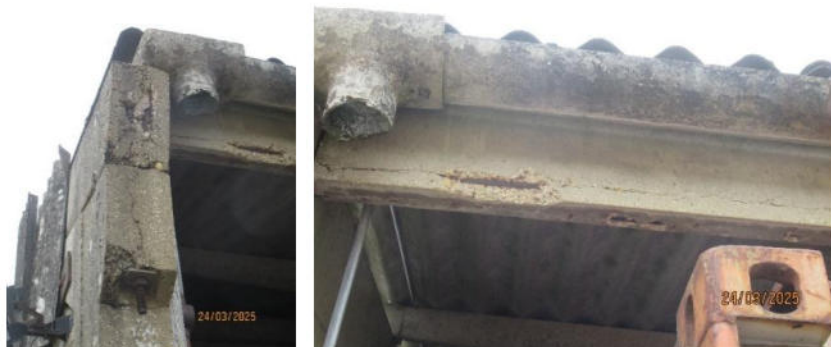
At the lean-to, four concrete eaves beams have minor spalling at their underside, revealing the steel reinforcement inside. The end of the primary rafter, located at the front, right hand corner of the lean-to has similar deterioration. The spalling is the result of minor rusting of the steel reinforcement embedded inside these components.

The beams should be repaired and sealed, with an appropriate treatment and filler material.

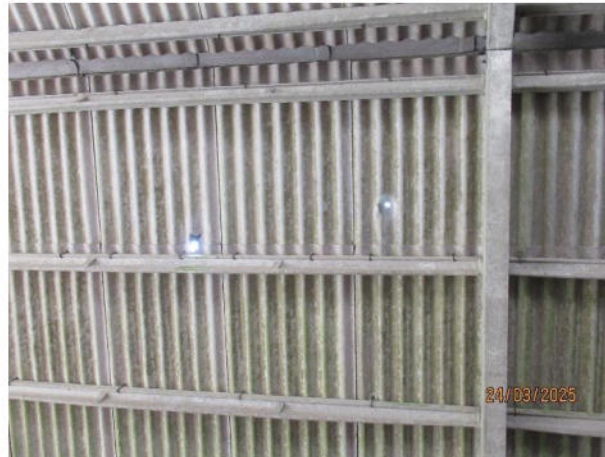
The roof covering is intact and extends across the entire barn. The roof covering contains four minor splits and four minor perforations through, which given the extent of the roof covering demonstrates only minor defect to be present. Whilst not a structural issue, the roof covering should be repaired, either by filling the splits and perforations or by localised reinstatement.

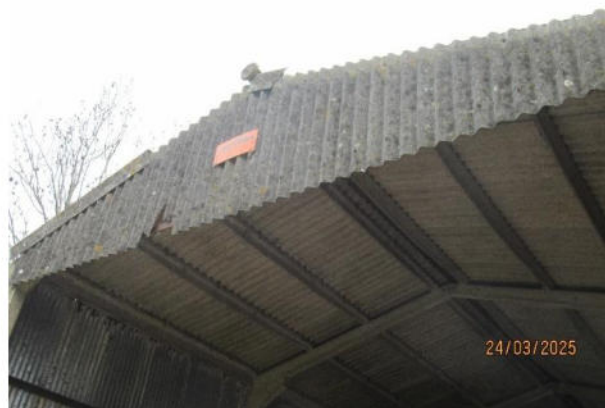
The eaves flashing has generally been lost across the front elevation, and rainwater goods are incomplete. These are not of structural concern but should be reinstated.

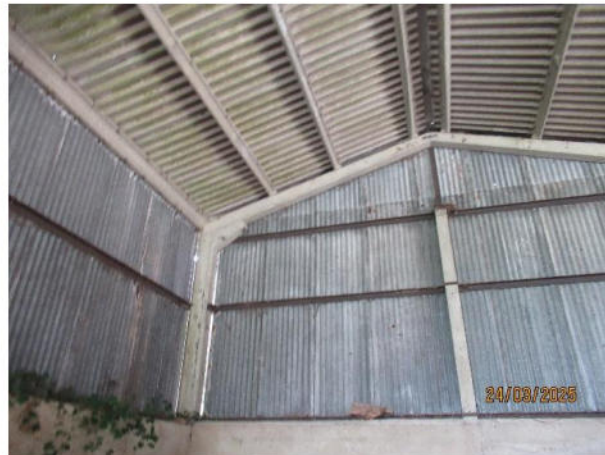
General minor surface rusting to the angle iron supports for the wall cladding, where the surface protective coating has been lost. The corrosion appears to be limited to the surface of each component and there are no signs of more significant corrosion; no visible loss of material was seen.

The cladding supports should be rubbed down and treated with a rust inhibitor then sealed and redecorated to prevent further corrosion and increase their durability.

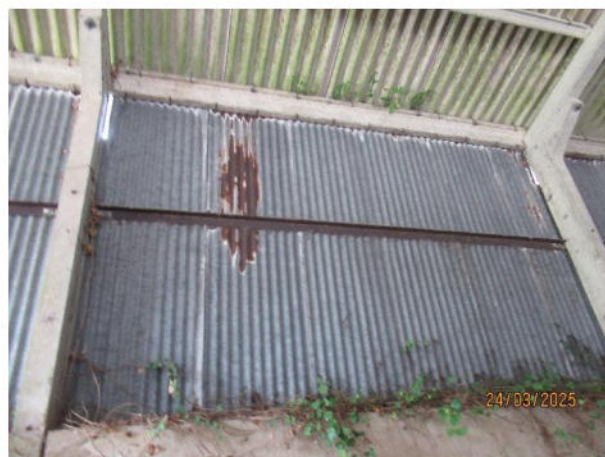
Minor surface corrosion to the corrugated tin cladding, to localised areas. This should be rubbed down and treated with a rust inhibitor.

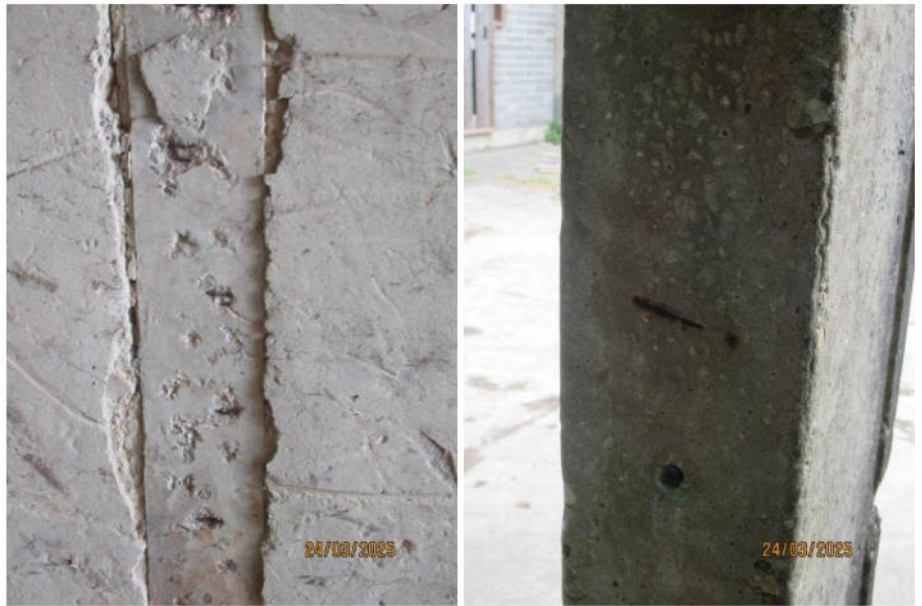
Minor spalling at the surface of seven primary columns, which appears to be the result of minor rusting of the steel reinforcement embedded inside these components.

The columns should be treated and refaced to provide additional cover to the reinforcement inside.

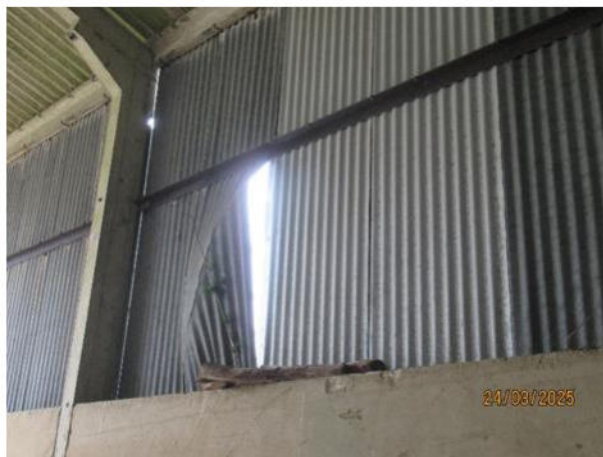
The cladding has historic impact damage towards the front side of the left-hand elevation, where one panel has deflected. The panel could be straightened and pressed back into shape as a repair.

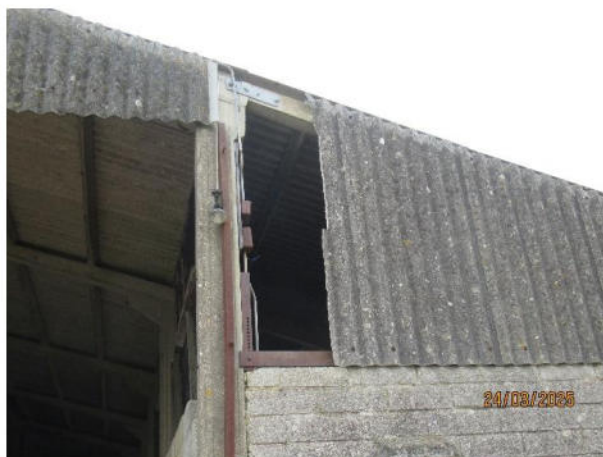
One wall cladding panel is missing, located centrally to the front elevation wall. Whilst not of structural concern, this should be reinstated.

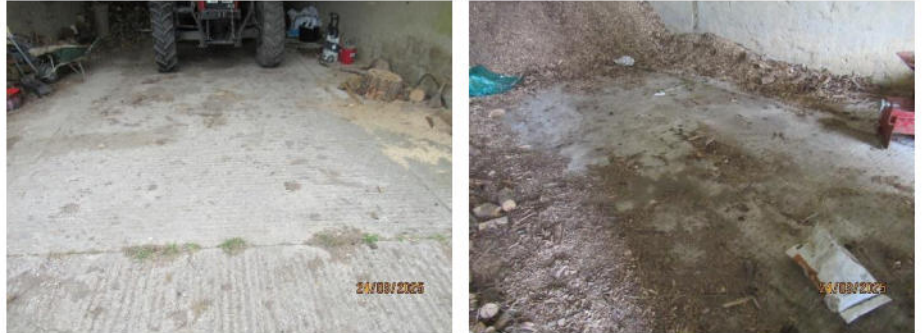
No significant defects were identified to the barn floor and each floor slab is complete across the barn.

The floor generally slopes down towards the front, left hand side of the barn. The floor across the lean-to is however generally level.

The barn floor is likely to be levelled across the barn during conversion, alternatively areas may be levelled and the floor stepped.
