# RIBA STAGE 3 - HERITAGE STATEMENT FOR LISTED BUILDING APPLICATION

Selborne House, 64 Pickwick Road, Corsham, SN13 9BX  
May 2026

## STRUCTURAL REPORT

November 2025

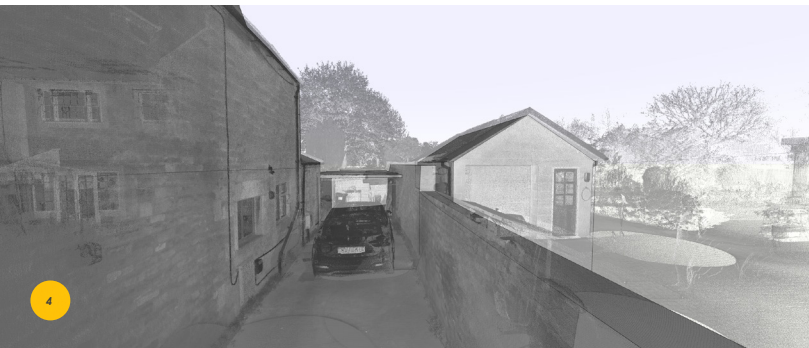
**Fig 3.** Perspective view from North - showing the existing garage and wall.

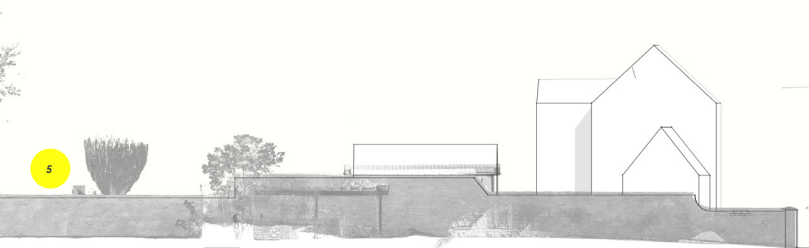
**Fig 5.** South East Elevation of wall.

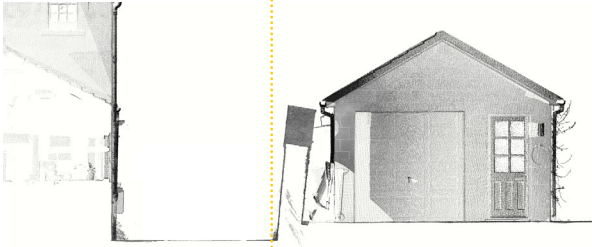
6

The following sections show the amount of deviation at varying points of the existing wall.

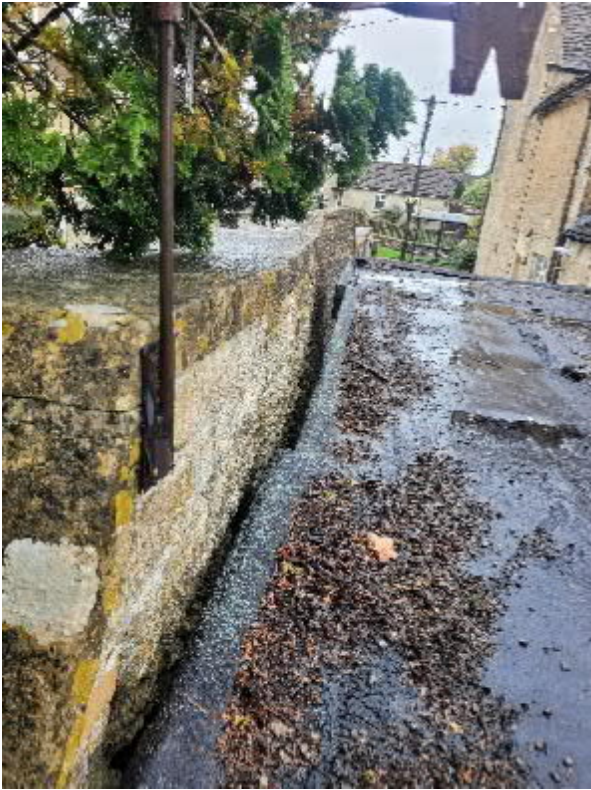
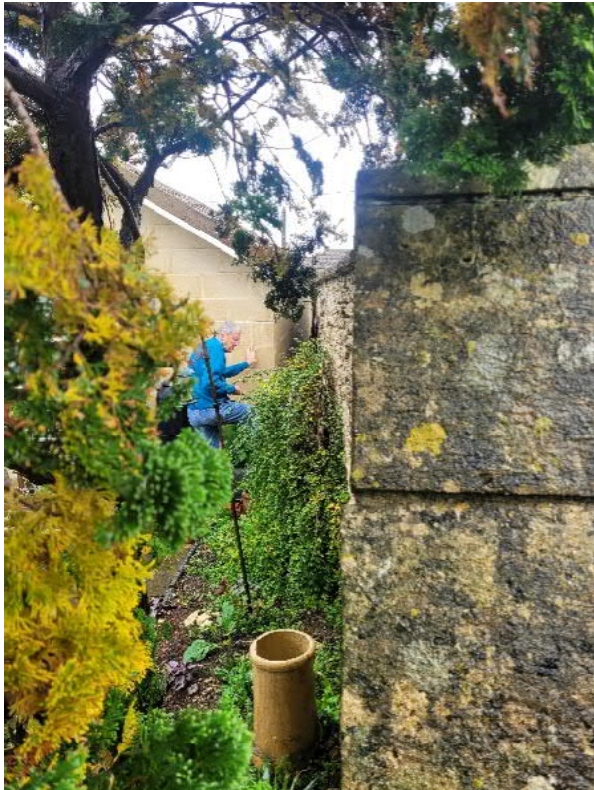
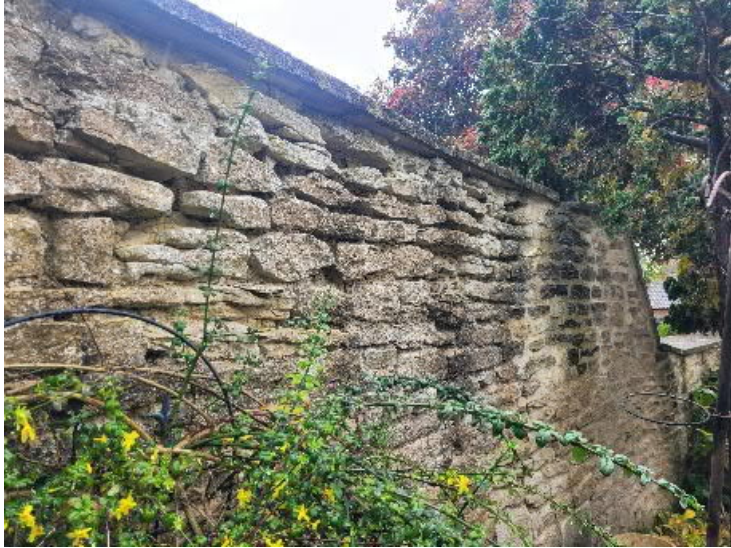
| <p>Figure 1; The wall is constructed in a slight S shape on plan, which can be seen in the way it deviates from the line of the single Storey carport.</p> | <p>Figure 2; The wall to the rear of the garage can be seen to curve on plan, but does not appear to lean out of plumb at this time.</p> | <p>Figure 3; to the rear of the neighbouring garage there is significant loss of mortar to the structure and signs of water ingress and abrasion causing degrading of the wall face.</p> |

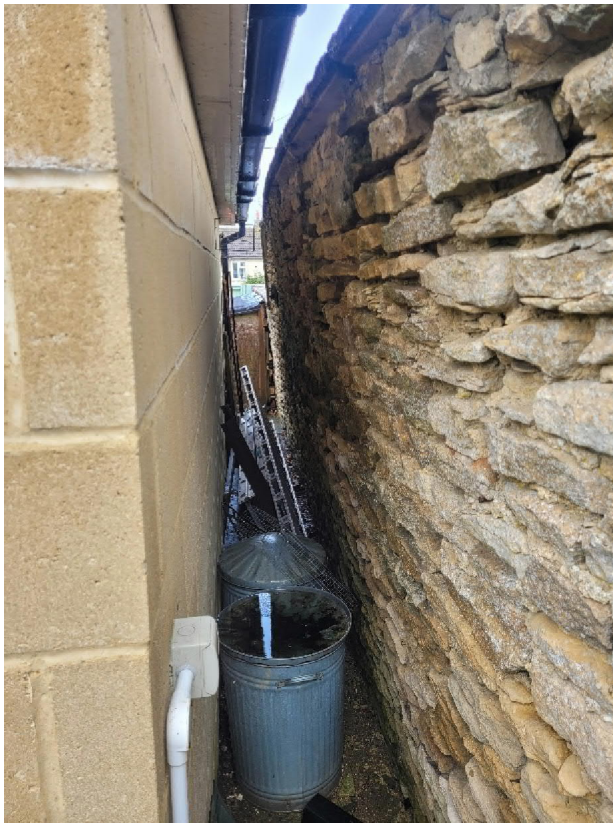
The overall geometry of the wall, relative to the neighbouring garage, shows that the base of the wall is constructed 600mm away from the garage. Whereas the head of the wall is only 300mm from the garage wall at eaves level. This indicates that the wall is 300mm out of plumb,

In the case of the wall at Selbourne House, the eccentricity of the load sits significantly outside this middle third, leaving it more susceptible to collapse in the short term. This is due to tensile forces being created on the rear of the wall, which are also exacerbated as it is retaining.

Figure 4: View From rear Garden side, the head of the wall has moved and can be seen to be leaning significantly towards the neighbouring garage. When measured, at lower level the wall is circa 600 millimetres from the garage wall and at eaves level it is circa 300 millimetres from the garage wall. This shows that the wall head has moved approximately 300mm over the years.

| Carefully dismantle original wall Stone by Stone, cleaning, retaining and storing stones for reuse. Wall to be dismantled down to level where wall becomes consolidated, straight and true. | Short term |
| Freestanding wall to be rebuilt of retained lower section of wall using traditional construction methods. | Short term |
| Original stones to be reused embedded using a traditional mix lime mortar to match the original construction. | Short term |

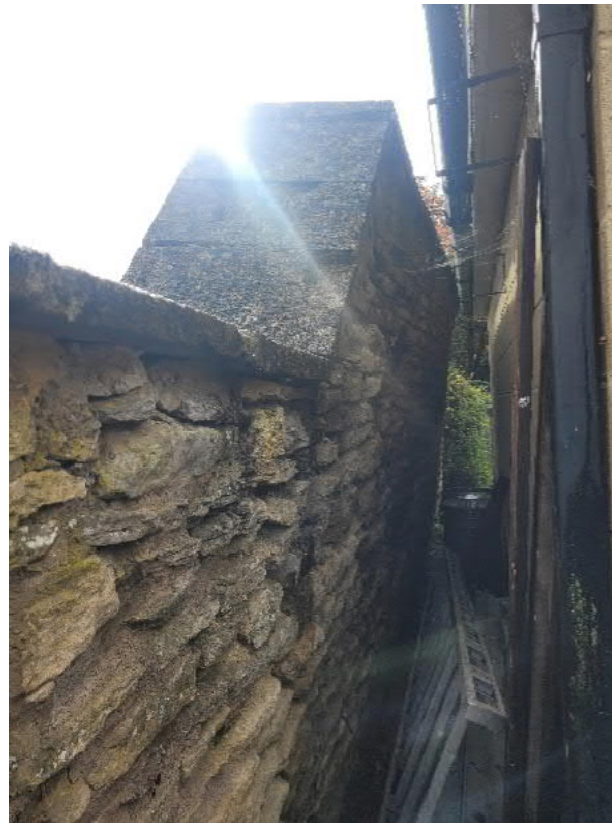
Figure 5; View from front of garage . wall visibly deviates out of Plumb and becomes significantly closer to the garage at its central point.

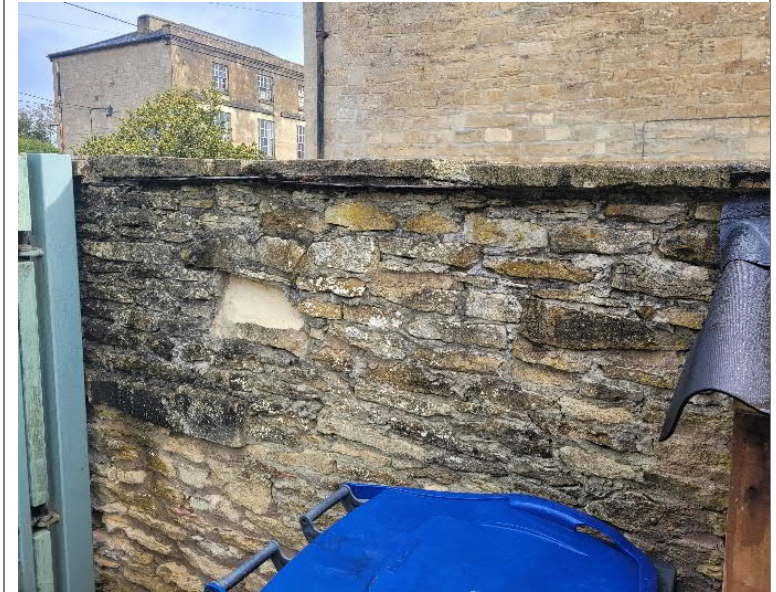
Figure 6; The front section of the wall is only 1.5 metres tall, This front section does not appear to suffer from the same out of plum characteristics as the taller section of wall alongside the garage.

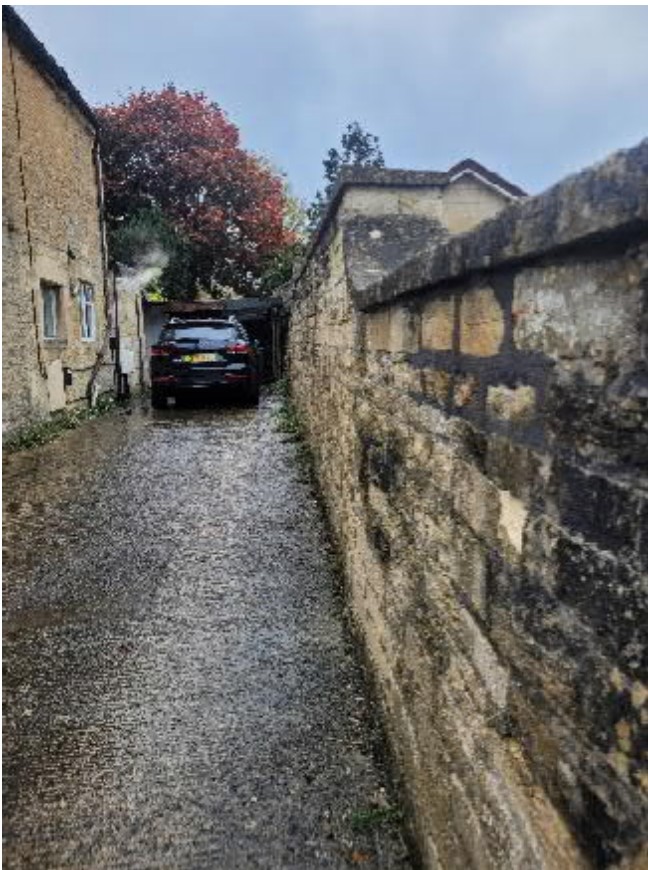
Figure 7: Alongside the driveway at 64 Pickwick Road the wall is low level height of 1.5 metres before it rises to a maximum of 2.75 metres. The out of plum nature only starts approximately in line with the garage, and only rises from the higher ground level.

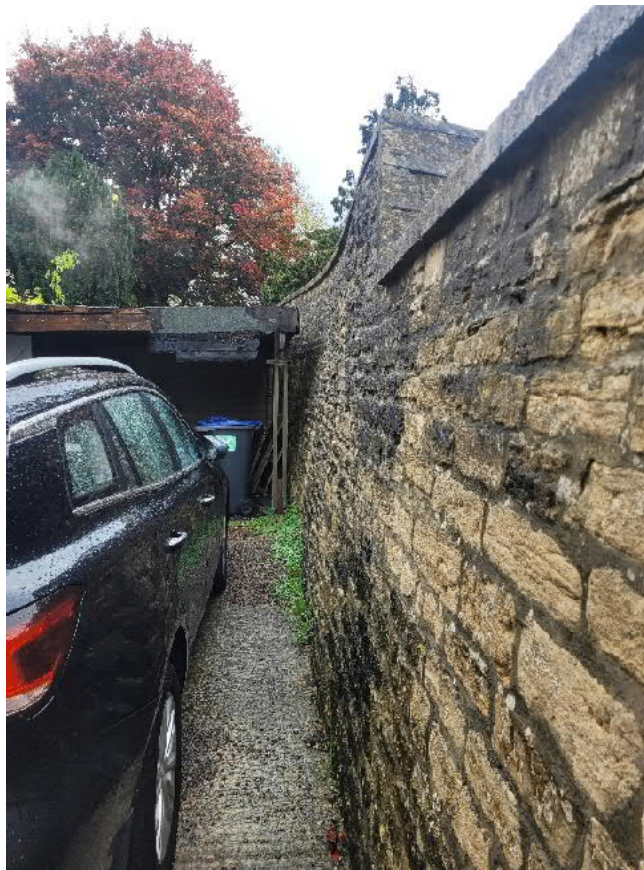
Figure 8; The wall can be seen to follow an S shaped geometry at the base of the wall, however at the head of the wall this geometry is exacerbated as the wall becomes out of plumb.

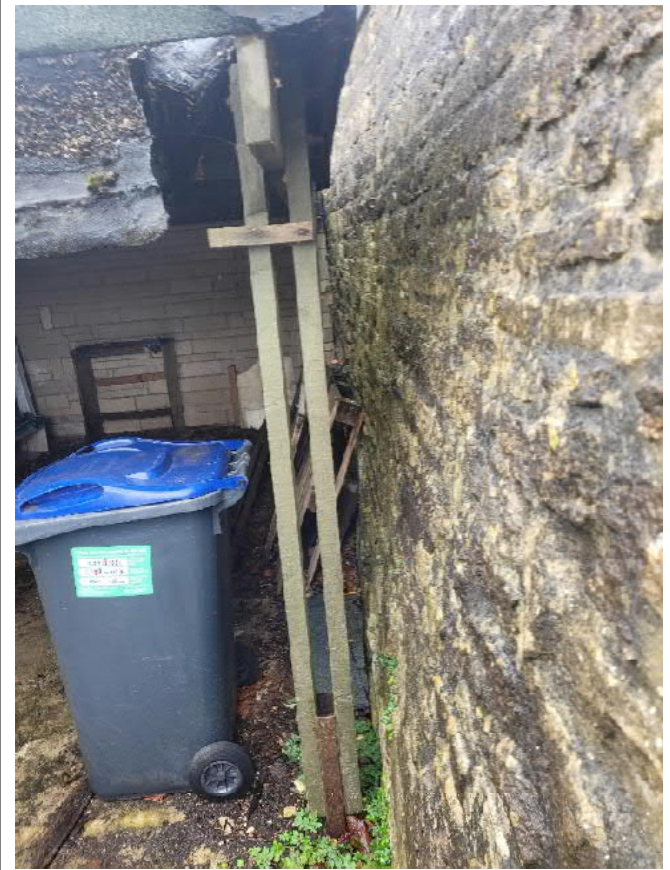
Figure 9; The out of plum geometry of the wall is more significant above 1 metre.

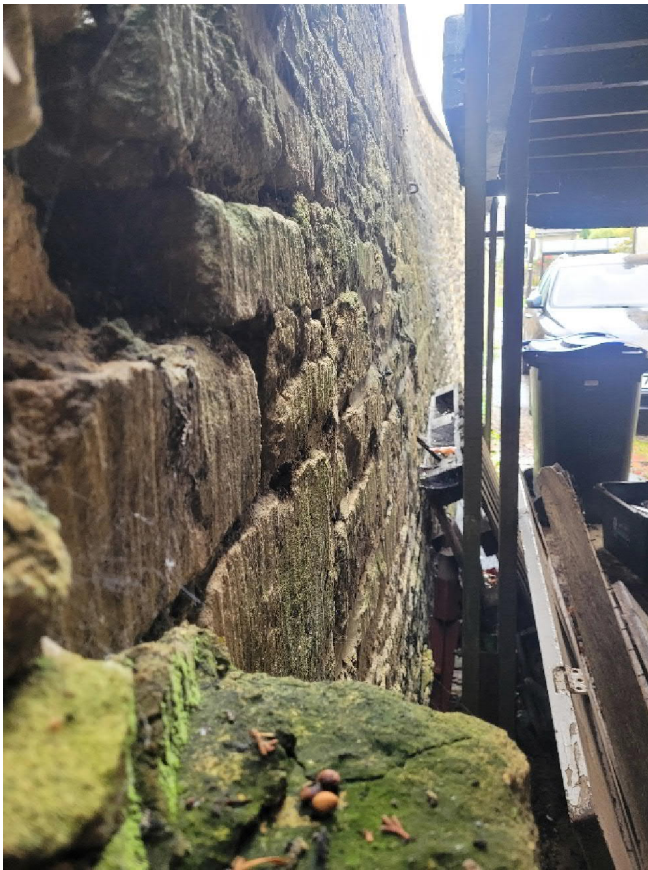
Figure 10; The wall in an S shape on plan and the curvature can be clearly seen. The head of the wall is inclined out of plumb towards the higher ground.

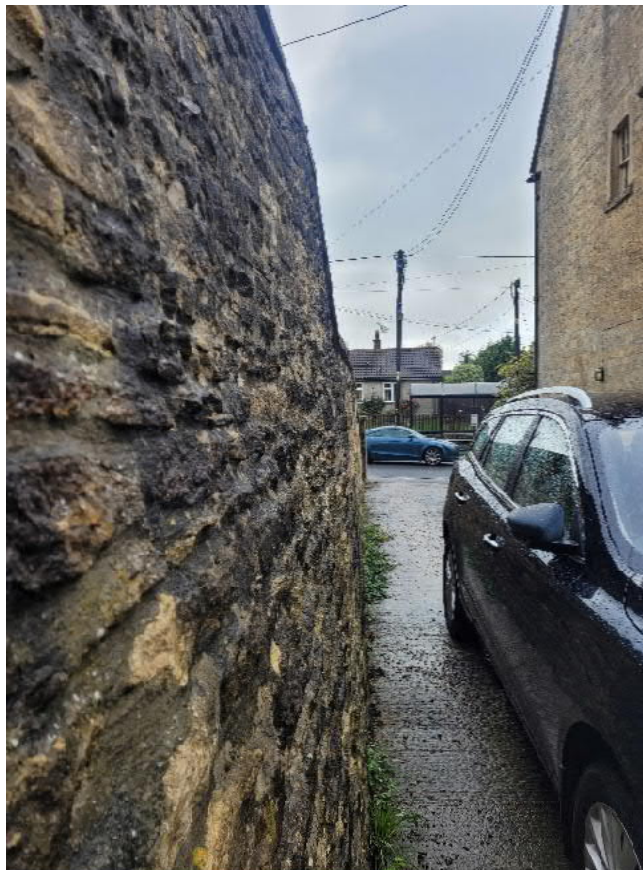
Figure 11; The front section of the wall appears to have been built straight in plan, but has moved to be out of plumb vertically.

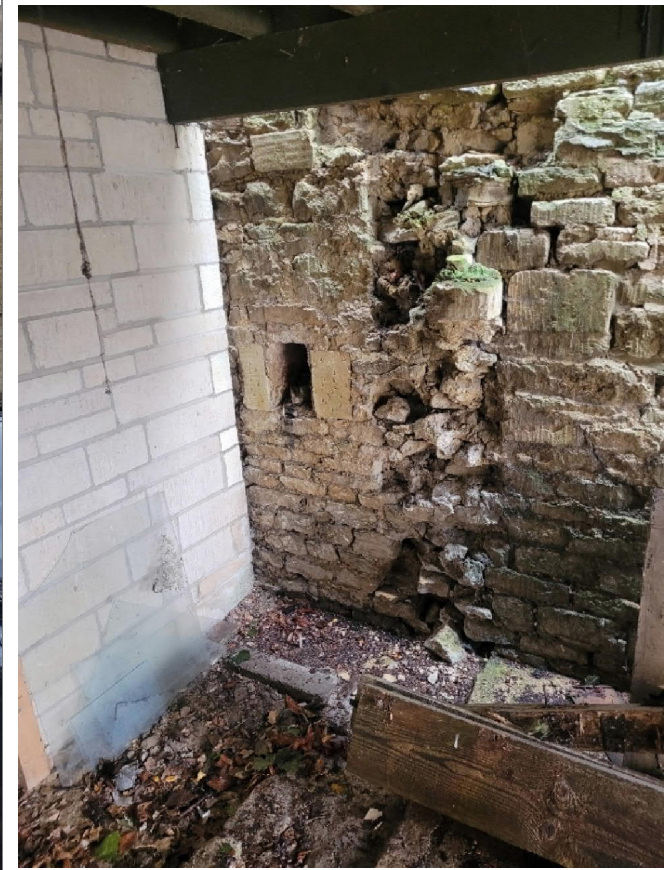
It is also possible to see scarring in the wall face where a buttressing wall has been removed to allow the construction of the carport.

Figure 12; Visible scarring in the wall within the carport shows where a previous buttressing wall has been removed. This has left the rubble exposed and unconsolidated. The out of plumb movement of the wall occurs forwards of this point

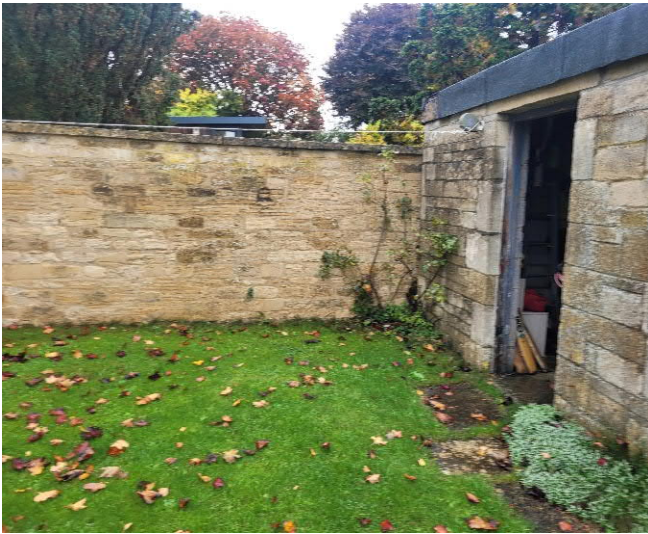
Figure 13; the rear section of the garden wall has recently been consolidated and repointed to the side of Selbourne House

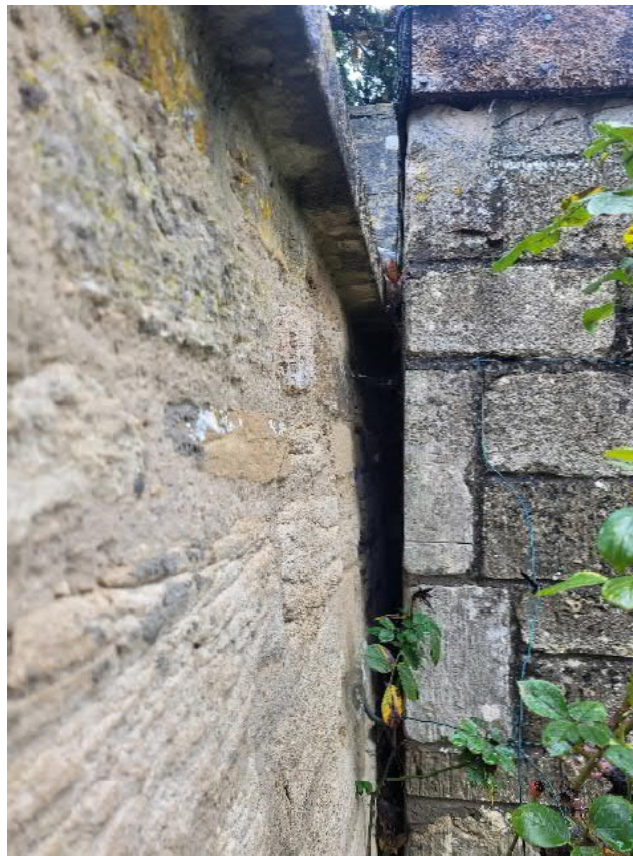
Figure 14; the Garden store does not provide any support to the garden wall

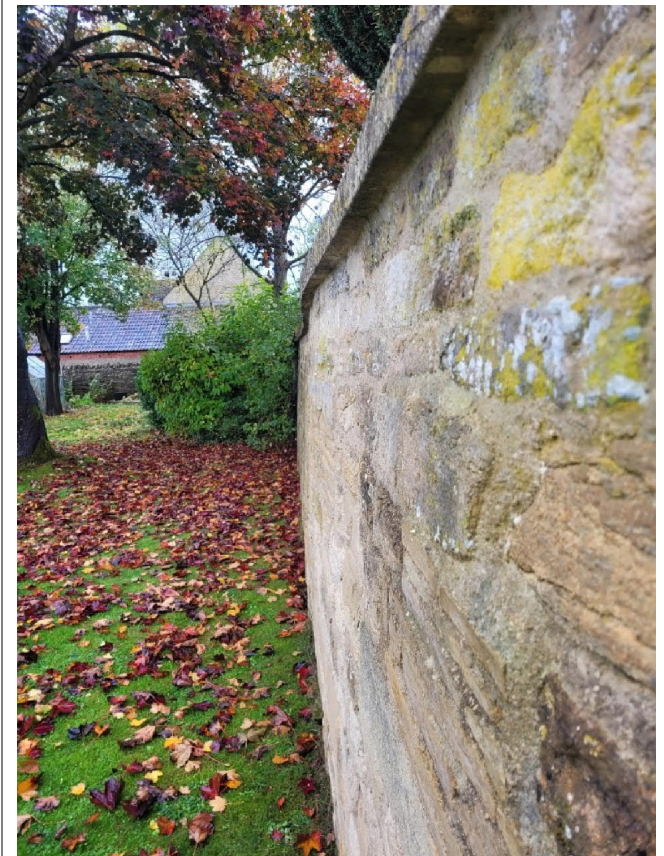
Figure 15; the rear garden wall also follows the gentle S curve shape on plan.

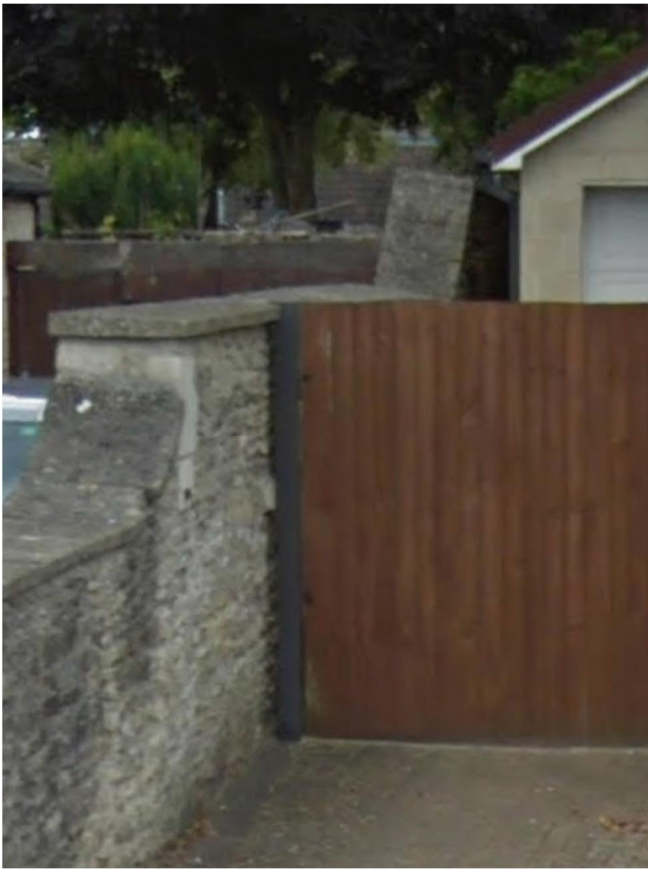
Figure 16; 2016 Google Streetview image showing wall on incline.

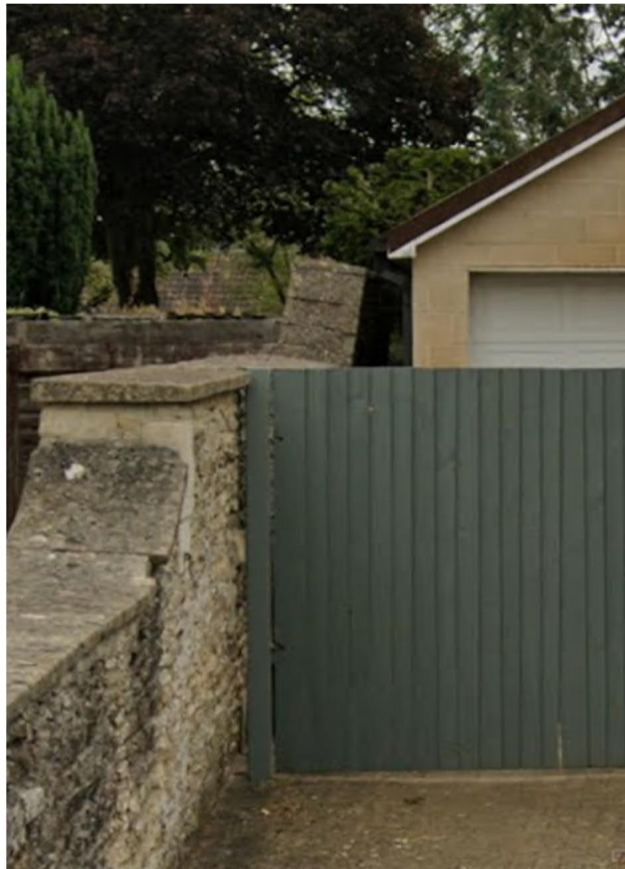
Figure 17; 2024 recent google Street View image showing increased wall incline.

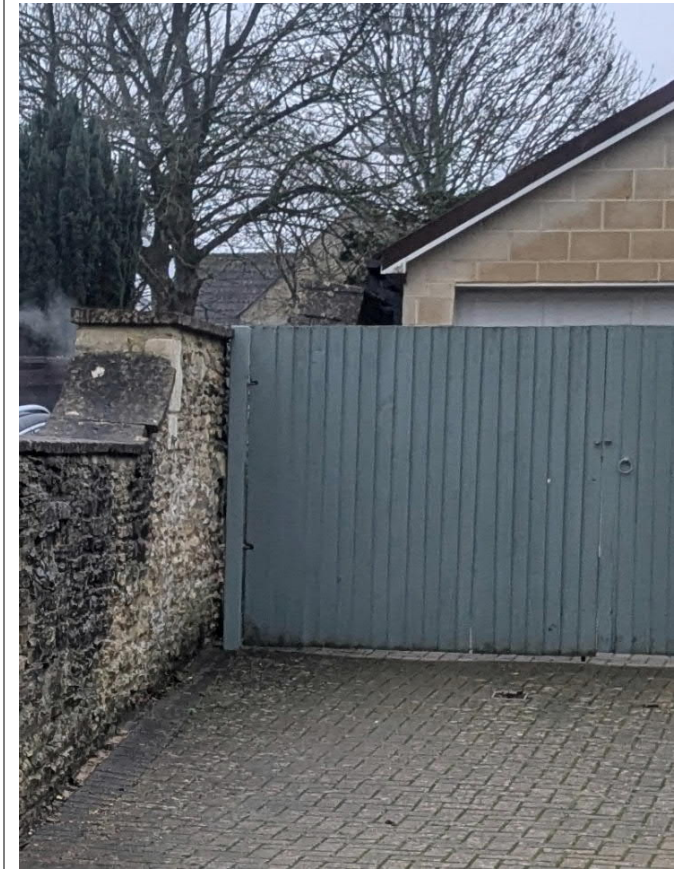
Figure 18: photograph taken to provide matching angle as Google Street View December 2025 This shows the wall is appearing closer to the garage than previously. Confirming recent, ongoing movement.
