# Structural Engineers Report For:

The White Hart, Chippenham

Visual Structural Inspection

REF: 24700

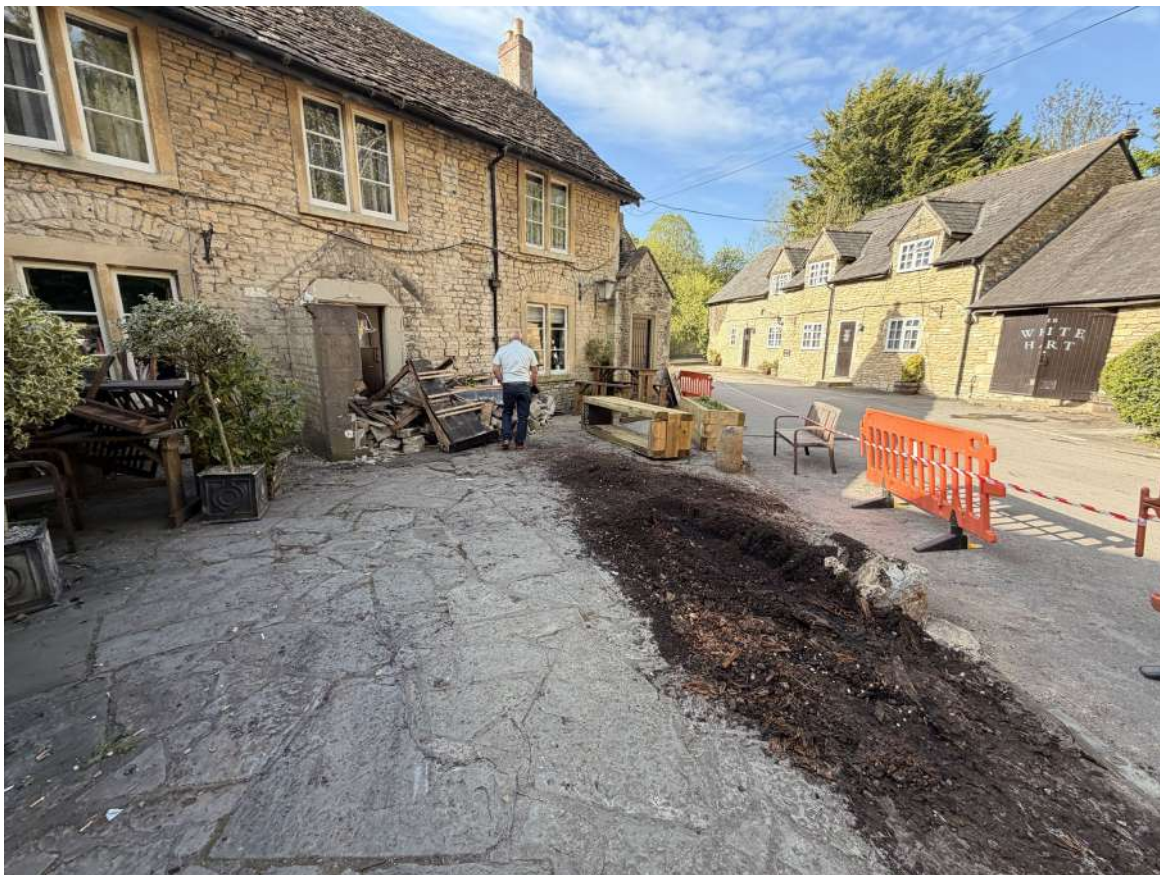
Photograph 1

| No | Photograph | Description |
|---|---|---|
| 1 | | Front elevation showing area impacted |

Where the vehicle impacted the front elevation porch structure, this has shunted the supporting masonry in at the ground floor level, causing a significant bowing and extent of cracking in the vicinity, with stonework depressed to the front external face, and shattered to the inner, internal face, with significant loss of internal finishes.

The porch structure to the front elevation has been almost completely demolished to the front elevation, and likely provided significant restraint and resistance to the impact from affecting the primary frontal elevation.

The external wall is then to be fully propped internally and externally to prevent any further movement or deterioration, before remedial works can be completed. The extent of the cracking to the front elevation is significant, and as a result the front elevation should be immediately propped, with the area cleared of all debris once made safe.

In our professional opinion, whilst the effect of the impact is significant, the extent of the cracking is such that the area of rebuild is not large. It is therefore our recommendation that once fully propped and supported, the ground floor area, circa 1m beyond the zone of impact in both directions, is fully taken down and reconstructed on the existing foundation arrangement, by a suitably qualified stonemason.

Once all necessary remedial and reconstruction works have been completed to the primary elevation, it is our recommendation that the client consider reinstallation of the front porch arrangement, as well as reinstatement of the bollard and barrier arrangement which provided meaningful protection to the front elevation prior to the impact.

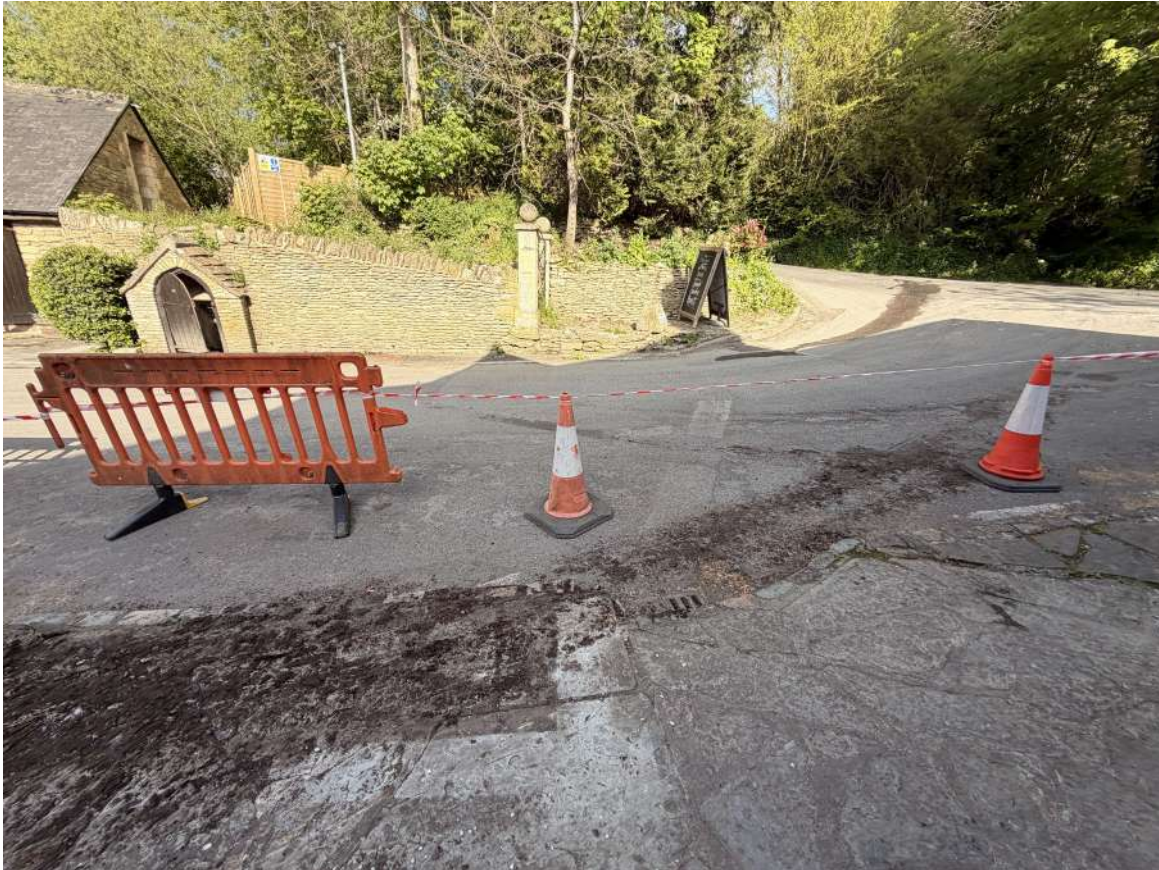
Photograph 2

| 2 | | Front elevation showing vehicle travel area |

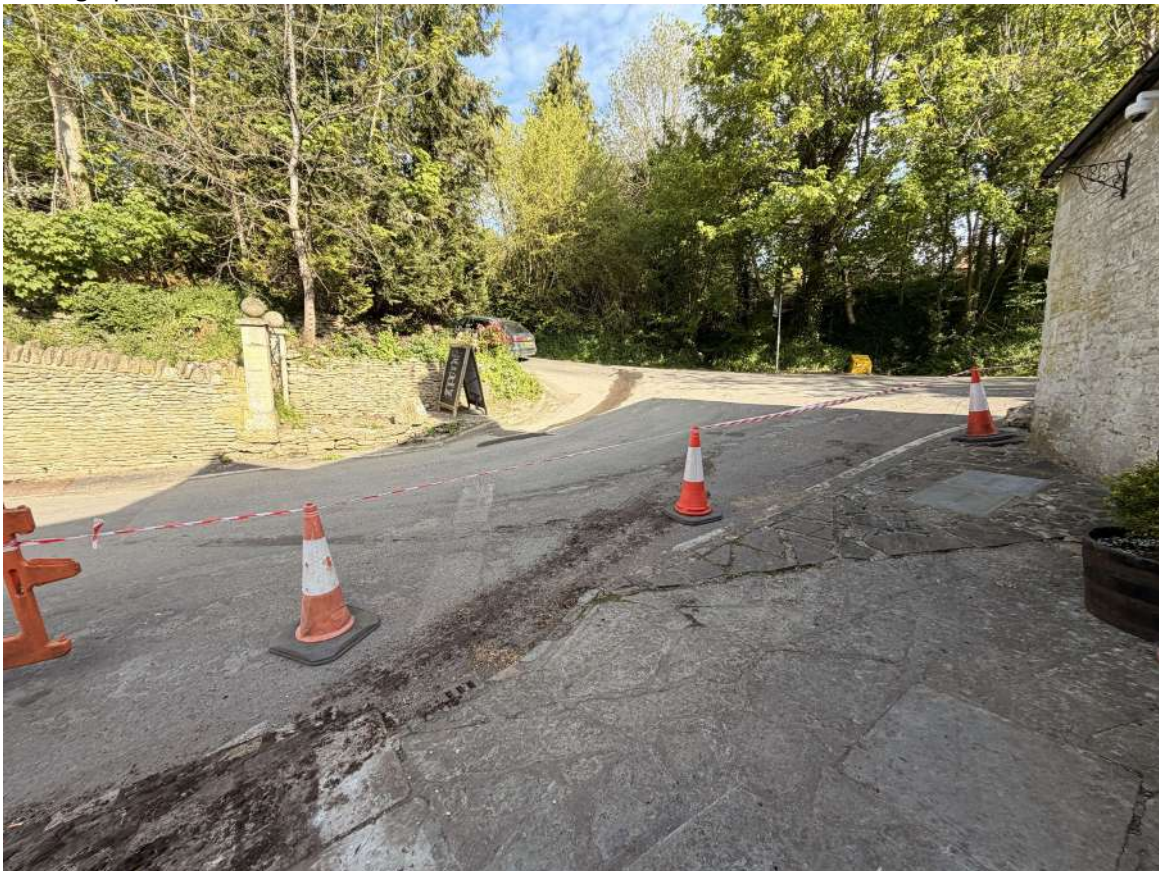
Photograph 3

| 3 | | Front elevation showing vehicle travel area |

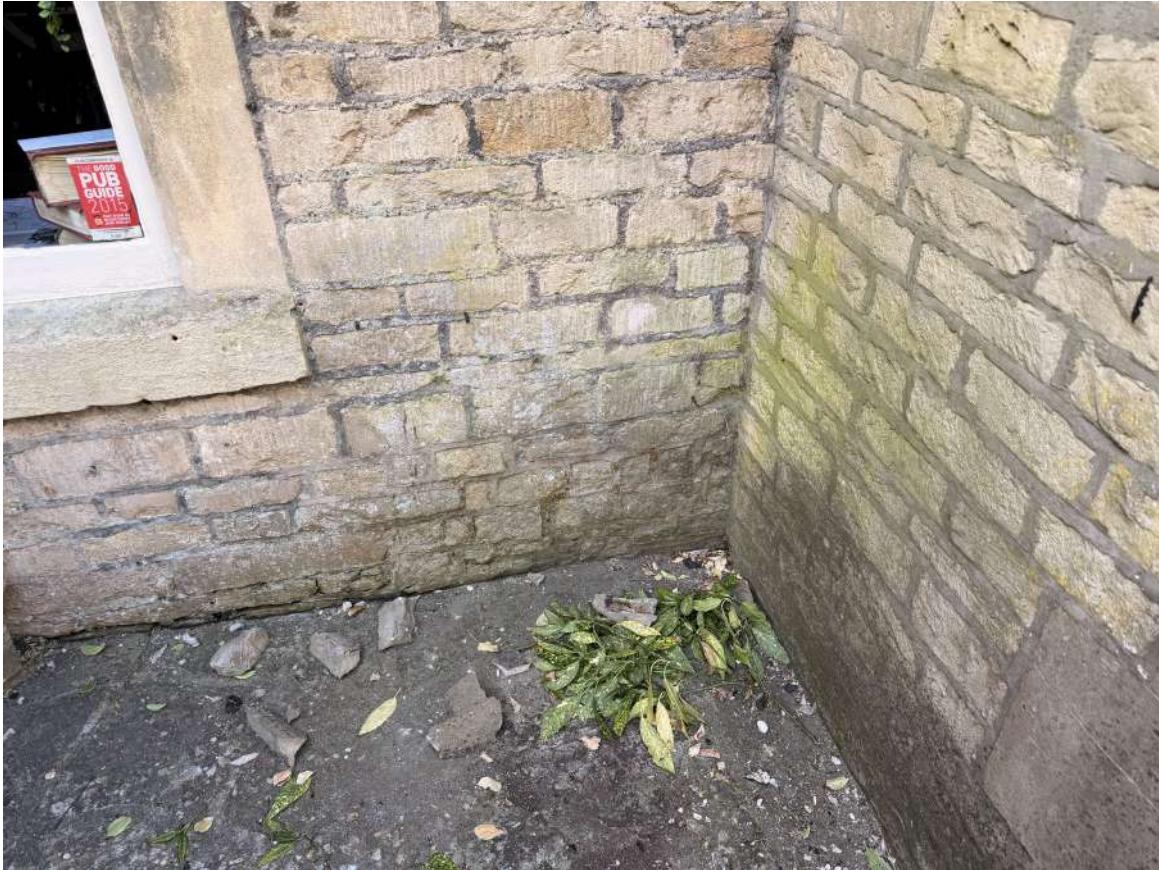
Photograph 4

| 4 | | Front elevation at junction between porch and main elevation |

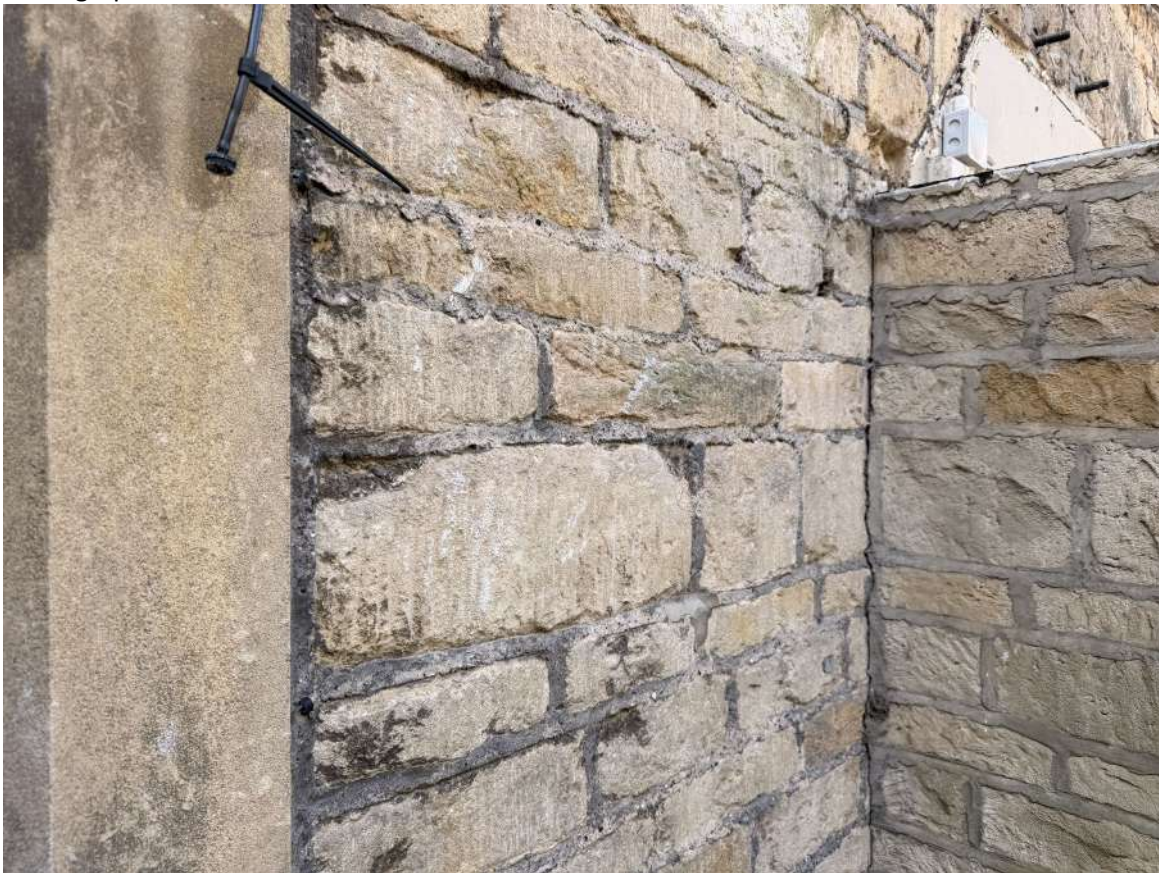
Photograph 5

| 5 | | Front elevation at junction between porch and main elevation |

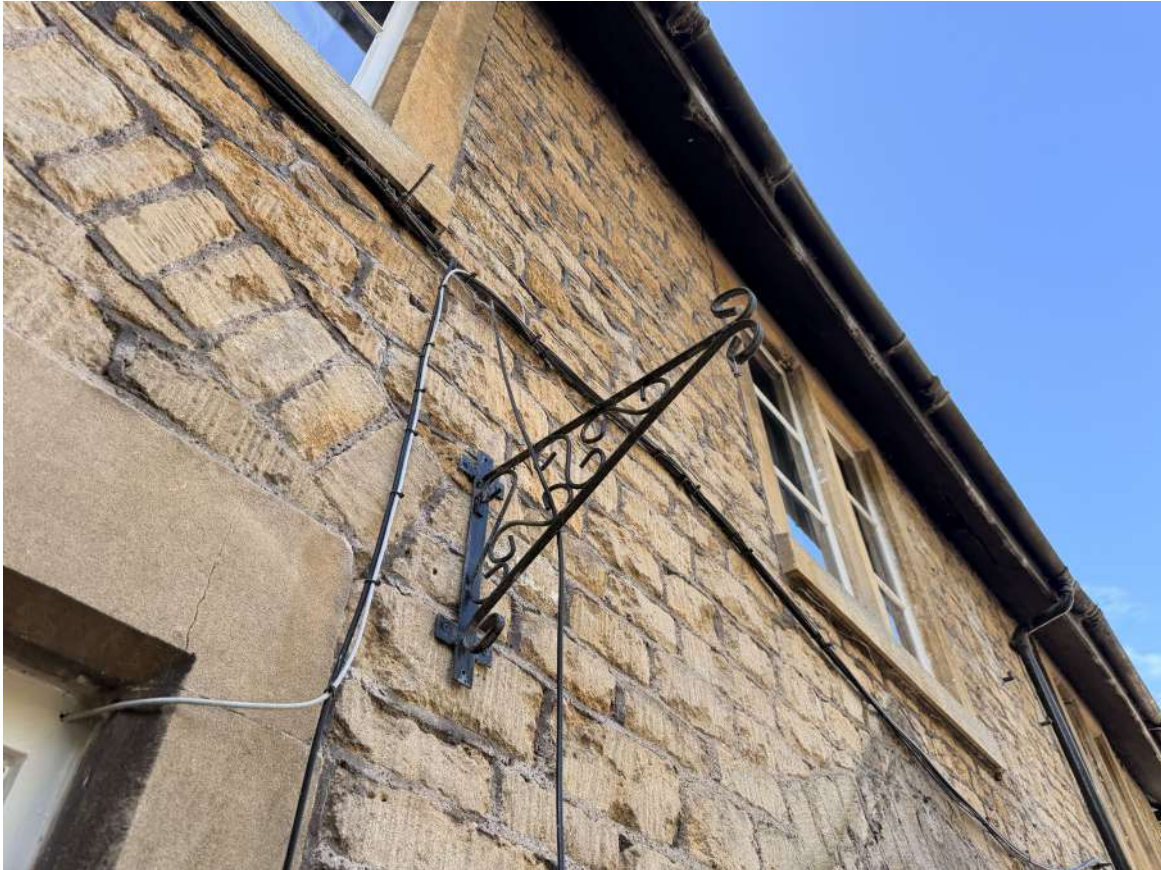
Photograph 6

| 6 | | Front elevation over front porch area |

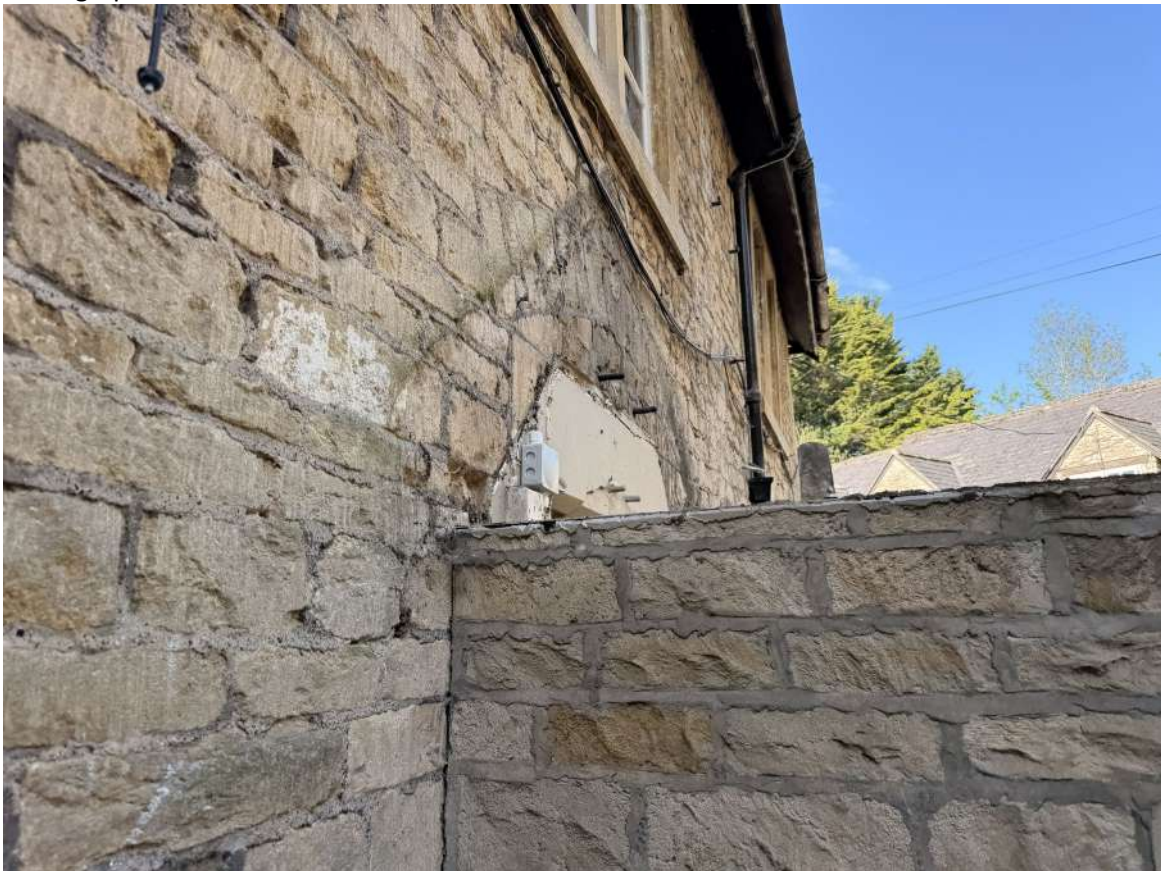
Photograph 7

| 7 | | Front elevation over front porch area |

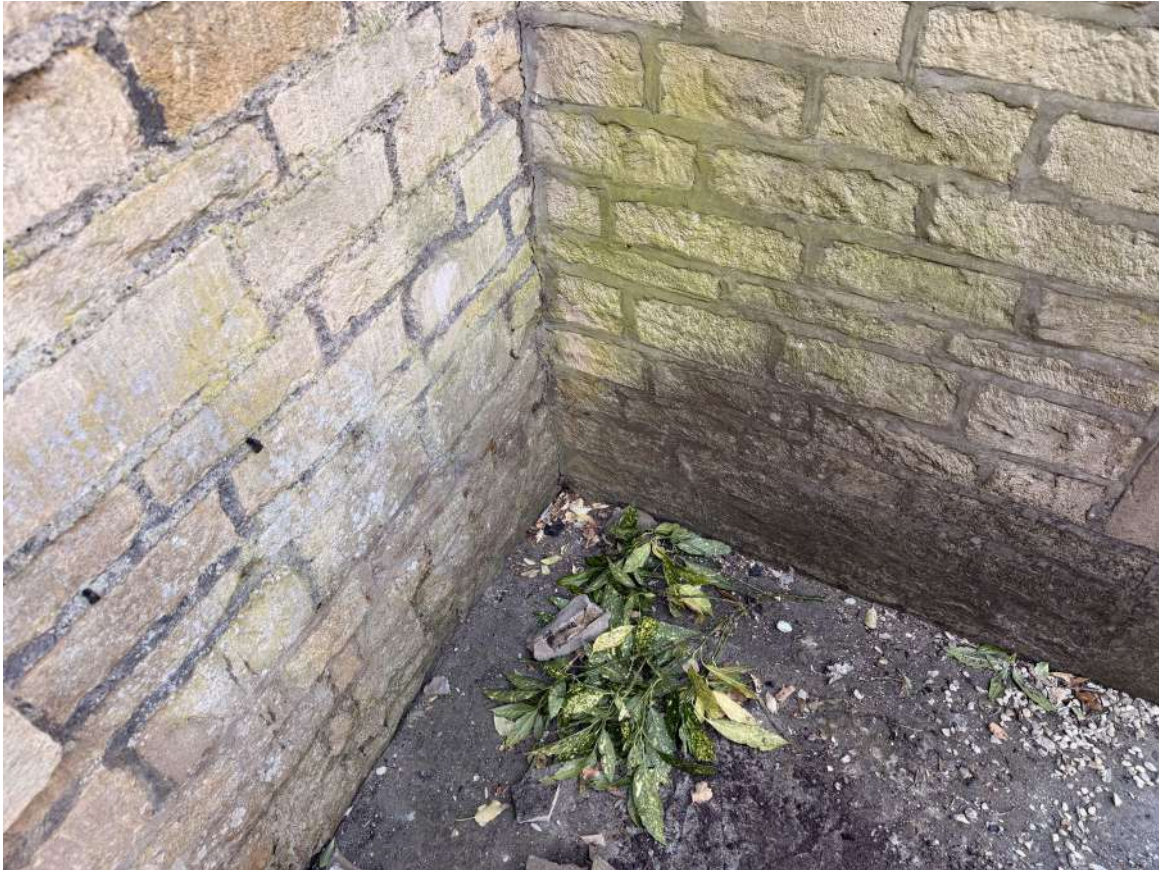
Photograph 8

| 8 | | Front elevation at junction between porch and main elevation |

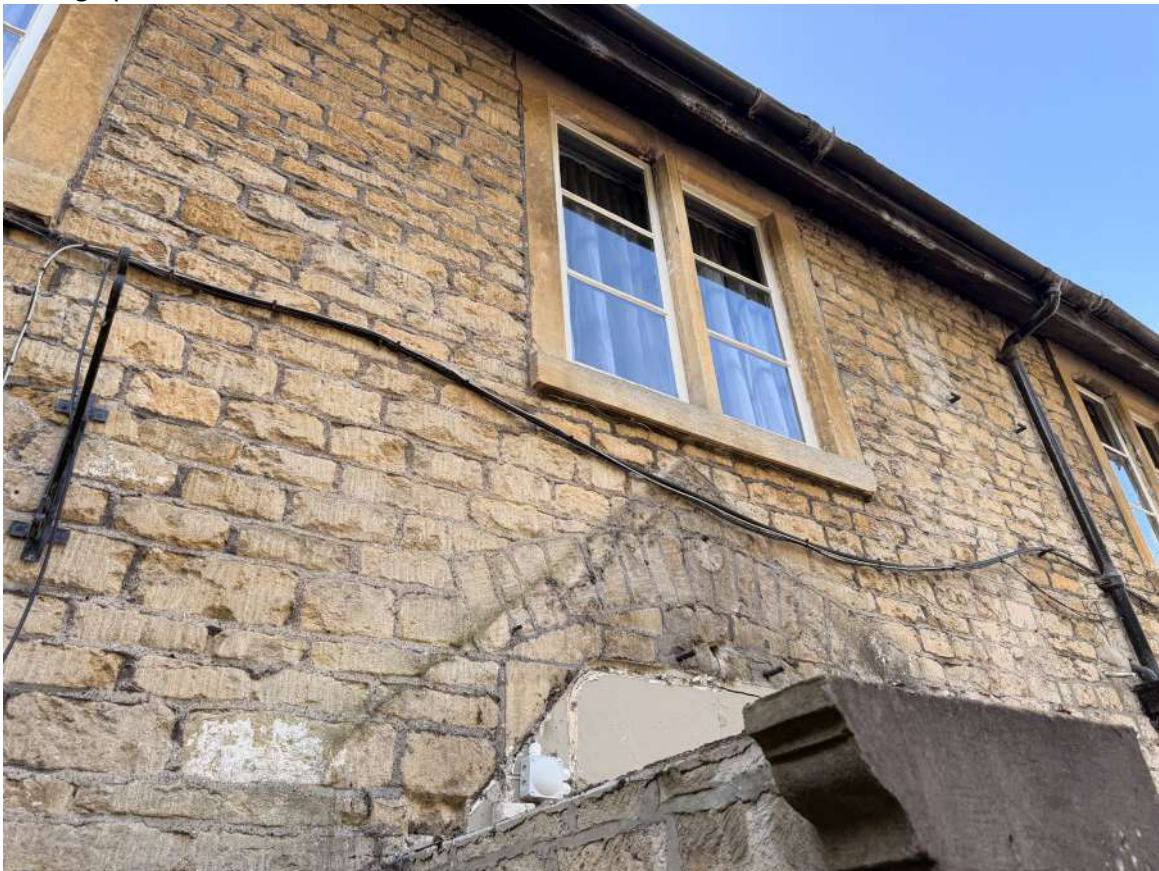
Photograph 21

| 21 | | Front elevation over porch area |

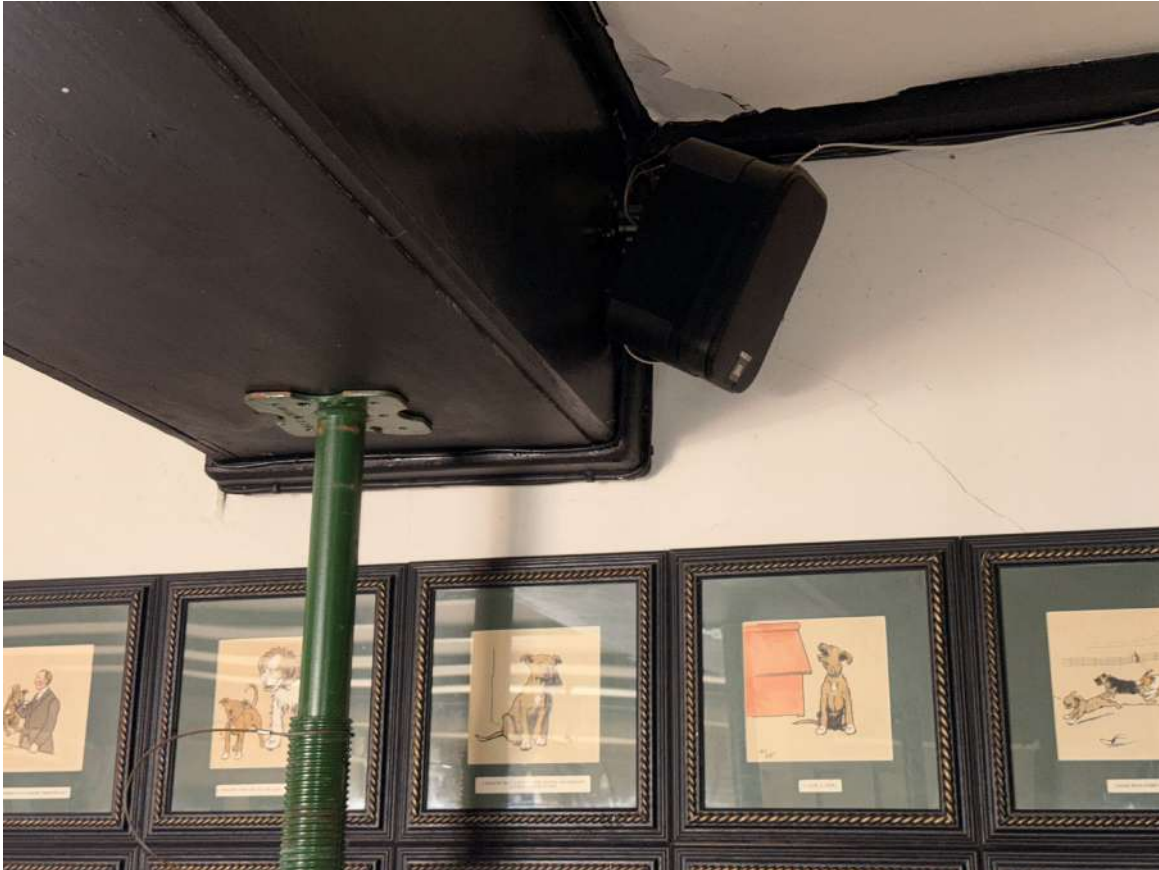
Photograph 22

| 22 | | Interior of front elevation<br>showing support for primary<br>beams over |

The existing timber and steel beams supporting the first floor construction over should be fully propped and supported in the temporary case, to release load from the external wall and prevent any destabilisation prior to remedial works being completed. Where the propping is proposed to the clad steel beam internally, the cladding is to be fully removed so that the props are installed tight to the underside of the primary structural member. The base of the props is to fully bear on suitable spreader boards (minimum 2no scaffold boards or similar steel plating), and the contractor is to ensure that this area is not bearing on the basement void below, but on the primary masonry wall below floor level. This is to be repeated below the primary timber beam also.

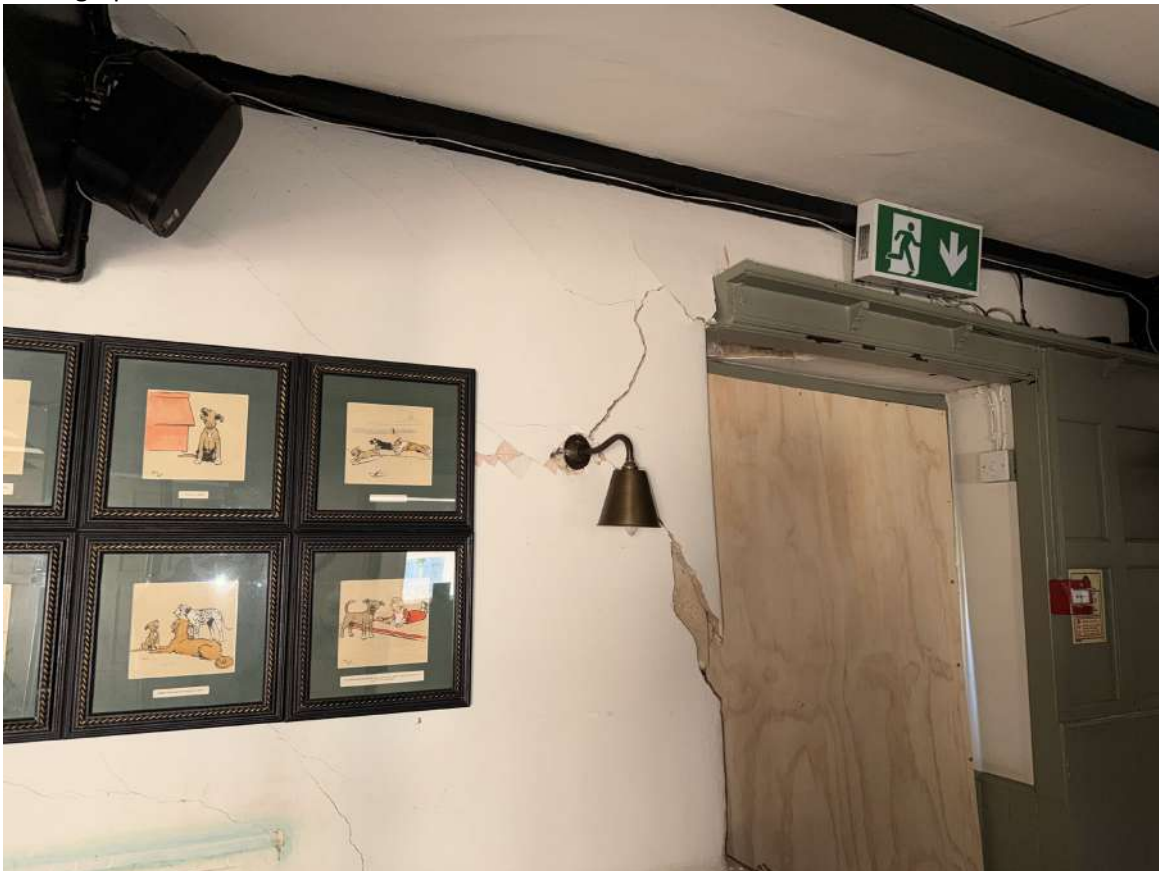
Photograph 23

| 23 | | Interior of front elevation in bar area |

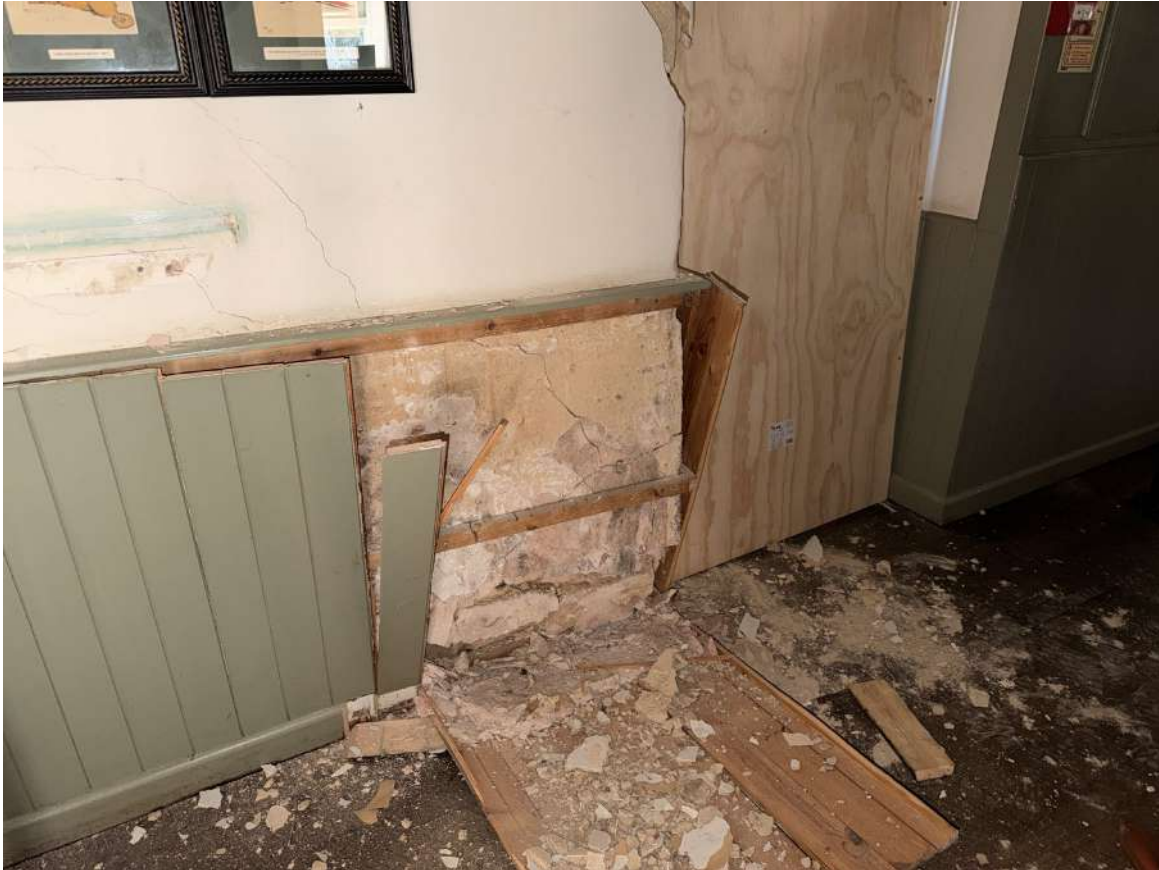
Photograph 24

| 24 | | Interior of front elevation in bar area |

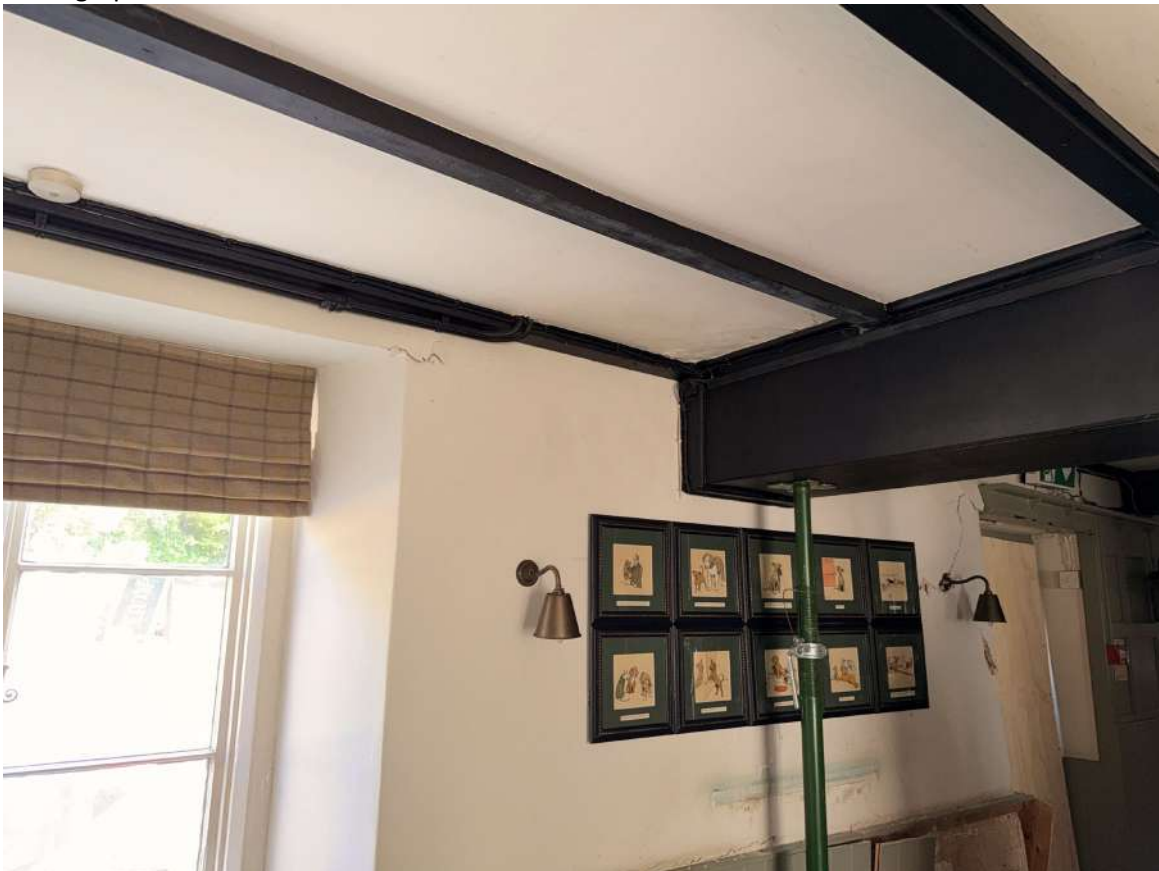
Photograph 25

| 25 | | Interior of front elevation showing support for primary beams over |

Once exposed, it is our further recommendation that the condition of the existing clad steel beam be considered, and where necessary, replaced on a like for like basis with a new member with modern design.

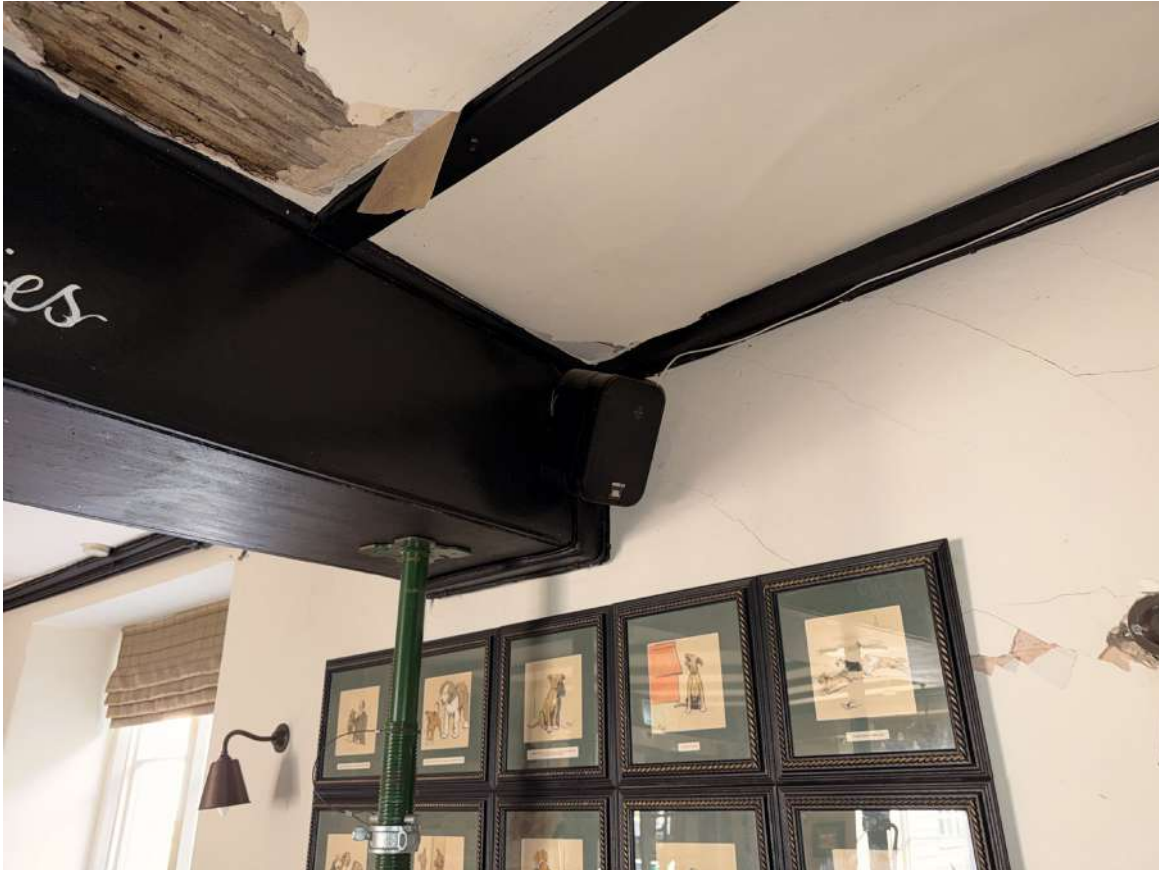
Photograph 26

| 26 | | Interior of front elevation showing support for primary beams over |

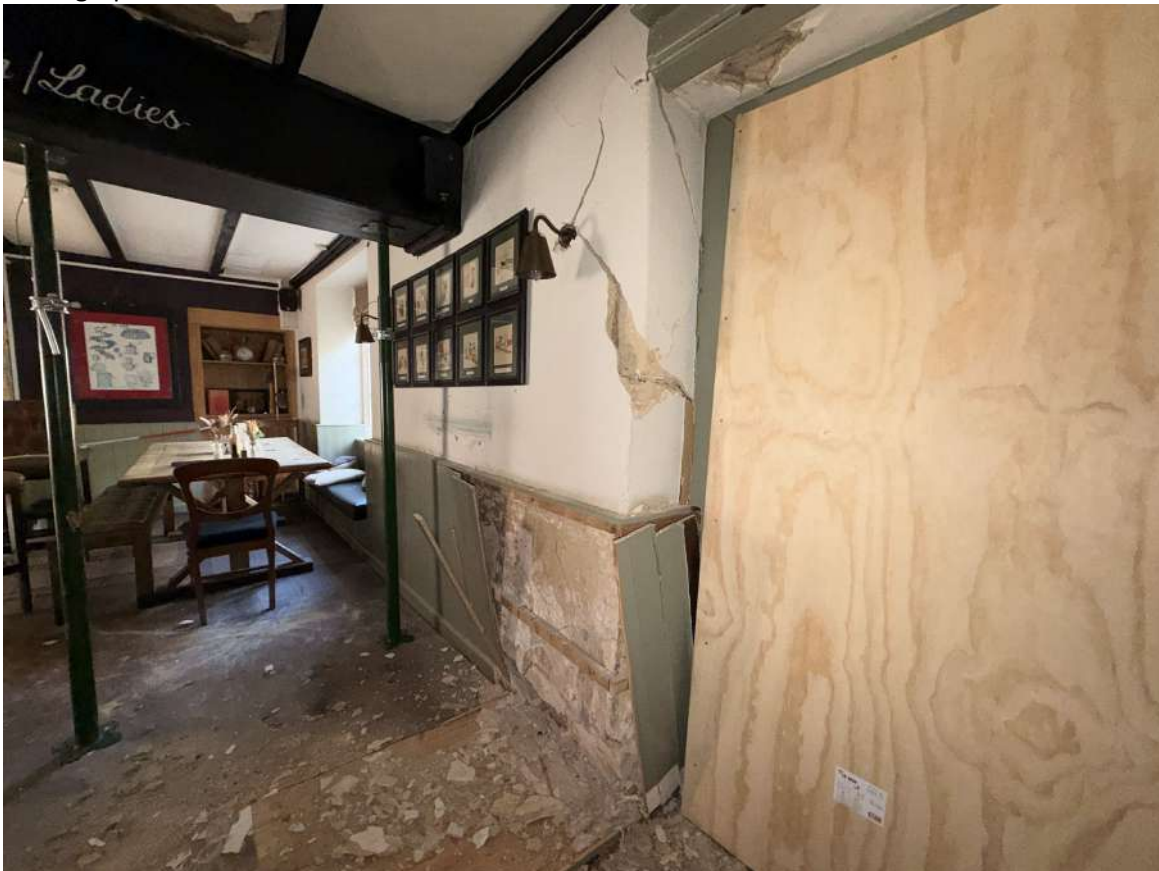
Photograph 27

| 27 | | Interior of front elevation showing support for primary beams over |

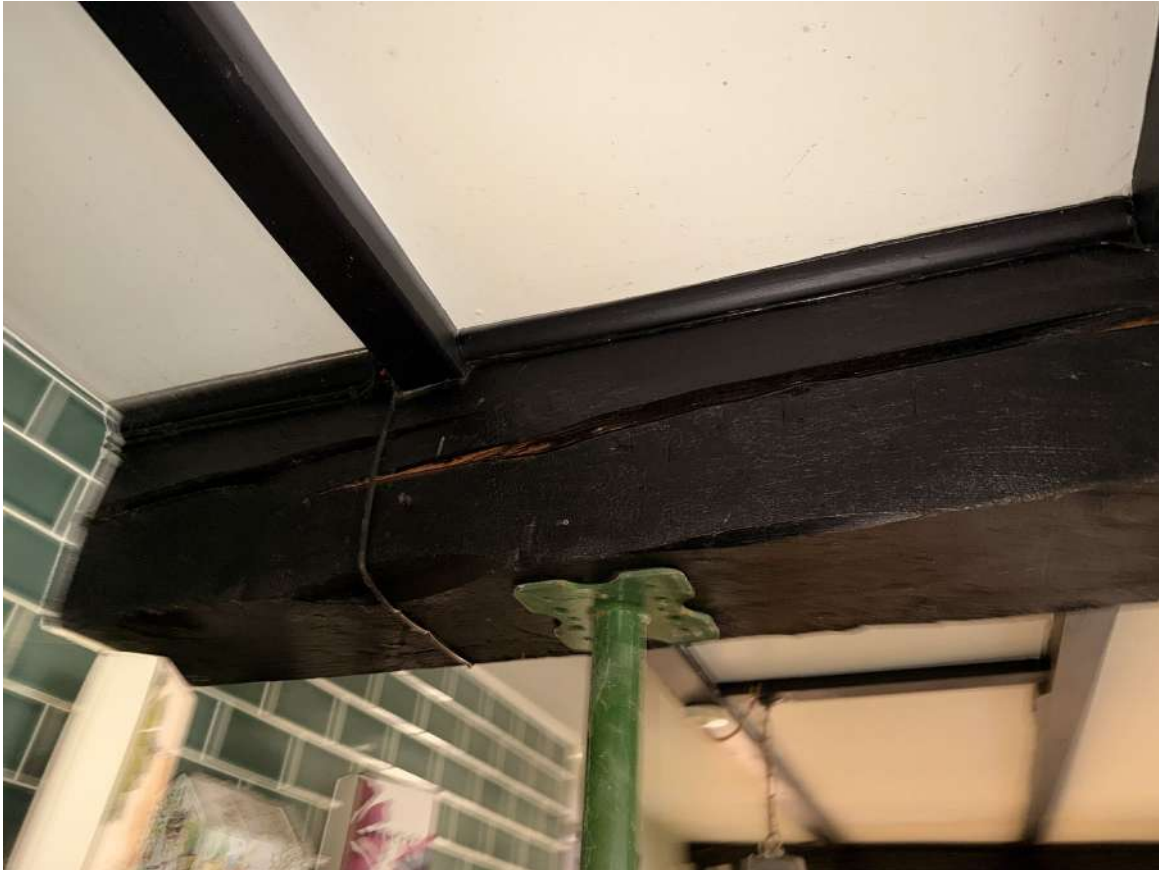
Photograph 28

| 28 | | Interior of front elevation showing support for primary timber beams over |

Where cracking has been noted to have further deteriorated to the existing hardwood timber beam, it is our recommendation that this member be fully replaced with a steel beam of suitable design, by a structural engineer, and clad, to match the existing adjacent member.

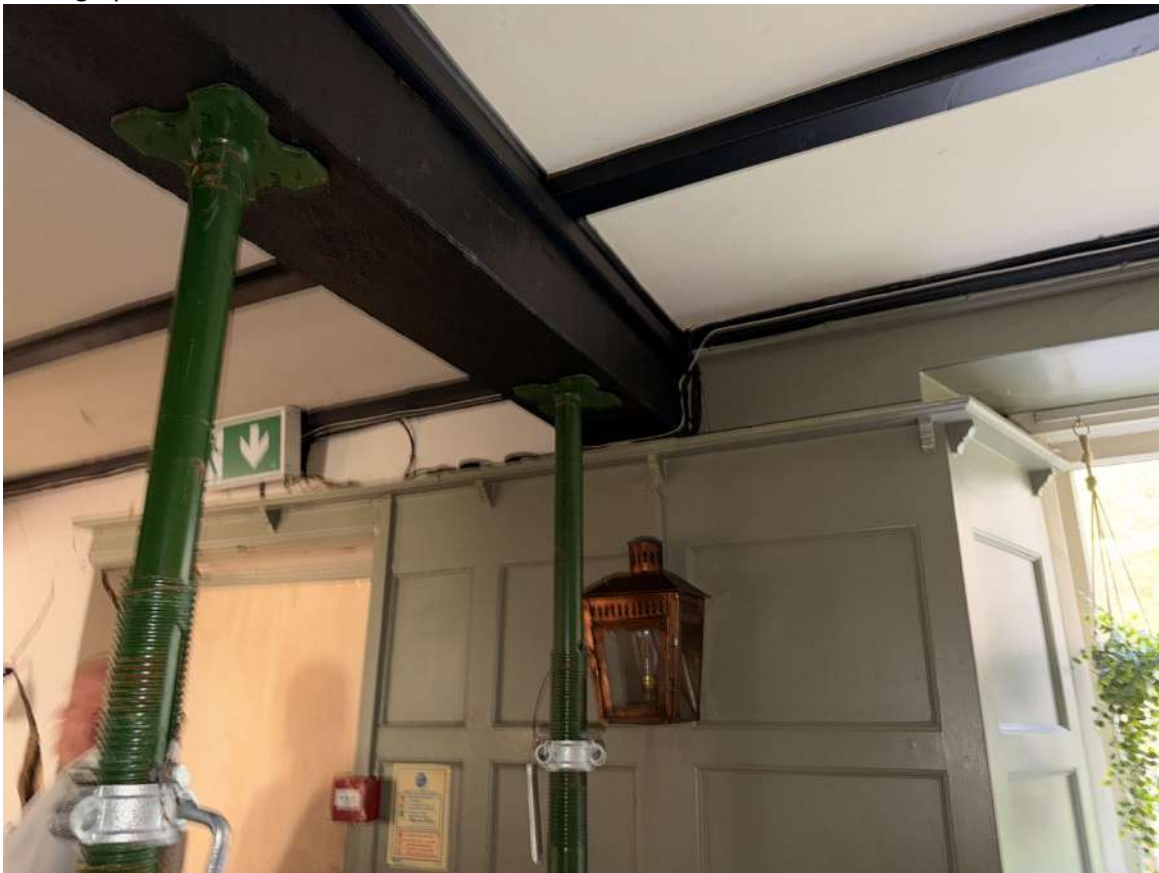
Photograph 29

| 29 | | Interior of front elevation showing support for primary timber beams over |

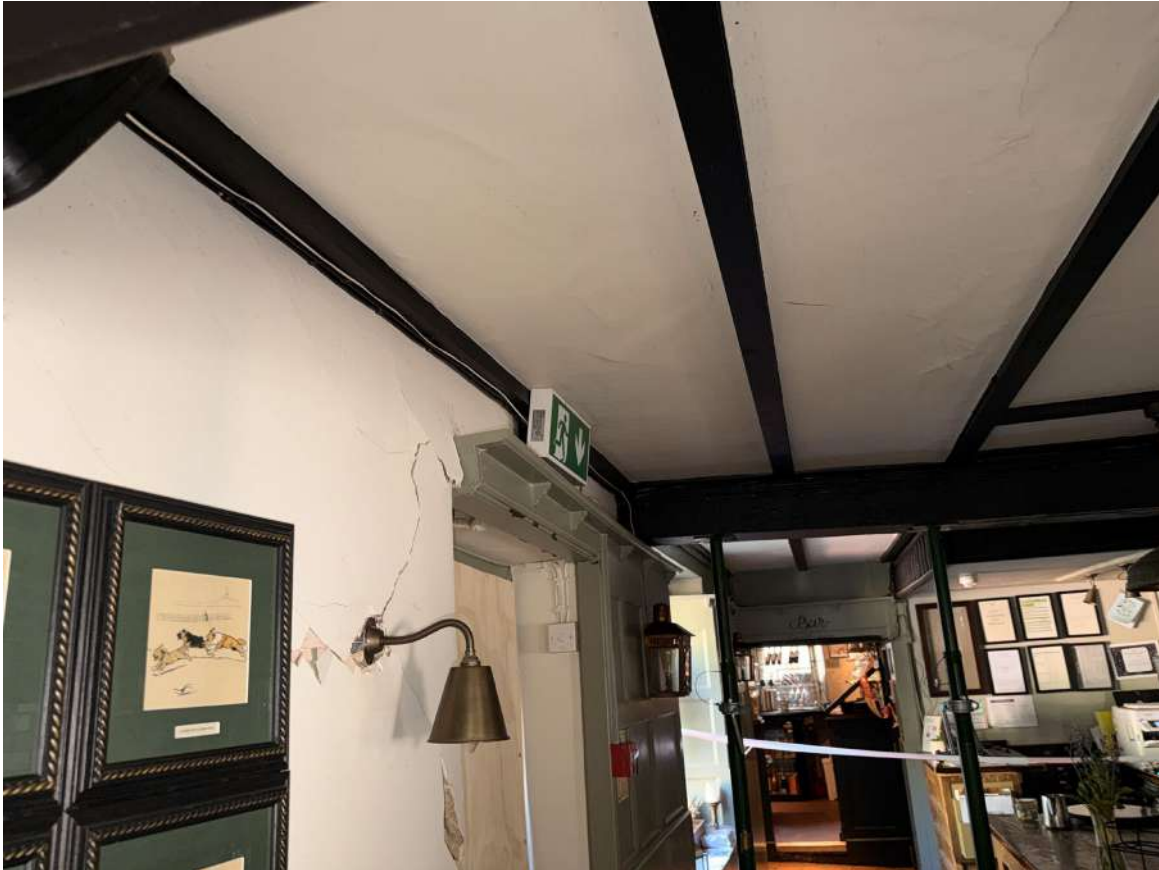
Photograph 30

| 30 | | Interior showing span of first floor feature joists over |

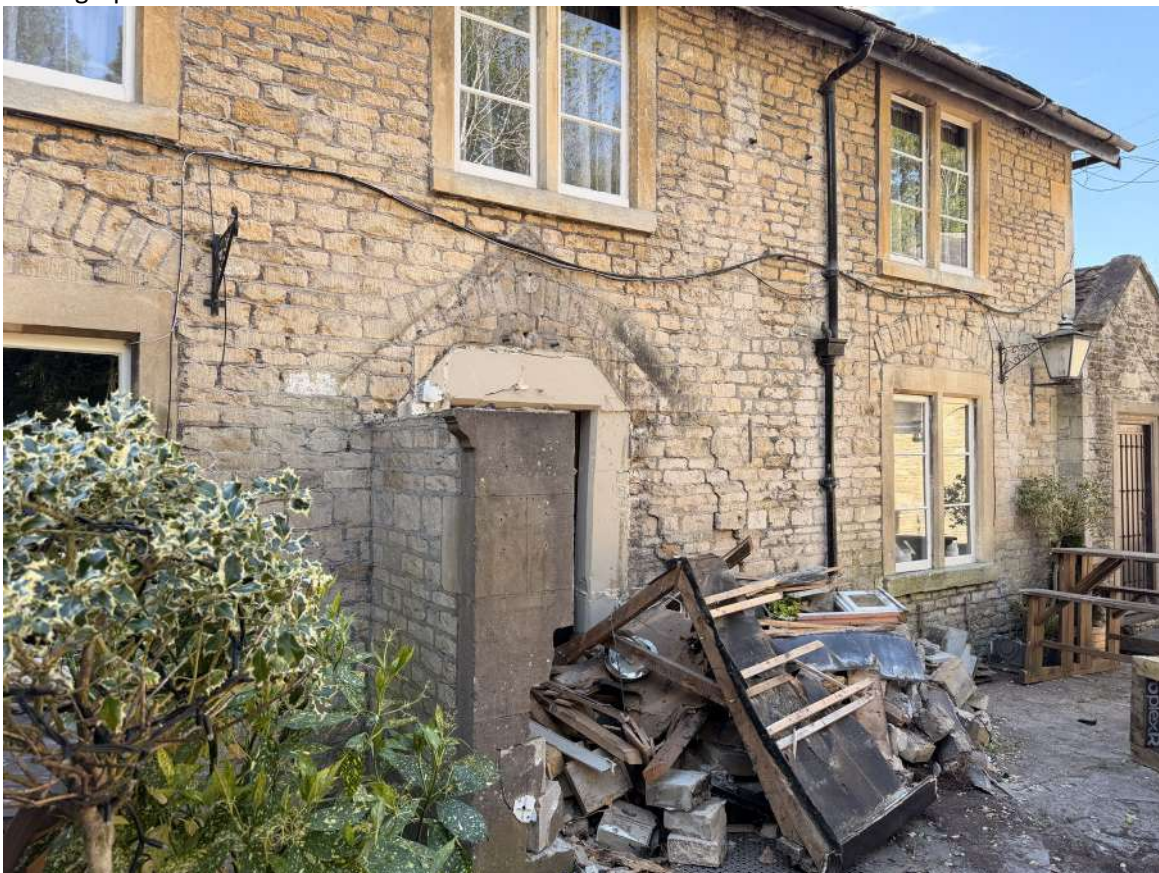
Photograph 31

| 31 | | Front elevation as viewed externally |

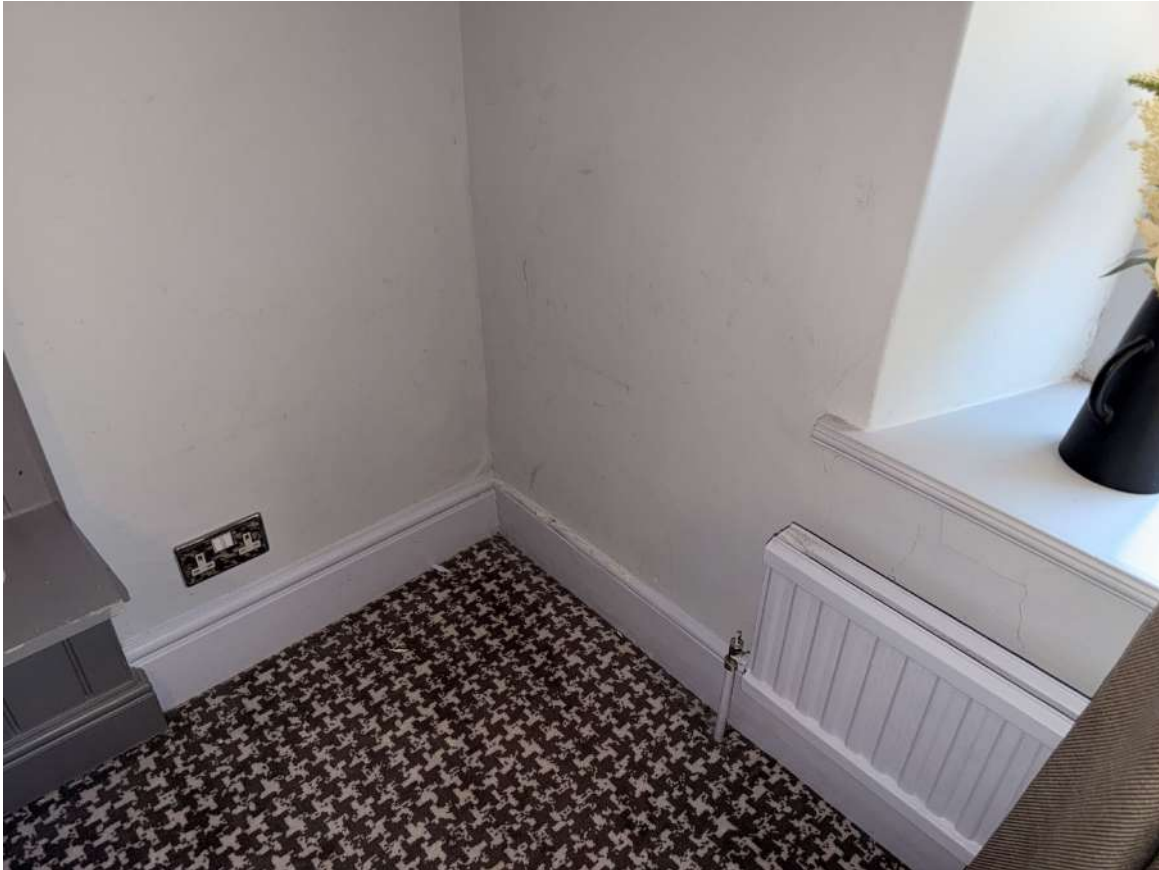
Photograph 32

| 32 | | Interior of first floor room over area of impact |

Where cracking has been noted to the first floor, in the residential spaces above, these cracks are not considered structurally significant and are recommended to be hacked back to exposed masonry, and replastered with the inclusion of plasterers lath mesh, to limit the likelihood of further cracking in the future. It is our further recommendation, that prior to replastering, where cracking is noted to penetrate the masonry, that these cracks are stitched using stainless steel helical bars at 300mm vertical centres, before refinishing, in accordance with manufacturers installation details (Helifix or similar approved).

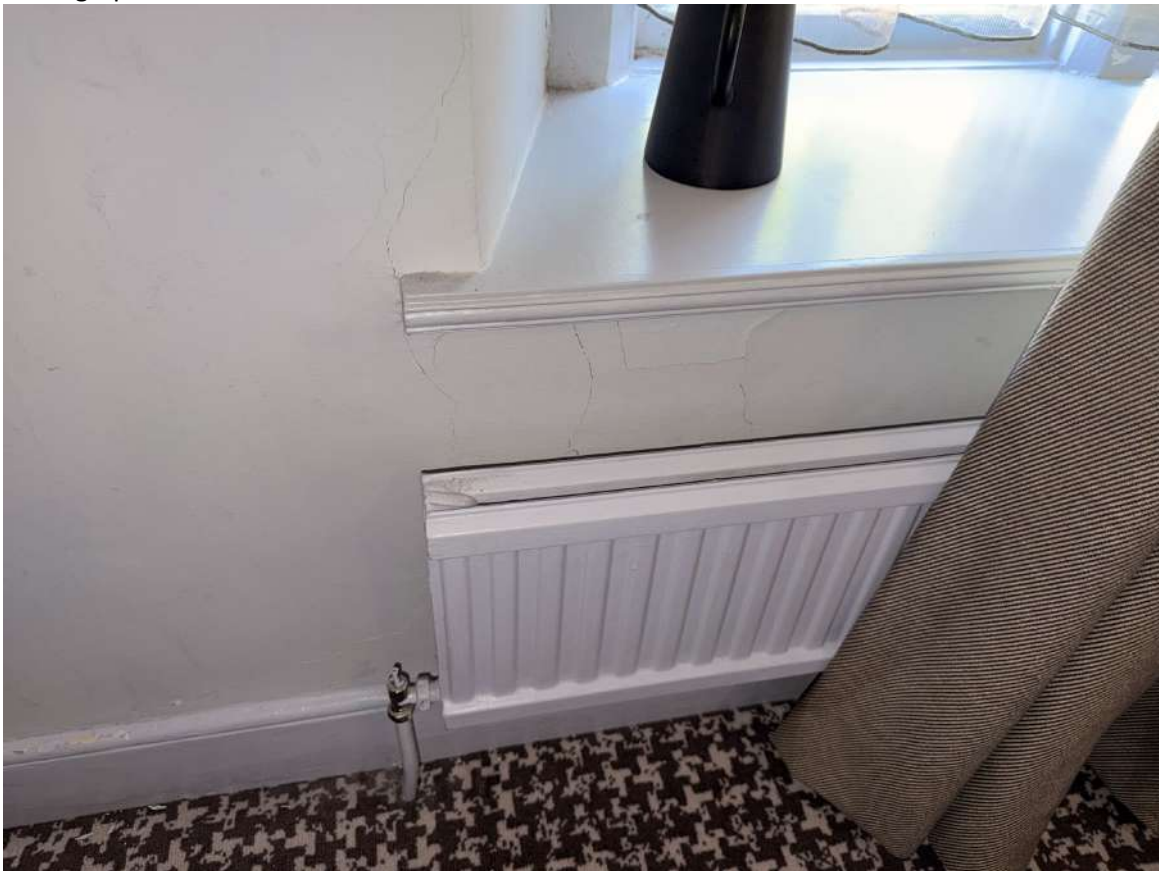
Photograph 33

| 33 | | Interior of first floor room over area of impact |
