# Structural Engineers Report For:

The White Hart, Chippenham

Visual Structural Inspection

REF: 24700

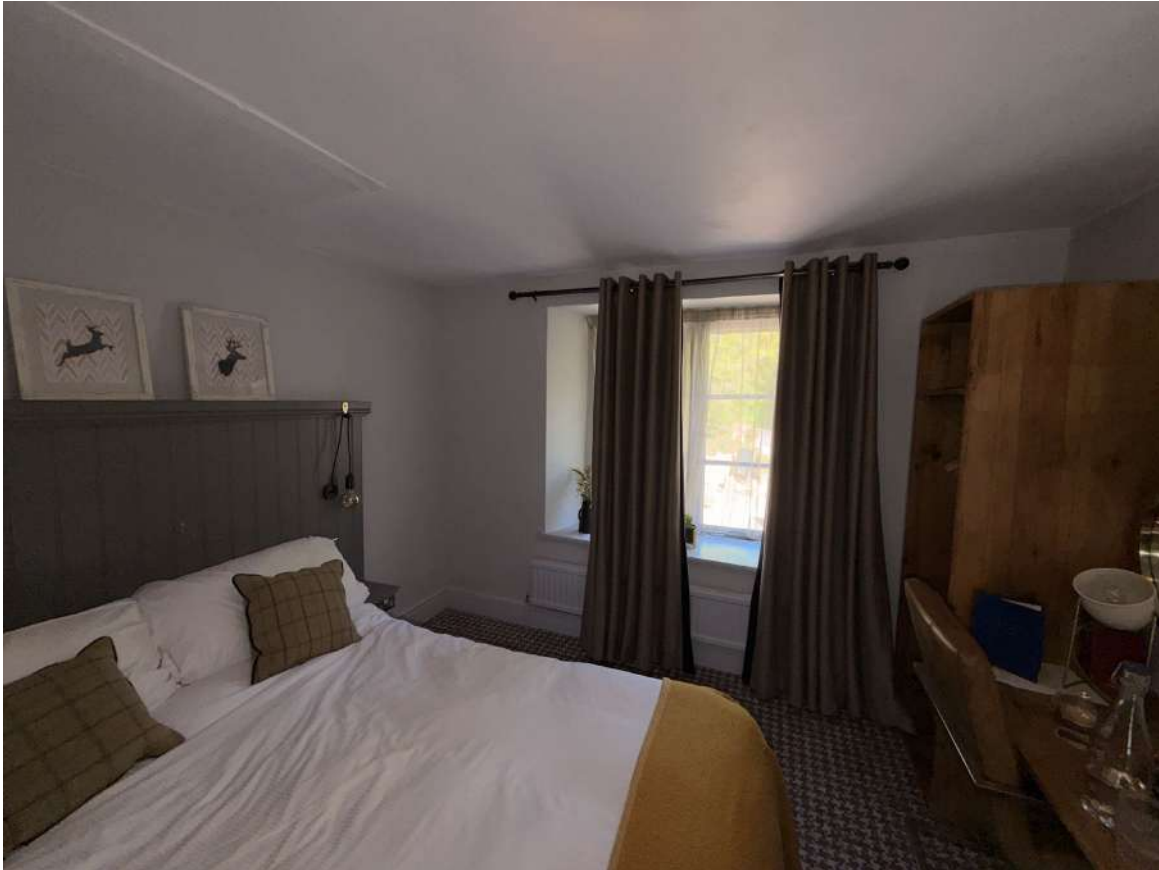
Photograph 34

| 34 | | Interior of first floor room over area of impact |

Where cracking has been noted to the first floor, in the residential spaces above, these cracks are not considered structurally significant and are recommended to be hacked back to exposed masonry, and replastered with the inclusion of plasterers lath mesh, to limit the likelihood of further cracking in the future. It is our further recommendation, that prior to replastering, where cracking is noted to penetrate the masonry, that these cracks are stitched using stainless steel helical bars at 300mm vertical centres, before refinishing, in accordance with manufacturers installation details (Helifix or similar approved).

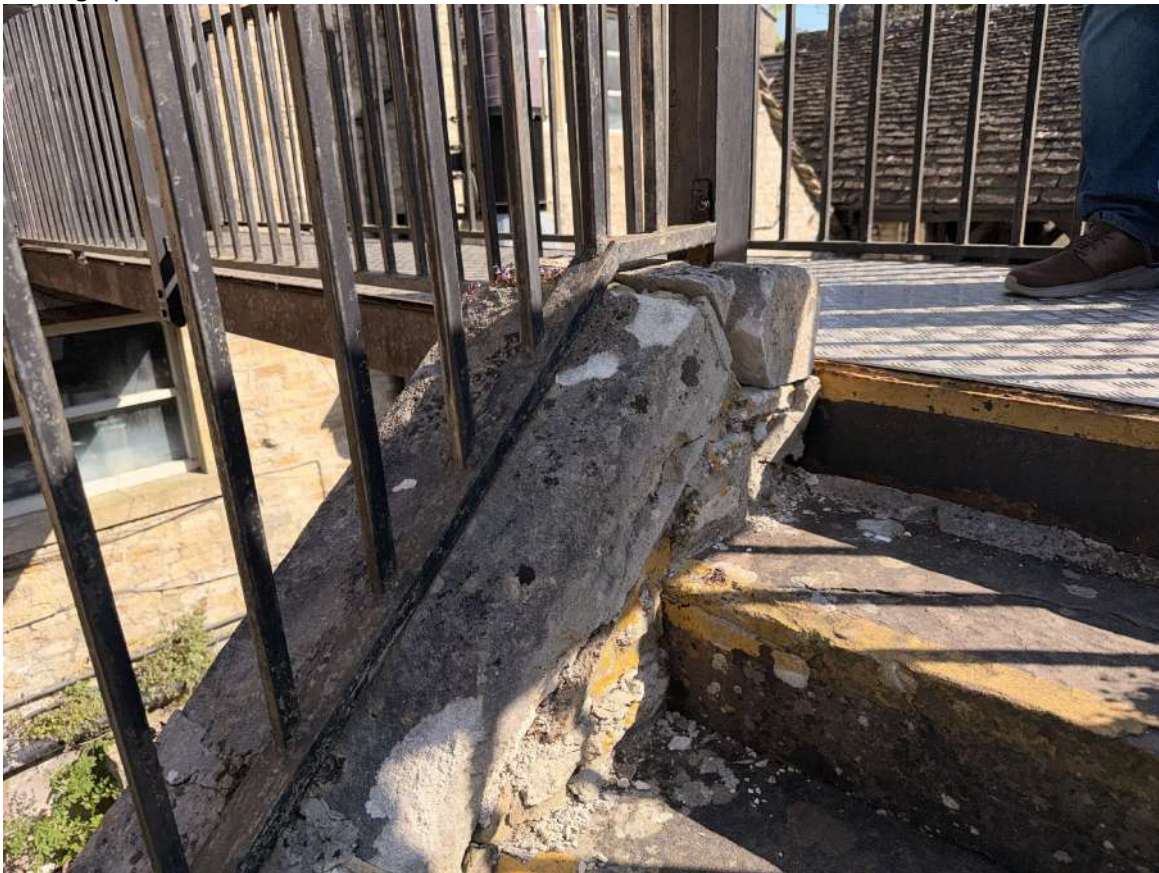
Photograph 35

| 35 | | Rear elevation footbridge over rear stream |

The damage to the stonework to the rear elevation bridge is not, in our professional opinion, as a result of the vehicular impact, however where stonework is noted to be loose, it is our recommendation that

these areas be made safe, and masonry reinstated and rejointed by a suitably qualified stonemason.

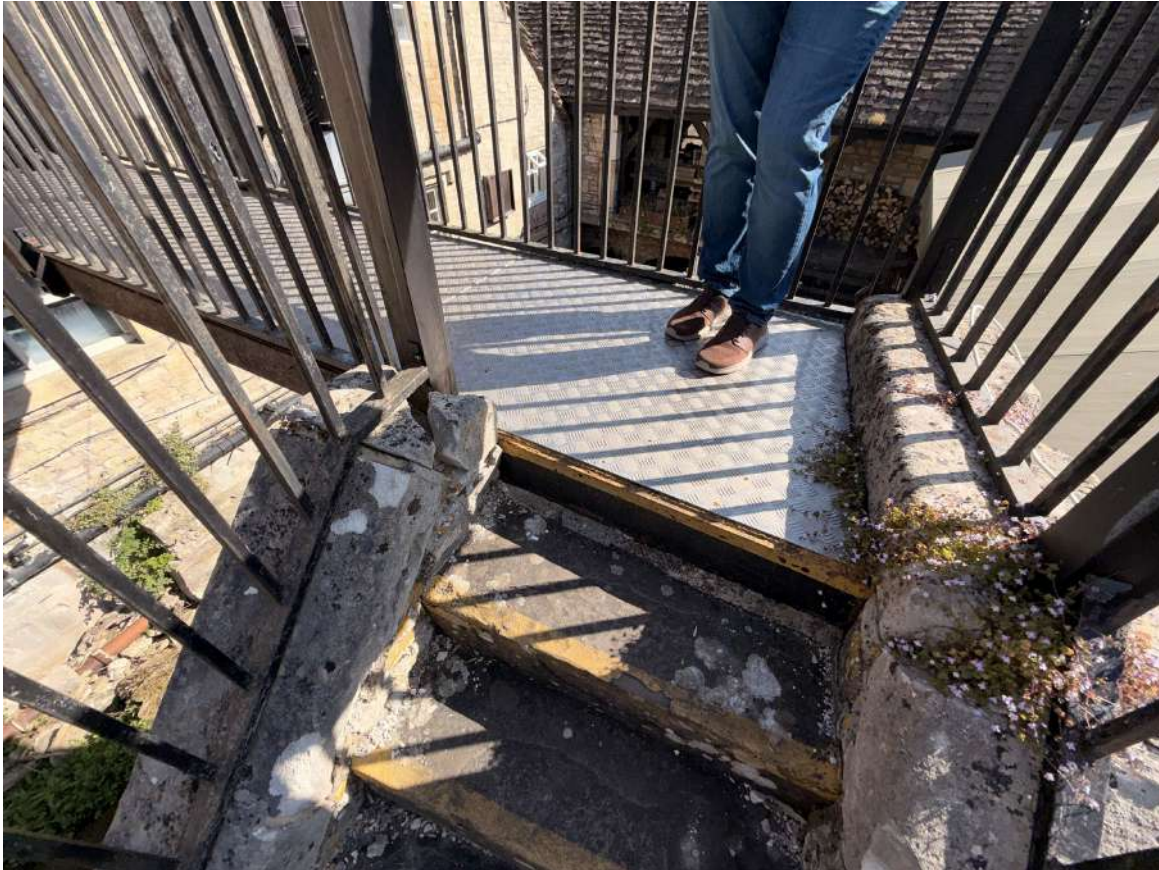
Photograph 36

| 36 | | Rear elevation footbridge over rear stream |
