## **ARBORICULTURAL SURVEY – BS 5837:2012 & CONSTRAINTS ASSESSMENT**

**SITE:** 27a CHURCHFIELDS ROAD, SALISBURY, SP2 7NH

**DATE:** 27 APRIL 2026

**REPORT REF:** AS-64-26

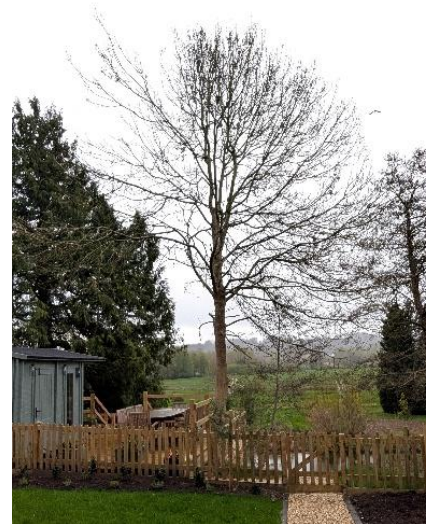
**Ash T1** This Ash is an early-mature specimen. The crown is in fair condition overall, with a reasonable density. It is weighted somewhat to the south west - the north west part has the appearance of having been suppressed, perhaps by neighbouring trees, during its early growth.

There is a narrow, occluded wound running up the stem from ground level to 3m on the north west side, but this appears to be only superficial, and not structurally significant.

**Fig. 1** Ash T1 view looking south, showing overall form. The decking and cabin are visible to the left.

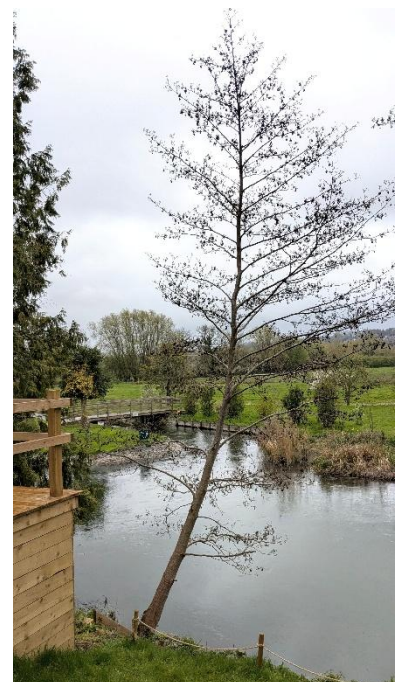
**Alder T2** This Alder is a riparian tree. It was self-set and has rooted against the brickwork of an old retaining wall, within 1.7m of the waterline (at the time of inspection). Its root development is likely to have been modified by the old retaining wall, and it will be preferentially rooting laterally along the bank where moisture and oxygen levels are optimal for the species.

The lower stem has a very significant lean (approximately 45°) to the south, over the river; however, recent growth is more upright, suggesting the lean is stable.

**Fig. 2** Alder T2 view looking south east. The decking, and the crown edge of T3, are visible on the left.

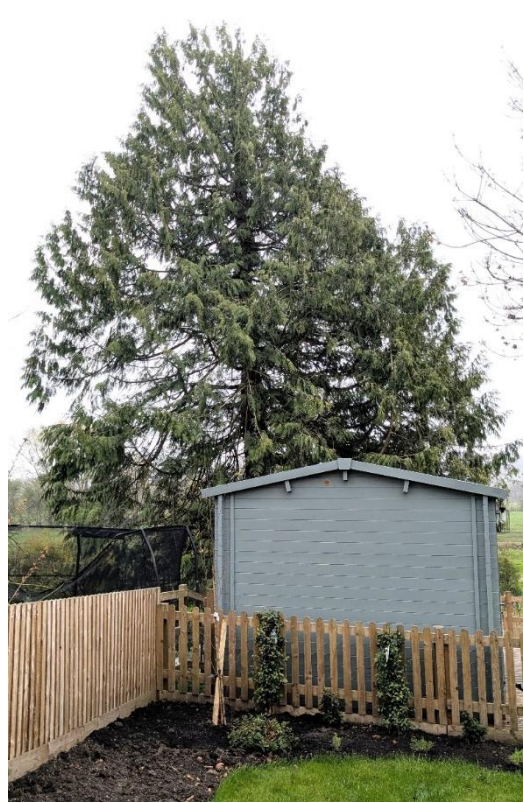
**Thuja plicata “Zebrina” T3, and Birch T4** The Thuja is a mature specimen, growing close to the boundary in the neighbouring property to the east. Structurally, it has a reasonable form, slightly weighted towards the river. The canopy has a lower than average vigour (it is particularly sparse on east side) which may be due to the fact that its growing conditions aren't optimal for the species. This is likely to limit longevity to significantly less than 40 years.

The Birch T4 is a very recent planting following construction. It's in the main garden area immediately north of the cabin. It appears to have established well.

**Fig. 3** Thuja plicata T3 (to rear of cabin in this picture) showing the lower crown density on its east side, and Birch T4 (post construction, new planting in the garden bed). View looking south east

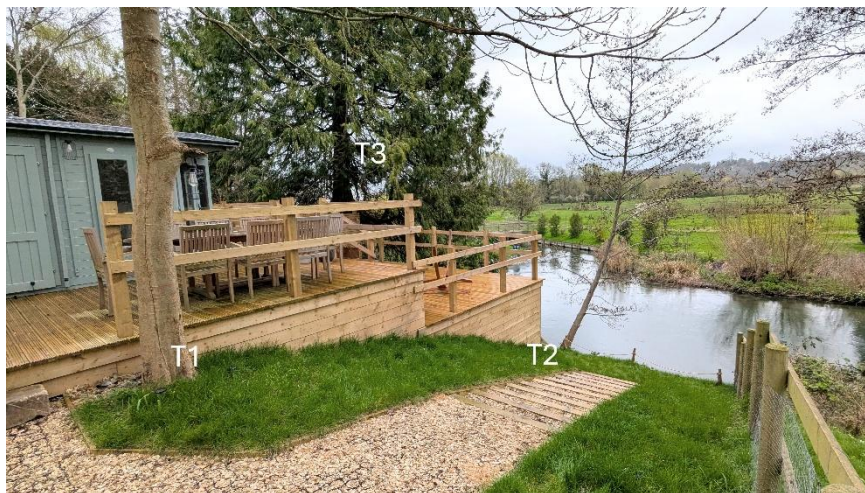
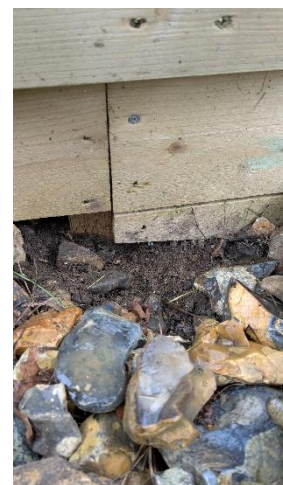
**Fig. 4 & 5** Left – general arrangement of the key trees in relation to the construction Right – close-up of hand-driven post, closest to the base of T1

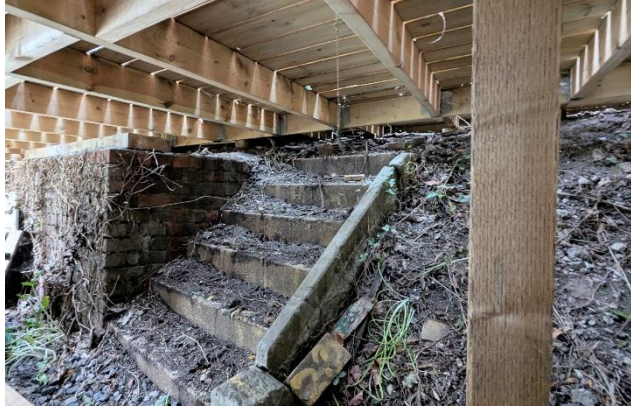
**Fig. 6** View of structures and levels retained in situ under decking.

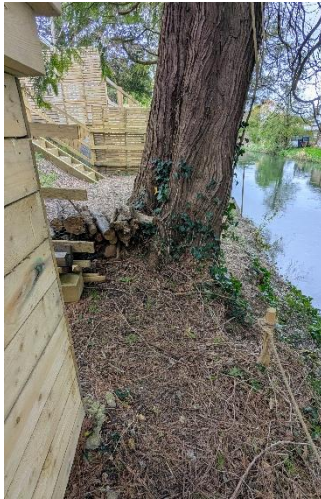
**Fig. 7** View east showing T3 in relation to the decking. Note: post-hole at the corner of the structure (visible bottom-left in this picture) was lined with impermeable lining before backfilling with concrete

- The construction was carried out by hand.
- The structure doesn't affect the growing conditions of the retained trees.
- Although the hand excavation of the post pit by T3 was close enough, potentially, to have caused root disturbance, I consider any impact would have been negligible given the nature and extent of the work.
