# Part Q Barn Conversion, The Old Rectory, Everleigh, Marlborough

Structural Report 7154-R01

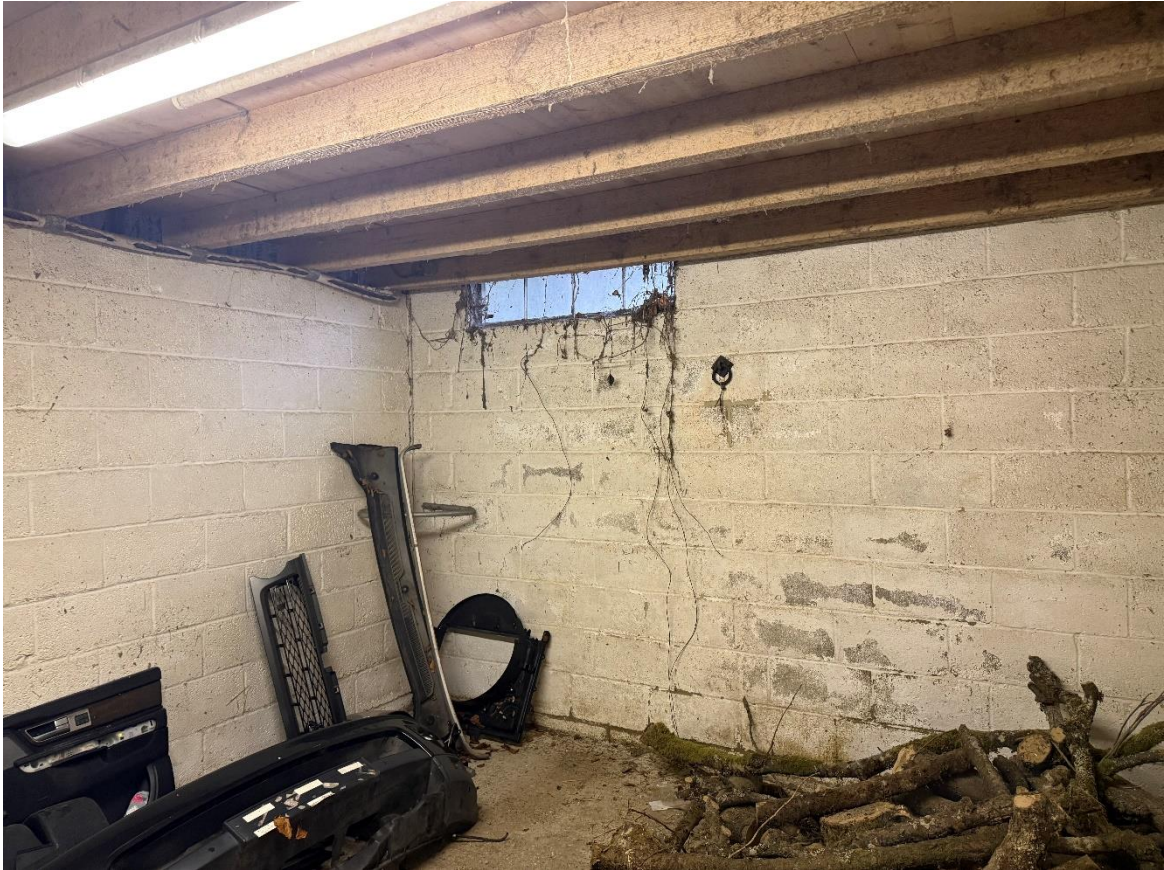
*Figure 7: Internal – South west end stabling*

- 2.6. Internally, blockwork walls subdivide the two south-western bays, forming what appears to be former stabling. These walls support timber joists that create an overhead storage platform (not accessed during inspection). The north-eastern end of the barn remains largely open plan.

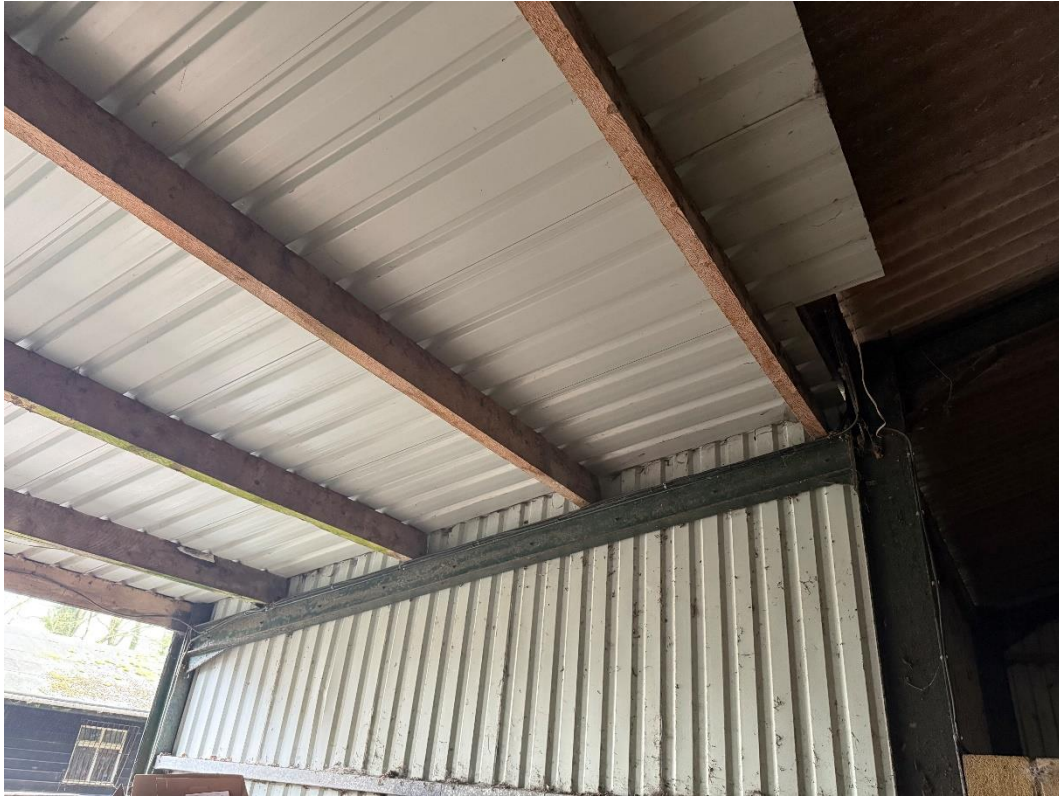
- 2.18. Internally, the steel frame exhibits surface corrosion throughout, with a greater concentration at lower levels adjacent to the blockwork and toward ground level. This is likely attributable to persistently damp conditions and the building's former use for housing animals. Due to the construction detail—where masonry is built within the depth of the steel sections—parts of the frame are externally exposed and therefore subject to prevailing weather conditions.

- 2.19. Notwithstanding this, the steel members remain in generally good condition. The corrosion observed is superficial in nature and there is no evidence of significant section loss, delamination, separation, or active flaking. The extent of corrosion is not currently considered sufficient to materially reduce the structural capacity of the steel frame.

**Figure 9: Mono pitch span + High level steel corrosion.**

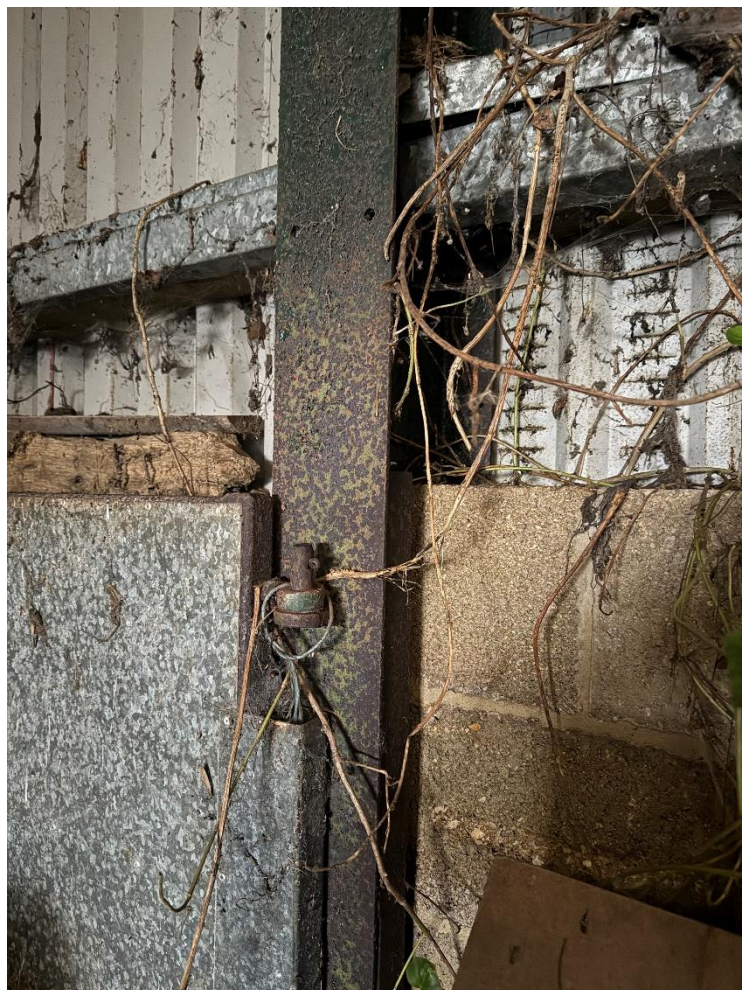
**Figure 10: Steel Corrosion 1 – Top of masonry internally**

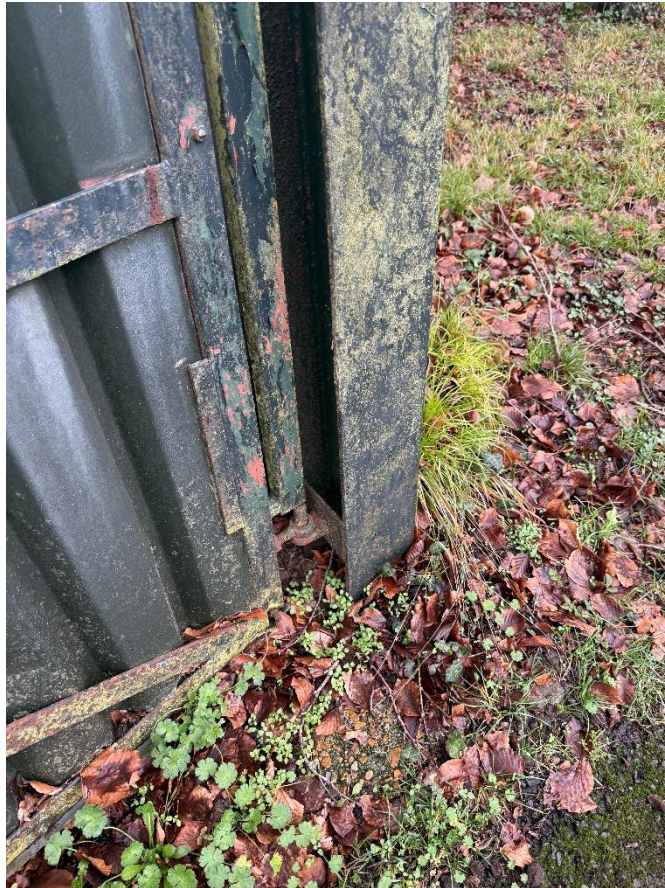
*Figure 11: Steel Corrosion 2, North-west Elevation*

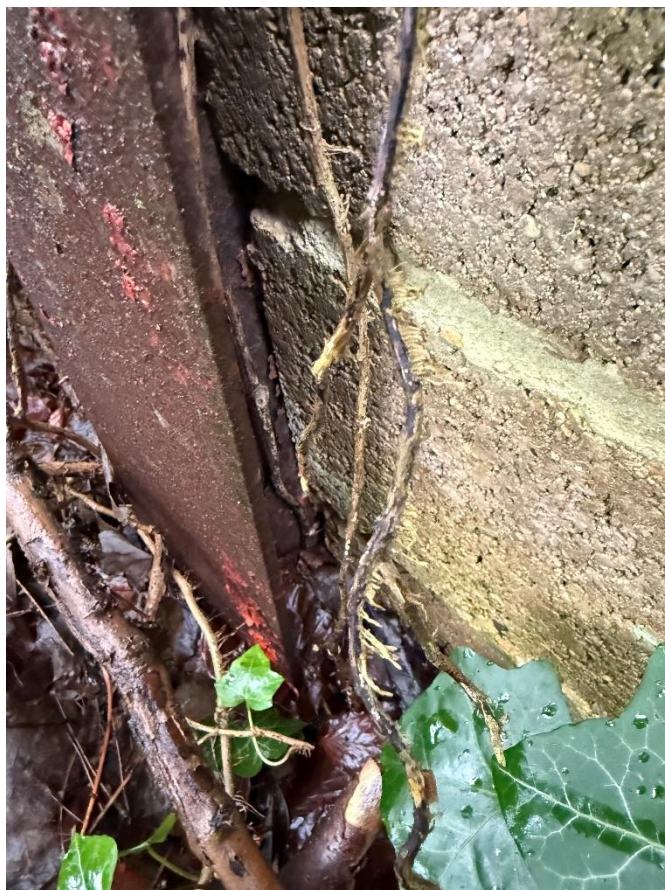
*Figure 12: Steel Corrosion 2, South-east Elevation*

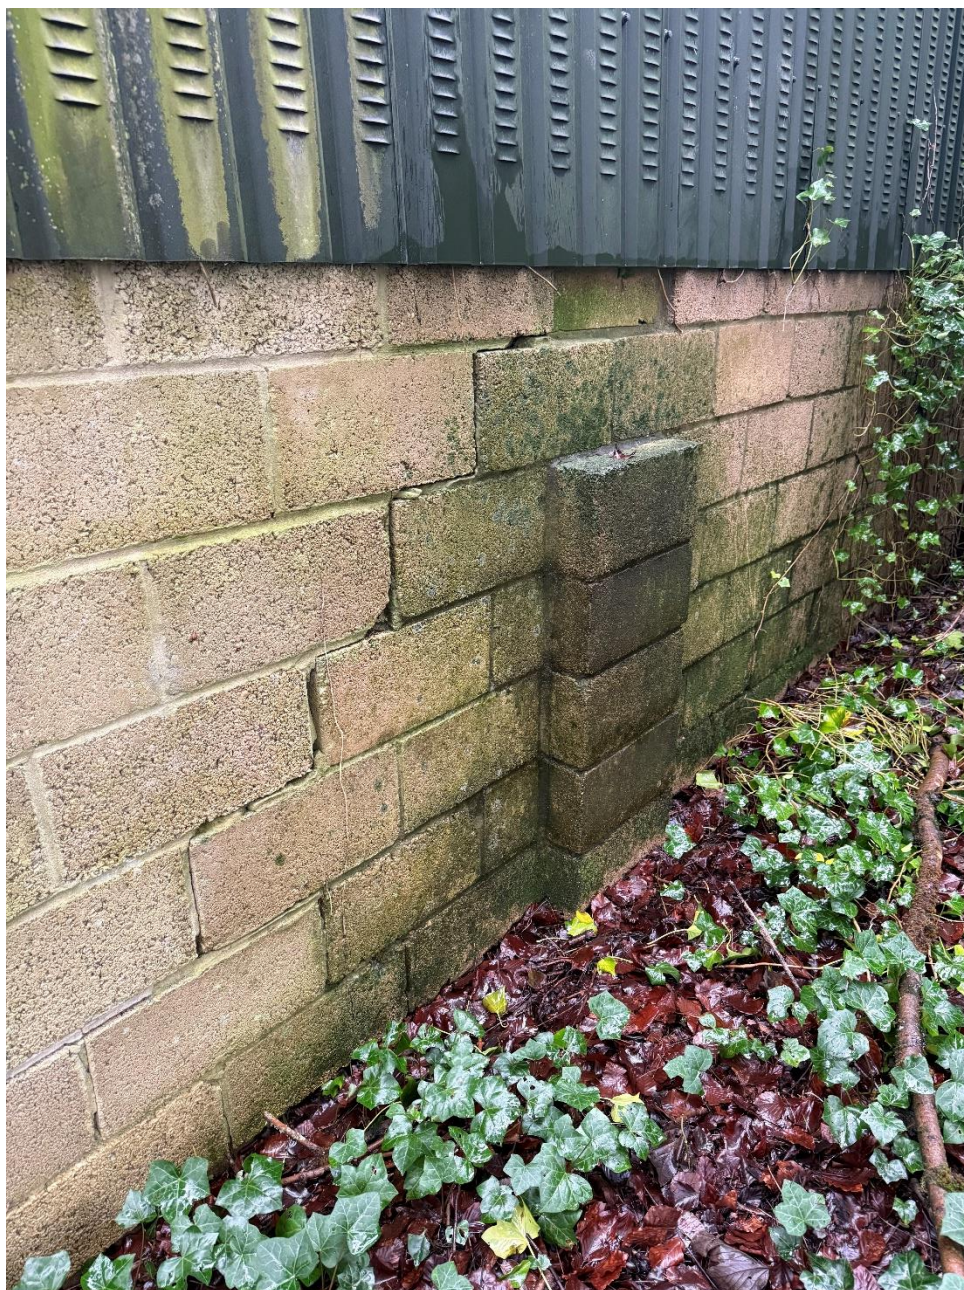
- 2.23. The lower masonry sections are also generally in good condition, with no significant cracking or bowing observed. Panels are typically plumb in relation to the steel columns they adjoin. No evidence of root or tree-related damage is visible, despite the presence of mature trees in close proximity to the boundary, suggesting that the foundations are sufficiently deep to resist such effects.
- 2.24. One masonry panel does show damage. On the south-east wall, the second panel from the north-east exhibits bowing toward the panel centre, with diagonal cracking following the masonry joints from the steel frame upward to the middle of the panel. The panel has also been externally reinforced with a blockwork pier. This would need some local rebuilding to rectify.

Internally, this location coincides with an old, large animal feeding trough. Based on the cracking pattern and context, it is likely that the damage results from user-induced impact, such as contact with vehicles or equipment, rather than structural failure.

*Figure 13: Masonry panel damage*
