# Preliminary Ecological Appraisal and Roost Assessment

Home Farm, Shaw Hill, Shaw, Wiltshire, SN12 8EW

This report is prepared to inform a planning application with the Wiltshire Council. The proposal is described as:

‘The erection of 2no. dwellings with associated soft landscaping’.

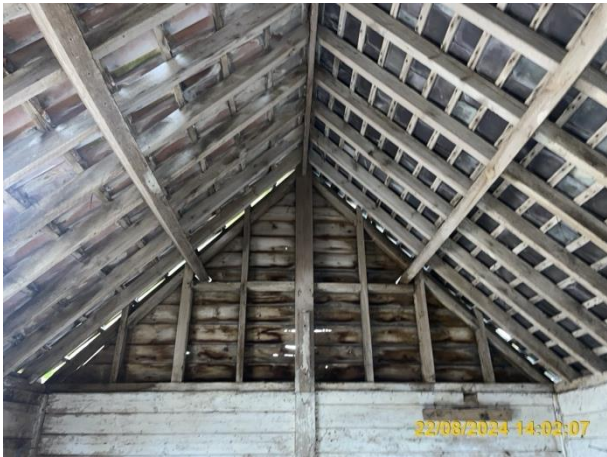
| Internal voids<br>B1a | Timber rafters and ridge beam. Open floor to ridge. Mortise and tenon joints. Internal stone wall with large opening below the ridge beam. | <p><b>Condition/description</b></p> <p>Internal space measures approx. 10 m long, 4 m wide, floor to ridge height approx. 5 m. The internal timbers appear to be original and in good condition. Humidity of the interior was 80.7%, with mycelium present on walls. Internal stone wall separates area with unrestricted opening and creates darker interior with only small amount of natural light spill from gaps in door frame and eaves. There is slate lining under the slate tiles on the northern elevation, and no lining on the southern elevation.</p> <p><b>Suitability/access/evidence of bats</b></p> <p>Low number of bat droppings (~10) and discarded moths and butterfly wings (~5) were found on the floor of the building. Samples of bat droppings were collected for DNA analysis. Some droppings were of bigger size, which is indicative of large bat species. Discarded insect parts indicate bat-feeding activity inside the building. Moreover, high humidity inside the building and low number of droppings would be indicative of a non-maternity roost. The unrestricted</p> | <p>22/08/2024 14:02:07</p> |

| | | <p>openings into the building, gaps in dislodged tiles and gaps in door frame and eaves provide access into the void. The void is suitable for roof-void dwelling bats, which require gaps from as small as the width of our thumb to access the roost and need timber joists or beams on which to roost.</p> | |

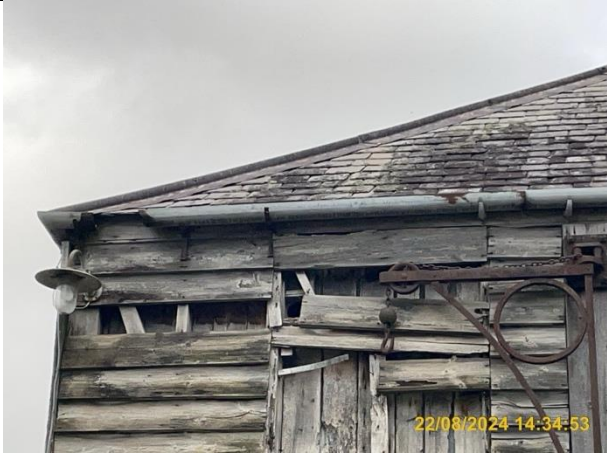
| Eaves B1b | Closed | <p><b>Condition/description</b><br/>Eaves are in poor condition with gaps between tiles and eaves on all elevations.</p> <p><b>Suitability/access</b><br/>These gaps can provide crevices through which bats could gain access into internal void and loft void.</p> | | <br>22/08/2024 14:34:53 | |

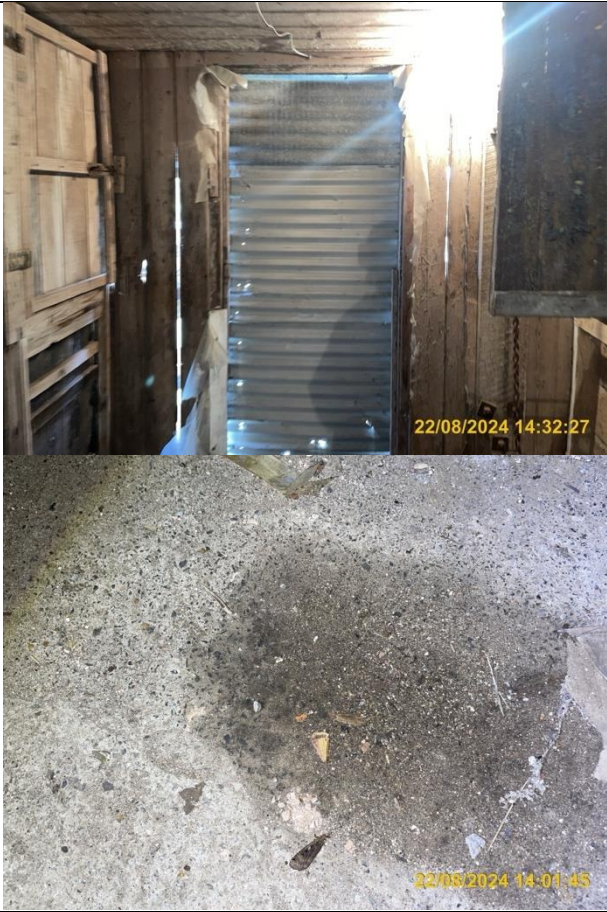
| Internal voids<br>B1b | Timber rafters and ridge beam. Open floor to ridge. Mortise and tenon joints. | <p><b>Condition/description</b></p> <p>First storey can be accessed through opening into the corridor between B1a and B1b. The interior was dark with low levels of natural light spill through gaps in window frames and brickwork. Second storey is accessed by a ladder and contains two dark enclosed spaces, running along eastern elevation and western elevation of the building. Both spaces don't have a barrier in their opening, allowing full access. The second storey has some natural light spill through the gaps between timber cladding and metal sheets which were used to board up windows and door.</p> <p><b>Suitability/access/evidence of bats</b></p> <p>First storey had a low number (&lt;5) of discarded moths and butterfly wings. A large number of bat droppings (~50) with mixture of colours and discarded moths and butterfly wings (~20) were seen within both two dark enclosed spaces on the second storey. Samples were collected for DNA analysis. There is a mixture of colours which shows different ages of droppings, with darkest droppings indicating more recent activity. Size and shape of droppings indicate a large bat, such as serotine or horseshoe.</p> | |

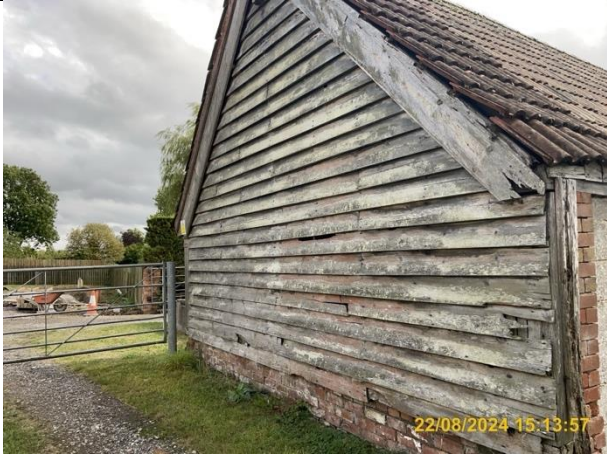
| Barge boards/fascia boards B2a | Timber | <p><b>Condition/description</b><br/>Barge board on the gable end is aged and broken with gaps between the board, cladding and tiles.</p> <p><b>Suitability/access</b><br/>These gaps provide roosting habitat for bats and access into the internal void.</p> | |

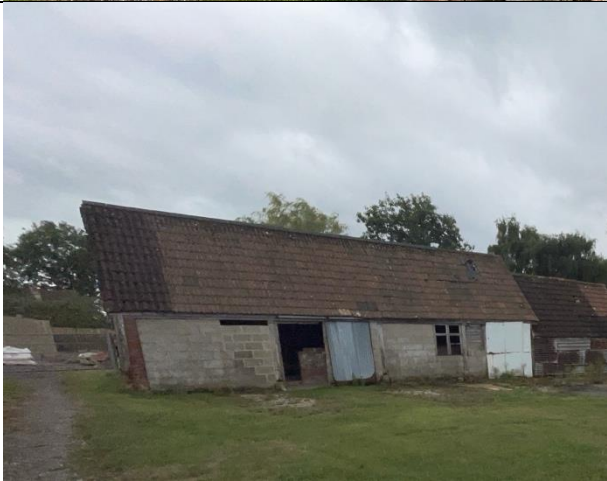
| Window/doors frames and lintels B2a | Timber | <p><b>Condition/description</b><br/>Timber frames on the northern elevation are in poor condition – aged and rotten, creating crevices.</p> <p><b>Suitability/access</b><br/>Crevices formed within timber frames provide roosting habitat for crevice-dwelling bats.</p> | |

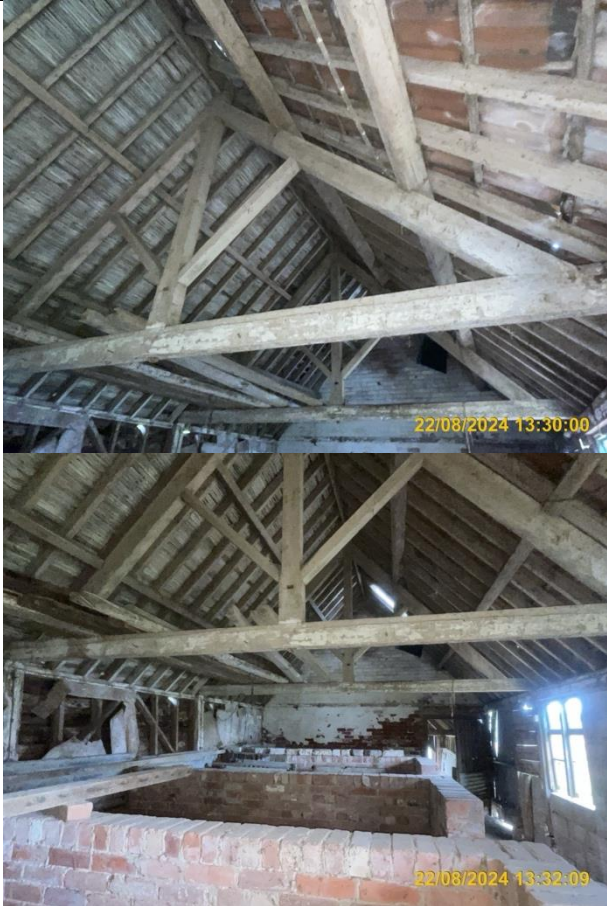
| Internal voids<br>B2a | Timber rafters and ridge beam. Open floor to ridge. Mortise and tenon joints. | <p><b>Condition/description</b></p> <p>Internal space measures approx. 11.5 m long, 4.5 m wide, floor to ridge height approx. 5 m. The internal timbers appear to be original with traditional mortise and tenon joints. There is timber lining under clay tiles and some areas with plastic and metal sheets on eastern elevation and no lining on western elevation. Gaps in timber cladding, metal and plastic sheets and roof tiles are present, especially on the northern and western elevation. The void has a large amount of natural light entering the space through gaps in timber cladding, clay tiles, missing breeze blocks, window and opening into B2b. There were four old bird nests on the intersection of timber beams.</p> <p><b>Suitability/access/evidence of bats</b></p> <p>Between 20 - 59 bat droppings and ~20 moth and butterfly wings were found on the floor. Samples were collected for DNA analysis. Size and shape of droppings indicate a large bat species. There is a mixture of colours which shows different ages of droppings, with darkest droppings indicating more recent activity. This, along with the volume found eliminates a one-off exploratory visit. High level of natural light internally is indicative of this space not being used as a day or maternity roost, and therefore the void is most likely used as a feeding roost.</p> | |

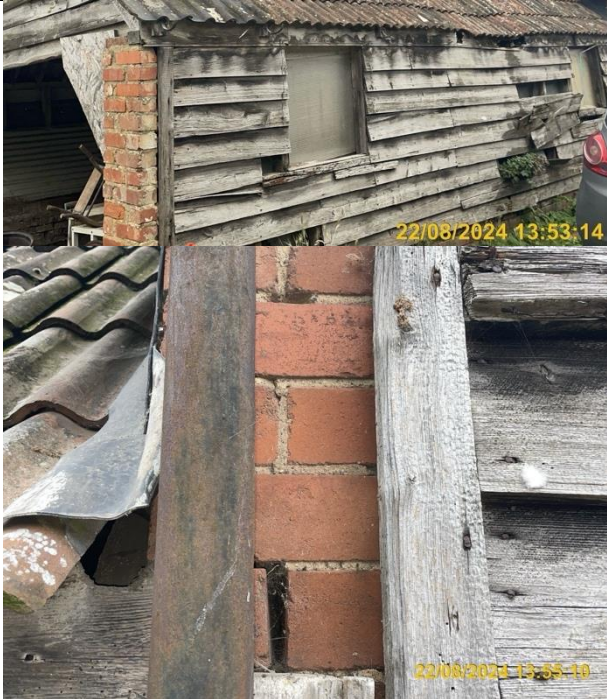
| Walls B2b | Timber clad, brick columns, metal sheets. | <p><b>Condition/description</b><br/>Aged, lifted and broken timbercladding on the southern, and eastern elevation, creating crevices. Metal sheets on the western elevation, brick columns with gaps on the southern elevation. There is no wall on the southern elevation, creating open area into the exterior.</p> <p><b>Suitability/access</b><br/>Crevices formed under lifted cladding and in brick columns provide roosting habitat for bats and access into the internal void. The interior can also be accessed through the open area on the southern elevation.</p> | |

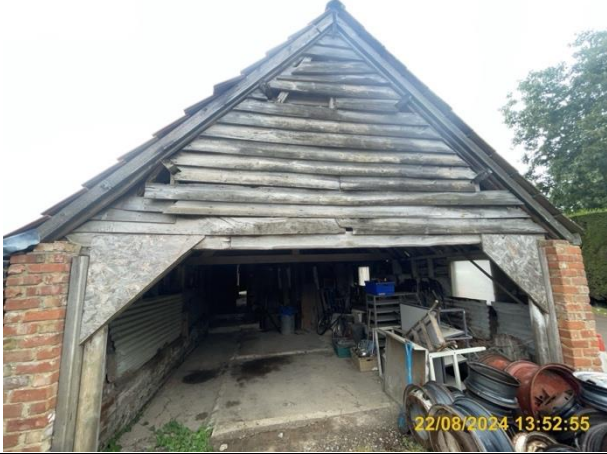
| Windows/door frames and lintels B2b | | <p><b>Condition/description</b><br/>Timber frames on the western elevation are in poor condition – aged and rotten, creating crevices.</p> <p><b>Suitability/access/evidence of bats</b><br/>Crevices formed within timber frames provide roosting habitat for crevice-dwelling bats.</p> | |
