LONGLEAT  
Longleat House

Roof Slip D Ceiling  
Condition Survey

Drawing No. 0155S.093 -

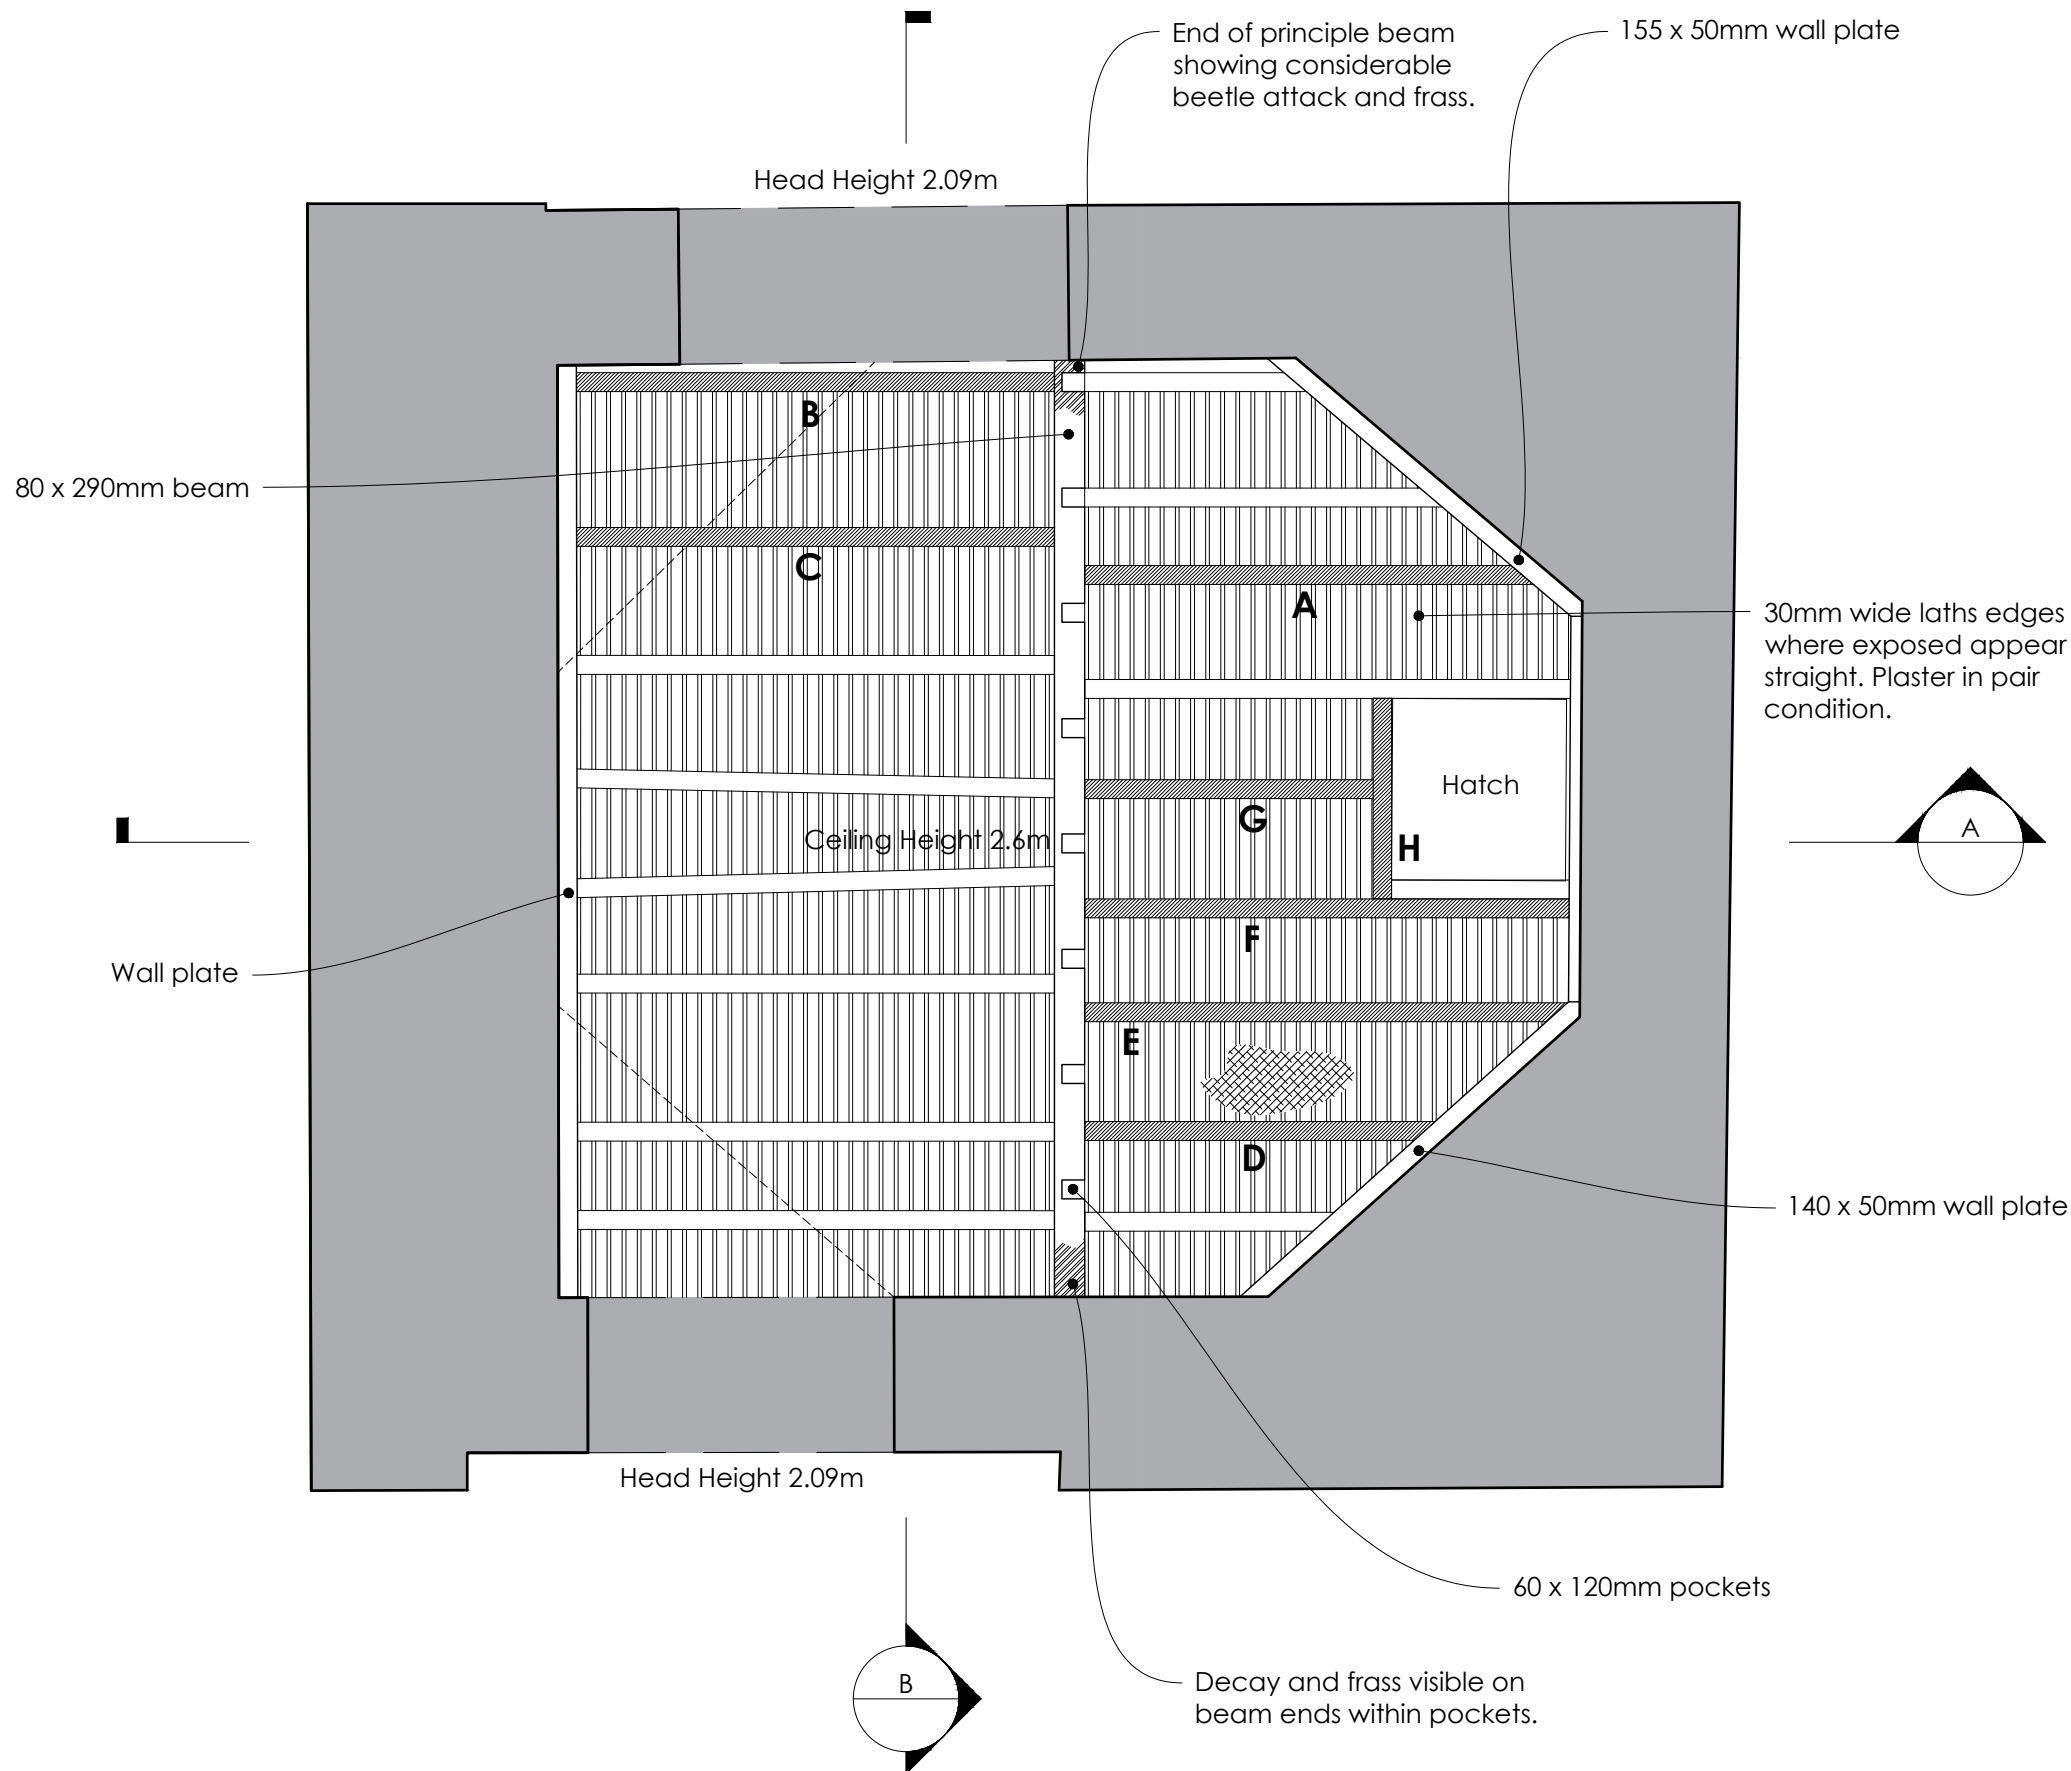
## Ceiling Layout Plan

- A** Detached not supporting very soft lots of decay
- B** Wall plate end thinned down 10mm width
- C** Bearing at wall plate gone. 50 - 75% gone
- D** Bearing at wall plate gone. 50 - 75% deterioration
- E** Surface soft but intact
- F** Deteriorated centrally 50 - 75% integrity
- G** No bearing at beam 50% integrity
- H** No bearing at beam 50% integrity
-

Water damage from roof. Stained plaster with some detachment.
