LONGLEAT  
Longleat House

Title  
Elevation Roof Slip D  
Ceiling Condition Survey  
Stage  
Survey

benjamin + beauchamp  
architecture design conservation  
the borough studios, the borough,  
wedmore, somerset BS28 4EB  
T 01934 713313 F 01934 713314  
Drawn By: JLB Date: 11.12.2025 Scale: 1:20 at A1  
Drawing No: 0155.S.094  
Studio: b2architects.com www.b2architects.com

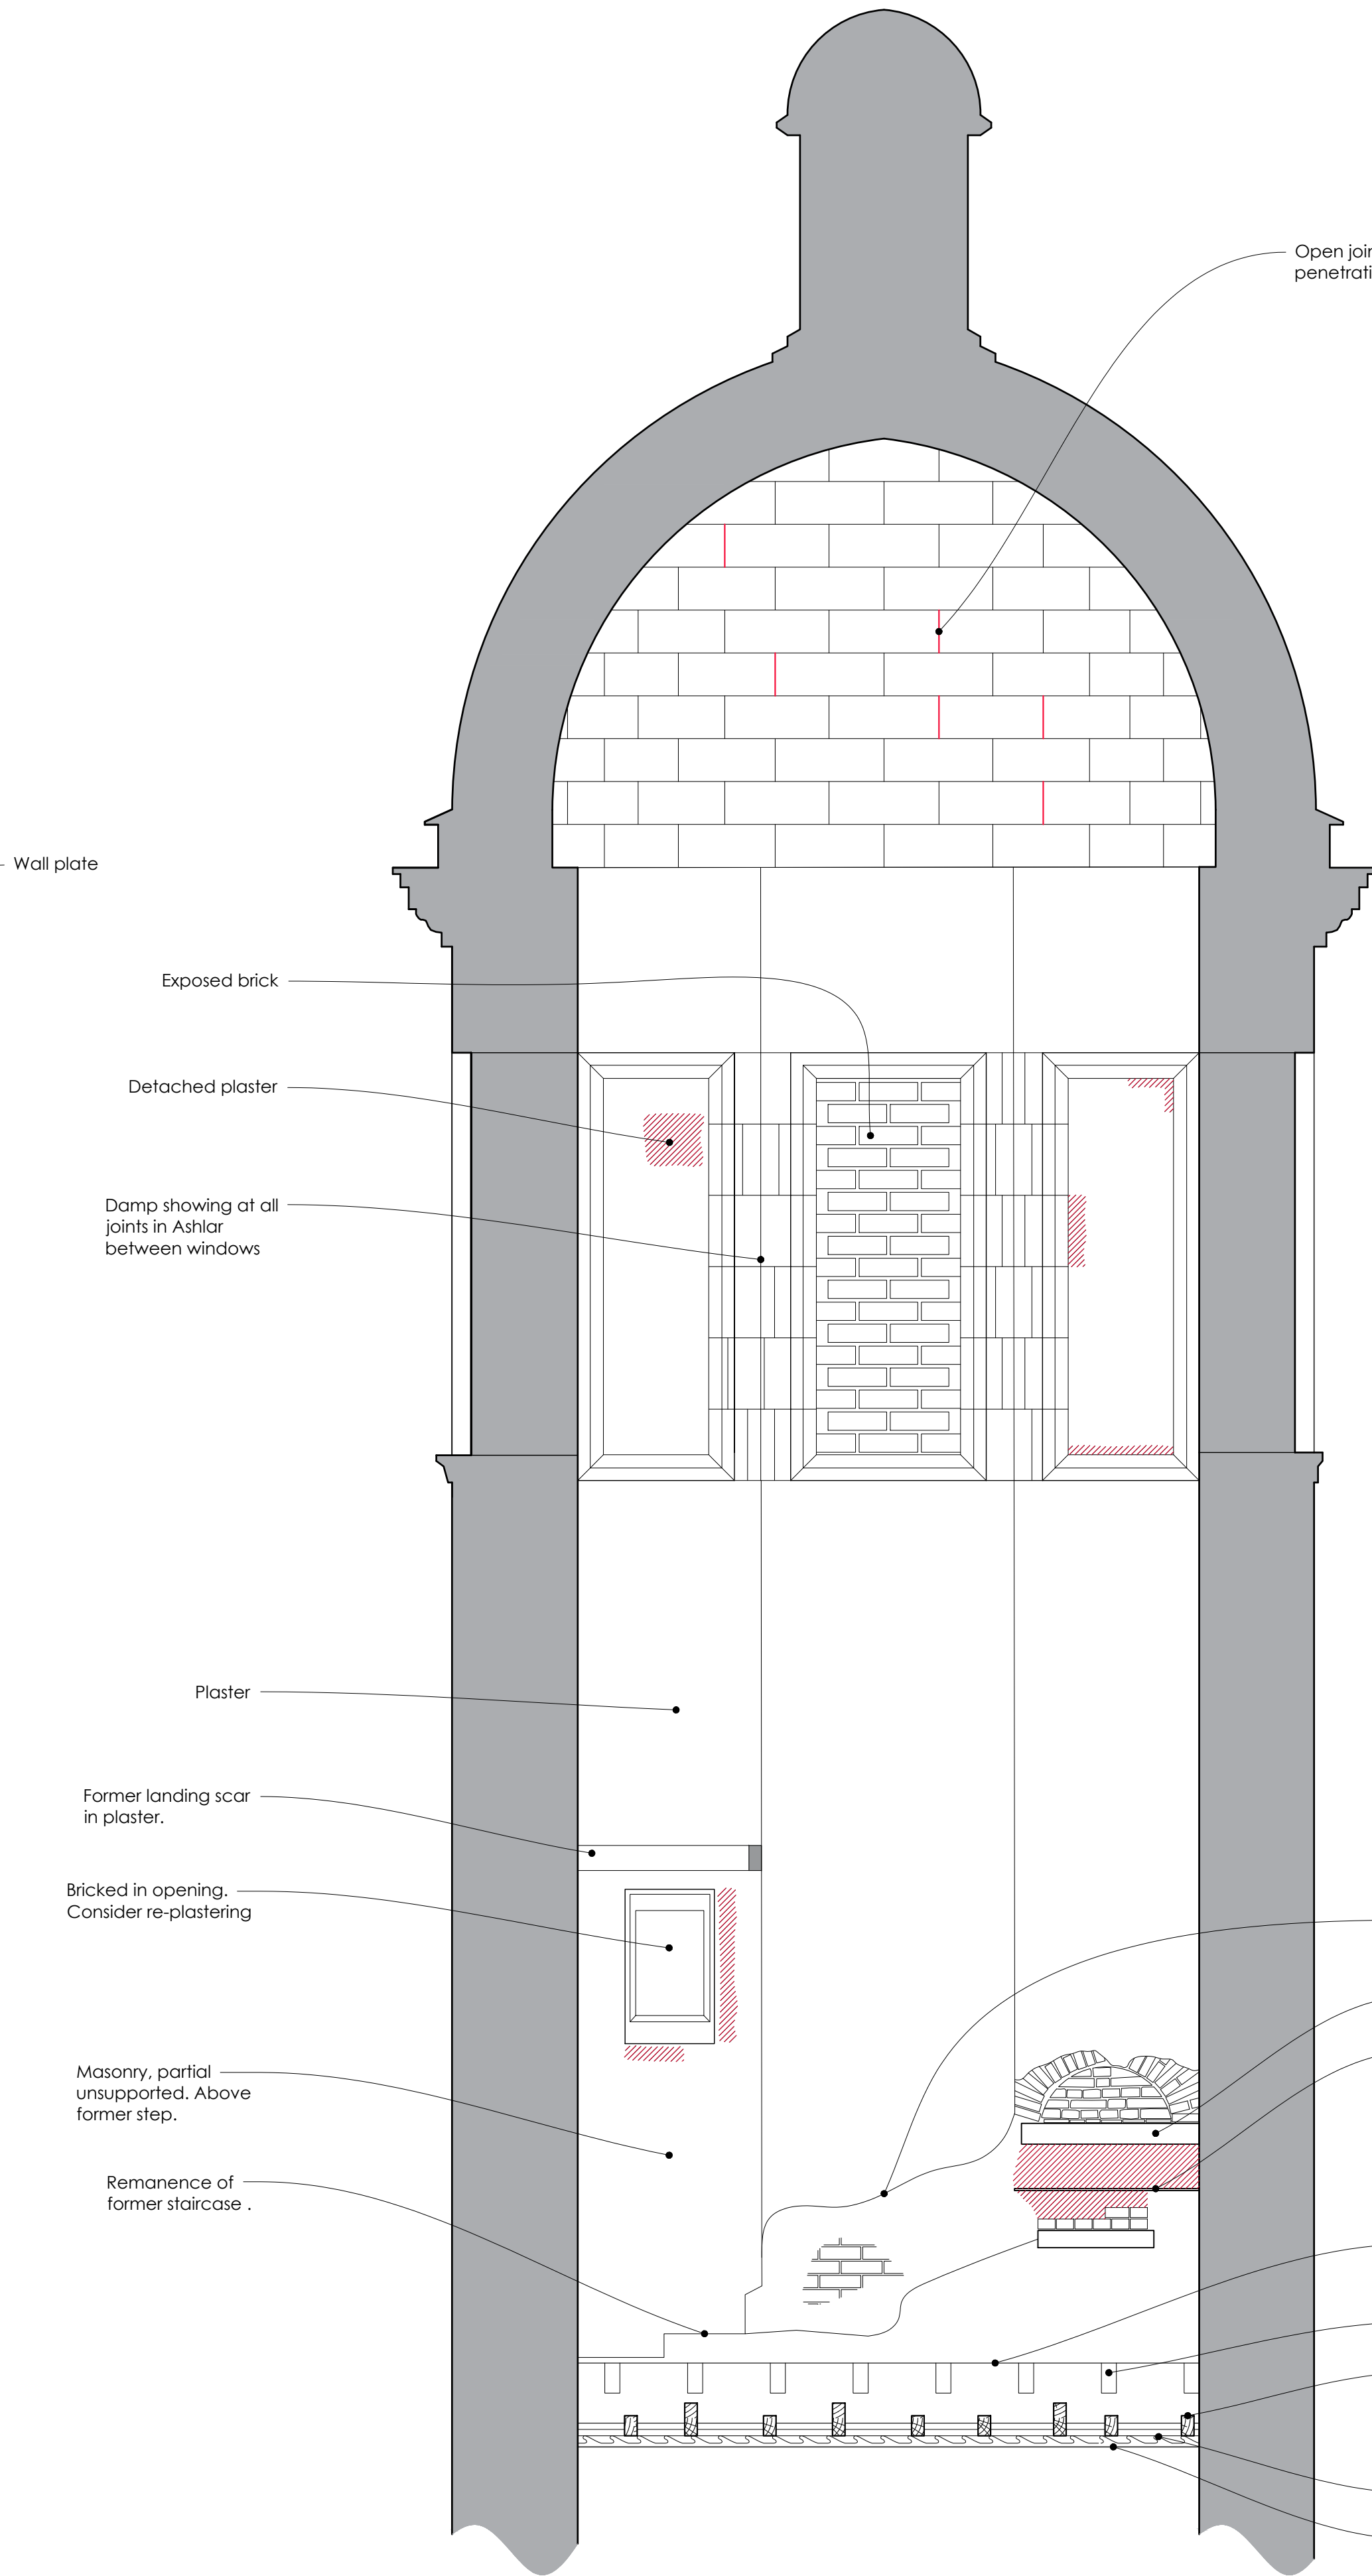
Section B  
scale 1:20

Open joints in the roof structure allow water penetration into the roof slip.

Masonry decay to cornice on south elevation.

Render failure.

Stone erosion needing mortar repair.

Detached plaster

Timber lintel

Flat steel with unbonded masonry (brick above). Part rebuild required with improved support.

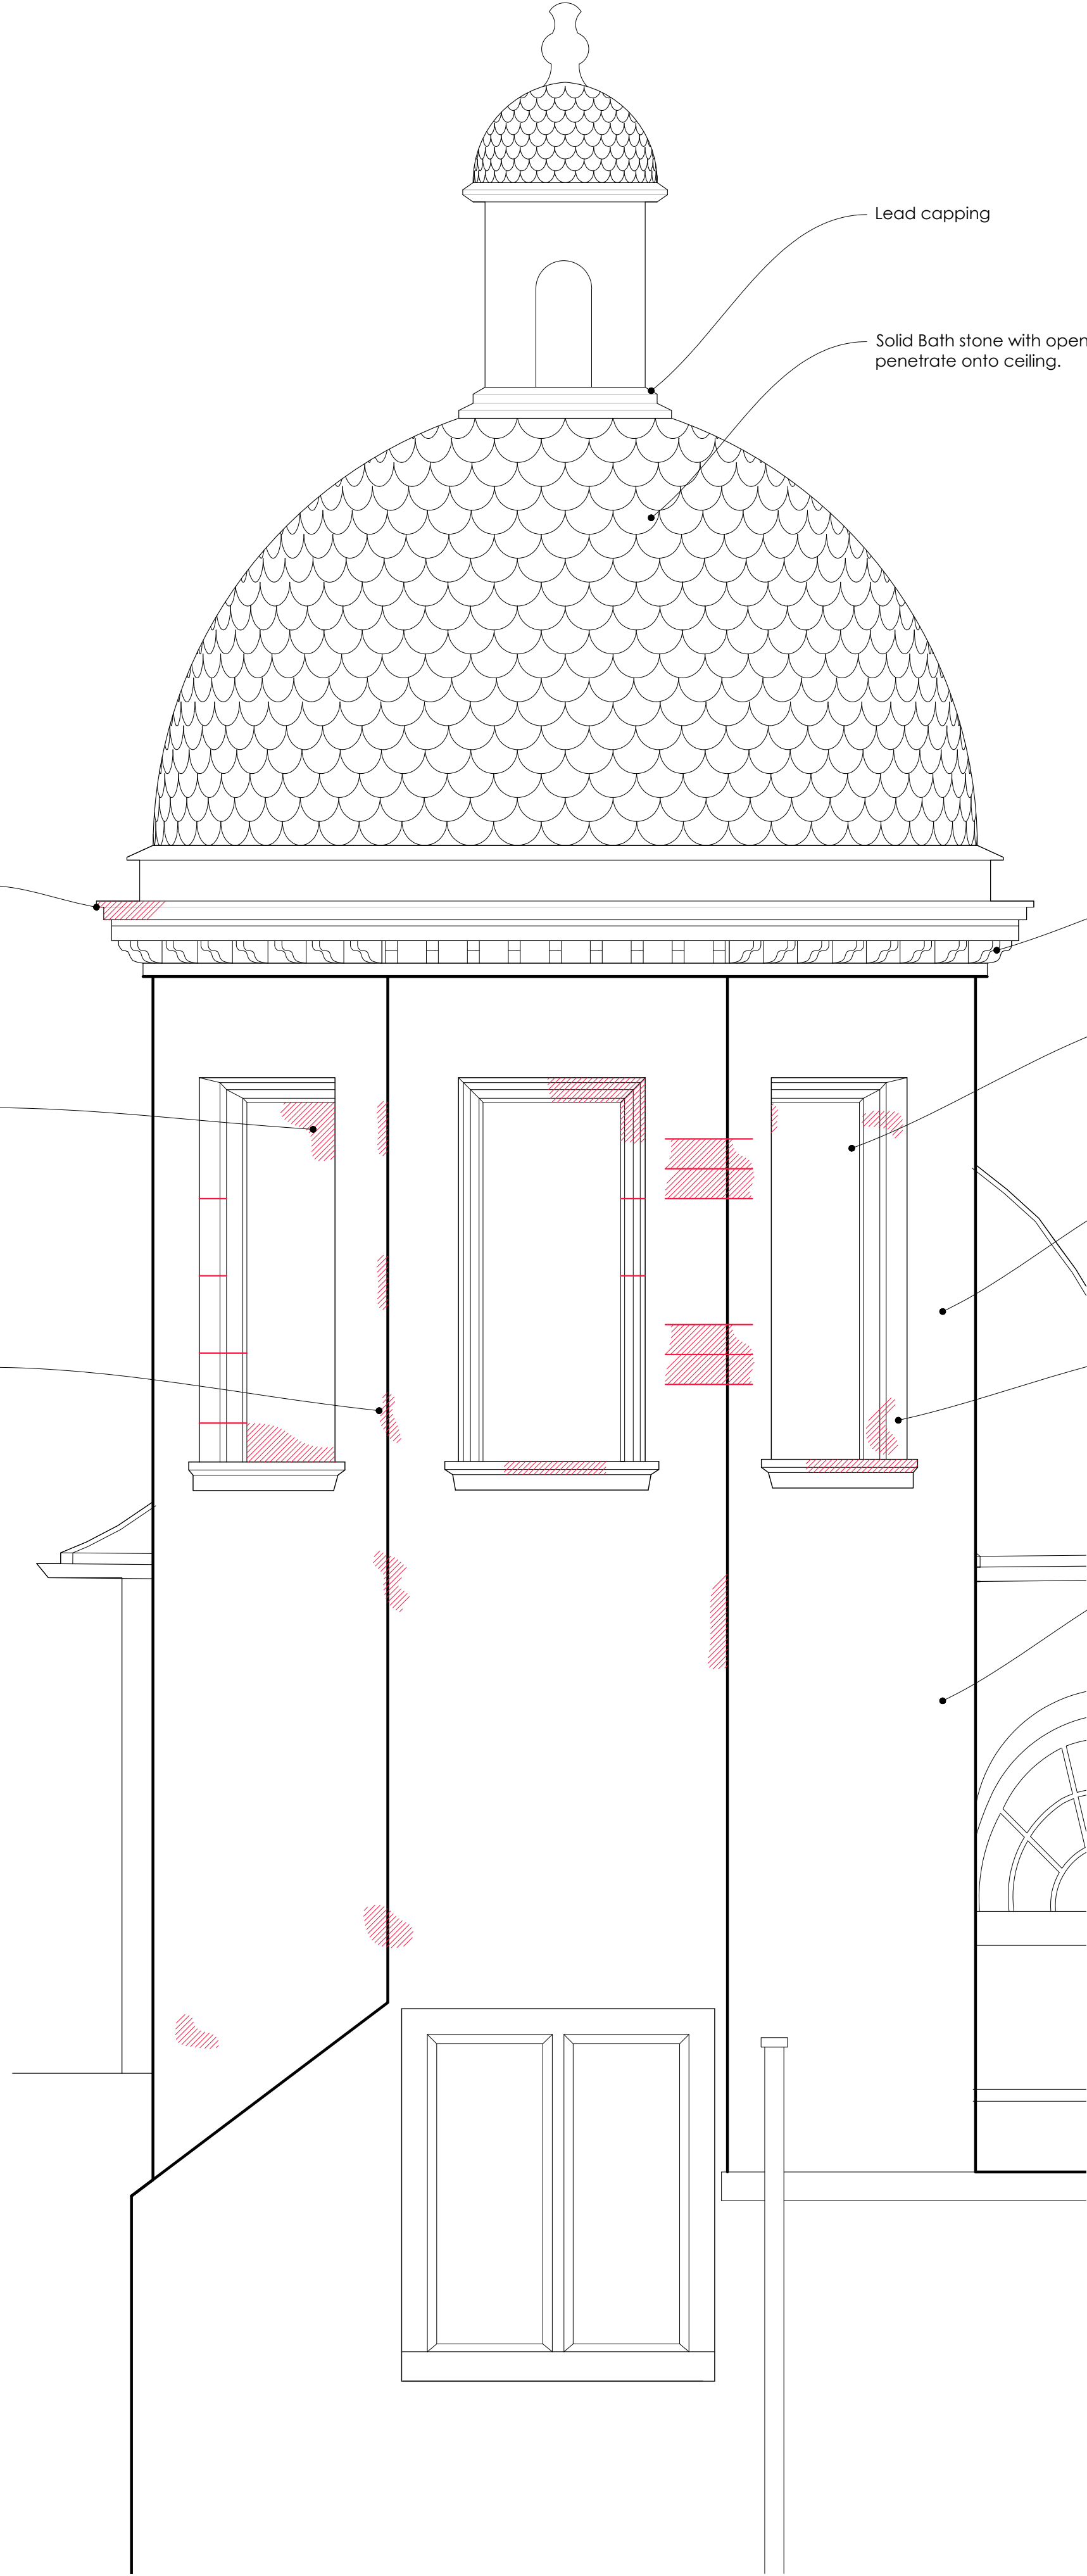
East Elevation  
scale 1:20

Solid Bath stone with open joints between allowing water to penetrate onto ceiling.

Dentils require checking by rope access mason.

Rendered blind windows in fair to poor condition.

Cill and jamb eroded requires mortar repairs .

Part render repairs with scribed Ashlar lines.
