## LONGLEAT HOUSE Roof Slip D

Proposed repairs & internal access floors

### Heritage, Design and Access Statement

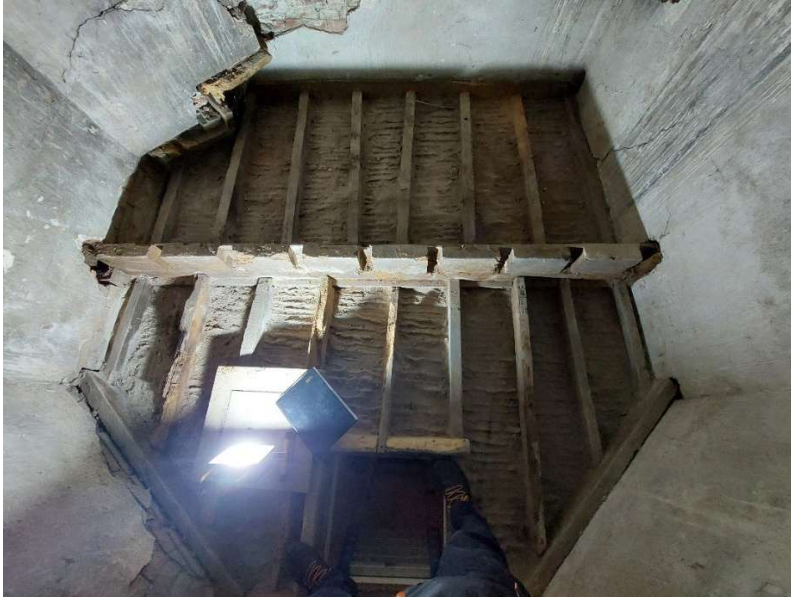
- 5.1. Roof structure cleaned of debris to allow better assessment of the ceiling condition. The notches in the central primary beam indicate that a landing would have been located on the east side of the tower.

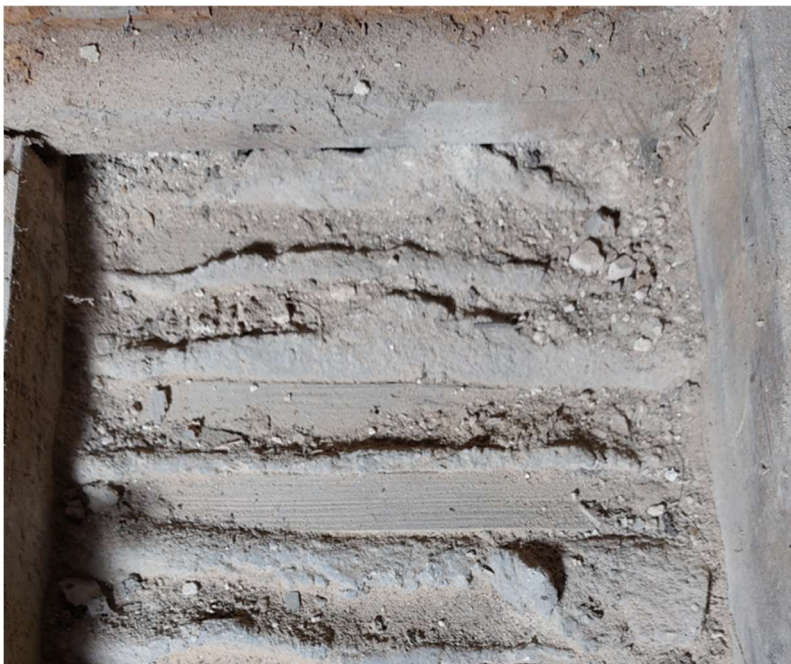
- 5.2. The plaster is well adhered to the lath, the edge is only visible in a few locations but appears to have a uniform, cut edge rather than being split lath.

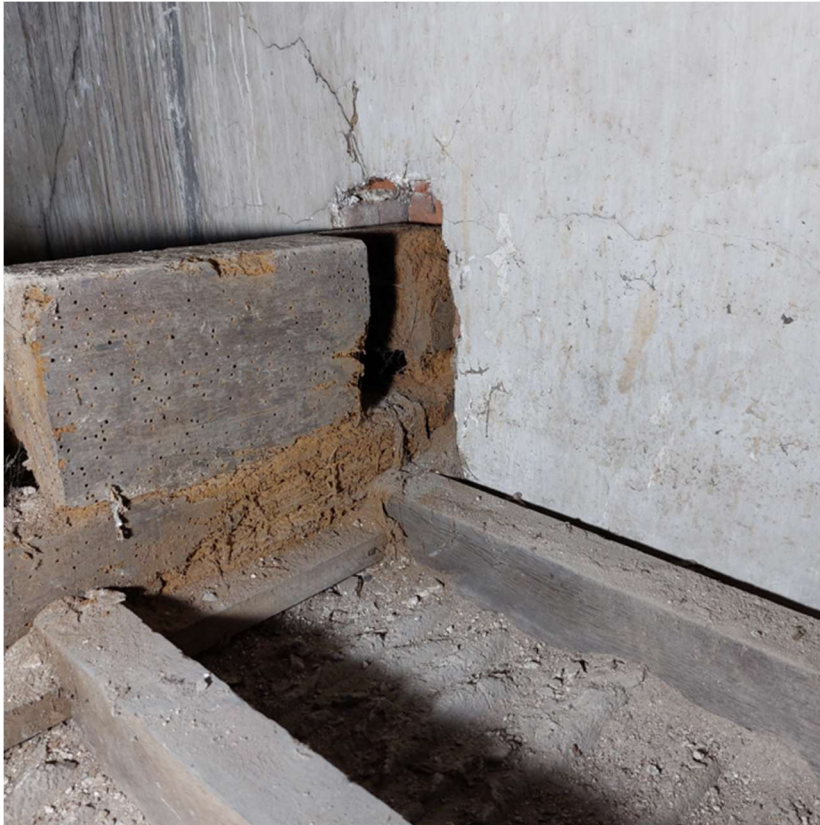
- 3.8. The existing plaster and lath ceiling is not considered original historic fabric, although it has been in place for a considerable period. The principal beam has deteriorated where it bears into the north wall masonry and requires further structural investigation.

- 5.3. North wall junction, showing beetle attack and deterioration of the principal support. The section size is large but the ceiling joist are only minimally supported by it.

**Proposed Works** – Existing primary beam is to have splice repairs, in air-dried oak, to each bearing end, with the intent to retain as much of the ceiling and joist pockets as possible. Existing ceiling joists that have lost their structural integrity will be paired with new air-dried oak joists. Stainless steel screw fixings with washers will be installed through the plaster into the new joists to support the existing lath and plaster ceiling. Washer heads will be lightly recessed and made good with a skim coat of proprietary interior filler gauged with whiting. Existing joist pockets will be reused to form a lightweight landing above ceiling level, ensuring loads are not imposed directly onto the ceiling structure.

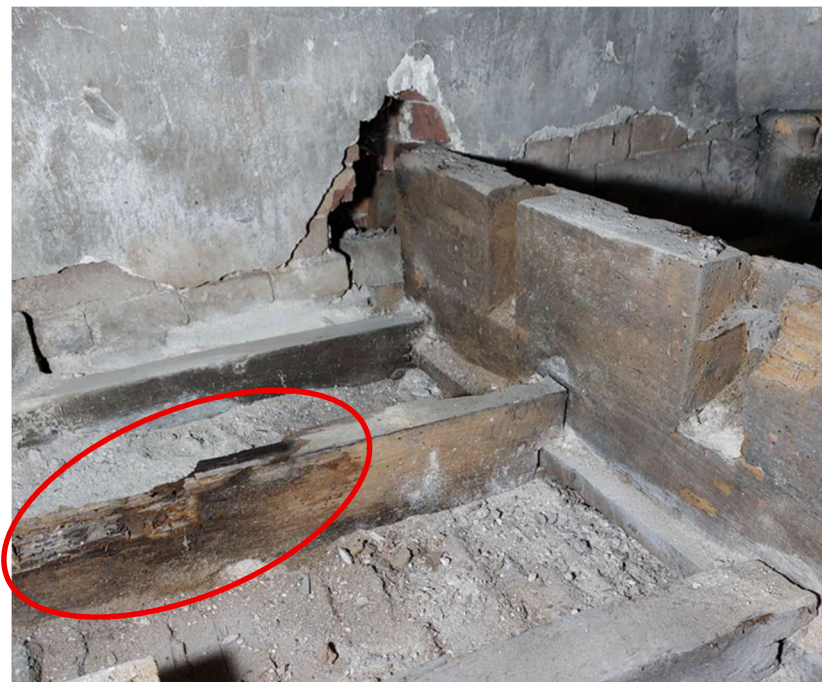
- 5.4. South wall junction, appears to be in better condition. Joist deterioration due to water penetration is circled but this particular joist appears more modern than the joist in the foreground.

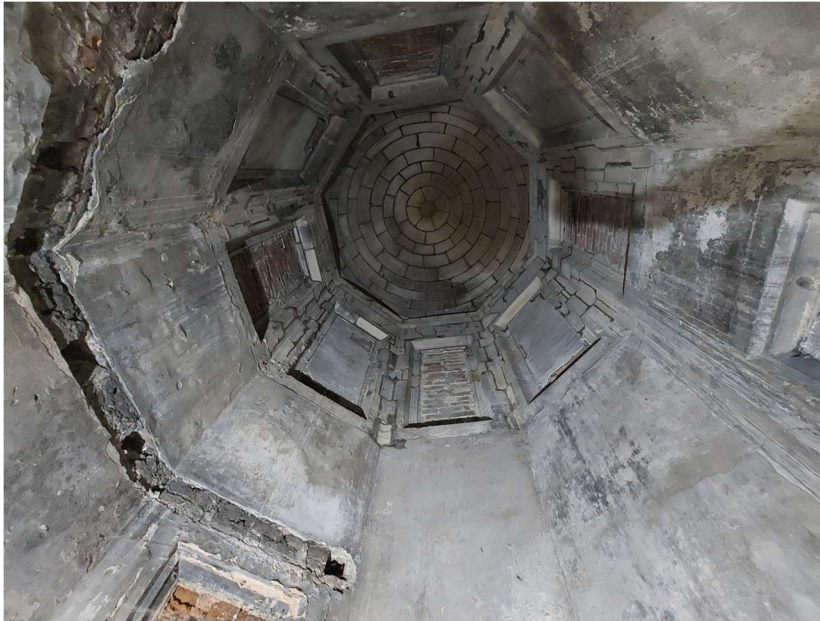
- 5.5. Domed roof and masonry walls. The dome is single skinned which allows water to penetrate through failed mortar joints. The scar of a former landing is also evident. A line of water penetration can be seen on the right-hand side of the photo coming from above the upper window facing north.

**Proposed Works** – The stone domed roof will be repointed where the existing mortar has failed. Repointing to be carried out using a lime putty mortar, with exact mix to be agreed following sampling of existing mortar.

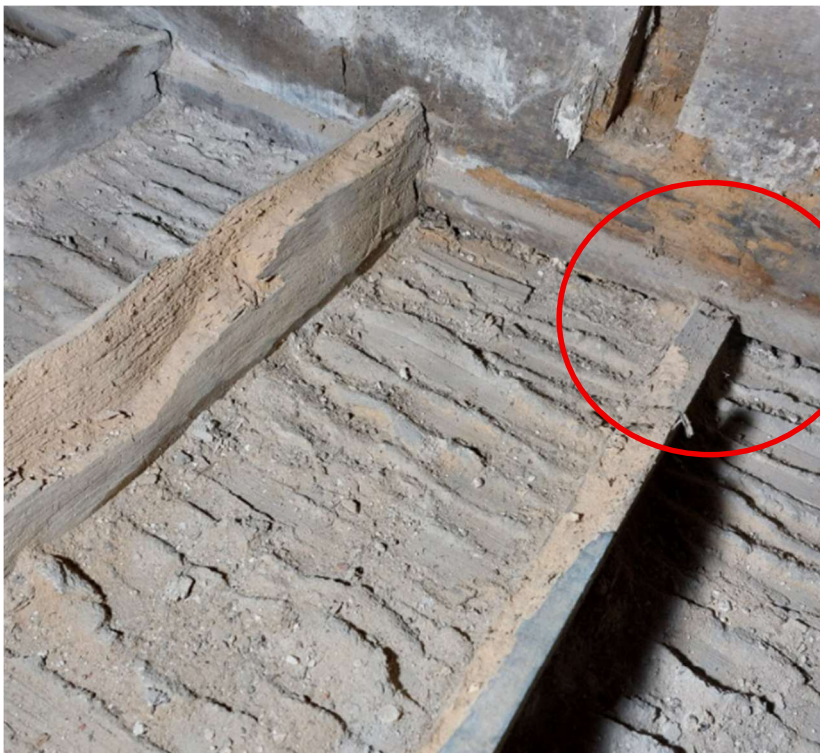
- 3.7. The eastern ceiling joists are in an advanced state of decay and affected by deathwatch beetle activity, with substantial loss of timber section rendering them unsafe. Joists within the north-west corner have also deteriorated significantly.

- 5.6. There is no end bearing on the joist in the foreground. Beetle attack is causing decay to the surrounding joists.

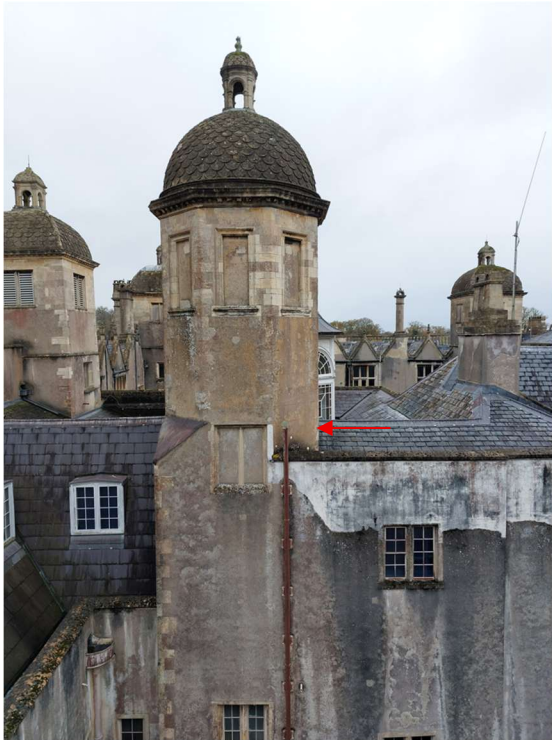
- 5.7. Photo of the East elevation from roof level. Ventilation to be introduced on the north side above the neighbouring roof. Creased tiles to be used to form hit-&-miss vent. This elevation is not visible from the park and there is some access via the adjacent parapet.

**Proposed Works** – A small creasing tile vent (maximum 200 x 200mm) will be introduced on the north elevation to provide ventilation above ceiling level. High-level drainage outlets will also assist ventilation by creating a stack effect. The works will require limited removal of historic masonry fabric.

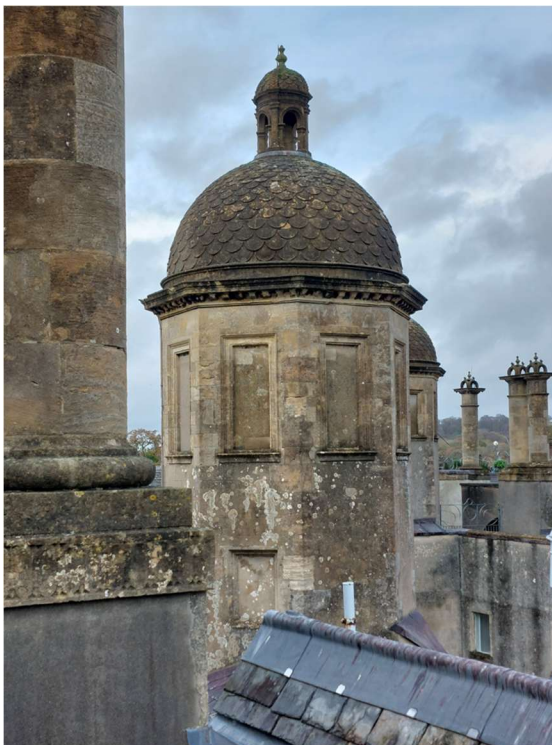
- 5.8. Render and cornice damage to be repaired. Open joints to be repointed with lime putty mortar. Proposed, small drainage outlets to above the cornice would be discrete and of limited visual impact.

Repointing and repairs to the blind windows and stucco render will be carried out at the same time, again with matching lime mortar to match the comparative hydraulicity of the existing mortars.

Missing or damaged sections of cornice to be assessed for sectional replacement, indent or mortar repair. To be in Bath stone and matching profile to existing.
