## **Lacock Visitor Reception Building Chimney Repairs**

The Fox Talbot Museum and Abbey Lodge  
High Street  
Lacock  
Wiltshire,  
SN15 2LG

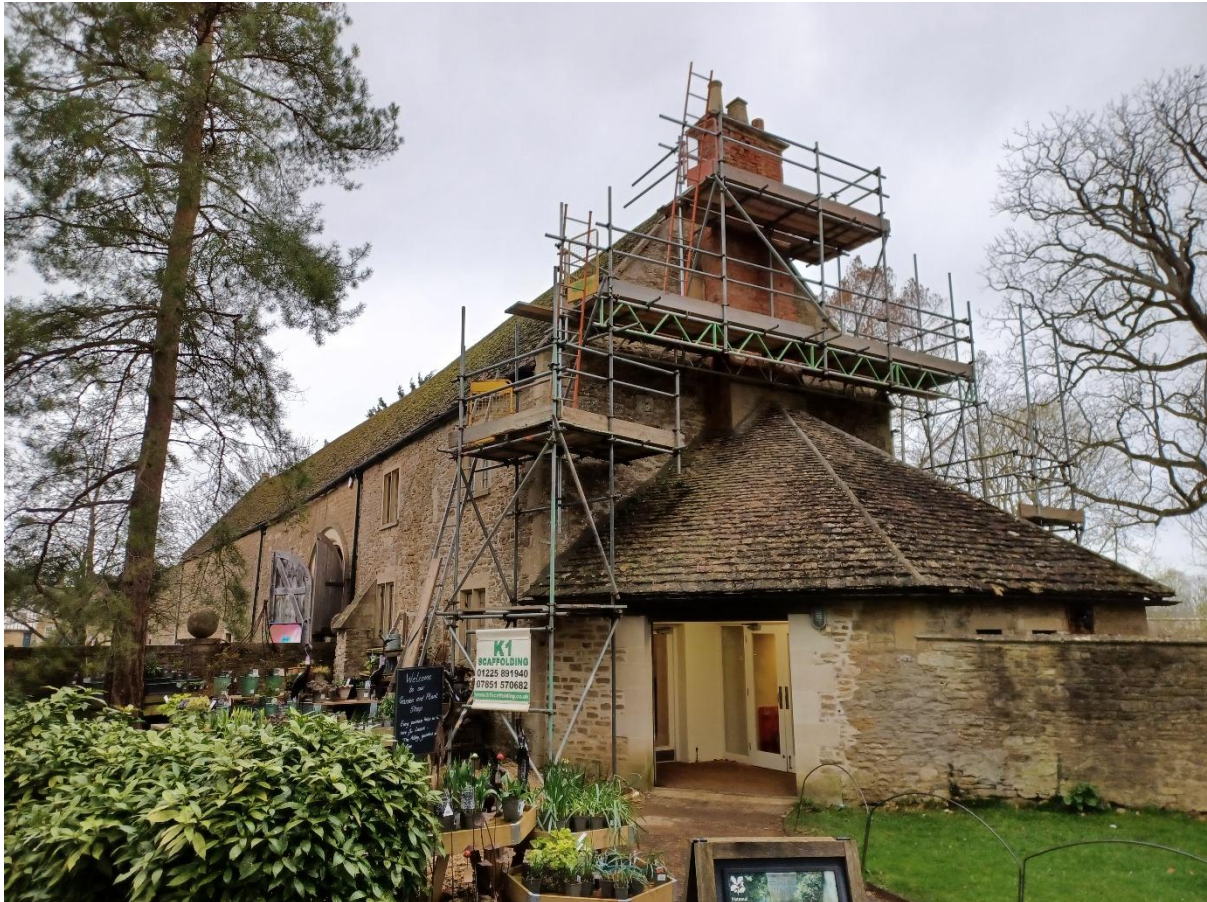
Image 1: Overview of Gable elevation showing location of chimney and single story extension with main visitor rout into Lacock Abbey Grounds beneath the stack.

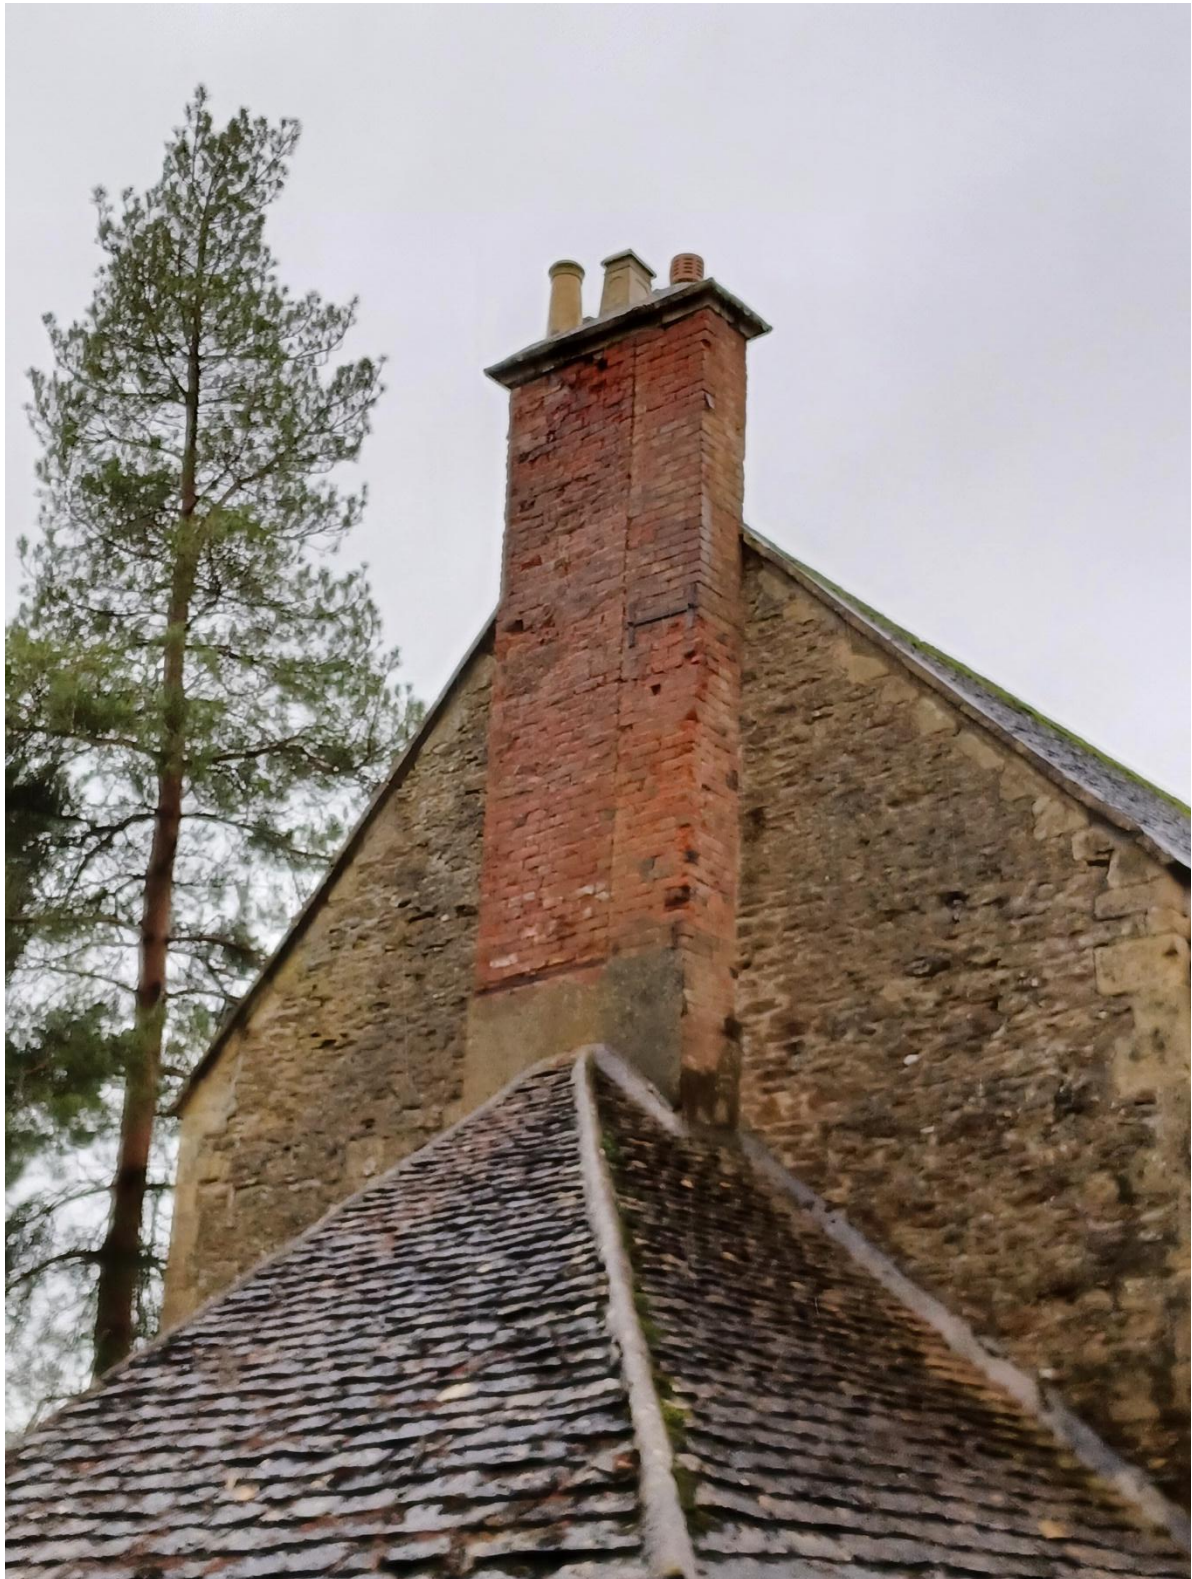
The stack is made of soft red brick and appears to have been built in two phases, with what appears to be two separate but adjacent stacks, with no apparent structural connections. The stack appears to lean into the gable wall, which itself is not plumb, until about 2m below the ridge, at which point the stacks straightens up and becomes plumb, avoiding the projecting coping stones on the gable. This creates a circa 2 inch gap between the original gable stone wall and the brick stack. There is no evidence of any structural tying in of the chimney at this point. The top of the chimney has a limestone crown that spans both stacks and all three flues.

Image 2: Overview of chimney once the render was removed, showing two distinct chimney stacks and damage to brickwork

| Options | Risks | Pros | Cons |
|---|---|---|---|
| 3: Use 6mm 'Helibar' stainless steel bands, inserted into the brickwork mortar joints to provide structural ties and lateral restraint, followed by rerendering | None | As above, the rendering will protect the masonry and be aesthetically appropriate for its location. In addition, the stack(s) will be consolidated and restrained, structurally tied into the gable wall. | Additional expense of steel ties. The steel ties proposed are an 'invisible' solution, drilled into the stone gable wall. |

**Note on use of Helibar:** The 7no Helibar bands are to be inserted into mortar joints within the brickwork . The bedding joint of the brickwork will be chased out to a depth of 40mm. We propose that mechanical chasing would be acceptable as the brickwork is relatively modern, in poor condition, is constructed with cement mortar, and would not be visible after the rendering is completed. No damage to the brickworks as a result of the chasing would ever been seen. A single 6mm 'Helibar' will be inserted into the chase, encased in a proprietary 'HeliBond' cementitious grout.

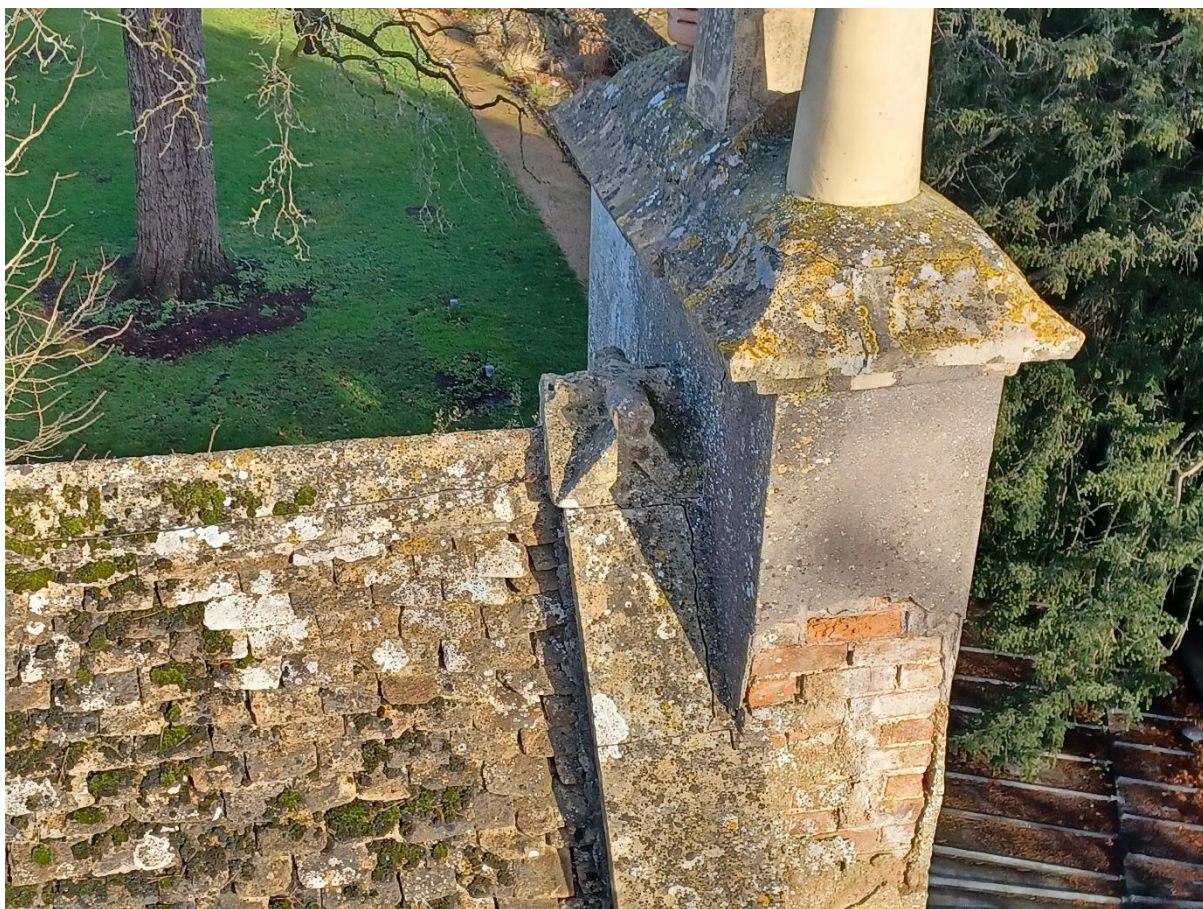
Until recently, the Chimney stack was rendered and the masonry beneath not visible. Following reports of loose and falling sections of render, the property team took the decision to scaffold the chimney stack and defrass any lose sections of render. They found that the render to the chimney stack was generally in poor condition, almost entirely hollow and unbonded, and comprised a patchwork of various inappropriate cement containing products over a soft red brick. Large areas of render were found to be dangerous and the entire removal of the loose render was deemed necessary to make the situation safe. Upon removing the render we discovered that the stack was in fact two adjacent stacks, with little apparent structural ties either to each other or to the stone gable of the building.

Image 3: showing cementitious render and damage/loss of render, before removal

**Note on lime render choice:** Given the medium exposure of the brick chimney, balanced by the apparent softness of the brick, we propose that the render mix

incorporates an NHL2 lime, with an appropriate well graded sand, colour matched to mortar joints in the gable elevation, in a ratio of 1 part lime to 3 parts sand.

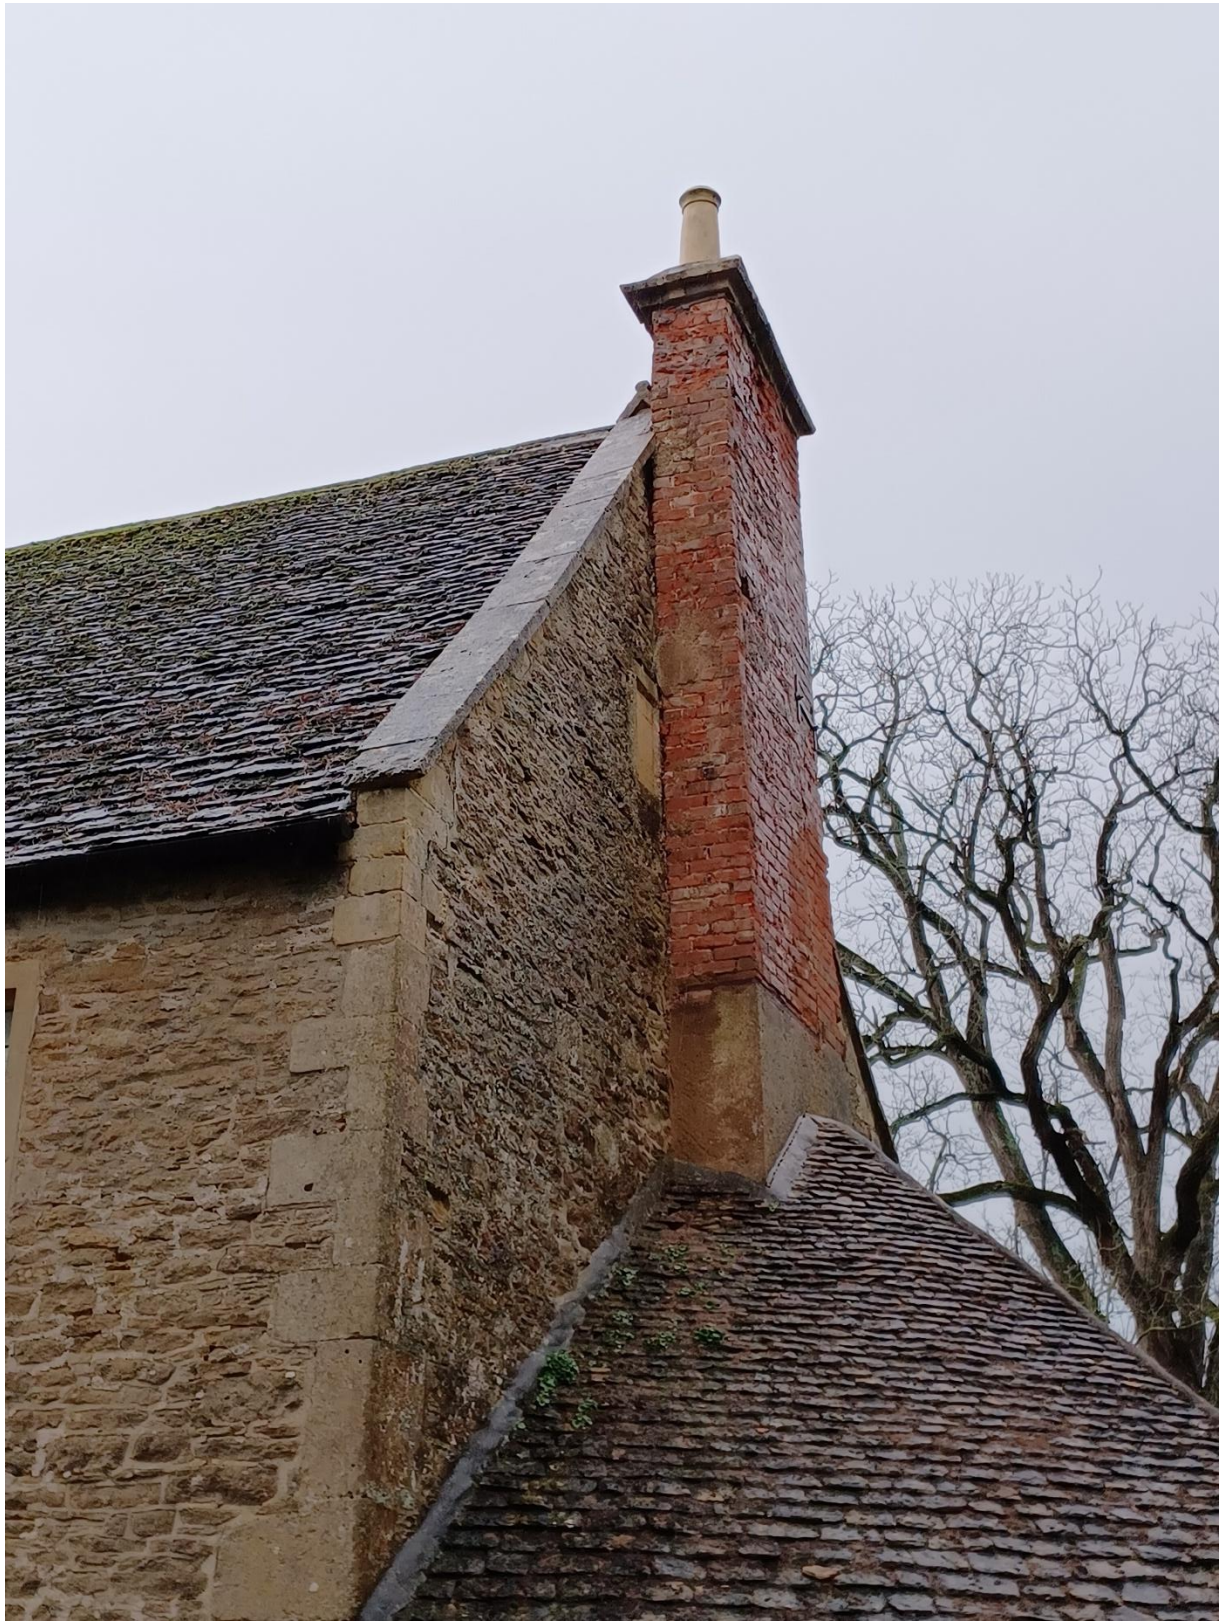
Image 4: showing gap between stack and gable wall

The steel 'Helibar' ties are installed in the mortar joints of the brickwork and drilled 400mm back into the stonework, using a resin fixing on the gable wall on the south side of the chimney (the proposal on the north side is to simply return the helibar back to the gable wall but not drill into it). Above the roof line, the proposals is to return the Helibar all the way around the mortar joint of the chimney to create two

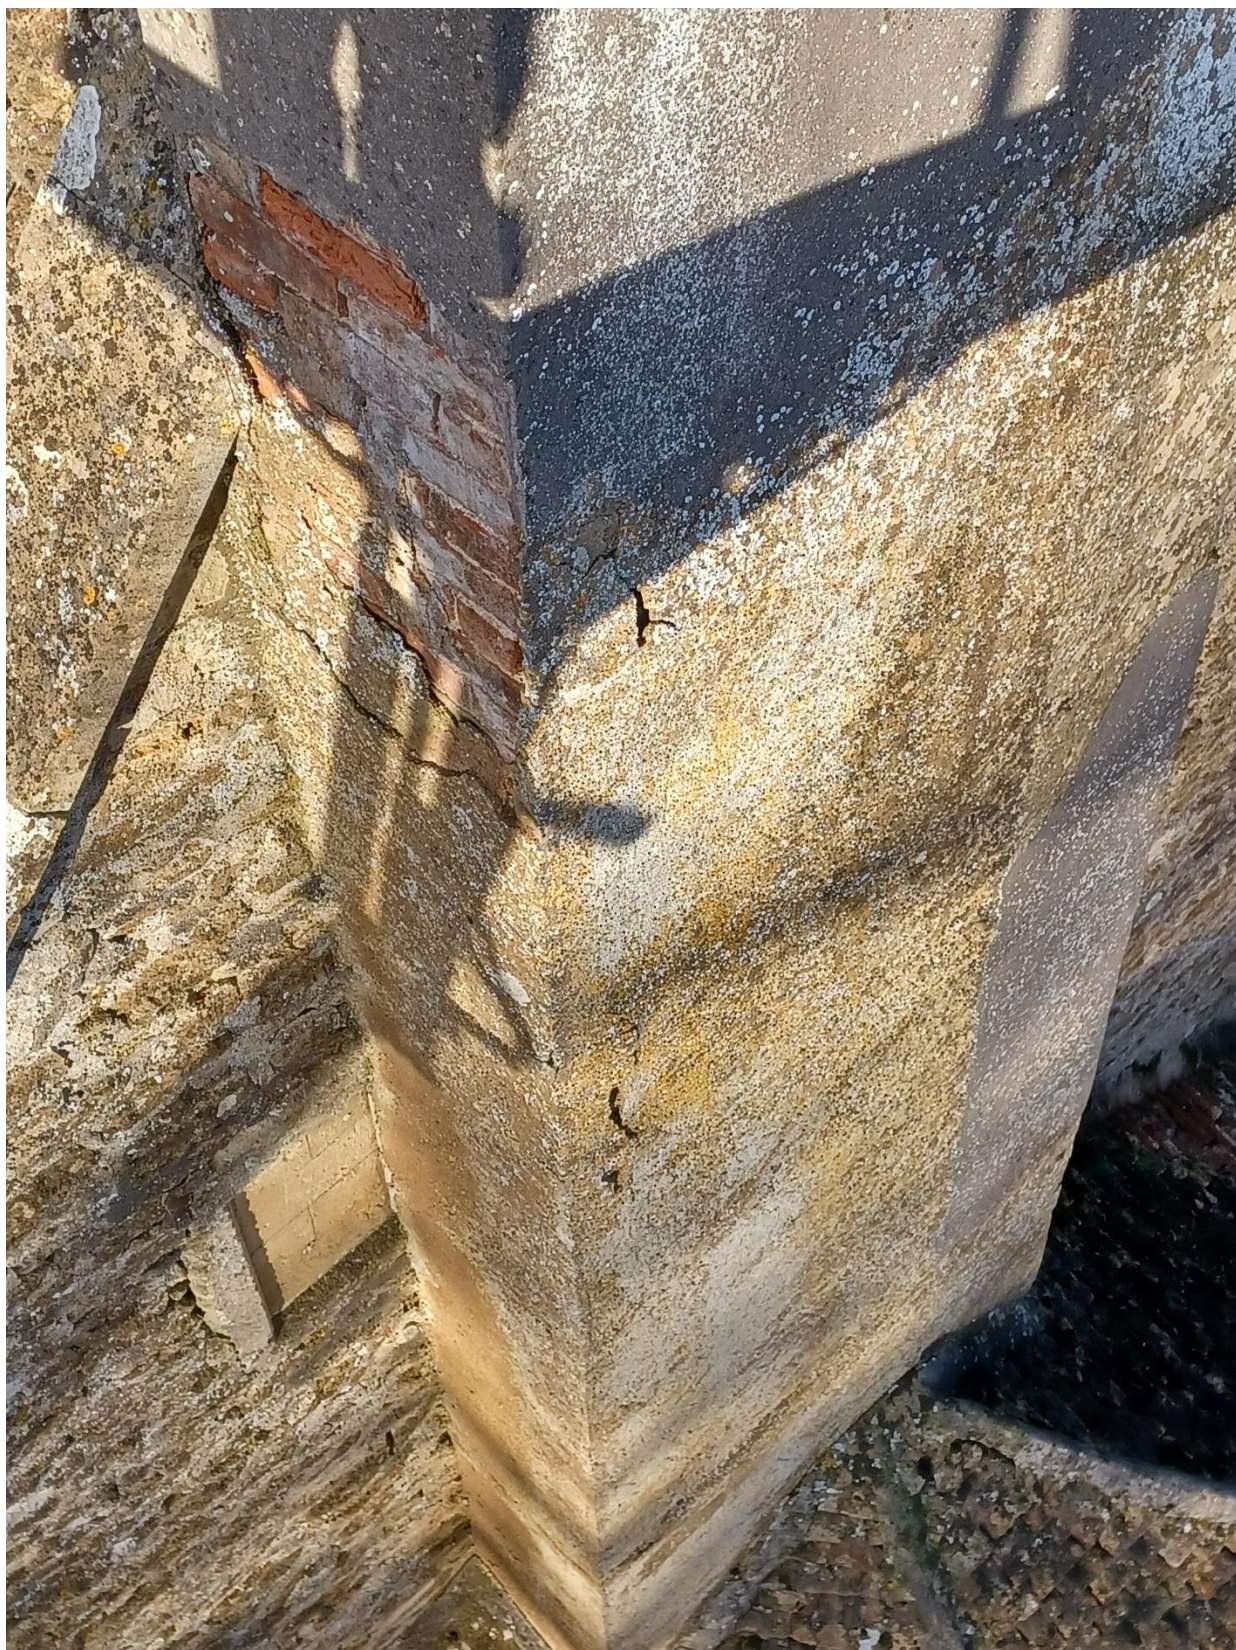
Image 5: showing loss of render and differing renders across stack.
