Reybridge Farm Stables, Reybridge, Lacock, SN15 2PF

## STRUCTURAL STATEMENT FOR PLANNING

[1466GE]

| <b>Document ref</b> | 1466GE-02 |

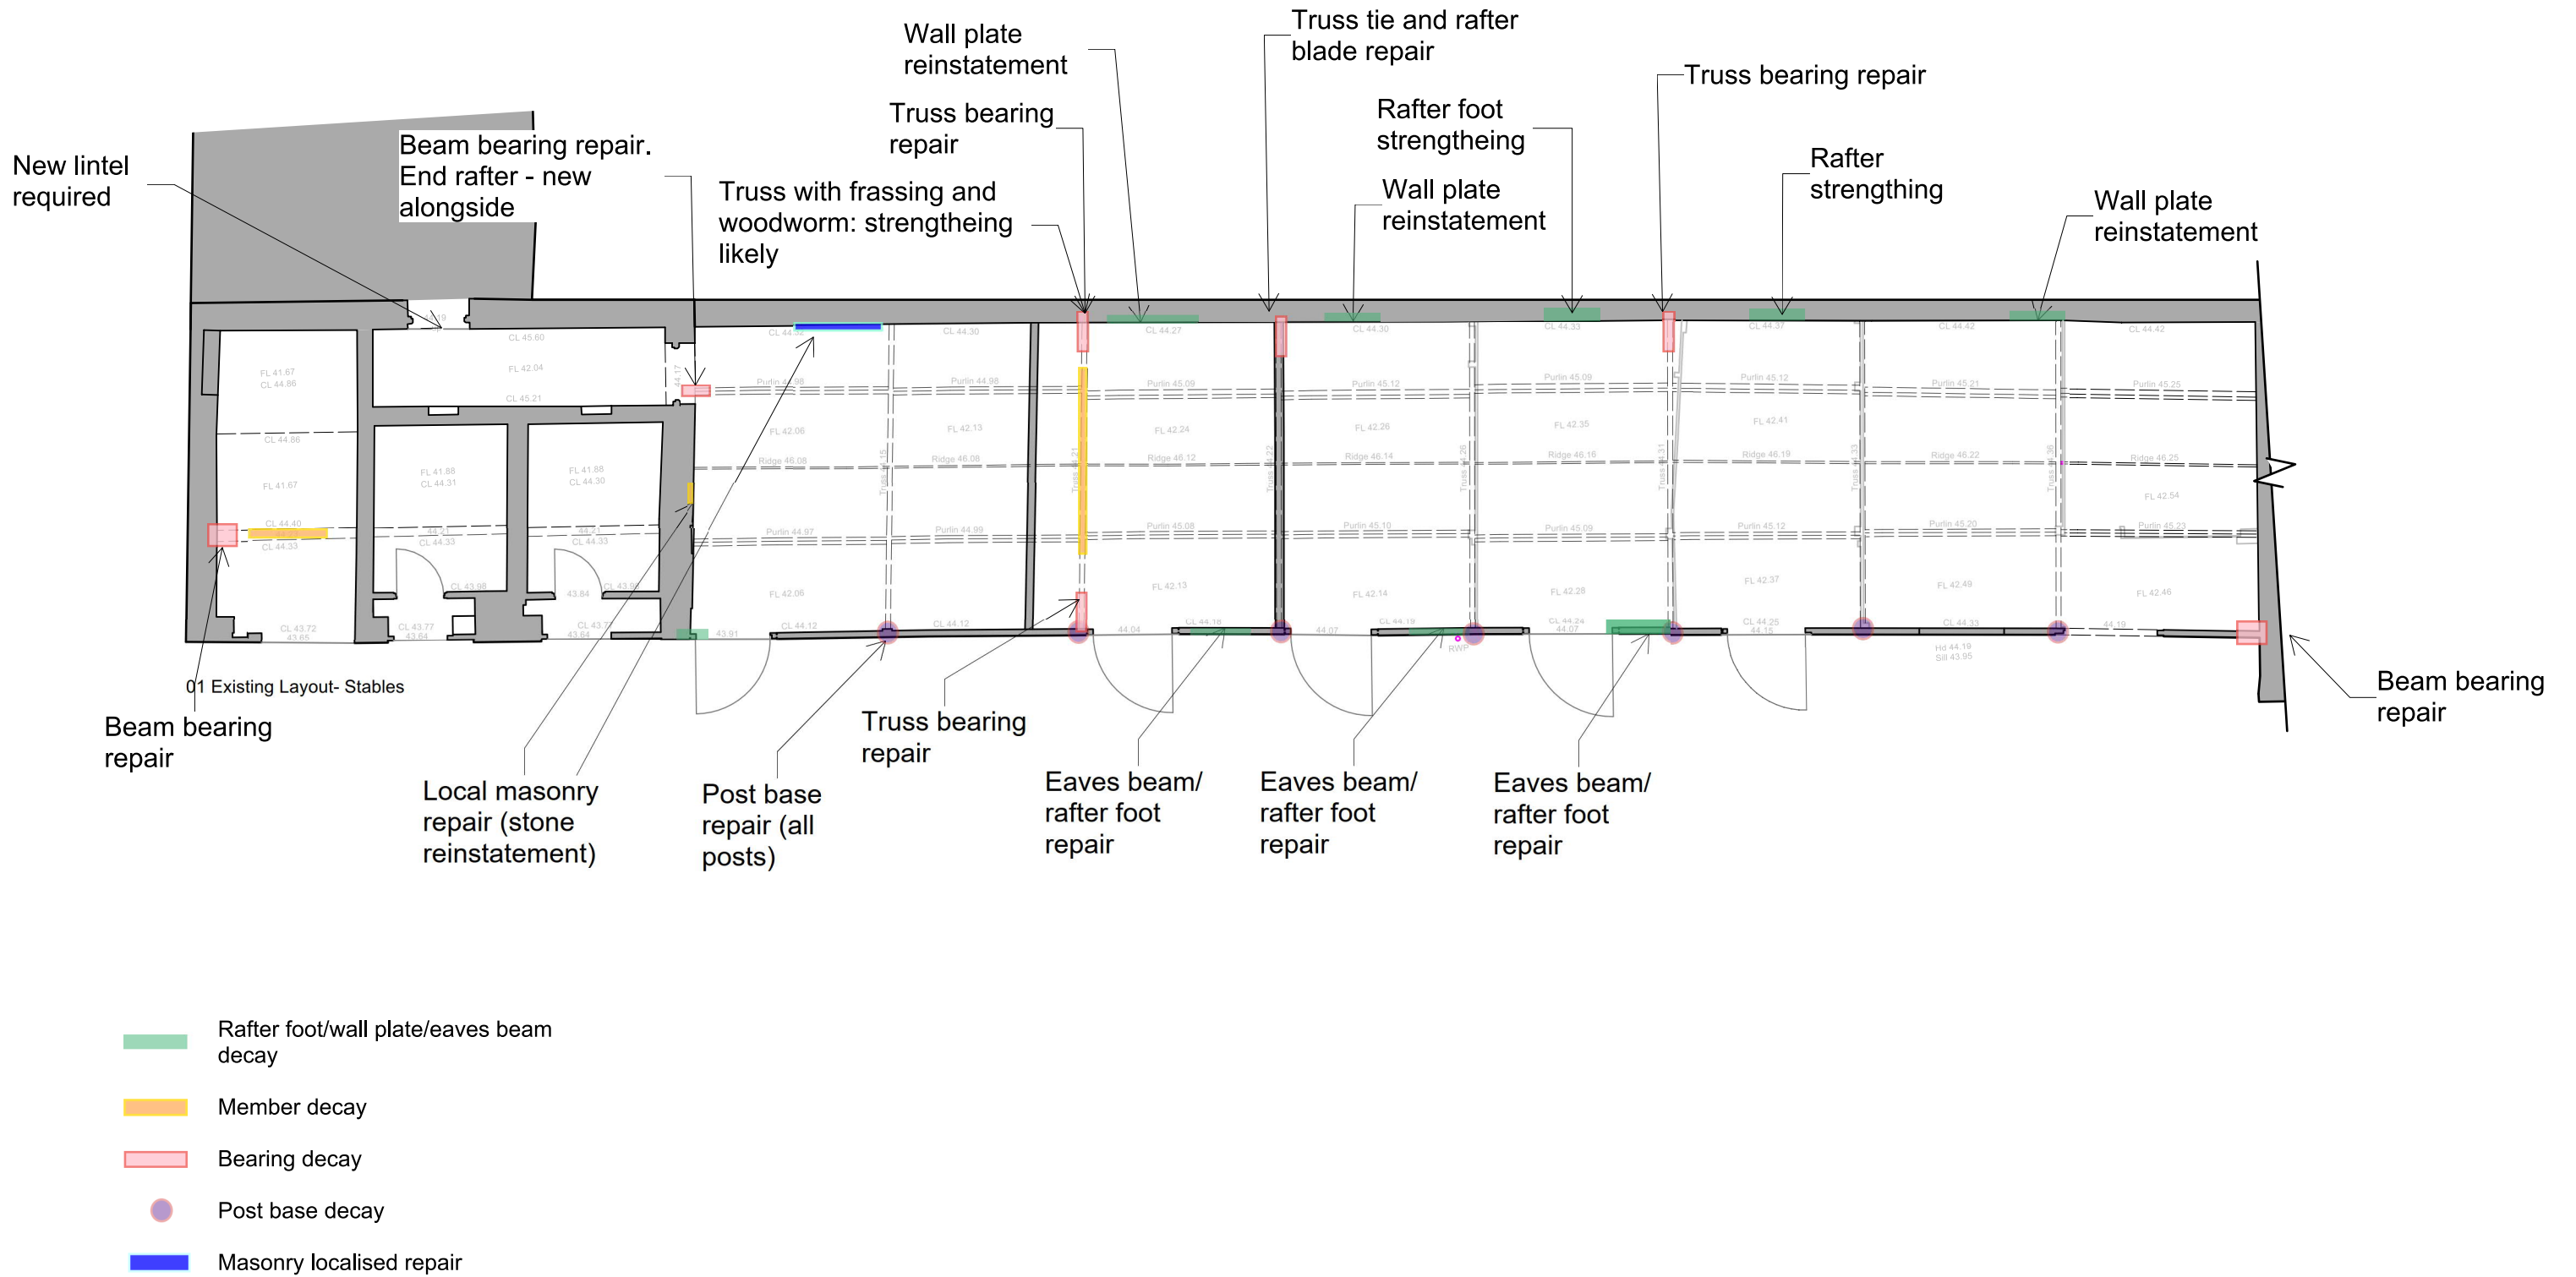
## Appendix B Proposed Repair Extents

As outlined in the original structural report the building itself is in structurally sound condition. Very little of the existing structure, as a whole, has any significant structural decay. Where structural degradation has occurred, it is limited to the typical elements:

- Where water has caused decay to timbers.
- Where lime mortar has been lost due to natural movement of the building and weathering.

- Rafters: New timbers alongside existing to strengthen where needed as well as retain existing materials
- Purlins: Provide steel plates to top side, if required, to strengthen and retain existing purlins. Where Timber is decayed, eg bearings, new sections of seasoned oak can be cut in using traditional scarfed joints.
- Trusses: Repair existing timber with the use of either steel bracket details applicable to farm buildings at the time, or provide traditional timber repair details, while retaining as much original materials in place as possible.
- Timber posts: Traditional timber scarf base detail to retain historic post and reinstate lost bearings, to allow the blockwork walls to be removed, which harm the historic appearance of the building.
- Masonry repairs: Repointing with traditional lime mortar to match original form
