## Off Mains Drainage Survey Report Prepared For:

2 Field Cottages  
Manningford Bruce  
SN9 6HU

**Date of Survey:** 16/04/2025  
**Engineer:** Paul Stewart

**Project Description:** CCTV Survey

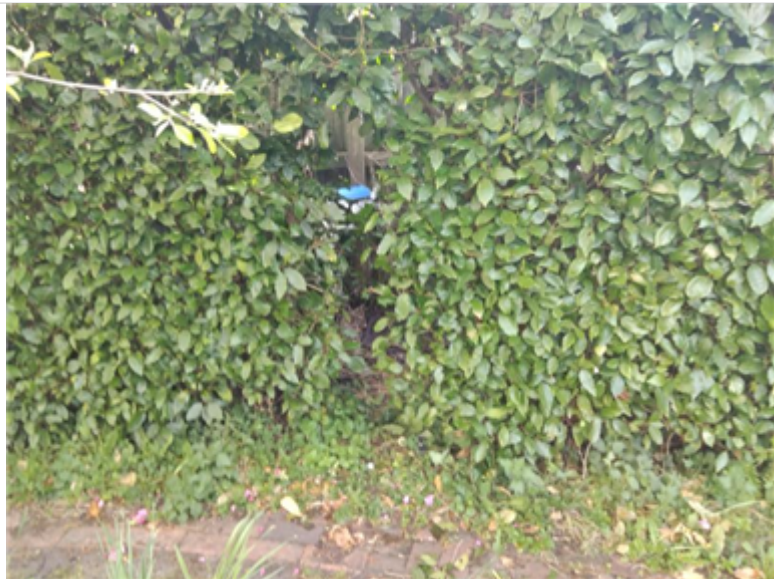
| Overall condition of the tank: | Satisfactory |
| Is the existing discharge functioning correctly? | No<br>Effluent level within the tank was sitting 100mm above the correct operating level, this indicates that the discharge is not functioning correctly. There was no power to the pump within the pump chamber. |

Photograph of the general area of the tank:

The tank is undersized for the maximum occupancy of the property and the discharge soakaway chamber is only 3m away from the seasonal ditch, therefore the system in place does not comply with building regulations and the general binding rules for discharge.

Install a new 12 population sewage treatment plant with pumped outlet. Inlet 1.0m. New STP to be located in the rear garden of No.1 as agreed.

Piece through existing tank with 2m of new pipework to turn and come out the side of existing zone 2. Install a further 8m of new pipework to the new STP location.

Install 10m of new pumped outlet and install a new sample chamber and new seasonal soakaway to run adjacent to the seasonal ditch to the rear left hand side of the No.1 rear garden. Permit required.

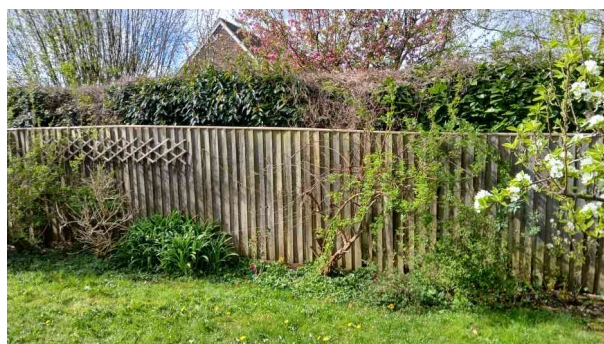
boundary fence to be taken down to access existing tank

Section of Pickett fence and feather edge boundary fence to be taken down for machinery access and re-erected on completion.

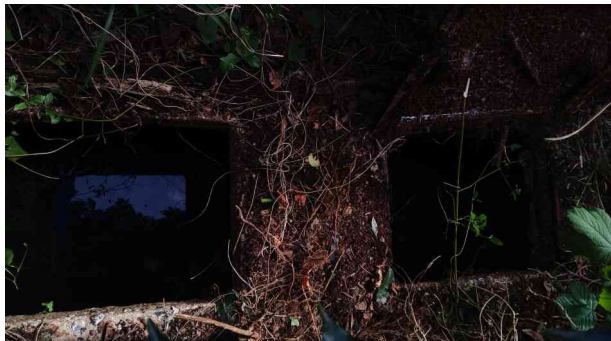
| Based on our calculations, is the tank adequately sized for the maximum potential occupancy of the property? | No |

existing tank

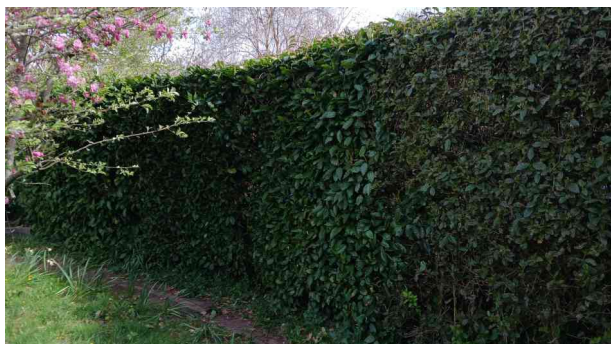
MH4 was unaccessible with the camera to carry CCTV, as was in a large thick hedge.

hedge in front of MH4 and tank

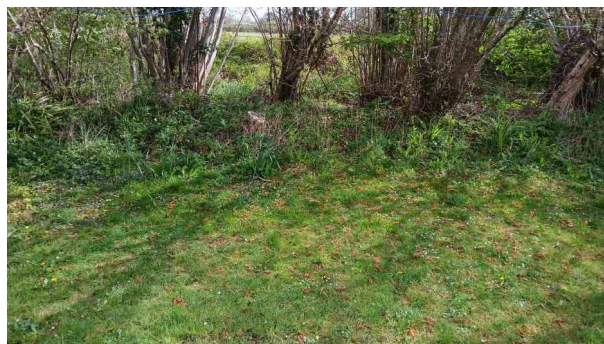
location for new seasonal soakaway adjacent to the seasonal ditch

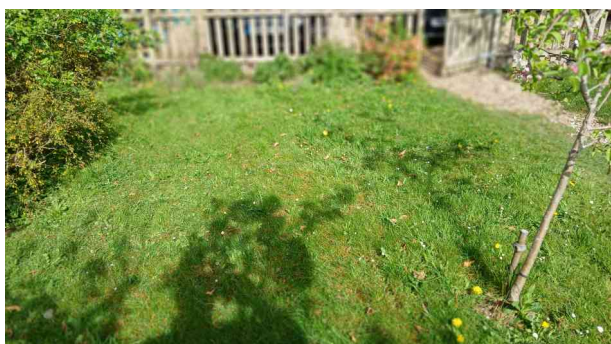
location for new STP

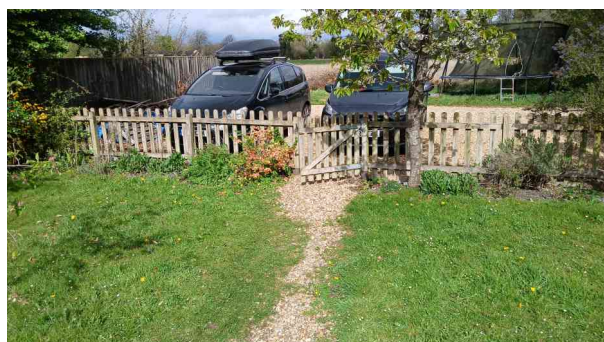
pickett fence to be taken down for machinery access to rear of No.1

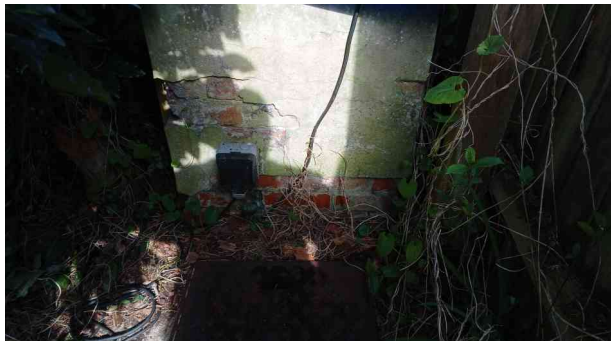
pump chamber with outside socket

Upto 12m of electrical cabling to be taken from existing outside socket for existing pump chamber.

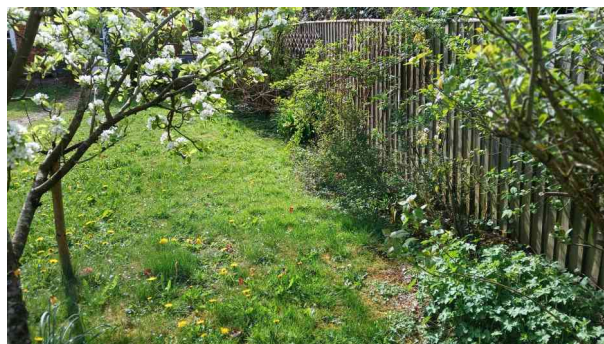
route for diverted pipework to new STP

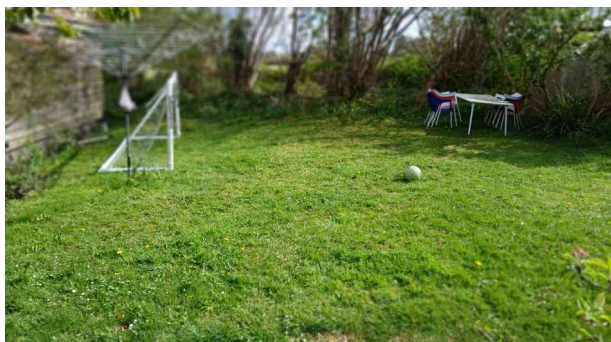
route for pumped outlet

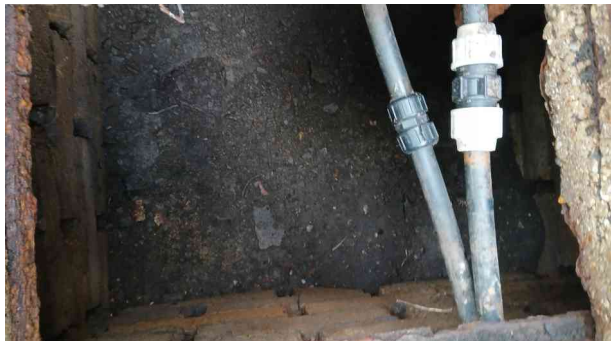
tank soakaway chamber 3m away from ditch

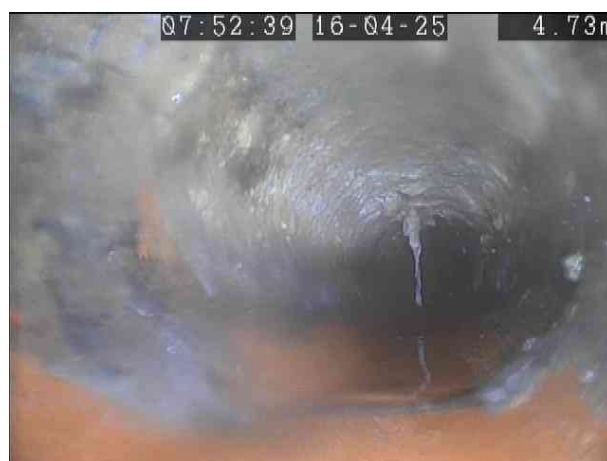
IC1X\_e8610c84-1073-4ada-9506-a02aa1d10ae5\_20250422\_203904\_779.jpg, 00:01:39, 4.77 m  
Survey abandoned, Unable to push any further

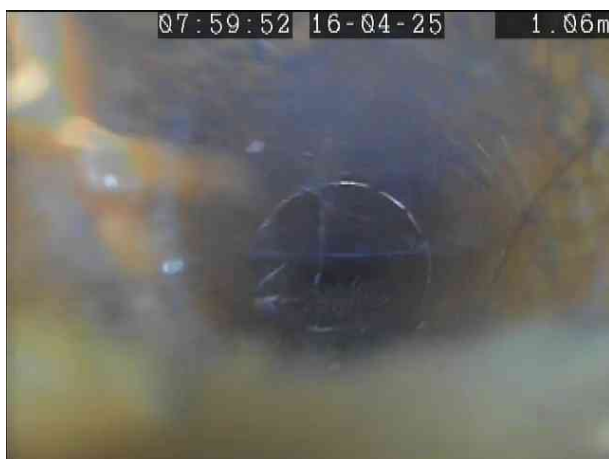
DISUSEDX\_043b217d-e816-4ba7-9350-1d089e2ba2b4\_20250422\_204151\_700.jpg, 00:00:13, 1.06 m  
Roots, mass, 15% cross-sectional area loss

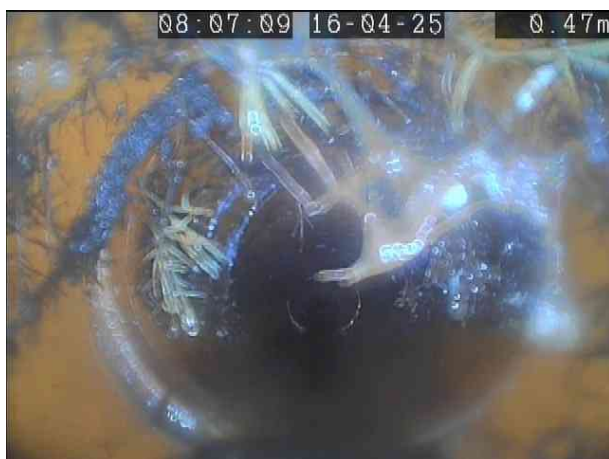
MH2X\_93f4c21f-08f1-4a5d-bf7c-08e50e9413d2\_20250422\_204816\_727.jpg, 00:00:14, 0.59 m  
Roots, fine, start

Run 5 serving No.2 - high pressure water jet and rootcut. Install 3m of 100mm liner from MH2 to MH3.

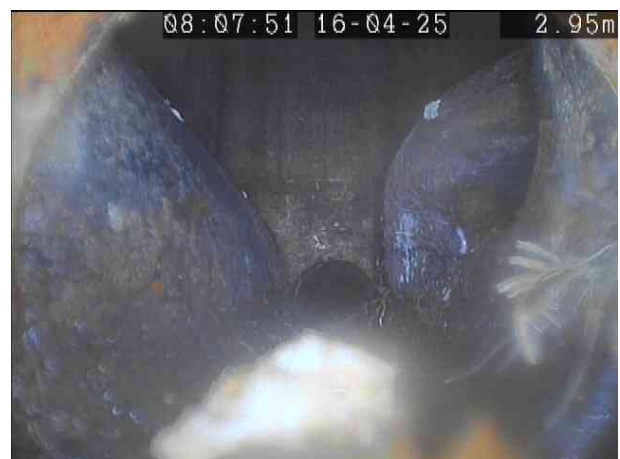
MH2X\_32397176-b3e9-44f8-82b6-dda267071c37\_20250422\_204854\_617.jpg, 00:00:55, 2.95 m  
Roots, fine, finish

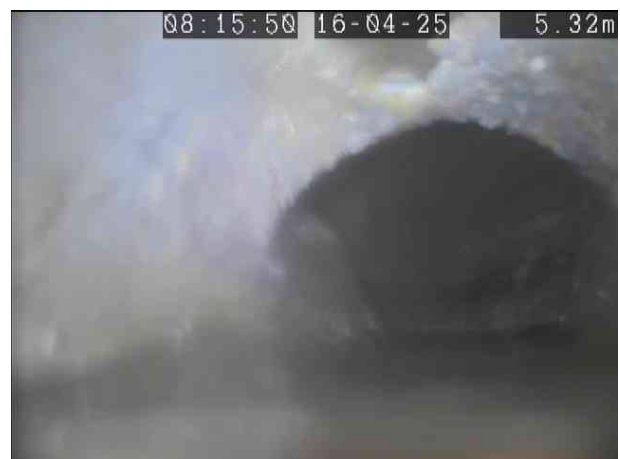
MH3X\_e89d4b18-d2d8-426b-8f30-43cd22dc57d6\_20250422\_205900\_637.jpg, 00:00:45, 5.32 m  
General remark, MH4
