## DEFECTS REPORT

TINKERS LANE SURGERY  
ROYAL WOOTTON BASSETT  
SWINDON  
SN4 7AT

REFERENCE: HW958  
DATED: MARCH 2026

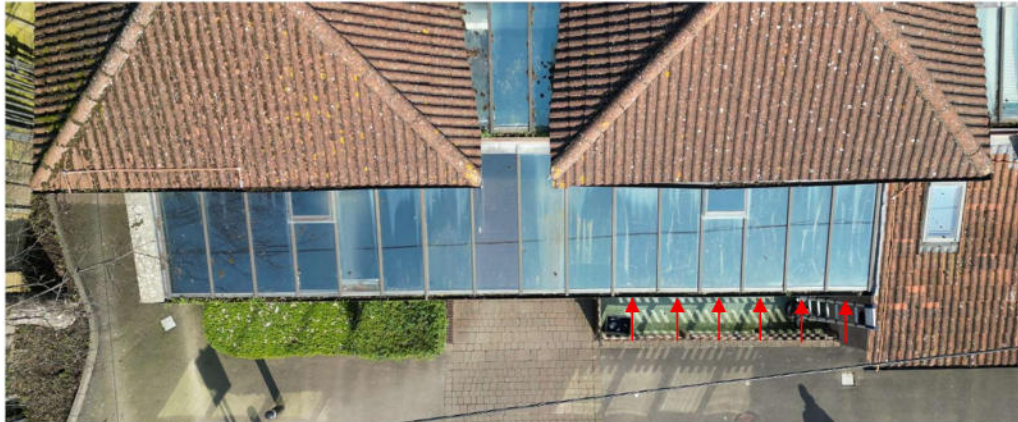
*Image 3: Aerial Image of Lean-To Roof.*

Cracking was observed to six internal glazing panes within the roof of the waiting room area of the lean-to structure. The affected panes are located within the section where solar reflective film has been applied to the glazing and where an insulated plasterboard ceiling has subsequently been installed beneath the roof glazing.

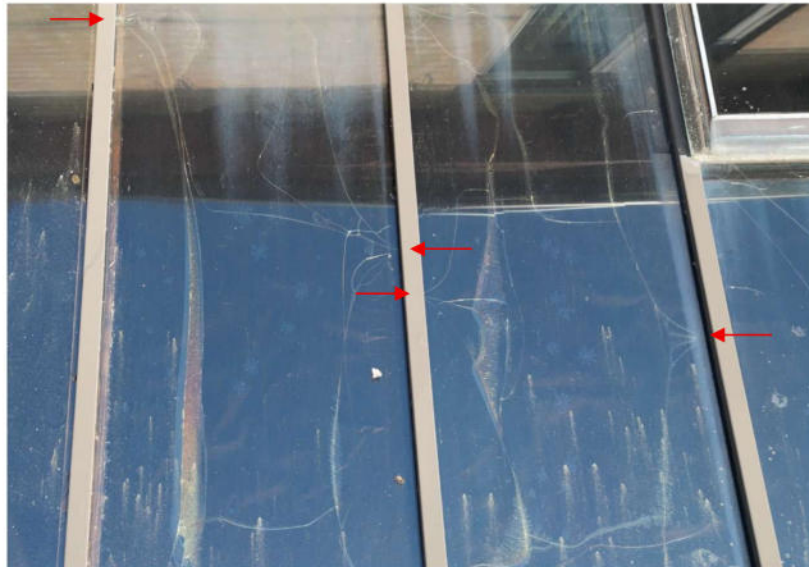
The pattern of cracking originates from the edges of the glazing panes and is consistent with thermally induced breakage. This is likely exacerbated by uneven heating and cooling of the glazing and surrounding glazing bars, resulting in expansion and contraction which generates stress concentrations at the edges of the glass.

*Image 4: Edge Damage.*

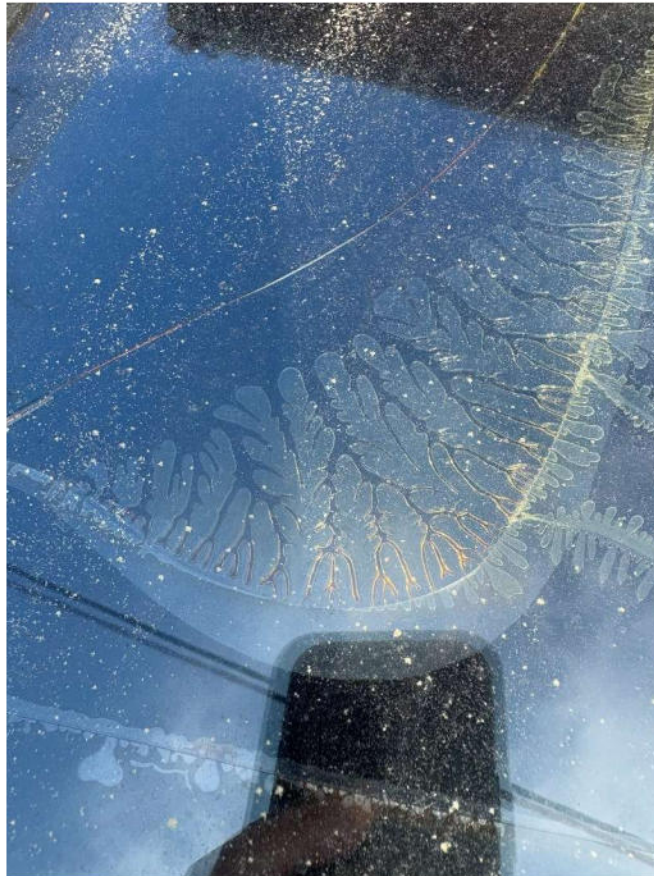
Additionally, the fern-like patterns observed within the glazing panels may be associated with the adhesive layer of the solar reflective film applied to the internal face of the glass. Solar control films typically utilise pressure-sensitive adhesives to bond the film to the glazing surface, and under conditions of elevated temperatures and prolonged solar exposure, the adhesive layer can deteriorate or distort, resulting in visible patterns within the glazing.

*Image 5: Fern-like patterns.*

It is also worth noting that where glazing is exposed to significant solar gain, particularly within roof glazing arrangements, the temperature of the glass and applied film can increase considerably. Over time, elevated temperatures can cause degradation or visual distortion within the adhesive layer, resulting in irregular or branching patterns visible through the glazing.

Such patterns can sometimes resemble fracture patterns or laminated interlayer deterioration; however, they may in fact be an optical effect caused by adhesive breakdown or stress within the film itself.

Given that solar reflective film has been applied to the glazing panels, it is considered possible that the patterns observed are associated with deterioration or thermal stressing of the film adhesive rather than being solely attributable to the glass pane itself.

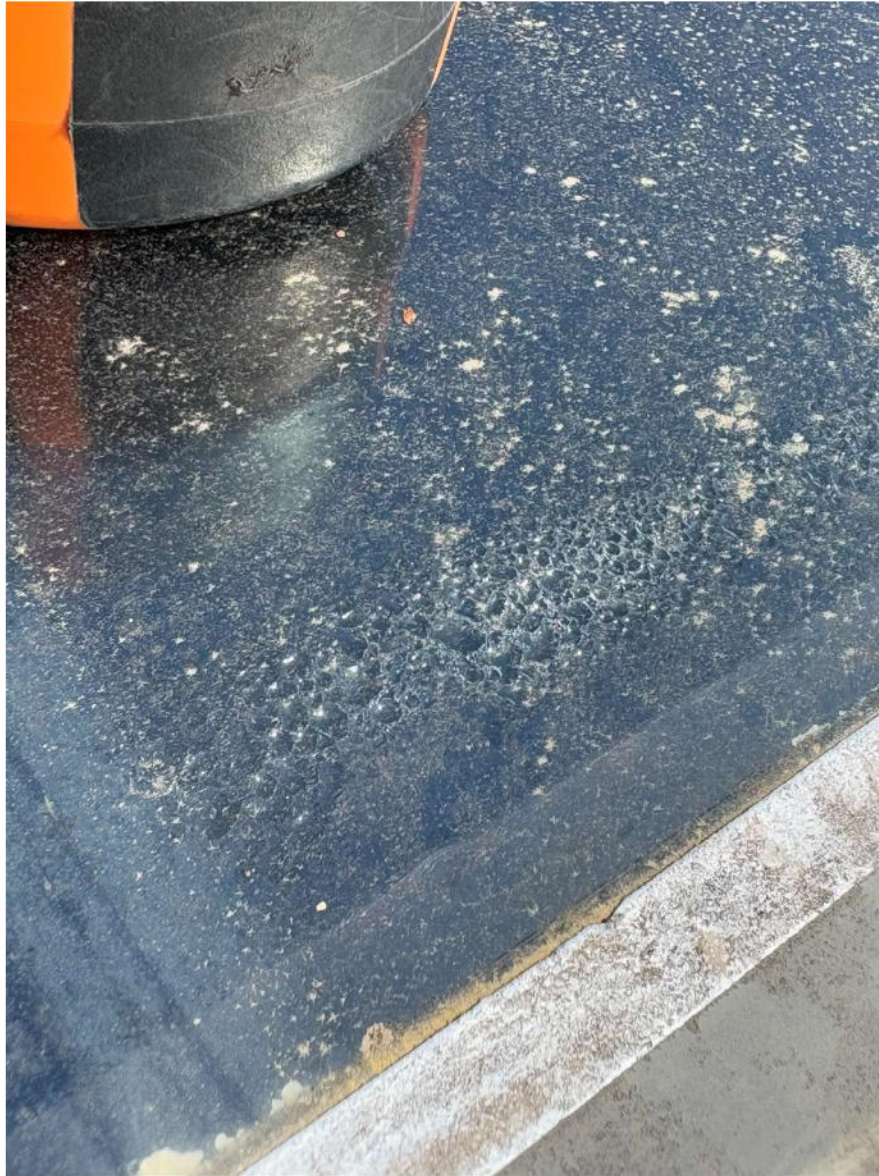
Moisture was observed within several double-glazed units, indicating failure of the perimeter seals to the glazing units.

*Image 6: Condensation on Glazing Pane.*

Failure of the perimeter seals allows moisture ingress and loss of the insulating cavity within the glazing unit, which can alter the thermal behaviour of the glass and contribute to increased thermal stresses. Whilst not typically the primary cause of cracking, such conditions may exacerbate the likelihood of thermally induced glazing failure.

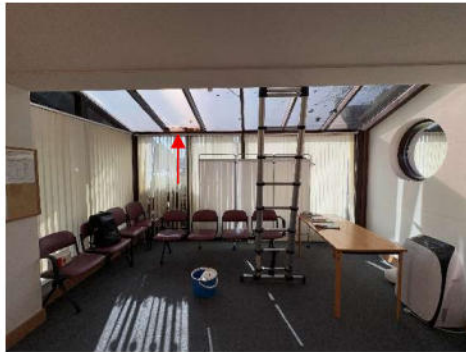
*Image 7: Consultation Room Internal.*

Cracking was observed only to the glazing panels within the waiting room area where the insulated plasterboard ceiling has been installed beneath the roof glazing. No cracking was observed within the consultation room section of the lean-to structure, where no ceiling installation has been undertaken, with the exception of a historic crack noted to an external glazing pane which is understood to pre-date the works.

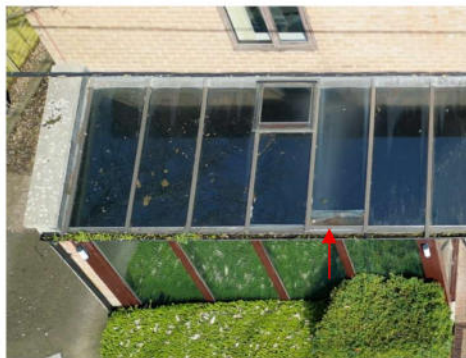
*Image 8: Consultation Room External (External Cracked Pane).*

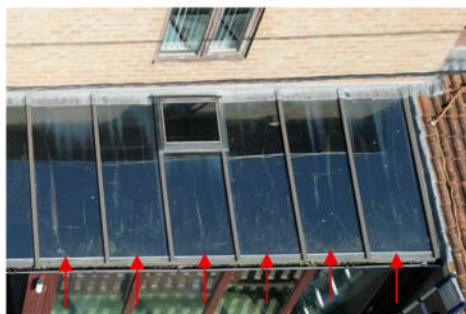
*Image 10: Waiting Room External (Internal Cracked Panes).*

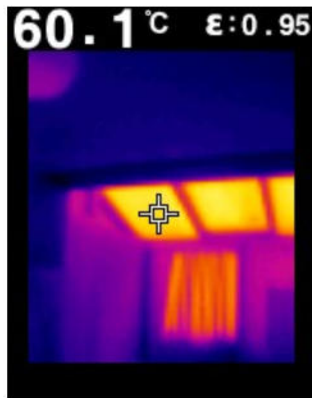
Using a thermal imaging camera for comparative assessment, the surface temperature of the glazing within the consultation room was recorded at approximately 60°C at the time of inspection. It should be noted that the external ambient temperature on the day was approximately 13°C, and therefore glazing temperatures are likely to increase significantly during warmer periods and under stronger solar exposure.

*Image 11: Consultation room glazing temperature recorded at 60.1°C (thermal imaging comparative assessment).*

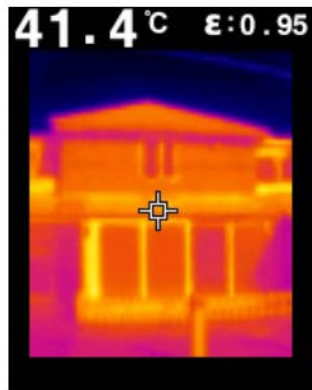
*Image 12: Waiting Room Glass Temperature (External).*

With the installation of insulation and a plasterboard ceiling beneath the roof glazing in the waiting room, the opportunity for heat to dissipate from beneath the glazing has been substantially reduced. As a result, heat is likely to accumulate within the void between the glazing and the ceiling, meaning the glazing within the waiting room is likely to be exposed to considerably higher temperatures during periods of solar gain.

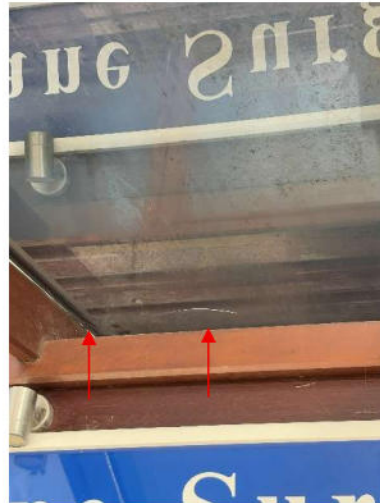
It was also noted that a crack was present within a glazing panel forming part of the entrance canopy where solar reflective film had been applied.

*Image 14: Cracked Glazing.*

The adjacent glazing panel, however, did not exhibit similar cracking. This may suggest that the application of the solar reflective film could be influencing the thermal behaviour of the glazing, potentially restricting the natural thermal flexibility of the glass and contributing to increased stress within the pane.

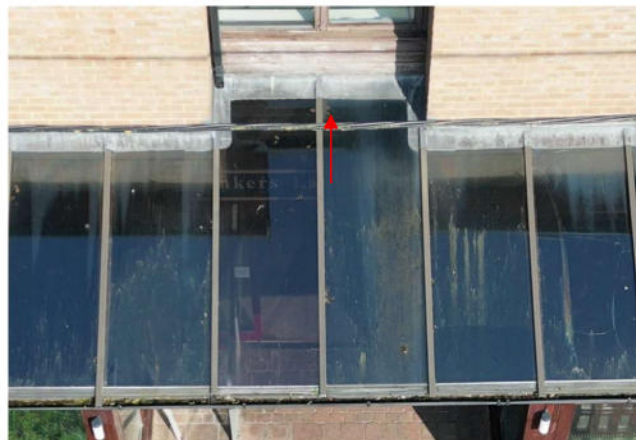
*Image 15: Different Applied Films.*

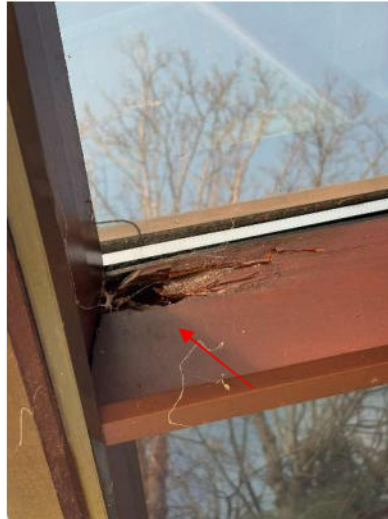
In the interest of our client, we draw attention to timber decay observed to the end section of a timber rafter within the canopy structure at the front entrance.

*Image 16: Timber Decay.*

This is considered likely to have arisen as a result of persistent wetting of the timber, likely associated with deteriorated or failed seals allowing moisture ingress. Prolonged exposure to moisture can progressively break down the timber fibres, leading to the development of timber decay over time.

With regard to the additional observations noted during the inspection, it is recommended that the areas of timber decay identified within the entrance canopy structure are addressed. This may involve localised splice repairs or resin repair systems, depending on the extent of deterioration. Any failed or deteriorated seals should also be repaired or replaced to prevent further moisture ingress and to reduce the likelihood of continued wetting of the timber elements.

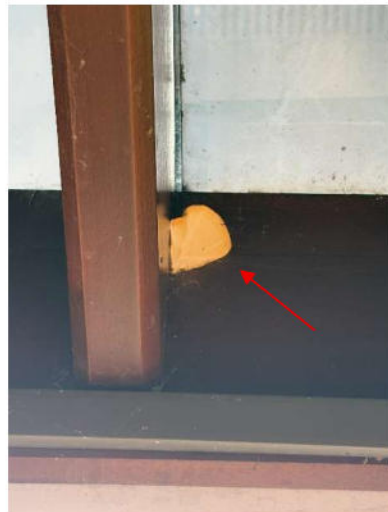
Additionally, a fungal fruiting body was observed on an adjacent timber rafter, which is indicative of fungal activity and suggests the presence of prolonged moisture exposure within the timber.

*Image 17: Fungal Fruiting Body.*
