# Method Statement for Repair and Conservation of Barn at The Compasses Inn Chicksgrove SP3 6NB

**February 2022**

This method statement describes the details of the structure and the way in which it is to be repaired, in-situ.

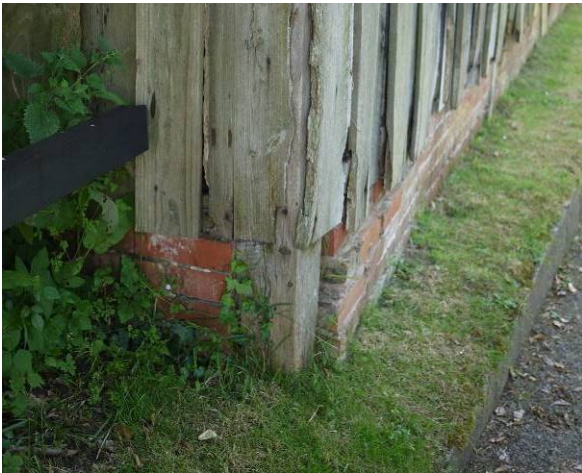
Photo 2. North east corner showing earth-bound principal

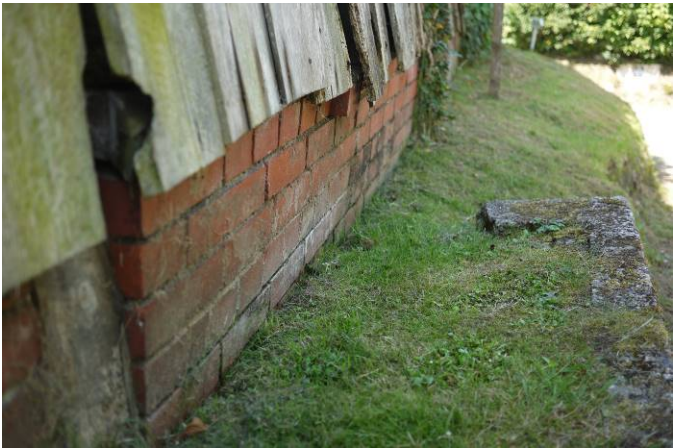
Photo 3. The junction at Truss T3 north side. Right are remains of a churn stand.

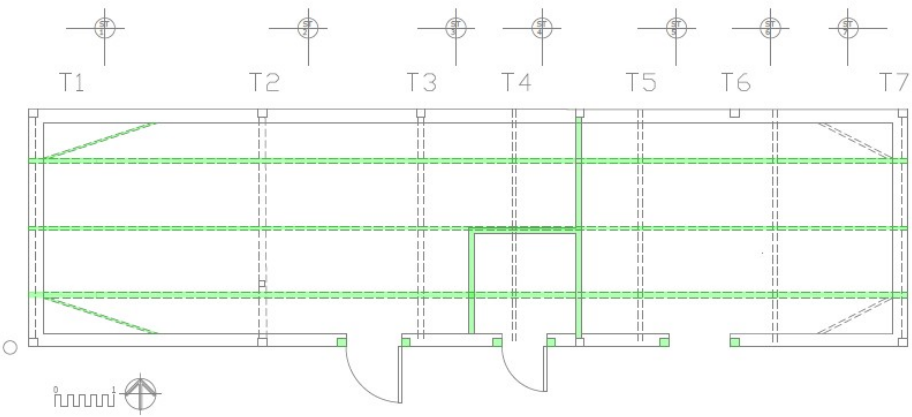
Image 4. Basic plan of the barn

Suspension frame of temporary structure  
Frame marked in green to be removed or replaced

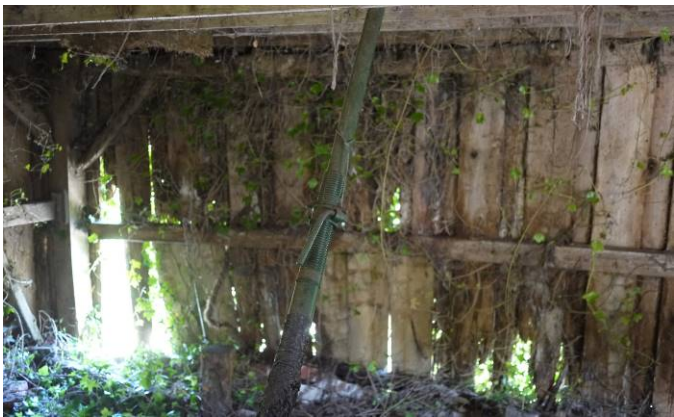
Photo 5. A prop in the west bay

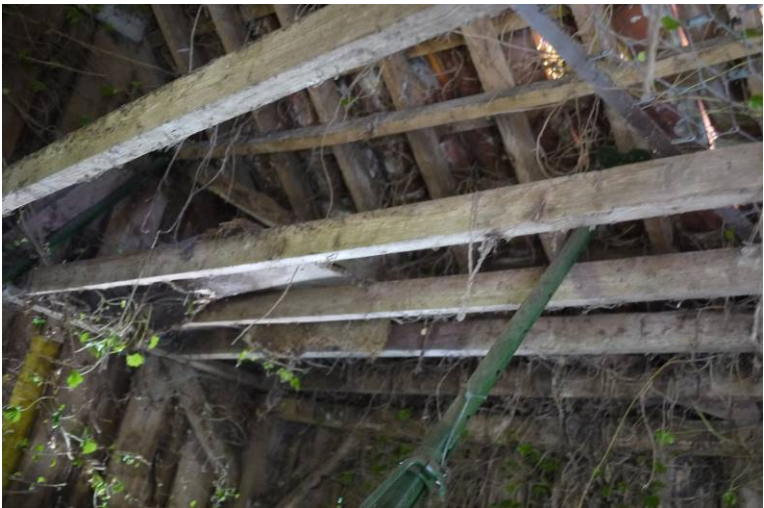
Photo 6. The underside of the roof adjacent Truss 1

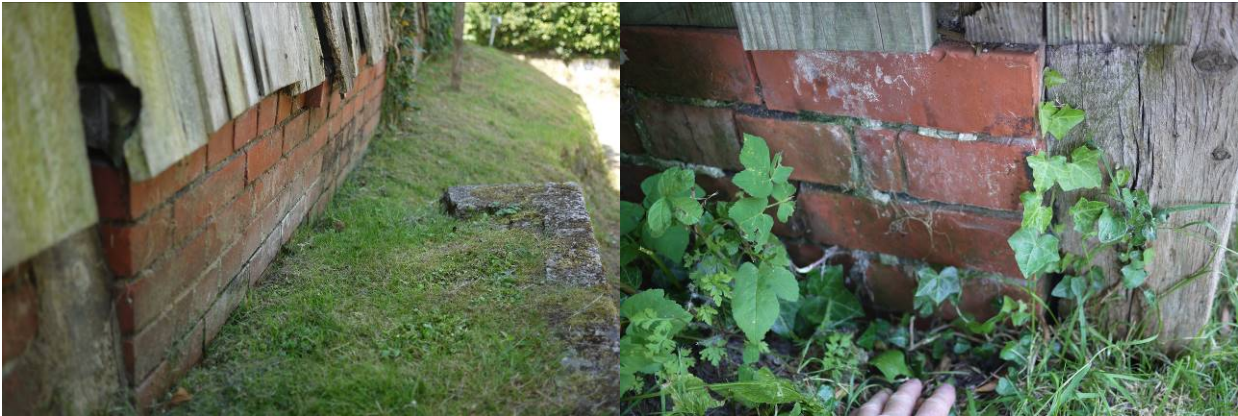
- The wall plate on the south elevation at the western end is largely missing resulting in the partial collapse of the building, towards the south.
- Brickwork underpinning has been misplaced and rotated outwards by the movement of the frame.

Photo 7. The rotated wall between trusses 1 and 3

Photo 8. Rotated underpinning at post base truss 1.

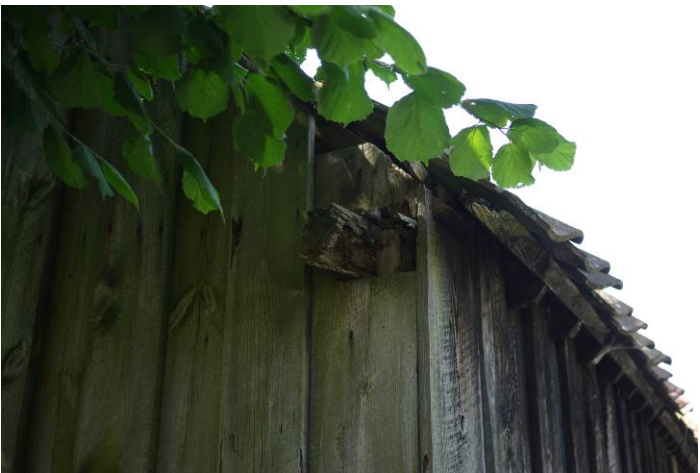
- Gable rafters and wall plate ends have rotted or are missing.
- At the east end, block and brick lining walls have been added with a mixture of render and steel covering. Structural timber is covered so that condition of the timbers is yet to be determined.

Photo 10. The rotted wall gable rafter

plate end and missing east

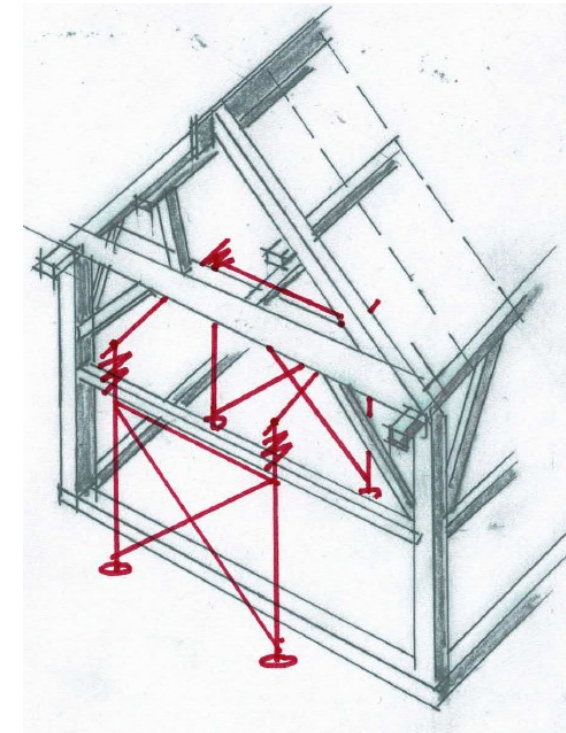
Fig. 11. Image showing the means by which the gable and intermediate trusses are to be re-positioned.

Once the ground floor has been cleared, standards are to be erected at 2 no. per principal post. They are to be linked together and placed so that each tie-beam end has a putlock beneath mounted with a jack each side with a total height movement of a minimum of 400mm.

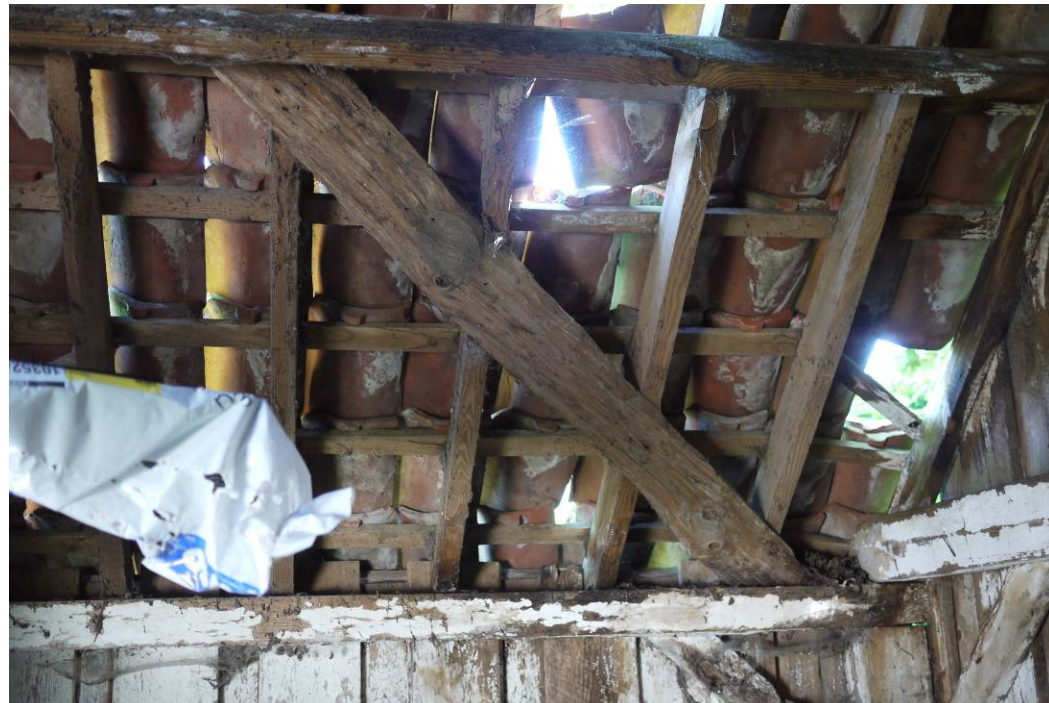
Photo 12 – showing the poor quality and rot in the purlins which are to be replaced.

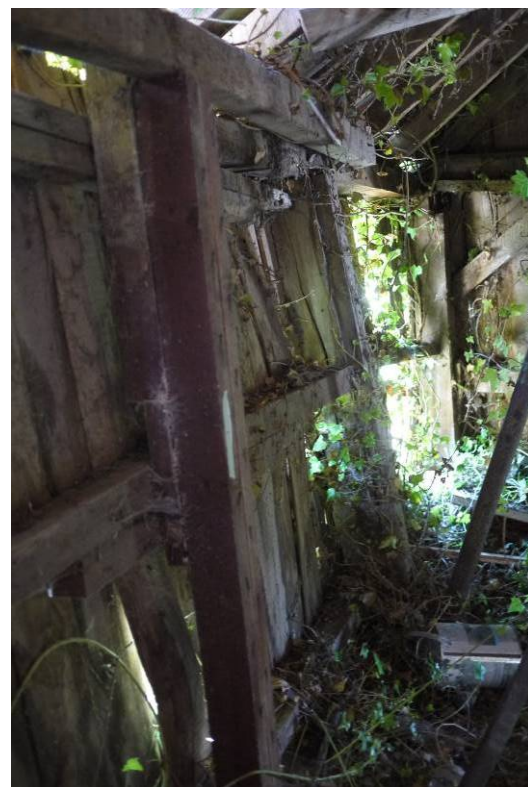
Photo 13. – showing the south west corner with temporary props.

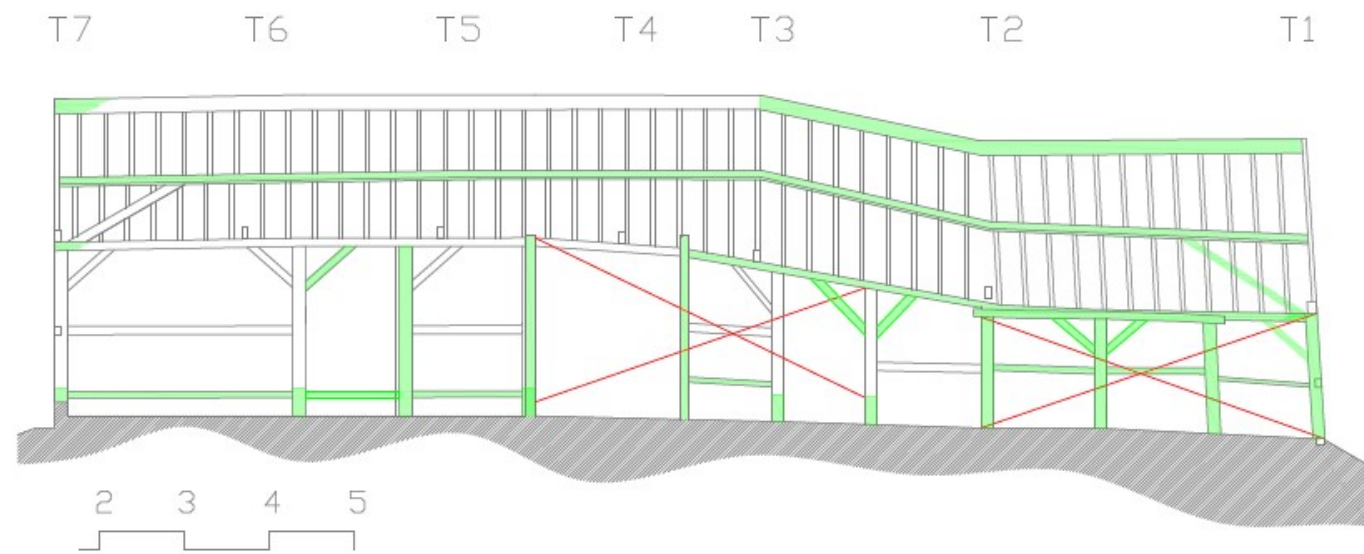
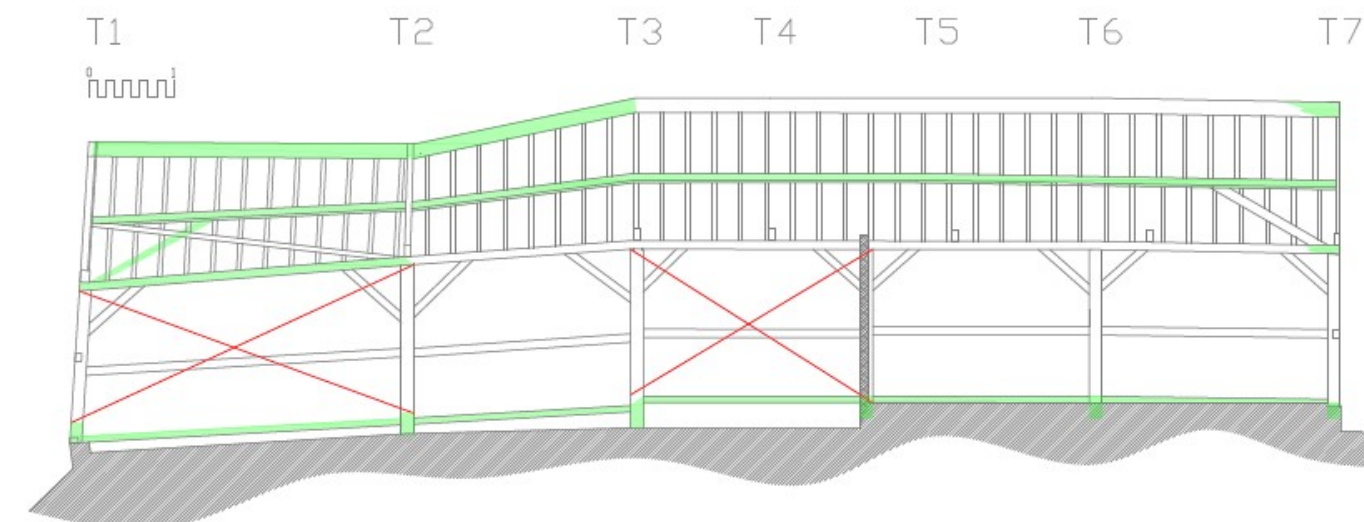
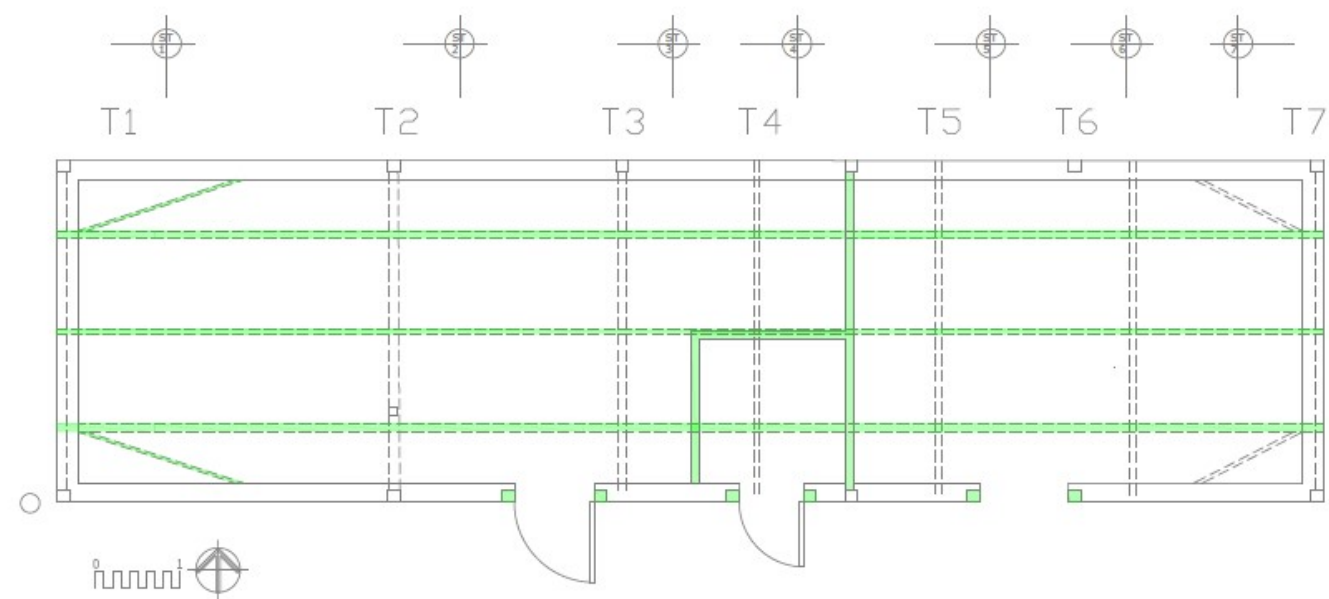
Red lines indicate positions of temporary bracing.
-

Green shaded timbers are to be replaced.

To prevent movement during repairs and replacements, temporary, horizontally mounted battens (say 25x100mm) are to be fixed to the posts and studs in 2 equally spaced at third intervals. See the red lines on the elevation drawings for suggested locations.

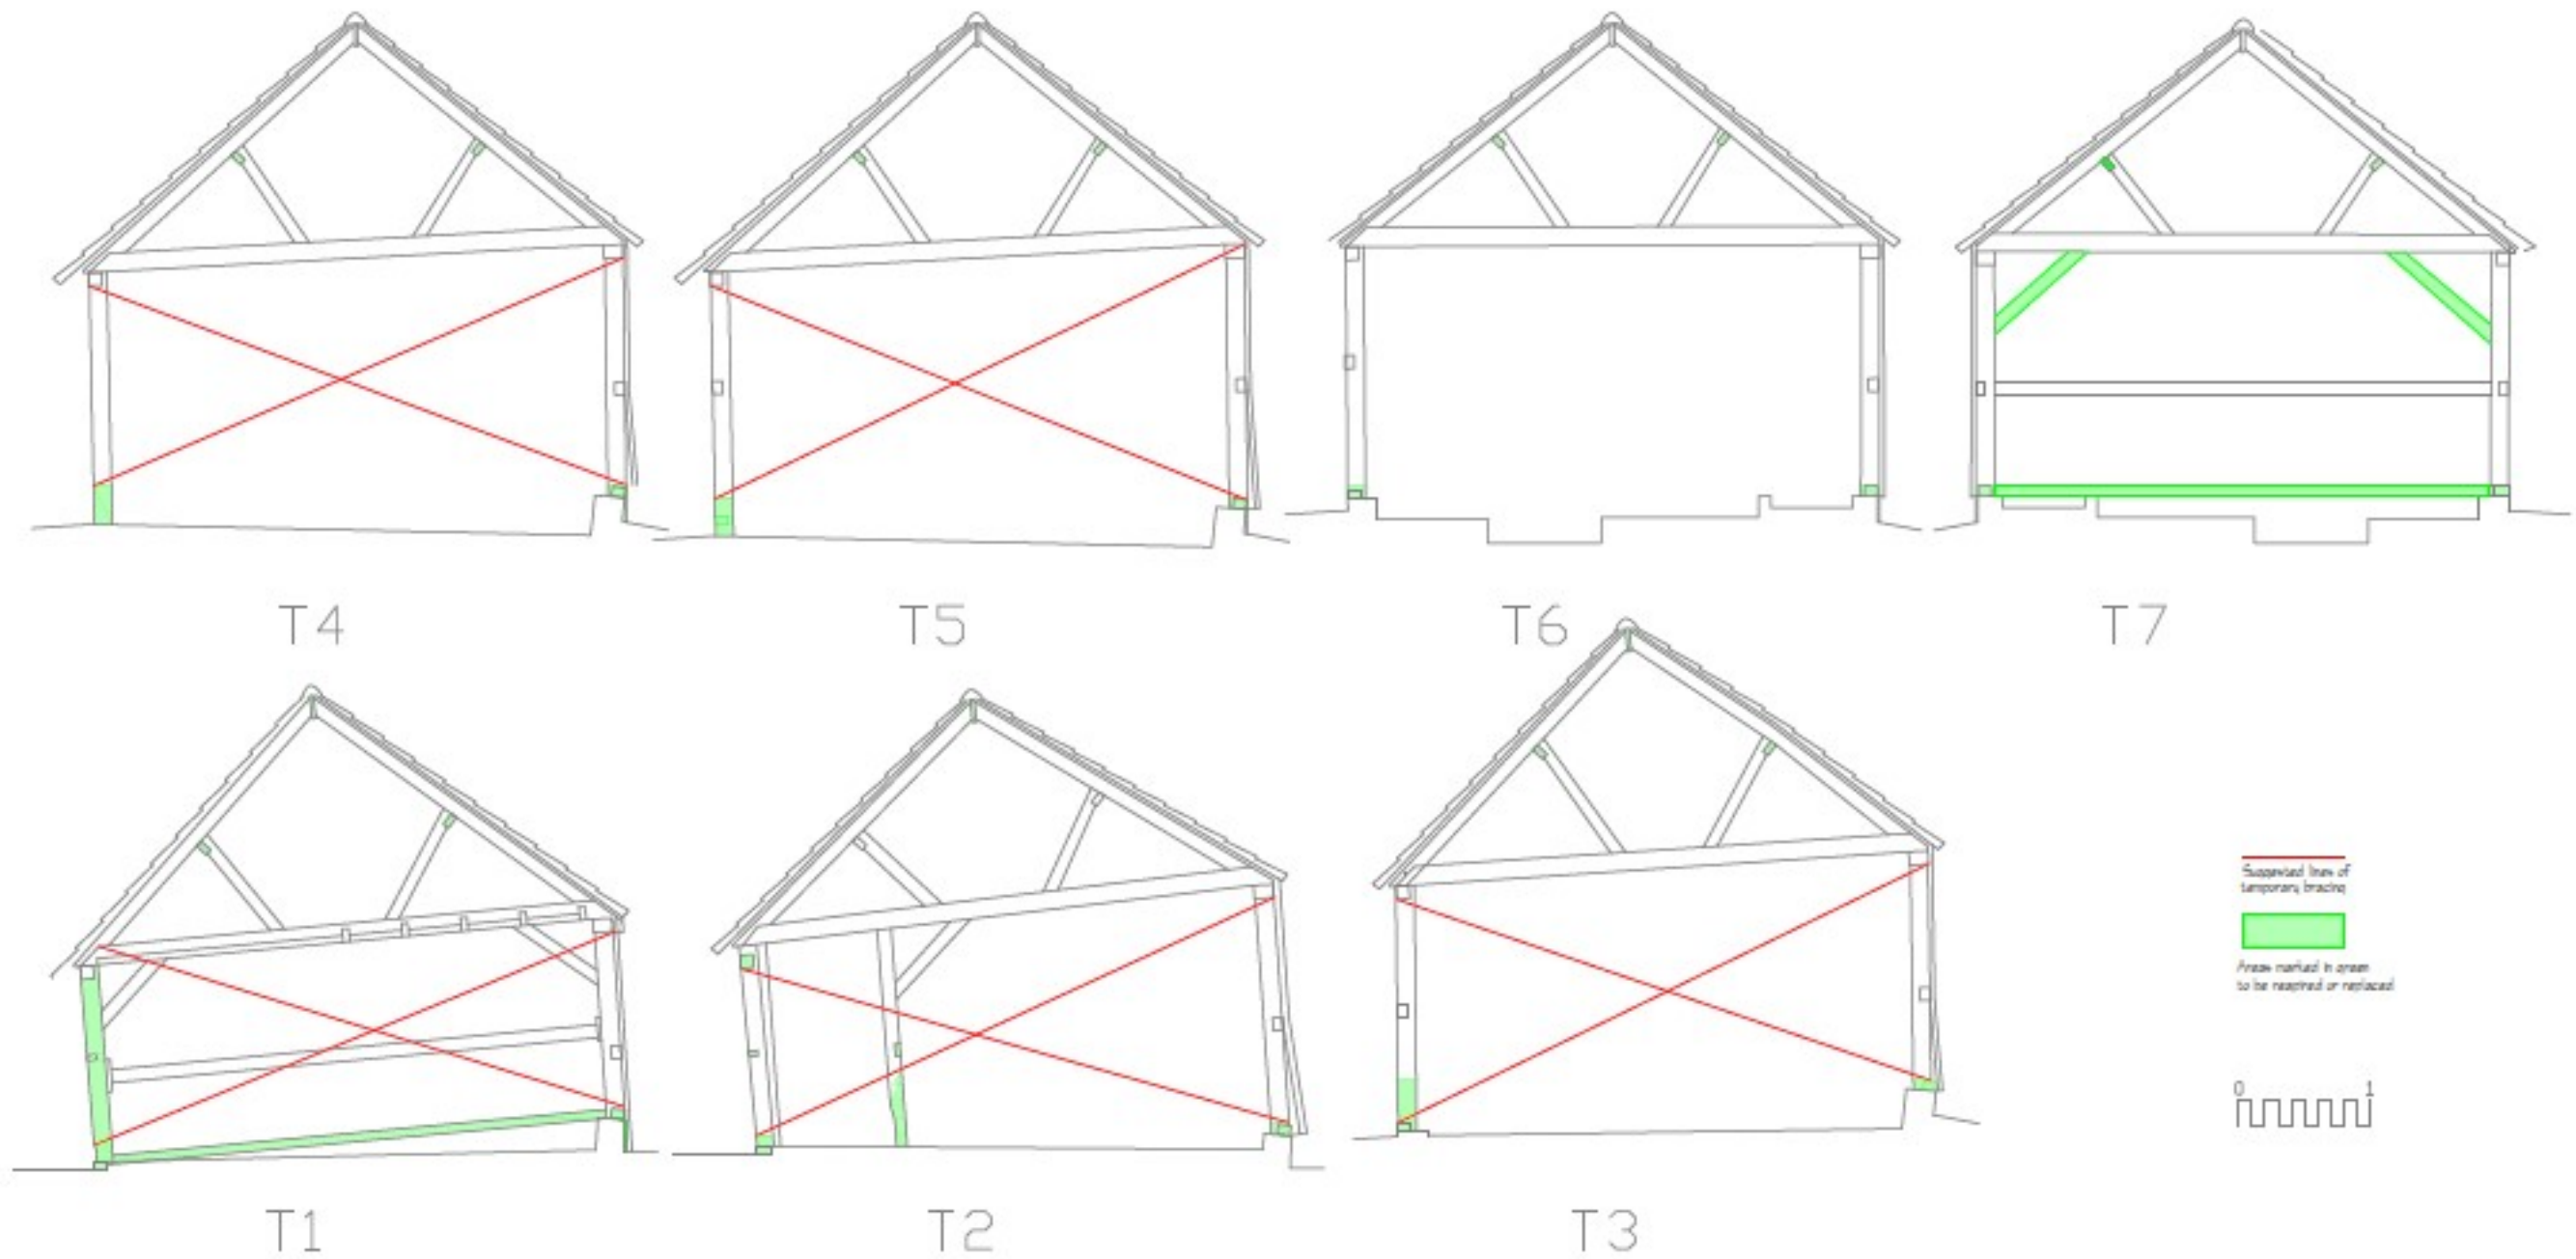
Cross sections through building at each truss position. Note that red lines indicate temporary cross bracing. Green shaded timbers indicate those to be replaced.
