TROWBRIDGE HSBC SURVEY OF SASH WINDOWS

Friday, 10 May 2024

Prepared For Henley's

86 Issues Identified

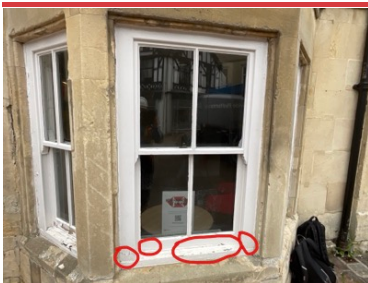
### **WE01 GR FLOOR**

Cill and pulley stile rotten

Bottom rail on bottom sash rotten

Top sash ok

Painted shut

\* full refurb. New parting beads, new staff beads and re cord.

Full Cill replacement with outer face and pulley stiles.

New bottom sash installed into existing frame

Top Sash in ok condition can be sanded down and decorated.

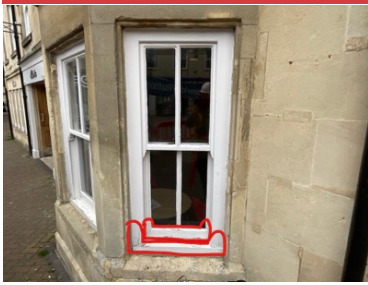
### **WE02 GR FLOOR**

Cill and pulley stile rotten

Bottom rail and stiles on bottom sash rotten

Top sash ok

Painted shut

\* full refurb. New parting beads, new staff beads and re cord.

Full Cill replacement with outer face and pulley stiles.

New bottom sash installed into existing frame

Top Sash in ok condition can be sanded down and decorated.

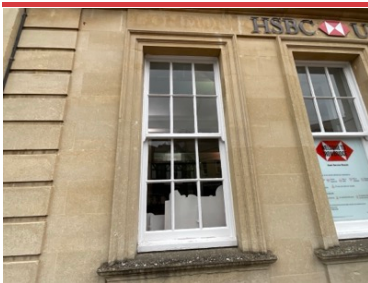
### **WE03 GR FLOOR**

Cill and pulley stile rotten

Bottom rail and stiles on bottom sash rotten

Top sash ok

Painted shut

\* full refurb. New parting beads, new staff beads and re cord.

Full Cill replacement with outer face and pulley stiles.

New bottom sash installed into existing frame

Top Sash in ok condition can be sanded down and decorated.

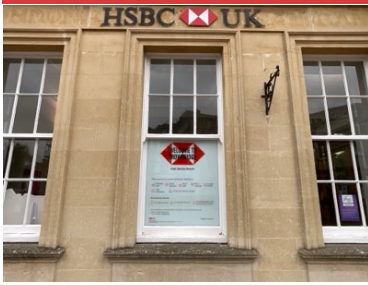
### **WE04 GR FLOOR**

Cill area solid

Bottom sash ok

Top sash ok

Painted shut

\* full refurb. New parting beads, new staff beads and re cord.

Top and bottom Sash in ok condition can be sanded down and decorated.

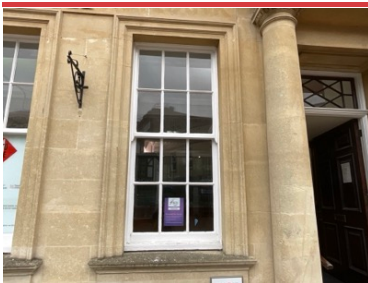
### **WE05 GR FLOOR**

Cill area solid  
Bottom sash ok  
Top sash ok  
Painted shut

\* full refurb. New parting beads, new staff beads and re cord.

Top and bottom Sash in ok condition can be sanded down and decorated.

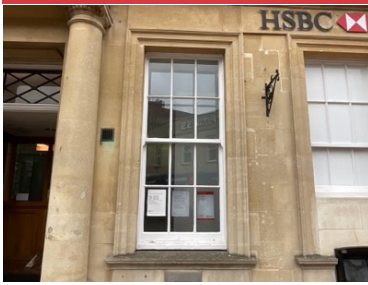
### **WE06 GR FLOOR**

Cill area solid  
Bottom sash ok  
Top sash ok  
Painted shut

\* full refurb. New parting beads, new staff beads and re cord.

Top and bottom Sash in ok condition can be sanded down and decorated.

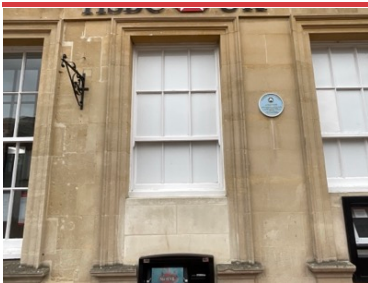
### **WE07 GR FLOOR**

Cill area solid  
Bottom sash ok  
Top sash ok  
Painted shut

\* full refurb. New parting beads, new staff beads and re cord.

Top and bottom Sash in ok condition can be sanded down and decorated.

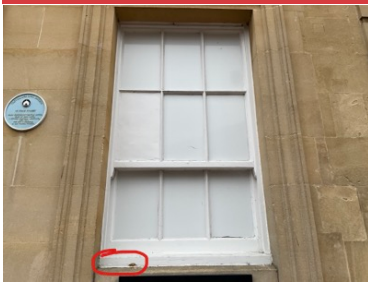
### **WE08 GR FLOOR**

Cill area solid  
Bottom sash ok  
Top sash ok  
Painted shut

\* full refurb. New parting beads, new staff beads and re cord.

Top and bottom Sash in ok condition can be sanded down and decorated.

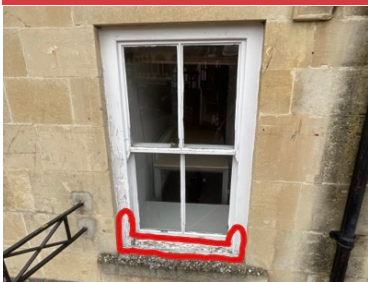
### **WE09 GR FLOOR**

Small area of rotten Cill

Bottom sash ok

Top sash ok

Painted shut

\* full refurb. New parting beads, new staff beads and re cord.

Splice repair in cill upto 300mm

Top and bottom Sash in ok condition can be sanded down and decorated.

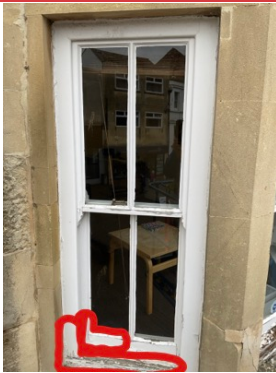
### **WE10 1ST FLOOR**

Top sash ok

Bottom sash ok

Painted shut

Cill and pulley stile rotten

\* full refurb. New parting beads, new staff beads and re cord.

Full Cill replacement with outer face and pulley stiles.

Sash's in ok condition can be sanded down and decorated.

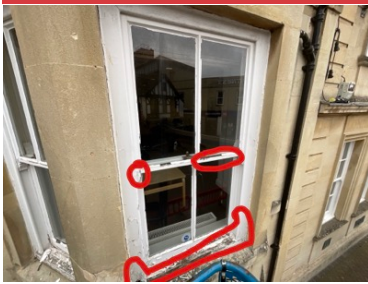
### **WE11 1ST FLOOR**

Cill and pulley stile rotten

Bottom rail and stiles on bottom sash rotten

Painted shut

\* full refurb. New parting beads, new staff beads and re cord.

Full Cill replacement with outer face and pulley stiles.

Needs new bottom sash

Top Sash's in ok condition can be sanded and decs.

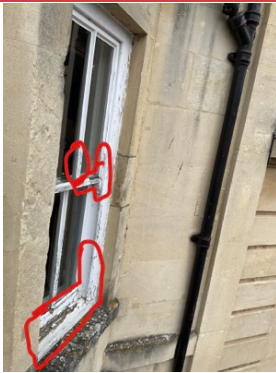
### **WE12 1ST FLOOR**

Cill and pulley stile rotten

Top sash rotten across meeting rail and at joints

Bottom sash rotten across bottom rail and up stiles

Painted shut

\* full refurb. New parting beads, new staff beads and re cord.

Full Cill replacement with outer face and pulley stiles.

New top and bottom sash manufactured and reinstalled into existing frame

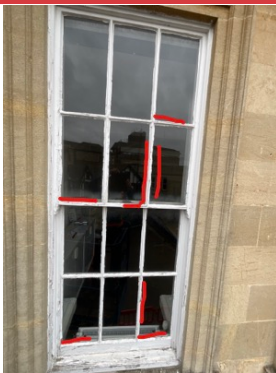
### **WE13 1ST FLOOR**

Cill and pulley stile rotten

Top sash glazing bar rotten

Bottom sash bott rail and glazing bar rotten

Stiles rotten.

Painted shut

\* full refurb. New parting beads, new staff beads and re cord.

Full Cill replacement with outer face and pulley stile

New top and bottom sash manufactured

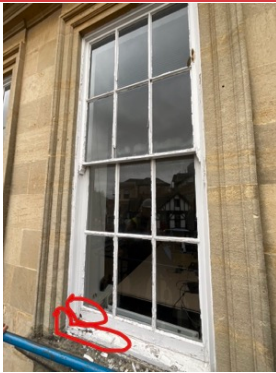
### **WE14 1ST FLOOR**

Painted shut

Top sash ok and refurb able

Bottom sash ok and refurb able

Putty missing

\* full refurb. New parting beads, new staff beads and re cord.

Re putty up to 1000mm

Both Sash's in ok condition can be sanded down and decorated.

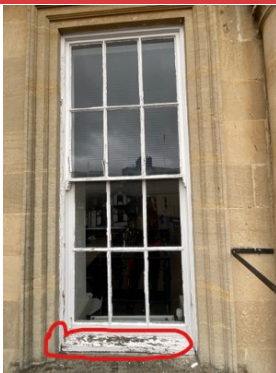
### **WE15 1ST FLOOR**

Cill and pulley stile rotten

Bottom rail and stiles on bottom sash rotten

Top sash ok

Painted shut

\* full refurb. New parting beads, new staff beads and re cord.

Full Cill replacement with outer face and pulley stiles.

New bottom sash installed into existing frame

Top Sash in ok condition can be sanded down and decorated.

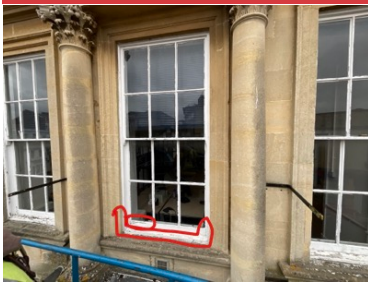
### **WE16 1ST FLOOR**

Cill and pulley stile rotten

Bottom sash ok

Top sash ok

Painted shut

\* full refurb. New parting beads, new staff beads and re cord.

Full Cill replacement with outer face and pulley stiles.

Top and bottom Sash in ok condition can be sanded down and decorated.

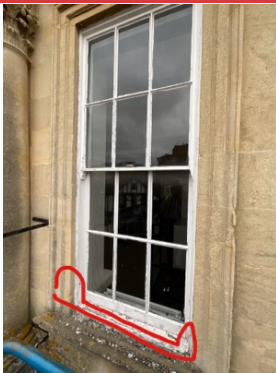
### **WE17 1ST FLOOR**

Cill and pulley stile rotten

Bottom rotten across bottom rail and up stiles

Top sash ok

Painted shut

\* full refurb. New parting beads, new staff beads and re cord.

Full Cill replacement with outer face and pulley stiles.

New bottom sash installed into existing frame

Top in ok condition can be sanded down and decorated.

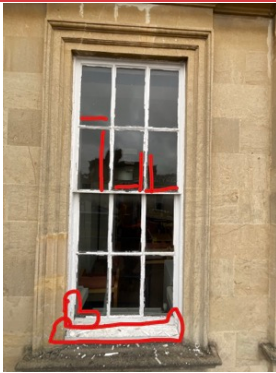
### **WE18 1ST FLOOR**

Cill and pulley stile rotten

Bottom sash ok

Top sash ok

Painted shut

\* full refurb. New parting beads, new staff beads and re cord.

Full Cill replacement with outer face and pulley stiles.

Top and bottom Sash in ok condition can be sanded down and decorated.

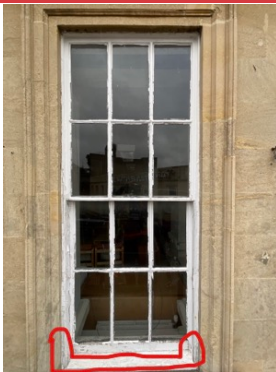
### **WE19 1ST FLOOR**

Cill and pulley stile rotten

Bottom rotten across bottom rail and up stiles

Top sash ok

Putty missing from top sash

Painted shut

\* full refurb. New parting beads, new staff beads and re cord.

Full Cill replacement with outer face and pulley stiles.

New bottom sash installed into existing frame

Putty repairs upto 1000mm

Top in ok condition can be sanded down and decorated.

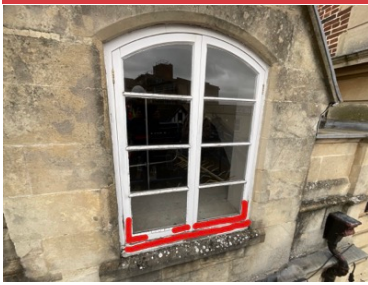
### **WE20 1ST FLOOR**

Cill and pulley stile rotten

Bottom sash ok

Top sash ok

Painted shut

\* full refurb. New parting beads, new staff beads and re cord.

Full Cill replacement with outer face and pulley stiles.

Top and bottom Sash in ok condition can be sanded down and decorated.

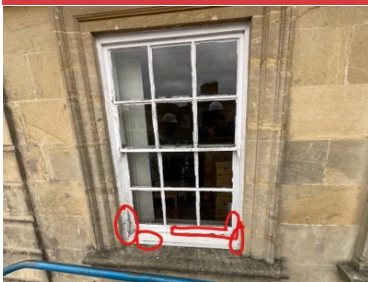
### **WE21. 2ND FLOOR**

Bottom rail on both casements rotten

Stiles rotten

Cill and lower jambs of main frame rotten.

Sub cill rotten

\* option 1 - manufacture 2 x new casements. Installed into exiting frame. New cill section and sub cill.

\* option 2 - remove casements and take back to shop to restore rotten sections.

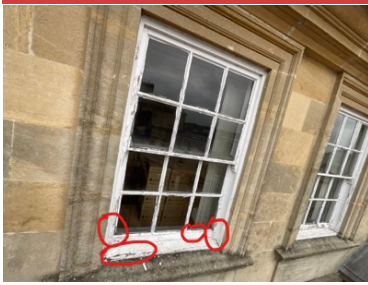
### **WE22 2ND FLOOR**

Cill and pulley stile rotten

Bottom rail and stiles on bottom sash rotten

Top sash ok

Painted shut

\* full refurb. New parting beads, new staff beads and re cord.

Full Cill replacement with outer face and pulley stiles.

New bottom sash installed into existing frame

Top Sash in ok condition can be sanded down and decorated.

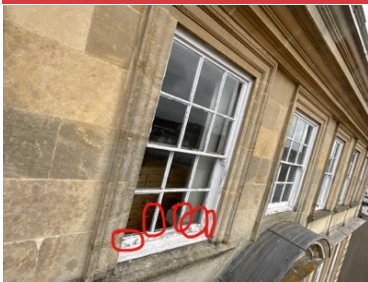
### **WE23 2ND FLOOR**

Cill and pulley stile rotten

Bottom rail and stiles on bottom sash rotten

Top sash ok

Painted shut

\* full refurb. New parting beads, new staff beads and re cord.

Full Cill replacement with outer face and pulley stiles.

New bottom sash installed into existing frame

Top Sash in ok condition can be sanded down and decorated.

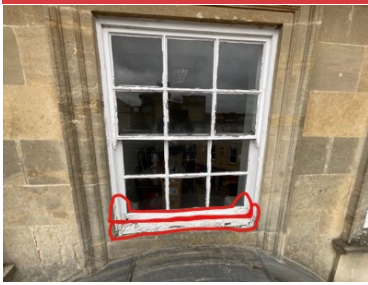
### **WE24 2ND FLOOR**

Outer face and pulley stile rotten possible cill

Bottom rail and stiles on bottom sash rotten

Glazing bars on bottom sash rotten

Top sash ok

Painted shut

\* full refurb. New parting beads, new staff beads and re cord.

Full Cill replacement with outer face and pulley stiles.

New bottom sash installed into existing frame

Top Sash in ok condition can be sanded down and decorated.

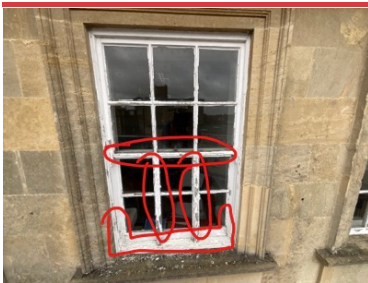
### **WE25 2ND FLOOR**

Cill and pulley stile rotten

Bottom rail and stiles on bottom sash rotten

Top sash ok

Painted shut

\* full refurb. New parting beads, new staff beads and re cord.

Full Cill replacement with outer face and pulley stiles.

New bottom sash installed into existing frame

Top Sash in ok condition can be sanded down and decorated.

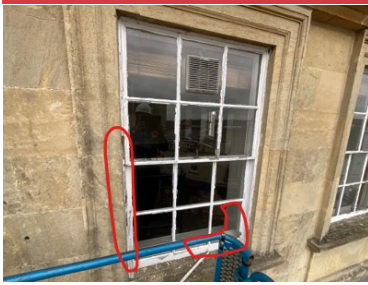
### **WE26 2ND FLOOR**

Cill outer face and pulley stile rotten

Bottom rail and stiles on bottom sash rotten

Top sash rotten across meeting rail.

Struts fitted under top sash to hold in position

Danger danger

Painted shut

\* full refurb. New parting beads, new staff beads and re cord.

Full Cill replacement with outer face and pulley stiles.

New bottom sash installed into existing frame

New top sash asap

Decs

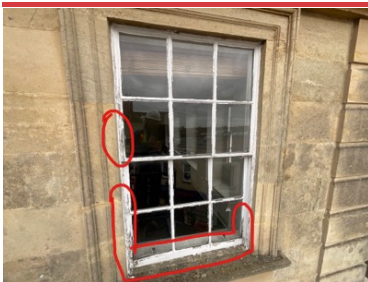
### **WE27 2ND FLOOR**

Cill outer face and pulley stile rotten

Bottom rail and stiles on bottom sash rotten

Top sash rotten up stiles

Existing box frame has no secure outer face and no cill section

Painted shut

\* full refurb. New parting beads, new staff beads and re cord.

Install Full Cill with outer face and pulley stiles.

New bottom sash installed into existing frame

New Top Sash to install.

Install new outer face around box.

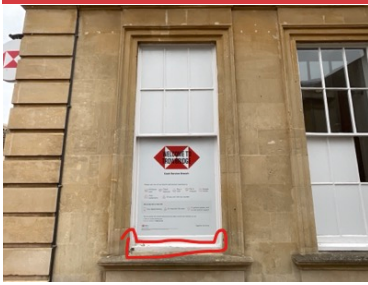
### **WE28 2ND FLOOR**

Cill outer face and pulley stile rotten

Bottom rail and stiles on bottom sash rotten

Top sash rotten up stiles

Existing box frame has no secure outer face and no cill section

Painted shut

\* full refurb. New parting beads, new staff beads and re cord.

Install Full Cill with outer face and pulley stiles.

New bottom sash installed into existing frame

New Top Sash to install.

Install new outer face around box.

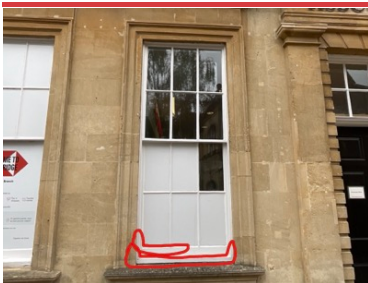
### **WN01 GR FLOOR**

Cill area rotten

Bottom sash rotten across bottom rail and stiles

Top sash ok

Painted shut

\* full refurb. New parting beads, new staff beads and re cord.

New bottom sash

Install new cill outer face and pulley stile

Top sash in ok condition can be sanded down and decorated.

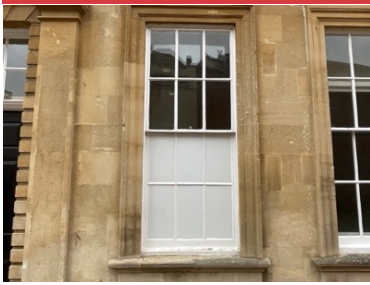
### **WN02 GR FLOOR**

Cill area rotten

Bottom sash rotten across bottom rail and stiles

Top sash ok

Painted shut

\* full refurb. New parting beads, new staff beads and re cord.

New bottom sash

Install new cill outer face and pulley stile

Top sash in ok condition can be sanded down and decorated.

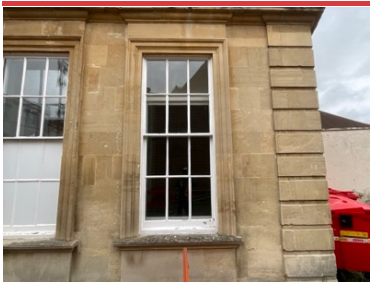
### **WN03 GR FLOOR**

Cill area rotten

Bottom sash rotten across bottom rail and stiles

Top sash rotten across meeting rails

Both sash's have been surface filled with 2 part filler

Painted shut

\* full refurb. New parting beads, new staff beads and re cord.

New bottom sash

New top sash

Install new cill outer face and pulley stile

Decs

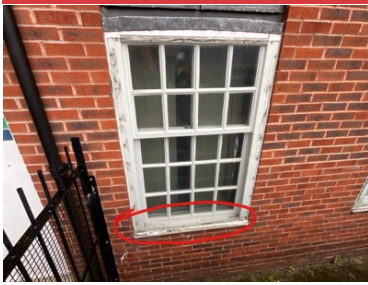
### **WN04 GR FLOOR**

Cill area rotten

Bottom sash rotten across bottom rail and stiles

Top sash ok

Painted shut

\* full refurb. New parting beads, new staff beads and re cord.

New bottom sash

Install new cill outer face and pulley stile

Top sash in ok condition can be sanded down and decorated.

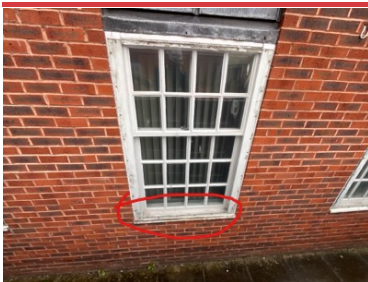
### **WN05 GR FLOOR**

Cill rotten

Bottom sash ok

Top sash ok

Painted shut

\* full refurb. New parting beads, new staff beads and re cord.

Refurb bottom sash

Refurb top sash

Full cill replacement

Decoration

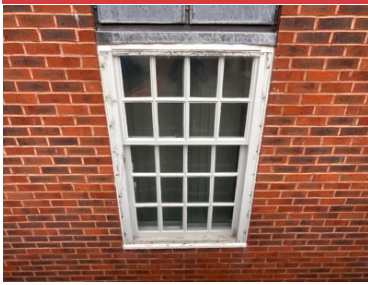
### **WN06 GR FLOOR**

Cill rotten

Bottom sash ok

Top sash ok

Painted shut

\* full refurb. New parting beads, new staff beads and re cord.

Refurb bottom sash

Refurb top sash

New cill section

Decoration

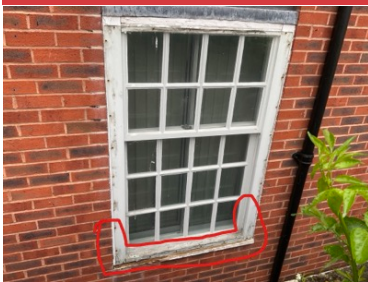
### **WN07 GR FLOOR**

Cill ok  
Bottom sash ok  
Top sash ok  
Painted shut

\* full refurb. New parting beads, new staff beads and re cord.

Refurb bottom sash  
Refurb top sash  
Decoration

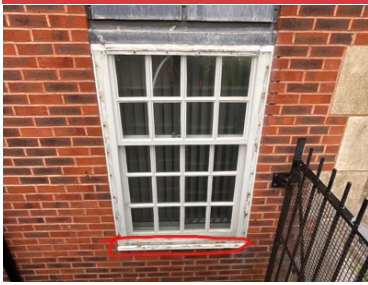
### **WN08 GR FLOOR**

Cill rotten  
Bottom sash ok  
Top sash ok  
Painted shut

\* full refurb. New parting beads, new staff beads and re cord.

Refurb bottom sash  
Refurb top sash  
Install new cill section  
Decoration

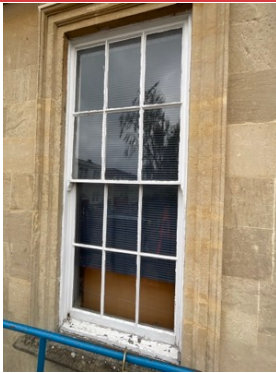
### **WN10 1ST FLOOR**

Cill area rotten

Bottom sash rotten across bottom rail and stiles

Top sash ok

Painted shut

\* full refurb. New parting beads, new staff beads and re cord.

New bottom sash

Install new cill outer face and pulley stile

Top sash in ok condition can be sanded down and decorated.

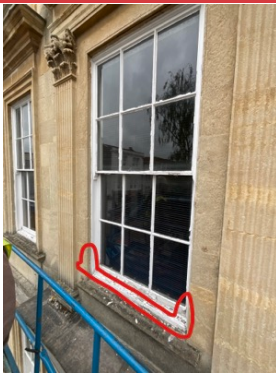
### **WN11 1ST FLOOR**

Cill area rotten

Bottom sash rotten across bottom rail and stiles

Top sash ok

Painted shut

\* full refurb. New parting beads, new staff beads and re cord.

New bottom sash

Install new cill outer face and pulley stile

Top sash in ok condition can be sanded down and decorated.

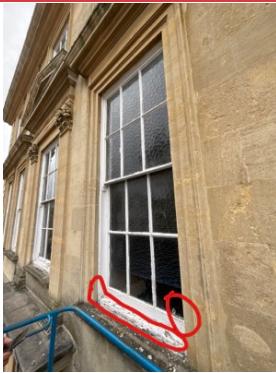
### **WN12 1ST FLOOR**

Cill pulley stile and outer face rotten

Bottom sash ok

Top sash ok

Painted shut

\* full refurb. New parting beads, new staff beads and re cord.

Full cill replacement pulley stile and outer face

Top and bottom Sash in ok condition can be sanded down and decorated.

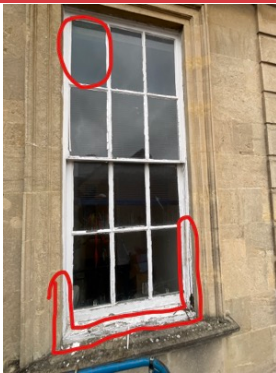
### **WN13 1ST FLOOR**

Cill area rotten

Bottom sash rotten across bottom rail and stiles

Top sash ok

Painted shut

\* full refurb. New parting beads, new staff beads and re cord.

New bottom sash

Install new cill outer face and pulley stile

Top sash in ok condition can be sanded down and decorated.

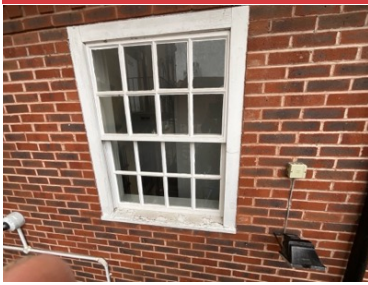
### **WN14 1ST FLOOR**

Cill pulley stile and outer face rotten

Broken pane of glass top rhs

Bottom sash ok

Top sash ok

Painted shut

\* full refurb. New parting beads, new staff beads and re cord.

Full cill pulley stile and outer face replacement

Top and bottom Sash in ok condition can be sanded down and decorated.

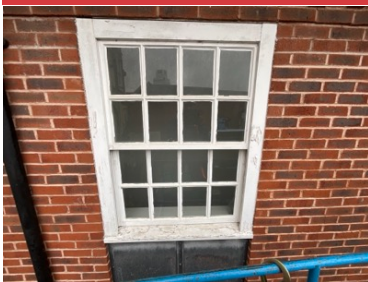
### **WN15 1ST FLOOR**

Cill ok

Bottom sash ok

Top sash ok

Painted shut

\* full refurb. New parting beads, new staff beads and re cord.

Refurb bottom sash

Refurb top sash

Decoration

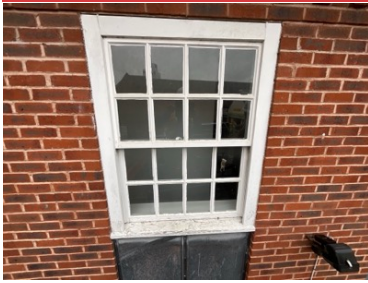
### **WN16 1ST FLOOR**

Cill ok

Bottom sash ok

Top sash ok

Painted shut

\* full refurb. New parting beads, new staff beads and re cord.

Refurb bottom sash

Refurb top sash

Decoration

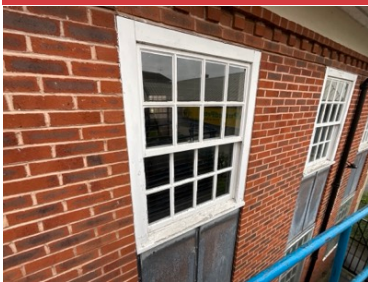
### **WN17 1ST FLOOR**

Cill ok

Bottom sash ok

Top sash ok

Painted shut

\* full refurb. New parting beads, new staff beads and re cord.

Refurb bottom sash

Refurb top sash

Decoration

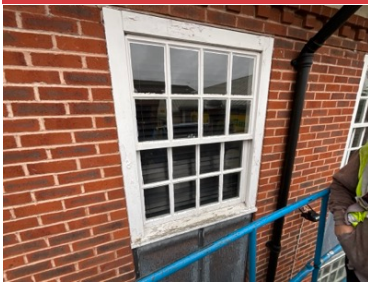
### **WN18 1ST FLOOR**

Cill ok

Bottom sash ok

Top sash ok

Painted shut

\* full refurb. New parting beads, new staff beads and re cord.

Refurb bottom sash

Refurb top sash

Decoration

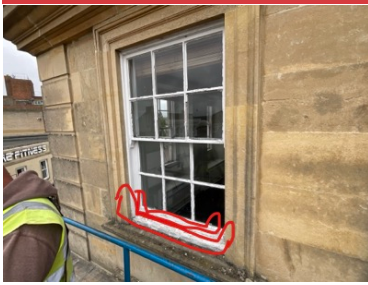
### **WN20 1ST FLOOR**

Cill area small rotten section

Bottom sash ok

Top sash ok

Painted shut

\* full refurb. New parting beads, new staff beads and re cord.

Refurb bottom sash

Refurb top sash

300mm slice repair

Decoration

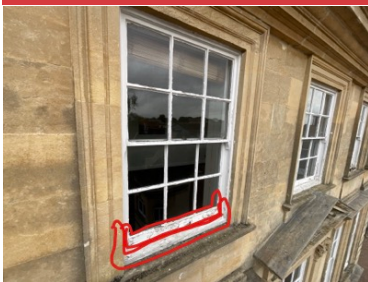
### **WN21 2ND FLOOR**

Cill area rotten original rotten front of cill cut away and a piece of 4x2 has been butted up to cover. No chamfer etc

Bottom sash rotten across bottom rail and stiles

Top sash ok

Painted shut

\* full refurb. New parting beads, new staff beads and re cord.

New bottom sash

Install new cill outer face and pulley stile

Top sash in ok condition can be sanded down and decorated.

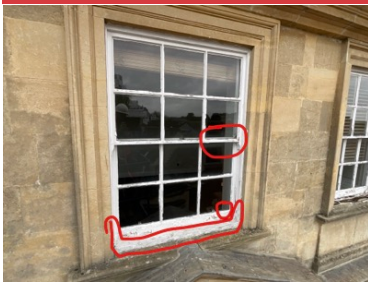
### **WN22 2ND FLOOR**

Cill area rotten original rotten front of cill cut away and a piece of 4x2 has been butted up to cover. No chamfer etc

Bottom sash rotten across bottom rail and stiles

Top sash ok

Painted shut

\* full refurb. New parting beads, new staff beads and re cord.

New bottom sash

Install new cill outer face and pulley stile

Top sash in ok condition can be sanded down and decorated.
