# TROWBRIDGE HSBC

Facade Survey

Monday 13 May 2024

Henley Restoration And Remedials Ltd For ISG

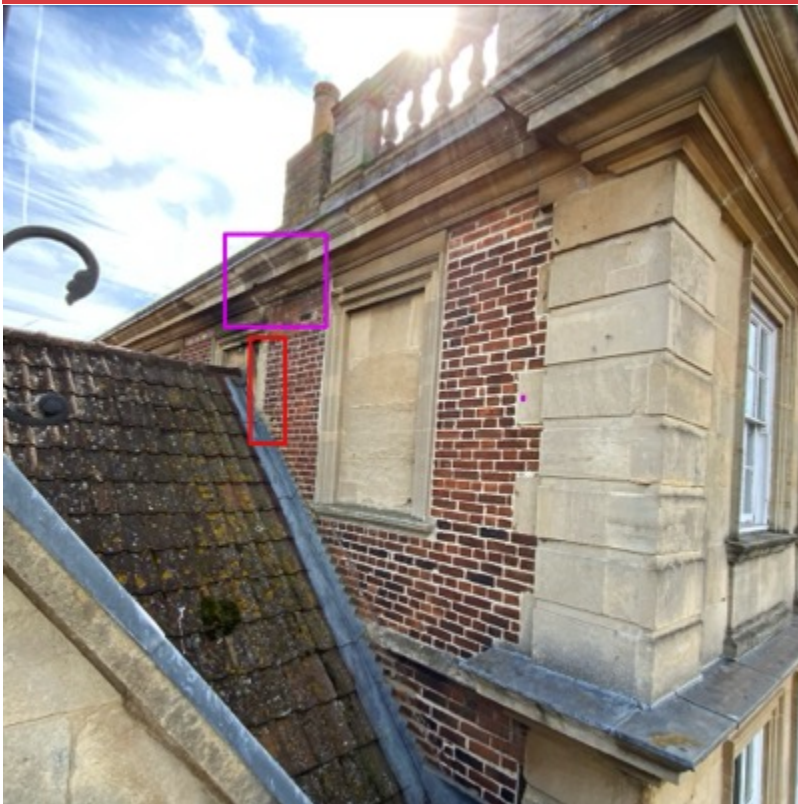
Note some loose and friable stone to upper cornice moulded detail. Repair to be quantified upon scaffold access.

Note some loss of stone detail to window surround. Repair to be quantified upon scaffold access.

Stone infills to “blind” windows. Are these being kept as is?

Note some vegetation seen within upper box gutter. Do you want this removing?

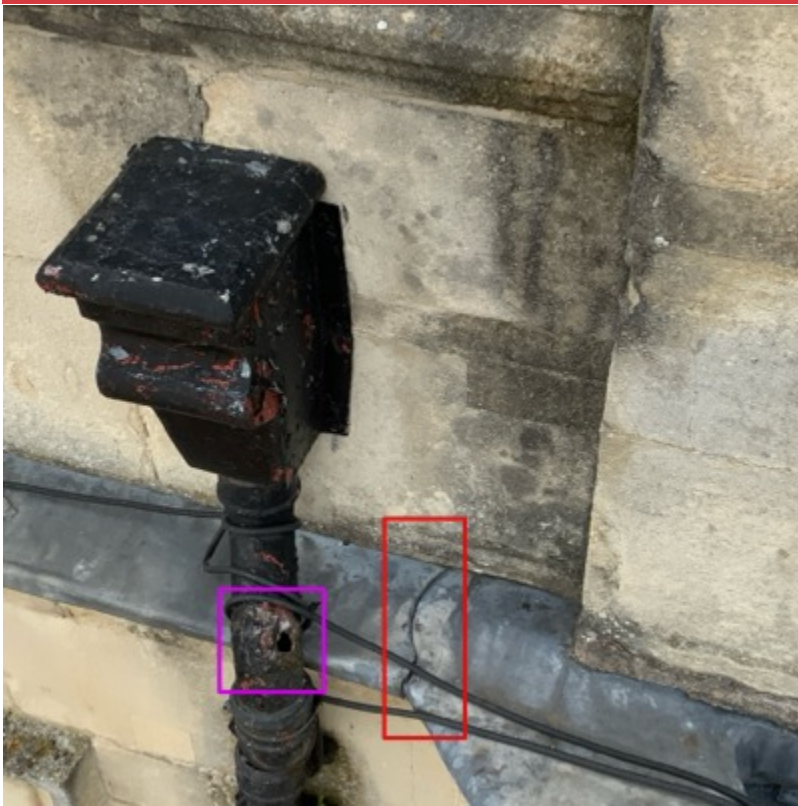
2.1 - Hole seen in 45 degree bend  
100mm diameter pipe. Allow to  
replace section.

2.2 - Allow to repair/replace  
oversized lead flashing.

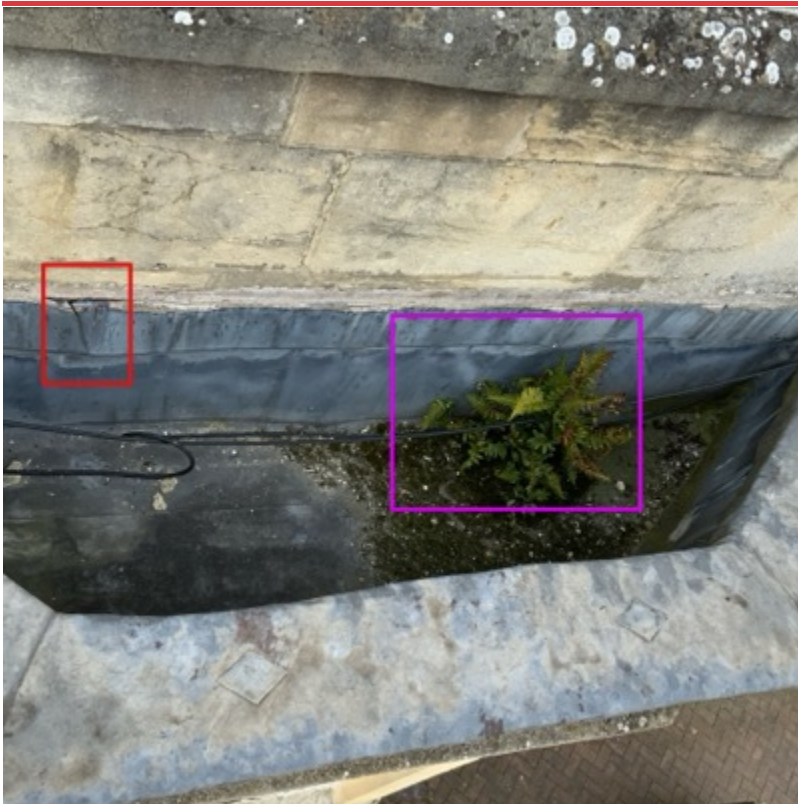
2.3 - Split seen in lead flashing.  
Allow to replace over sized  
flashing.

2.4 - Allow to clear out vegetation  
from top of the bay window

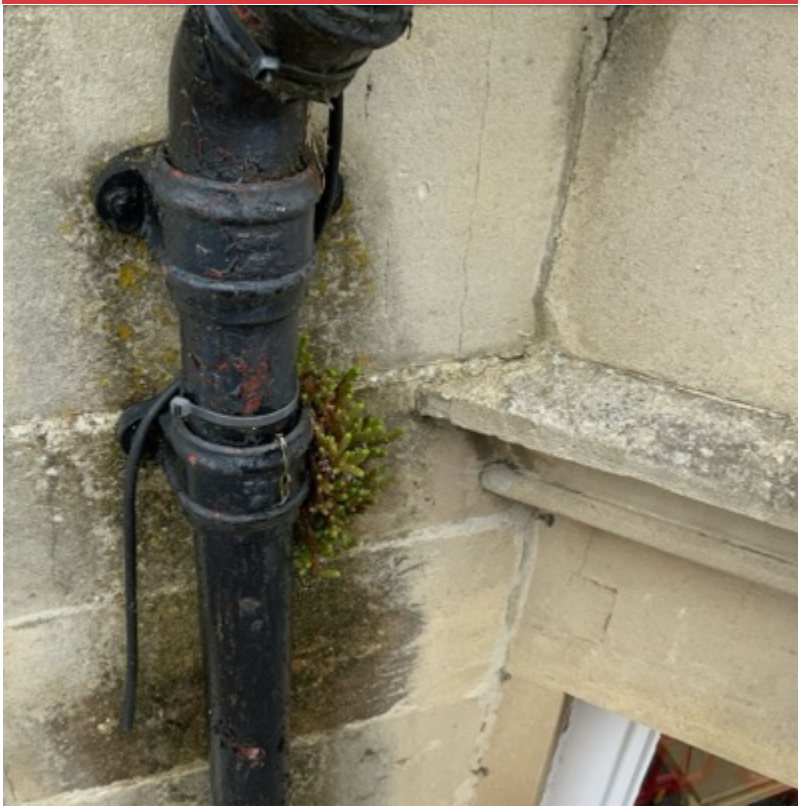
2.7 - Remove vegetation and apply bio cide. Downpipe doesn't look or feel damaged below the 45 swan neck although the facade shows signs of damp and moss

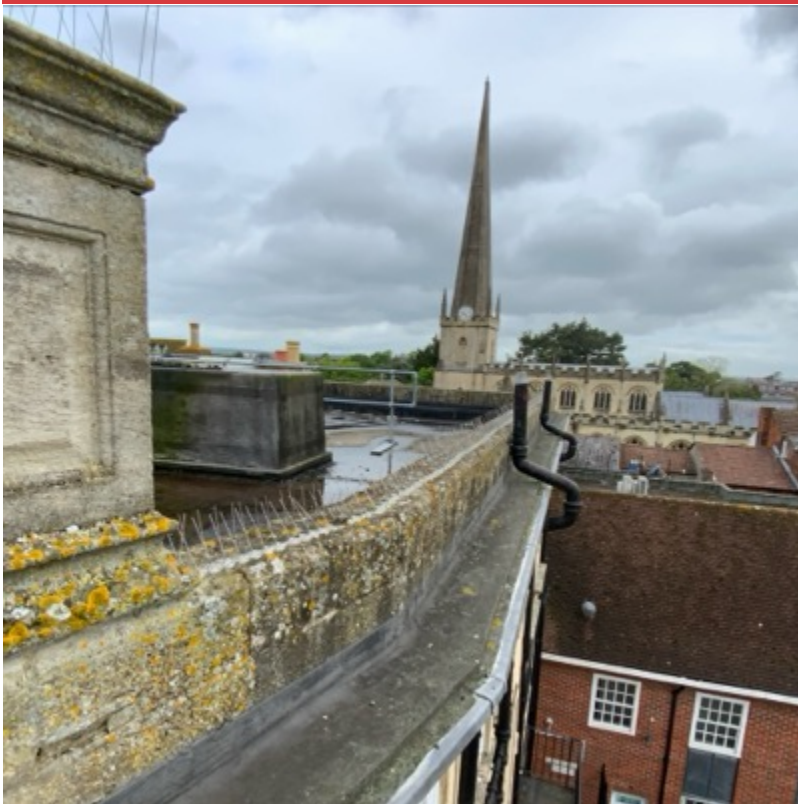
Missing parapet balustrade detail as shown on the drawing. Does this need to be detailed, manufactured and installed?

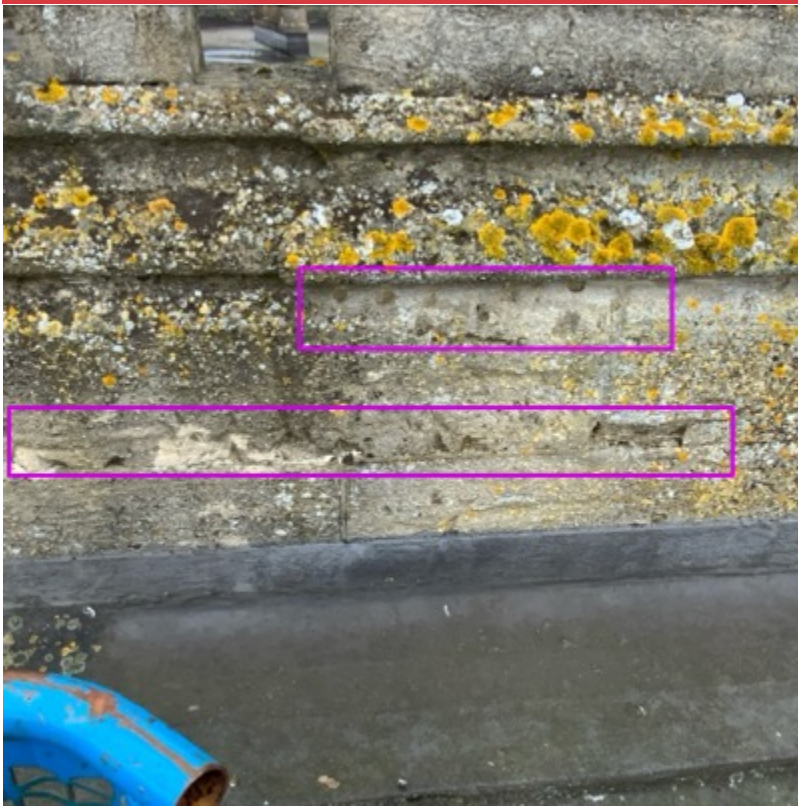
0.3 - Minor pitting to face of stone.  
Allow to mortar repair. Allow 0.900  
x 0.075 x 0.025

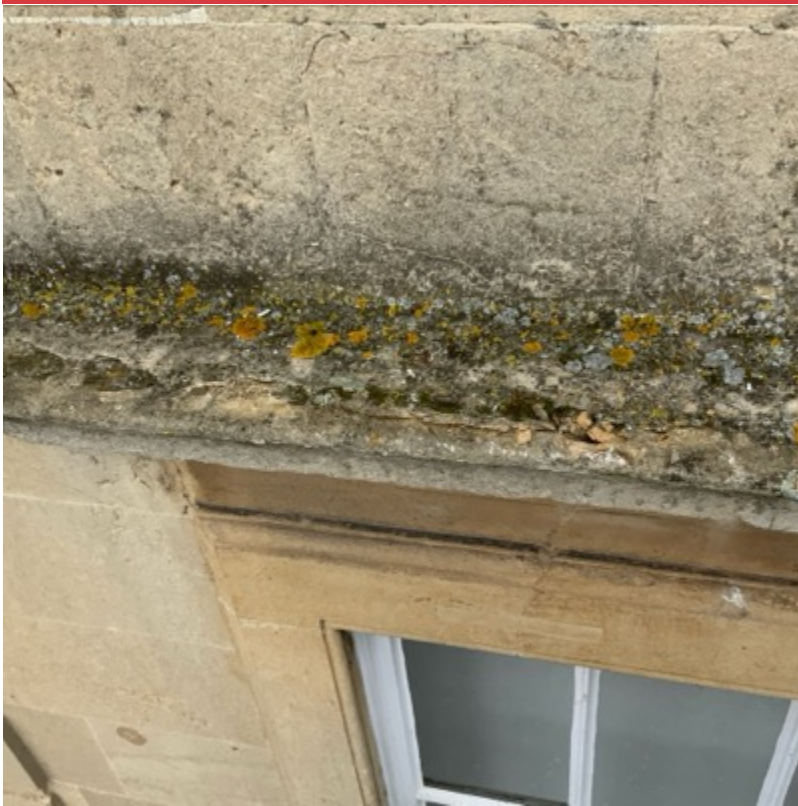
2.1 - Allow to detail and indent upper sky surface cornice projection above window as loose and defective. Stone removed for safety concerns. Allow 0.900 x 0.100 x 0.120

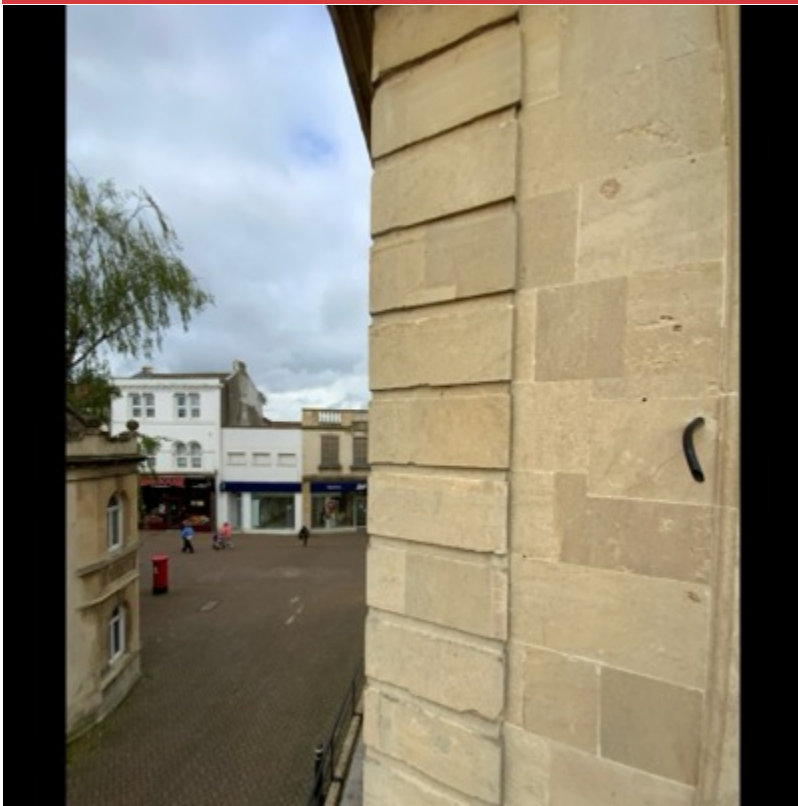
Note - Detail lost to quoin stones arises to LHS of the building. Previous indents and defrassing carried out. Do these arises need repair or indents? Allow 8nr quoins to be detailed and repaired/indented once the facade scaffolded and the building fabric is cleaned.

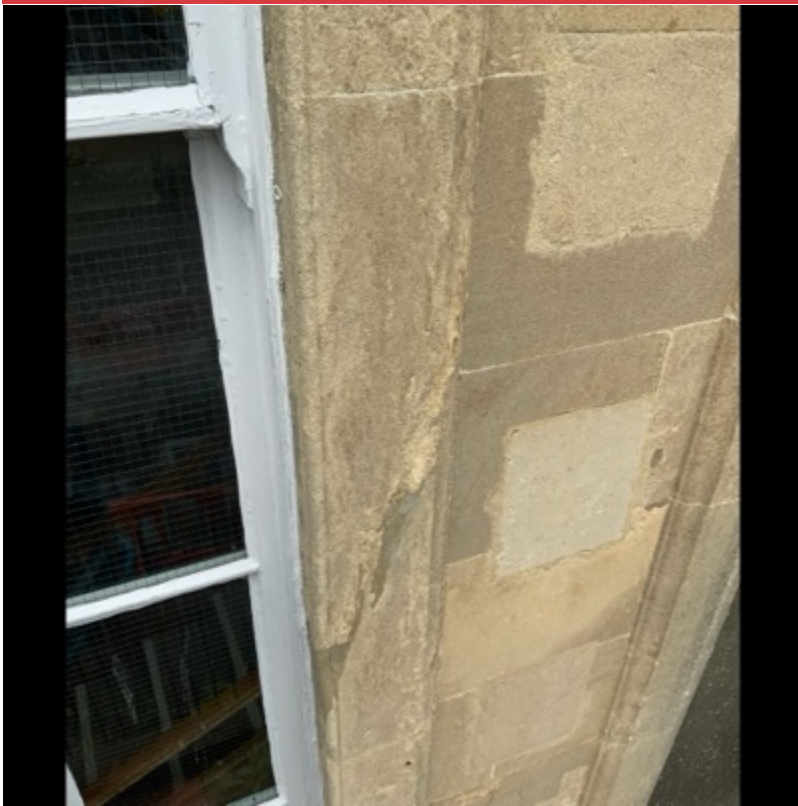
2.6 - Allow to indent RHS window reveal section where previous cementitious repair has failed. Allow 0.920 x 0.220 x 0.065

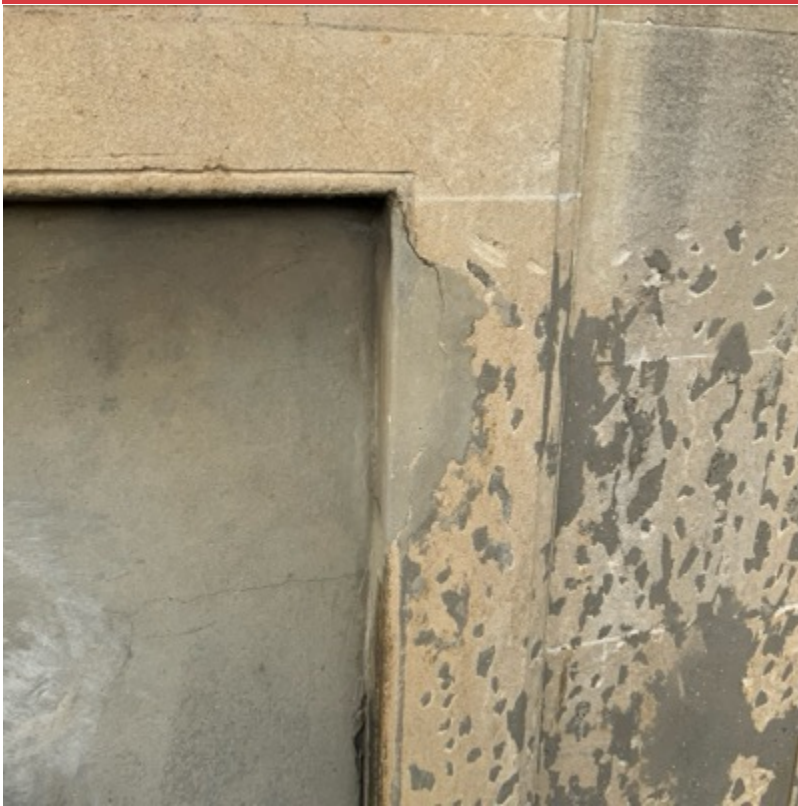
Note - Lots of cementitious repairs  
carried out around this location.  
Does this want to be picked up for  
repair/tinting or is the client happy  
with this being left as is?

2.9 - Allow to indent with new stone  
LHS blind window. Allow 0.350 x  
0.220 x 0.060

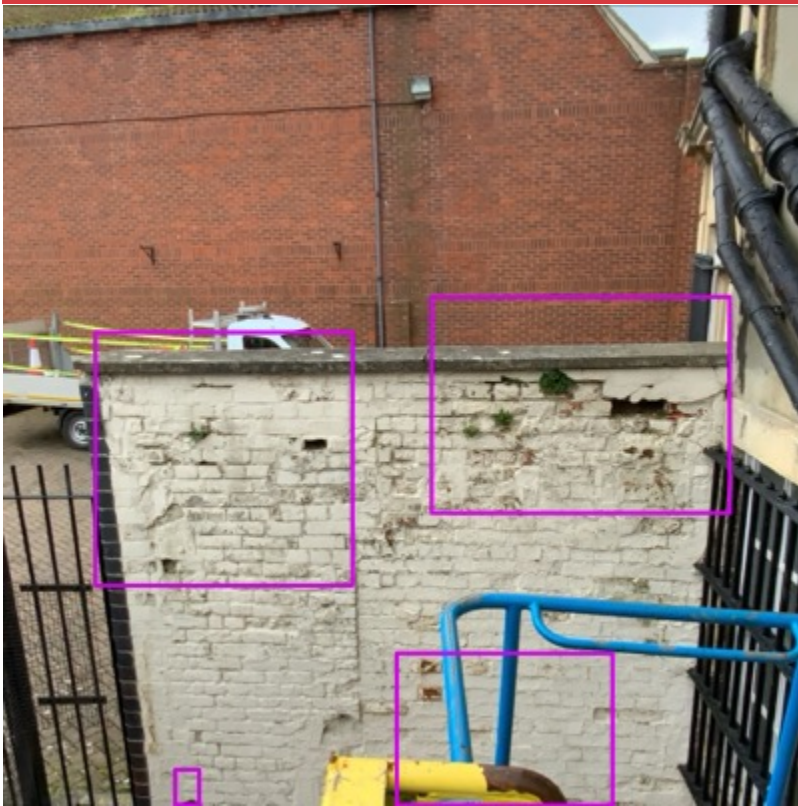
3.3 - Not picked up in drawings or scope.

Allow 2.5 m2 of brickwork re-build across the wall (if required).

Allow 6m2 of re decoration in masonry paint (if required).

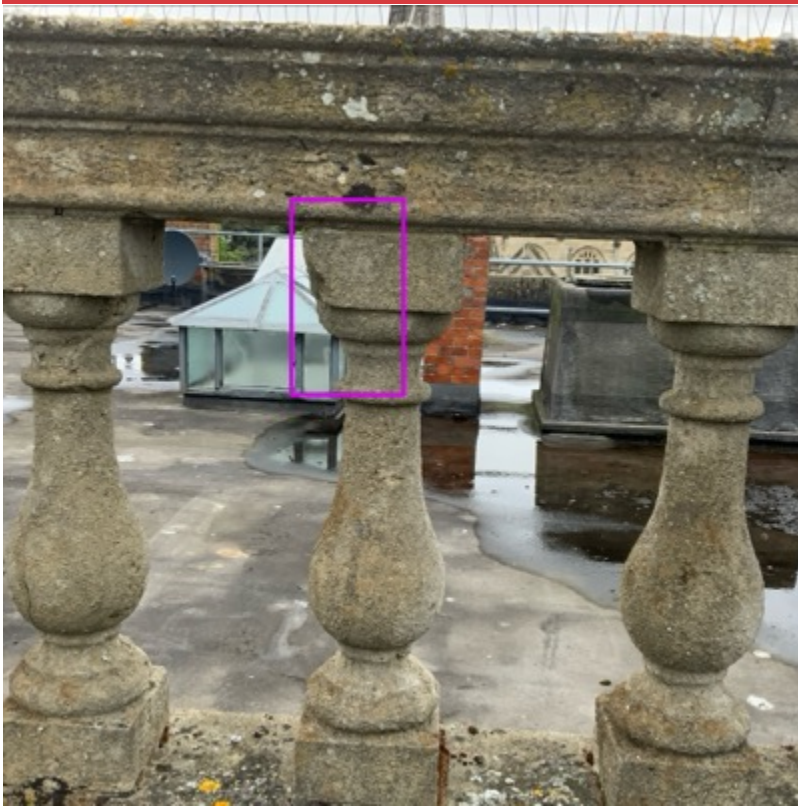
0.3 - Loss of upper corner to balustrade bottle. Looks safe currently.
