# PLAN IT JUPITER

STRUCTURAL  
DESIGN & DETAIL

**Re: Easton Cottage, Water Street, Berwick St John, Shaftesbury, SP7 0HS.**

We have been requested to provide a brief appraisal and opinion of the existing remaining dwelling, and potential solutions related to footings and inherent stability issues encountered.

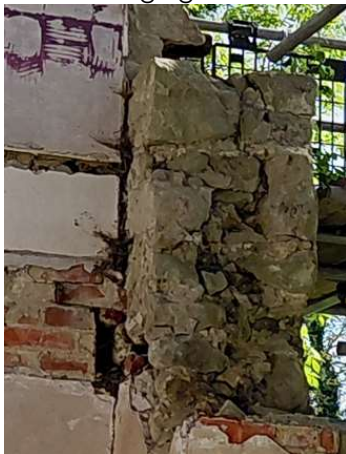
The walls appear solid, although built with inner and outer stone and rubble infill. The walls are not considered to be adequately bonded and inherent to delamination and movement particularly where bridging stone have flaws or liable to fracturing where settlement occurs.

The lack of bond is a concern, with obvious signs of damage and debonding, as this typical exposed section clearly shows and, in our opinion, any substantial re-modelling would be reliant upon an inherent defective wall construction for stability.

Typically, with this type of wall construction, mortar becomes friable and moisture penetration will tend to destabilize the wall with progressive bulging likely where migration of the rubble settles. The inner and outer leaves will tend to move apart.

In our opinion, significant amount of retro tying in and rebuilding would be required to the remaining walls. As the section indicates, inner and outer masonry do not tend to have a common level bed joint, and as such installing Helibar or similar ties may prove extremely difficult.

Considering all of the above, We conclude that the existing is not fit for purpose. Our recommendation is that the most appropriate action would be to demolish the existing remaining walls and salvage materials for any new building where appropriate.

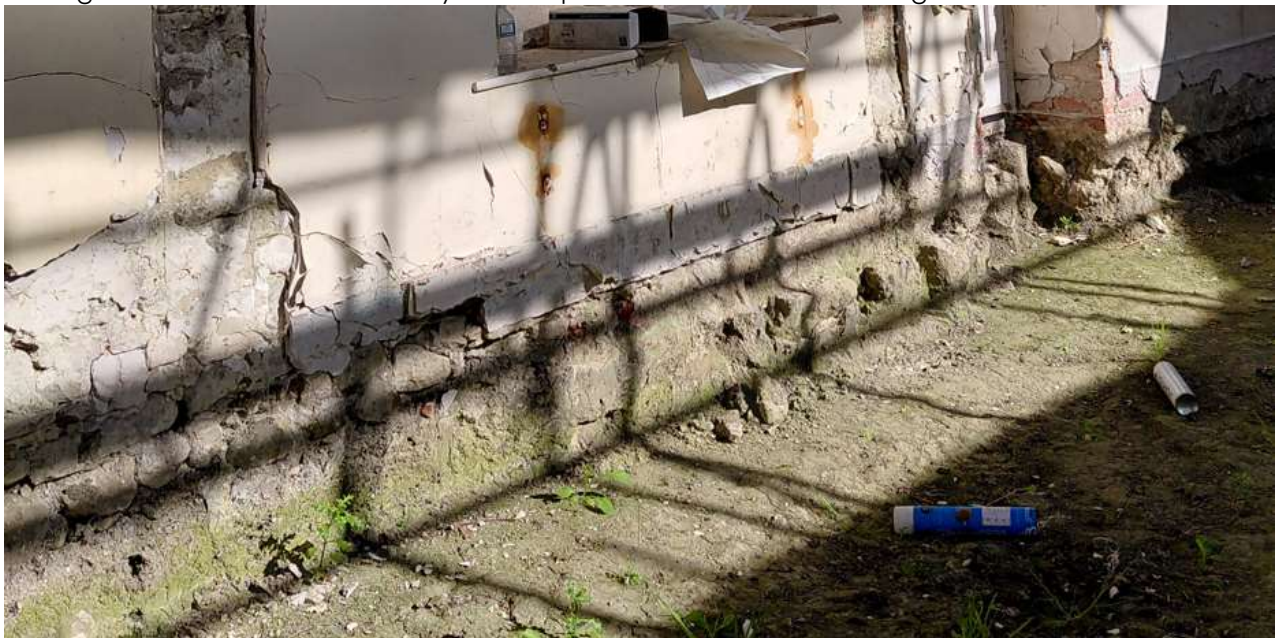
With respect to footings, the walls themselves appear to be built directly from ground with no obvious footing evident. The walls have very shallow penetration below external ground levels.

The topography of the site also suggests that the back of the property is built onto probably natural undisturbed material, but the front has most probably been built up, forming a typical plateau associated with cut and fill.

The soil appears to be a matrix consisting of topsoil and organic material with very silty soil. This we believe lies over weak saturated clay.

Although dry at the time of our visit, we have been advised that the contractor inserted a pike below footing level, which was inserted by hand very easily, when the ground was wet.

We therefore conclude that if the existing walls were to be retained, then considerable amount of underpinning would be needed. The extent and depth of any underpinning would be dependent upon any geotechnical advice, but we would not be surprised if the advise was deep and even piling considered as an option. The wall construction, being of a rubble form, does not lend itself easily to traditional underpinning.

New building to have new foundations with we anticipate a suspended ground floor. New foundations, potentially piles, but only following the advice of Geotechnical Engineer.
