## Off Mains Drainage Survey Report Prepared For:

Charlton Manor, Charlton St Peter  
Pewsey  
SN9 6EU

**Date of Survey:** 09/12/2024

## Drainage Survey

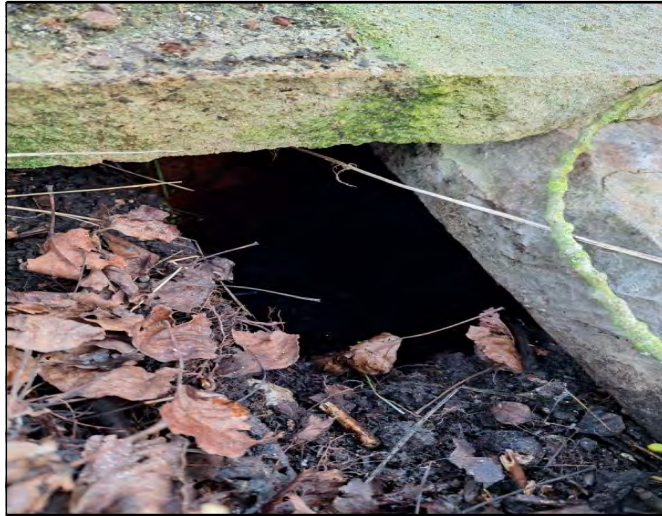
**Photograph of the tank  
before the system was  
emptied:**

| <b>Overall condition of the tank:</b> | Poor |
| <b>Tank condition - please specify:</b> | Very old |

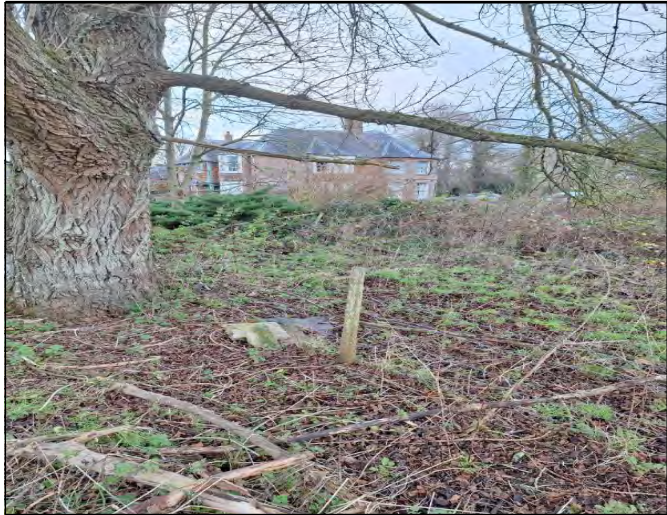
| Is the existing discharge functioning correctly? | No |
| Functionality of discharge - please specify: | Outlet pipe discharge into ground 6m from river |

No - Discharge onto ground at edge of woodland 6m from river bank

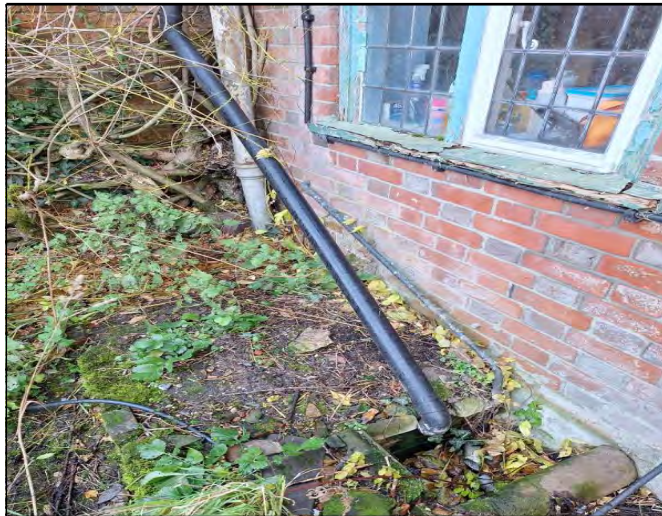
Photograph of dye test undertaken

| <b>Were there any cross connections found between the rainwater system and the foul system?</b> | Yes |
| <b>Where were the cross connections?</b> | FG2 has RW entering from downpipe |
| <b>Guidance on cross connections from rainwater system to the foul drainage:</b> | Cross connections from a rainwater system to a foul drainage system are not considered best practice and can hydraulically overload the system during periods of persistent or heavy rain fall. This can be a problem as it can raise the operating level within the tank, affecting the waste separation process which can ultimately lead to solid waste passing into the soakaway system. This can potentially cause it to fail prematurely. |

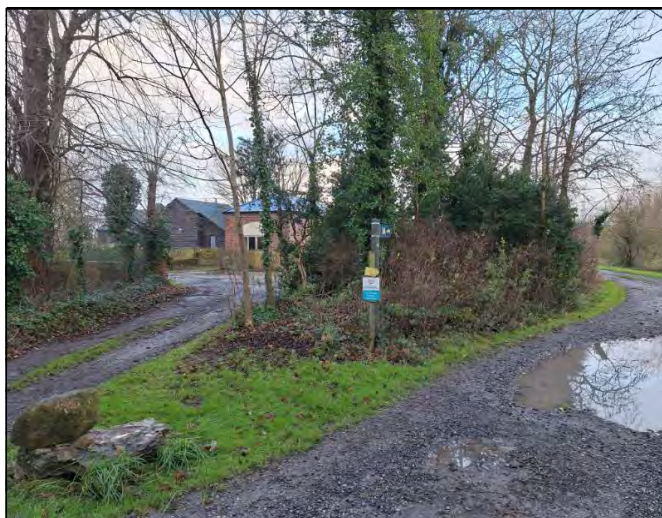
Additional photograph for the report:

route for access follows caravan access

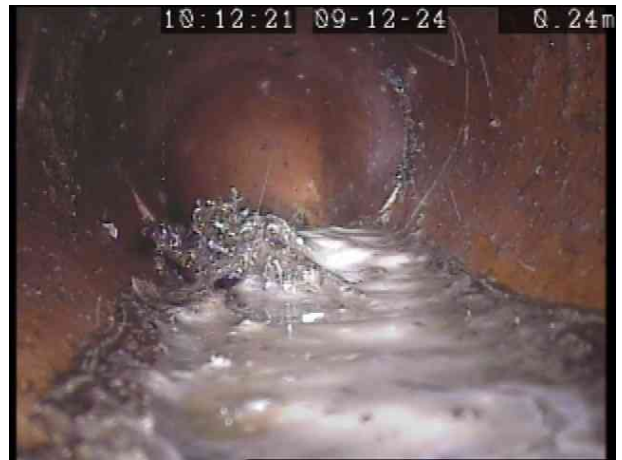
| Scale: | 1:50 | Position [m] | Code | Observation | MPEG | Photo | Grade |
|---|---|---|---|---|---|---|---|
| | | 0.24 | DE | Debris, other, 10% cross-sectional area loss: Sludge | 00:00:40 | FG1X_a46<br>6e43c-4f6<br>2-41f8-84e | 3 |

FG1X\_a466e43c-4f62-41f8-84e2-a58d6ec7e930\_20241211\_1  
24052\_375.jpg, 00:00:40, 0.24 m  
Debris, other, 10% cross-sectional area loss, Sludge

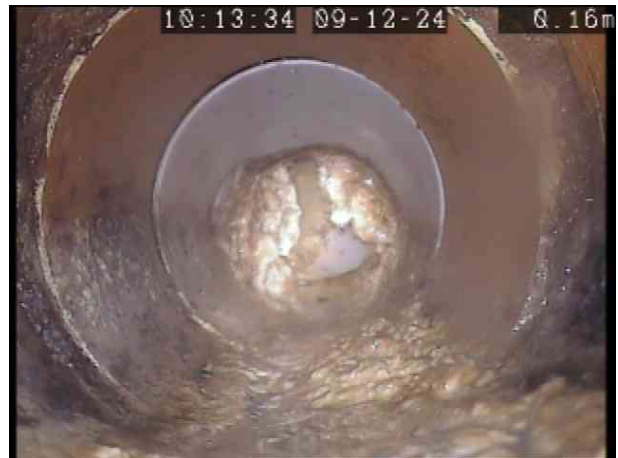
| Scale: | 1:50 | Position [m] | Code | Observation | MPEG | Photo | Grade |
|---|---|---|---|---|---|---|---|
| | | 0.16 | DEG | Debris, grease from 5 o'clock to 7 o'clock, 15% cross-sectional area loss | 00:00:14 | SVP1X_32<br>eb4c9d-ff2<br>6-42db-ad | 3 |

SVP1X\_32eb4c9d-ff26-42db-ad52-19f29558d6cb\_20241211\_124323\_505.jpg, 00:00:14, 0.16 m  
Debris, grease from 5 o'clock to 7 o'clock, 15% cross-sectional area loss

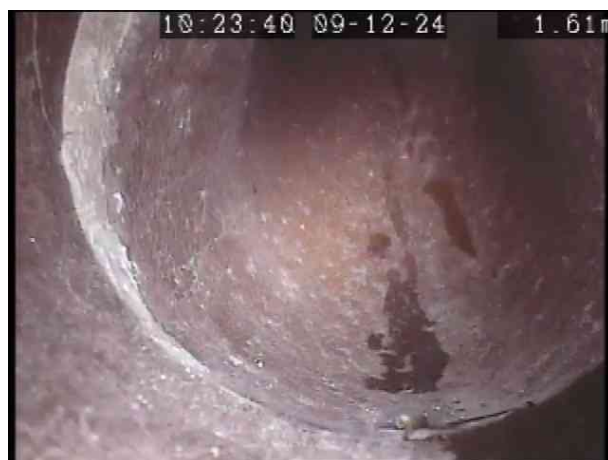
WCX\_68817590-9c3b-4920-bbbe-ad50cd0abec5\_20241211\_125303\_083.jpg, 00:00:22, 1.61 m  
Line of sewer deviates up, Rest bend
