# **STRUCTURAL INSPECTION REPORT**

Annes Cottage, Bishops Cannings

Visual Inspection of Rear Elevation Cracking and Structural Stability

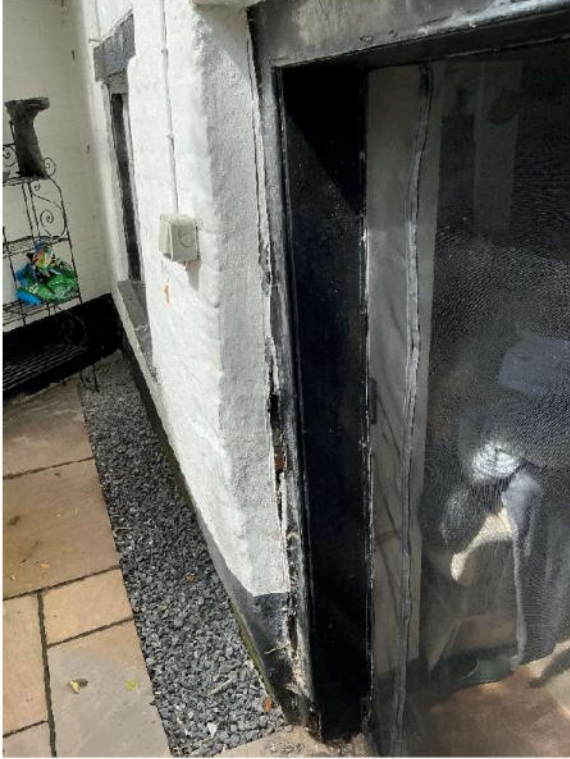
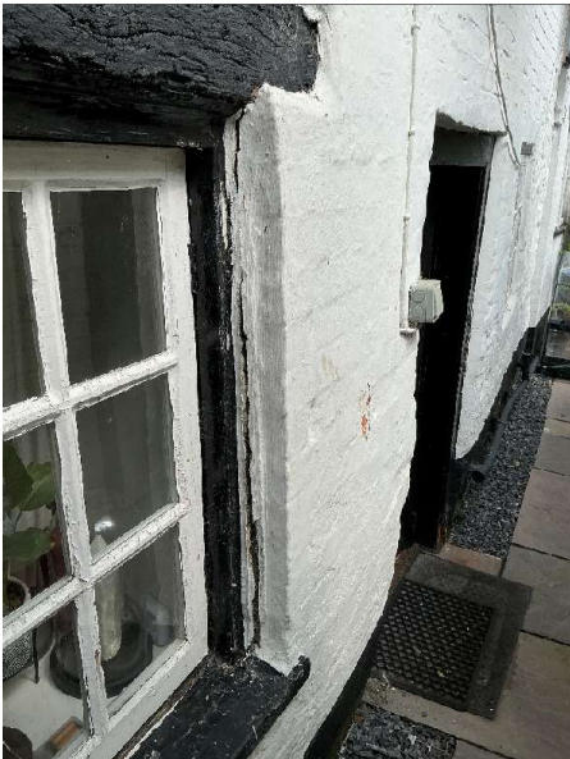
The external walls are approximately 500 mm thick and appear to be of cavity construction with rubble infill. The outer leaves of the wall panels between the door and windows have rotated about their base and bowed outwards by approximately 30 mm over the height of the door. The affected walls are now out of plumb by approximately 7 degrees, which has caused movement in the door and window frames.

We expect the foundations beneath these walls to be minimal at best.

There do not appear to be any effective lintels above the door and one of the windows.

In our opinion, these wall panels are at risk of collapse unless immediate remedial works are undertaken.

We recommend that the outer leaf of the affected wall panels, together with the areas beneath the windows, be dismantled and rebuilt on suitable foundations. New timber lintels of an appropriate specification should also be installed above the door and window. This opinion is based on a visual inspection only.
