4<sup>th</sup> June 2026

### 3 Northgate St, Gable Wall Repairs Design Statement

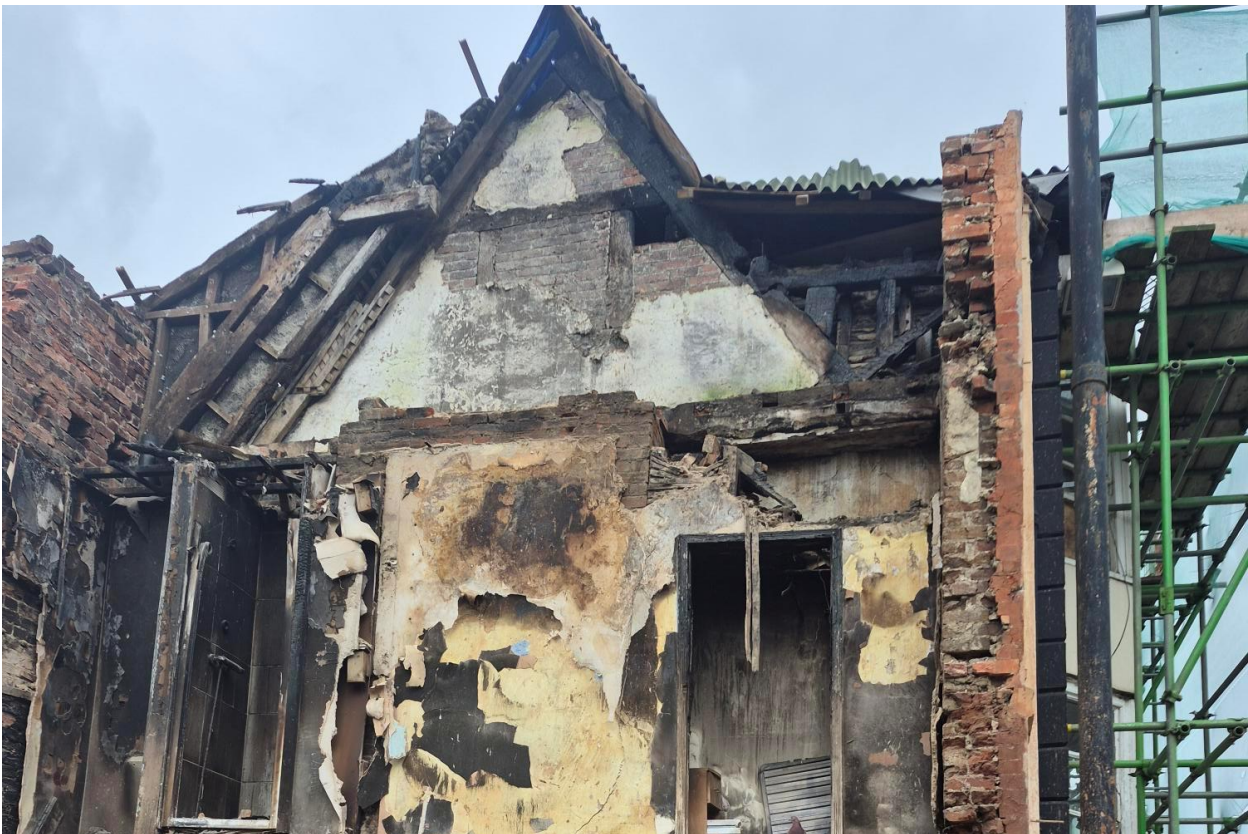
The demolition of No.2 Northgate Street has exposed the SE gable wall of No.3 Northgate Street and confirmed that the timber gable truss has been badly fire damaged. Based on a visual assessment, the proposed repair works include:

The fire damaged SE gable wall of No.3 Northgate Street following the demolition of No.2 Northgate Street.

- Splice repair to the western principal rafter
- Splice repair to the collar
- Replacement of the badly fire-damaged eastern principal rafter in oak
- Replacement of the badly fire-damaged timber stud work located to the east of the gable truss in softwood
