**Prepared by:** Esco trading Ltd

**Client:** Ed & Amy Shelton

**Address:** Knockdown Farm, Knockdown, Tetbury, GL8 8QY

# Infiltration Test Report

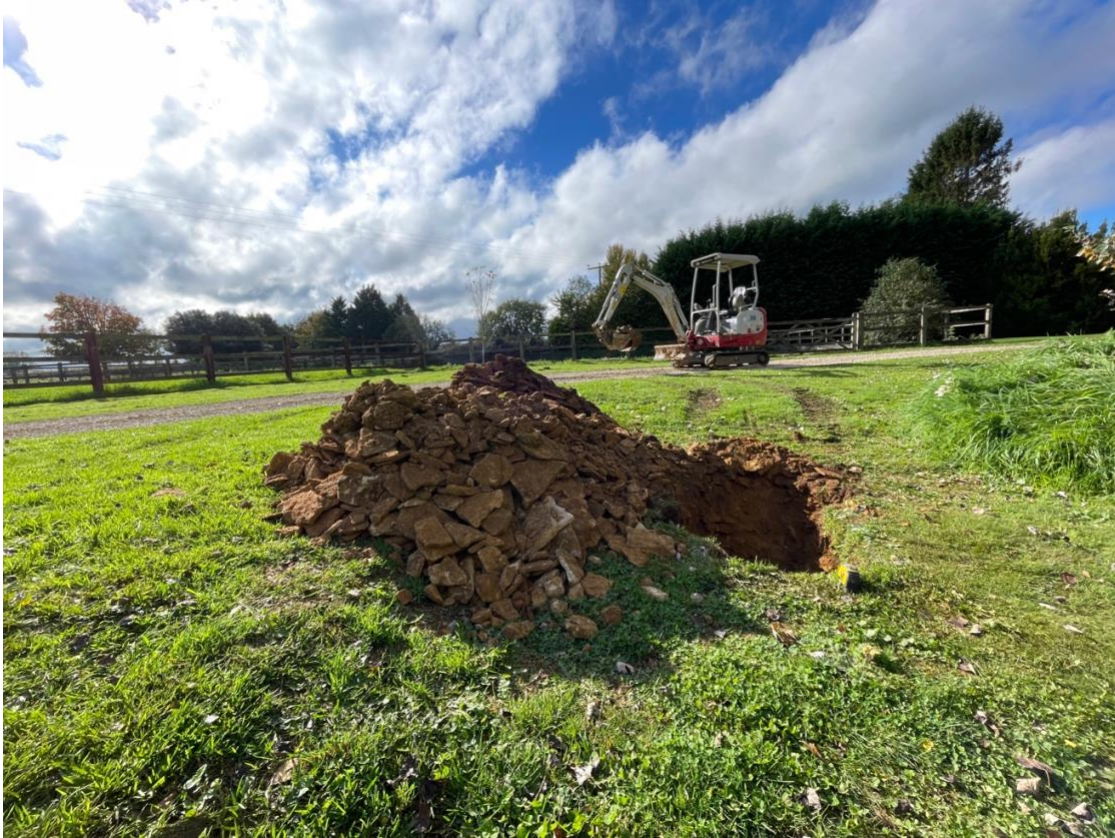
A trial pit was excavated by Pro Build Construction on 16 October 2025 at the proposed site at Knockdown Farm, Knockdown, Tetbury, GL8 8QY. The location was chosen as the lowest point on the proposed site ~0.5m lower than the surrounding soil.

Fig 2: Hole location at the lowest point on site

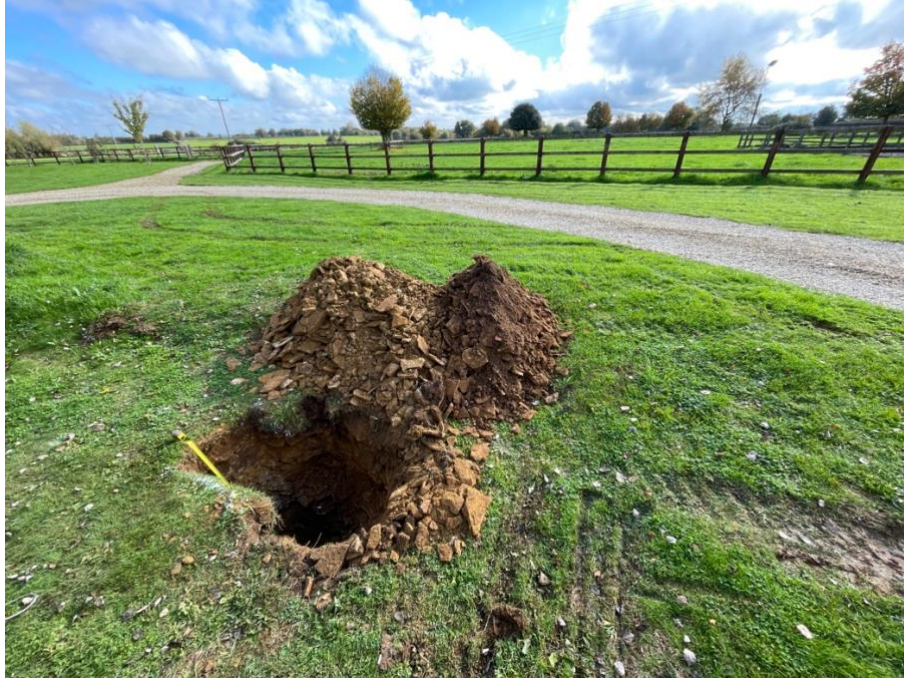
Fig 3: Hole location

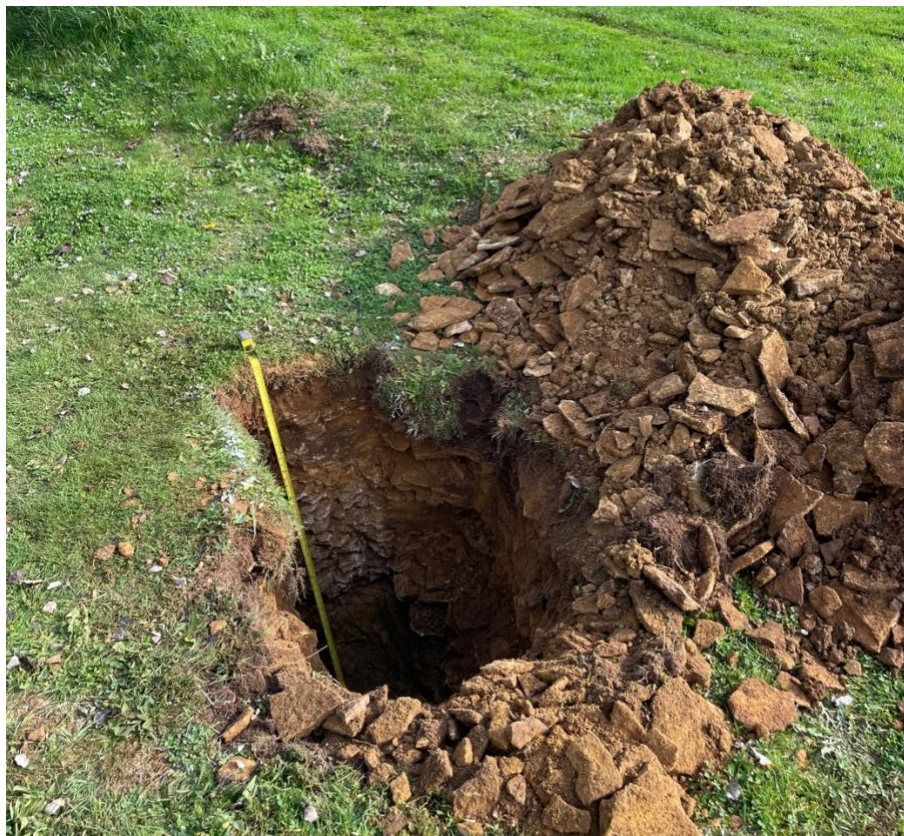
The excavation revealed a natural subsoil comprising weathered limestone with a mix of angular stone fragments and sandy clay fines, typical of Cotswold limestone-derived soils.

No water was observed on initial excavation.

Fig 4: Hole dimensions + Depth

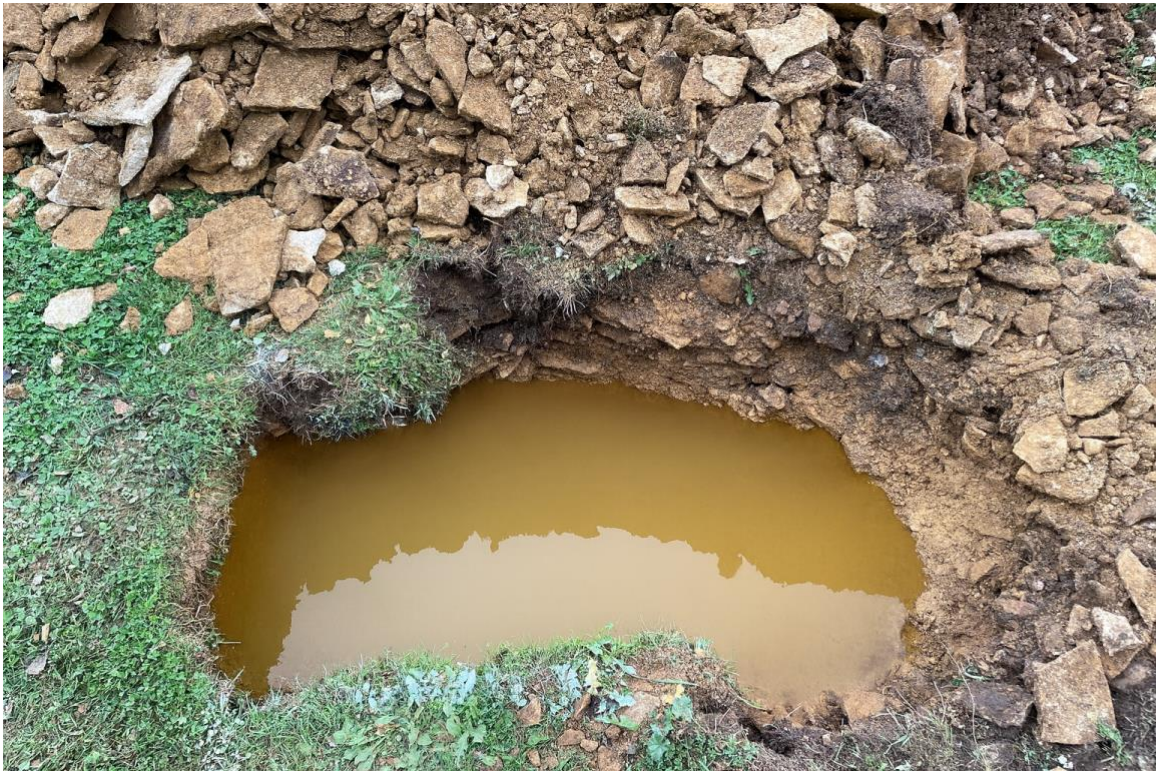
Fig 5: Hole After first fill

- The water level fell steadily over the test period, with no signs of perched or rising groundwater.
- At no point during the test was there evidence of water ingress into the pit from the surrounding soil.

The observed infiltration behaviour indicates that the site does not exhibit a high groundwater table within 2.0 m of the surface. The steady infiltration rate demonstrates that the surrounding soil is permeable enough to allow surface water to drain away naturally, thereby reducing the risk of localised flooding.
