## Design, Access and Heritage Statement

Lacock Abbey Dining Room

**Listed Building Application – May 2026**

**National Trust**

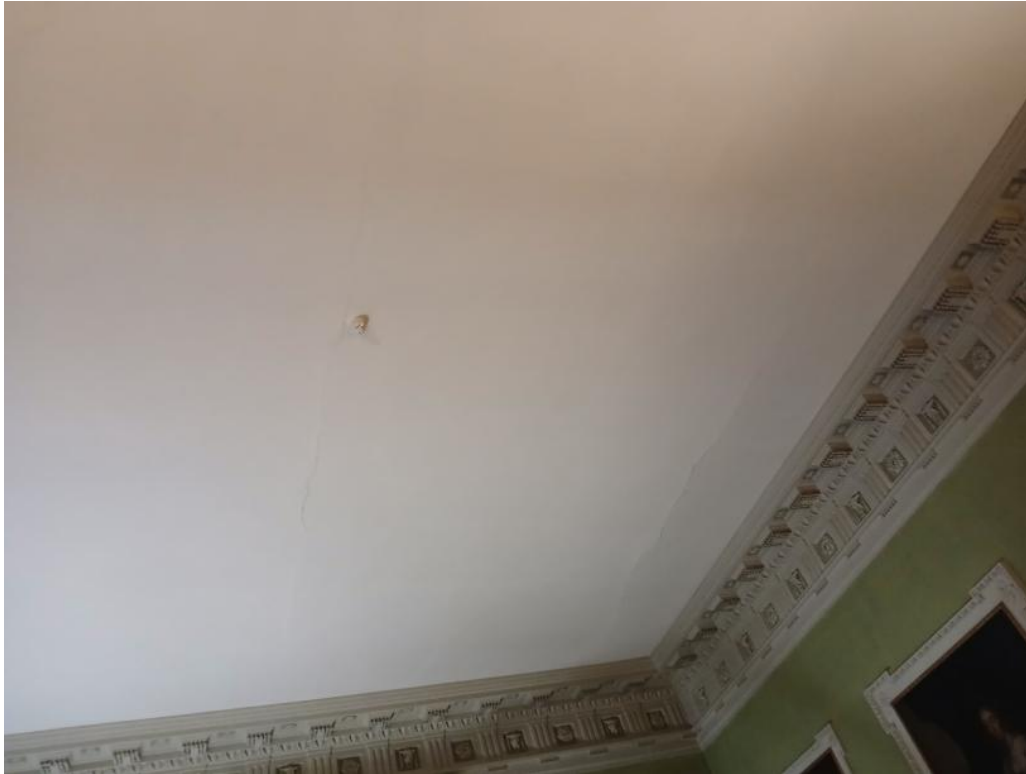
The ceiling in the dining room is showing two main cracks which have been increasing in severity.

The more significant crack is to the north (right hand side on the photo below). The other runs the full length of the centre of the room east to west.

Figure 1 - Current cracks to dining room ceiling - looking towards northwest

Firstly, the additional strengthening of the main trusses to reduce the deflection towards the centre of the ceiling. The details of the proposed changes are given in the attached structural engineer's report (Hockley and Dawson 22289). These changes involve the addition of a wire tensioning system with the suggested type 3 bracket. This approach requires minimal intervention and is largely reversible if required.

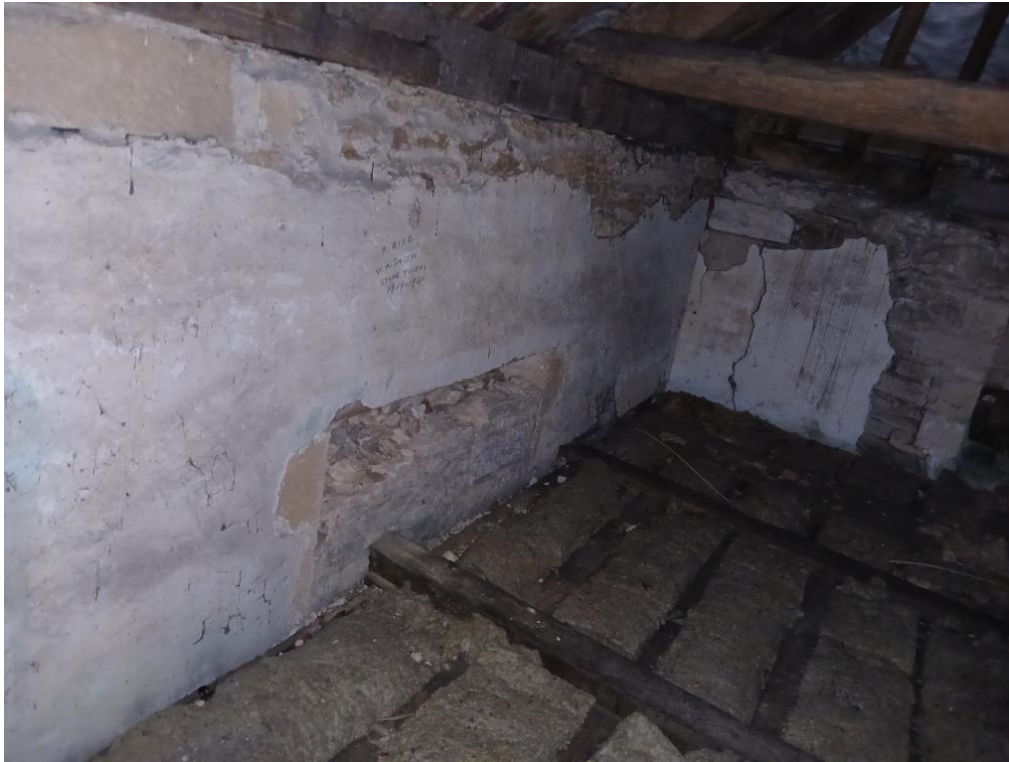
The walls in this area of the building show evidence of previous modification where the top storey floor structure was removed to allow the ceiling to be raised to create the dining room.

*Figure 2 - Filled in window at current ceiling height and previous ceiling joist sockets in wall plate above*

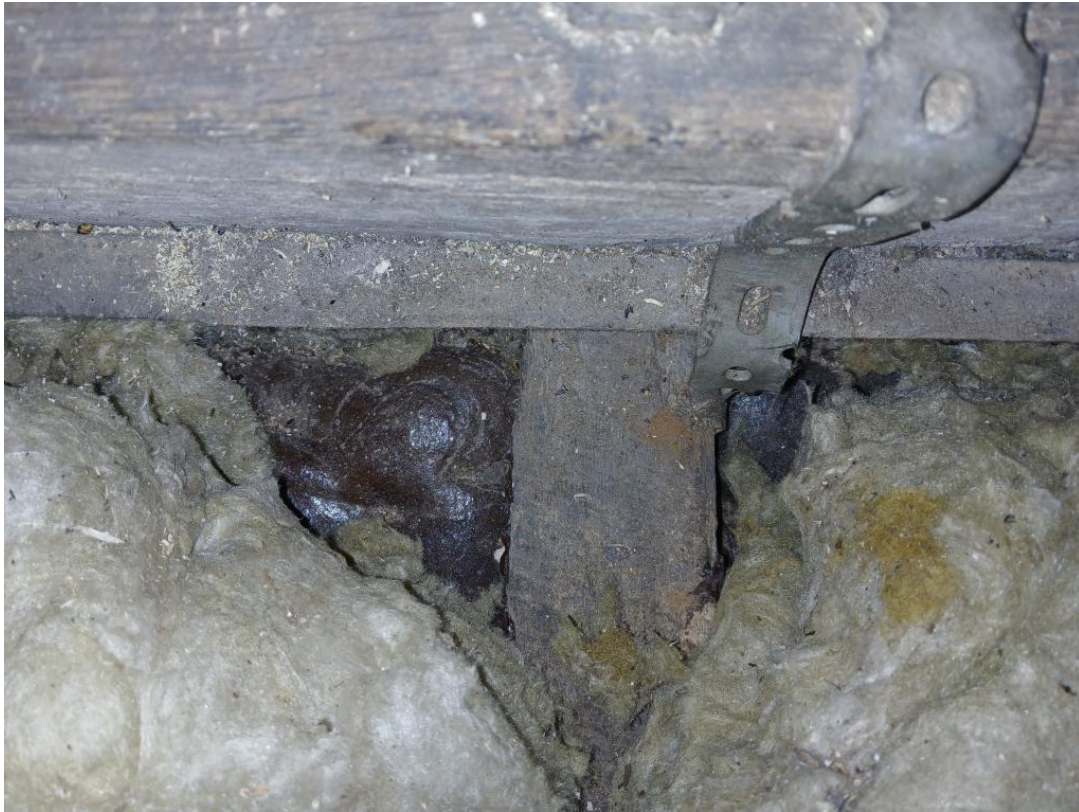
Previous repairs to the split secondary joist have been carried out with metal strapping. There have also been resin repairs to the ceiling in this area suggesting failure of the plaster nibs. This does not appear to have been the case throughout the ceiling, so likely relates to the deflection of the joists. These repairs likely date from before the 1980s.

*Figure 3 - Joist straps and resin repairs to ceiling*

Secondly, adding support to the split secondary joist to the northwest of the room. Details of this repair are given in 22289-3.03C. These repairs will require a section of the existing ceiling to be removed to allow a hanger to be installed. The area removed are expected to be only as large as needed to install the hanger, rather than removing the whole area below the joist. This approach will retain as much of the historic fabric as possible. The addition of coach screws from below will then be carried out, spaced evenly along the beam. This required small areas of plaster to be removed along the length of the secondary beam. If the timber is unable to hold a particular screw, the proposed strapping in drawing 22289-3.03C will be installed from above, without the need for further plaster removal. This assessment will be made on a per-fixing basis. Repairs to the ceiling will be carried out with matching timber lathes and lime plaster. It is not expected that any repairs will be required close to the decorative cornice.

It is expected that this repair is substantial enough to support the beam, but if further cracking reappears, a pair of additional beams are proposed, which are fitted by hanger to the primary joist and external wall. Details are given in 22289-3.04. These beams will then support the ceiling joist with angle bracket, removing the load from the failed secondary beam. No further ceiling opening will be required.

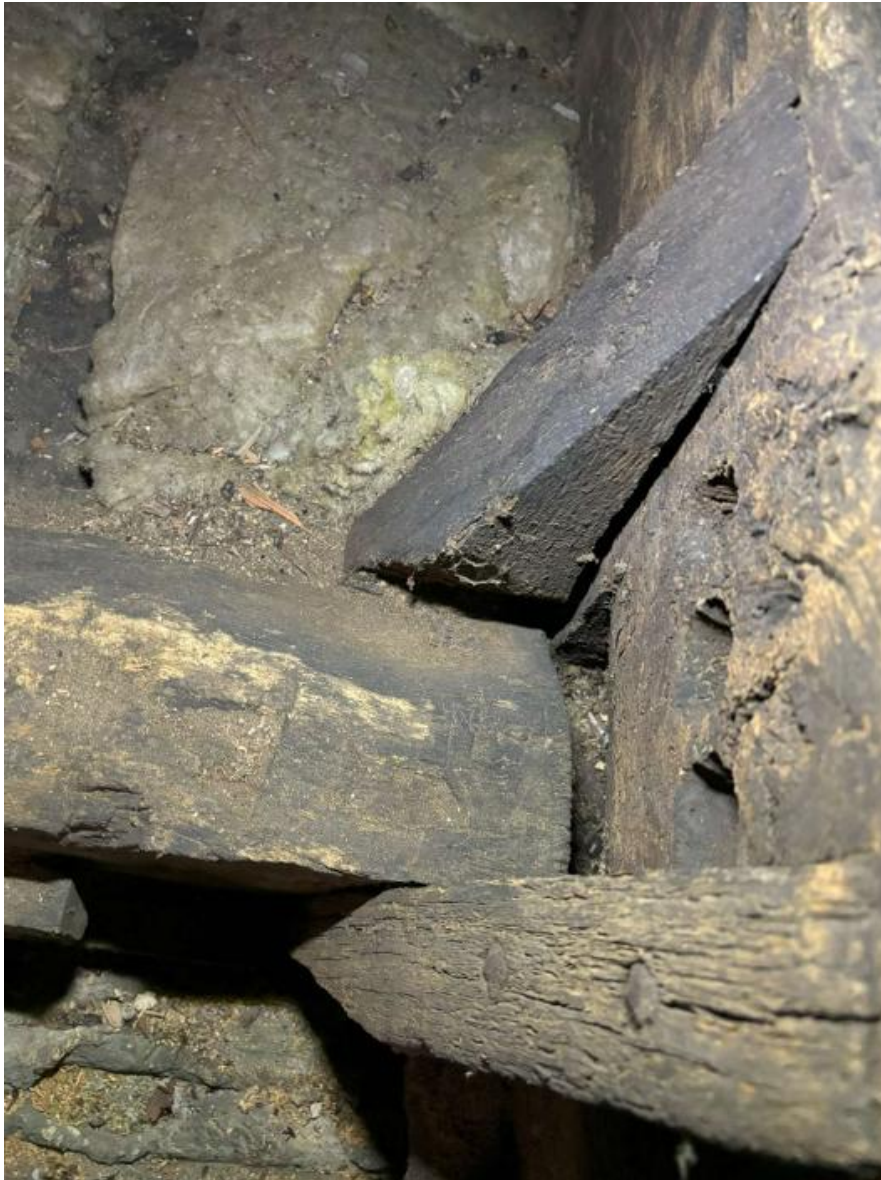
Some secondary beams have timber support blocks. It is not clear if these were added at construction, or later additions. Some of these blocks are now loose and not adding any support.

*Figure 4 - Typical joint between primary and secondary beams*

Thirdly, additional support is proposed to the joint between the primary and secondary ceiling beams. This is intended for the joints above where there is an area of failed ceiling plaster (see drawing LA4-02) but would also be considered on any joints where the timber blocks are loose. The strapping will allow existing timber support blocks to be retained, and it is reversible. A small area of failed ceiling will require repair once the brackets are in place.
