LACOCK ABBEY  
DINING ROOM

SECONDARY CEILING BEAM  
PROPOSED STRAPPING DETAILS

| rev | description | | date |
|---|---|---|---|
| Job No<br><b>22289</b> | Drg No<br><b>3.03</b> | Rev<br><b>C</b> | |

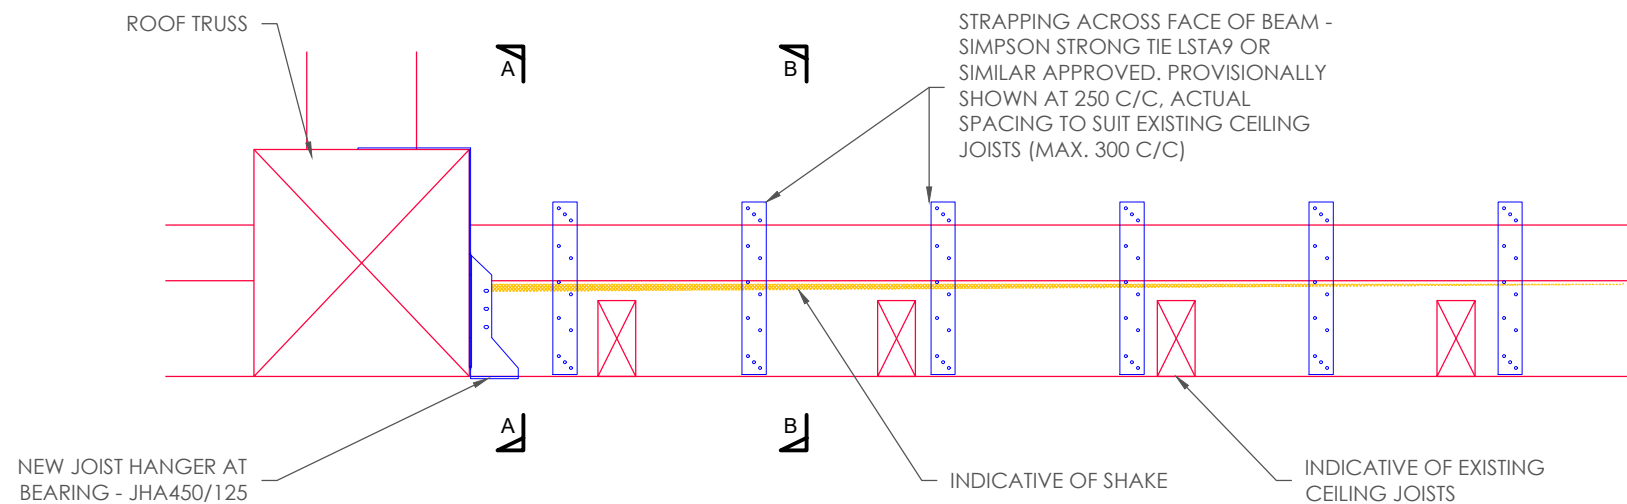
## ELEVATION OF SECONDARY BEAM

STRESSES IN BEAM AT TENON BEARING CONTRIBUTING TO FAILURE. JOIST HANGER SUPPORT TO BE INSTALLED TO PROVIDE SUITABLE SUPPORT AT BEARING, REDUCING STRESSES IN TIMBER.

CEILING OPENING UP TO BE RESTRICTED TO END BEARING AT CEILING TRUSS.

LSTA9 STRAPS TO BE INSTALLED FOR LENGTH OF SHAKE TO DETAIL AND EXISTING RESTRAINT BANDING MAY BE REMOVED. ALTERNATIVELY, NEW STRAPS NOT REQUIRED IF EXISTING RESTRAINT BANDING IS RETAINED PROVIDED THEY ARE IN REASONABLE CONDITION WITHOUT ALLOWANCE FOR MOVEMENT, AND STRENGTHENED WITH M12 COACH SCREWS INSTALLED AT MAX 150mm CENTRES ALONG THE BEAM, FROM TOP WHERE SHAKE IS IN THE TOP HALF OF THE BEAM AND BOTTOM WHERE SHAKE IS IN THE BOTTOM HALF OF BEAM, SCREW LENGTH TO ACHIEVE MINIMUM 85mm EMBEDMENT TO TIMBER ACROSS SHAKE AND MIN 50mm EDGE DISTANCE TO THE SIDES OF THE BEAM WITH MIN 50mm DIAMETER WASHERS.
