**Title:**        **Lacock Abbey**  
                  **Dining Room Roof**

**Job No:**    **22289**

**Date:**        **September 2025**

**Client:**      **The National Trust**

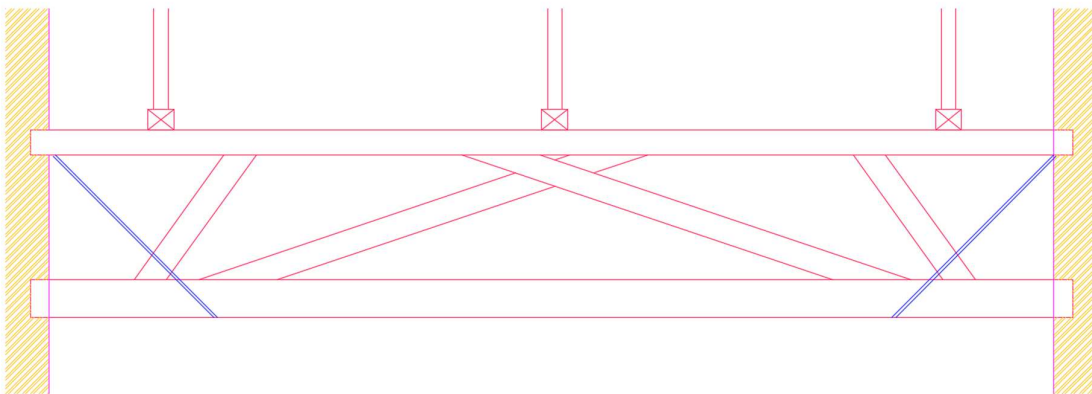
Figure 1 - Existing elevation of girder truss

Whilst there were three sets of struts, ties, or braces, it was noted that these primarily provided support to the top beam member, focussing the stresses towards the end of the bottom tie beam. There was no intermediate support to the lower tie beams.

The existing structure was modelled, and found to have excessive deflection of the lower tie beam. The upper beam was also slightly over the allowable limits. These recommended limits are based on  $\text{span} / 360$  for all loading, or  $\text{span} / 250$  for imposed load only. The stresses and worst case forces from the girder analysis were reviewed for the principal beam members, and both the upper and lower tie beams passed these checks. It should be noted that the lower tie beam was found to be running at 98% capacity in this analysis.

Given that the individual timbers passed the initial checks, the issue under consideration was the overall deflection of the truss system. The proposed model introduced a pair of tension rods or wires to support the bottom tie, hanging it from the top member and transferring the stresses back through the existing system of struts. The results of this proposed variation can be seen in detail in Appendix A, but the results of the two systems has been summarised in the tables below. This snapshot is based on one set of equivalent models, and pin-pin base supports. The timber grade has conservatively been taken as a hardwood grade D30, and typical section sizes for the members were used. The survey found the range of section sizes to generally be within 20mm across similar members.

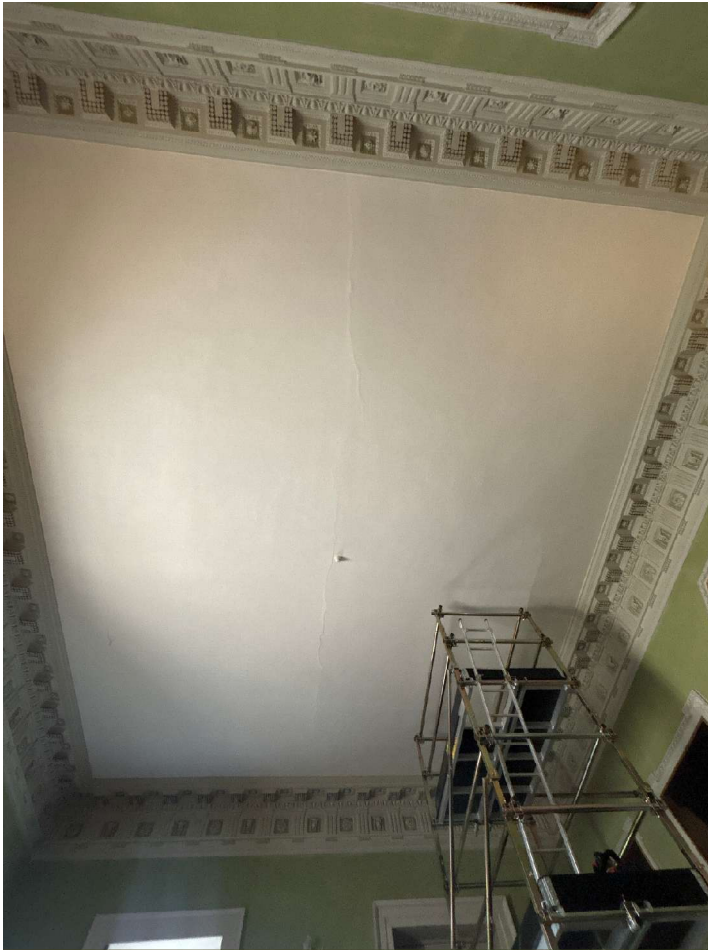
The existing roof structure fails in deflection, and the theoretical deflection of the bottom tie beam is likely to be the primary cause of cracking across the dining room ceiling. Where the cracking is noticeably worse the secondary ceiling beam has failed at the end bearing. All members analysed passed the typical stress checks, however some elements are running at very high capacity for combined tension and bending.

Dining room ceiling, with visible cracking along the midline. Worst cracking located above the scaffold tower position.

To increase the stability of the ceiling and the overall roof structure, two sets of tension ropes could be added to each girder truss as shown on the proposed elevation. For the installation of these brackets, either local sections of the ceiling finishes would need to be cut back and reinstated, or the bolts would need to be introduced through the bottom tie beam. Please note that the bracket type 2 option (patch repair of ceiling) is only suitable if there is sufficient depth of finishes to allow for the bracket – estimated to be 15mm thick.

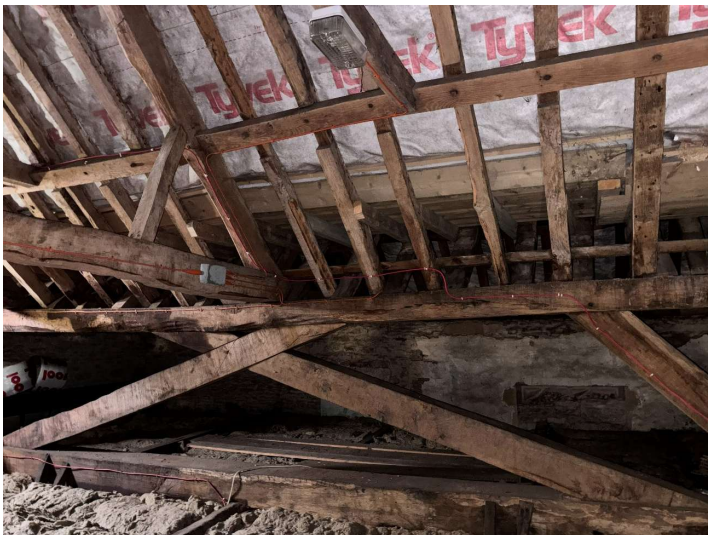
Girder truss beneath valley with roof structure over

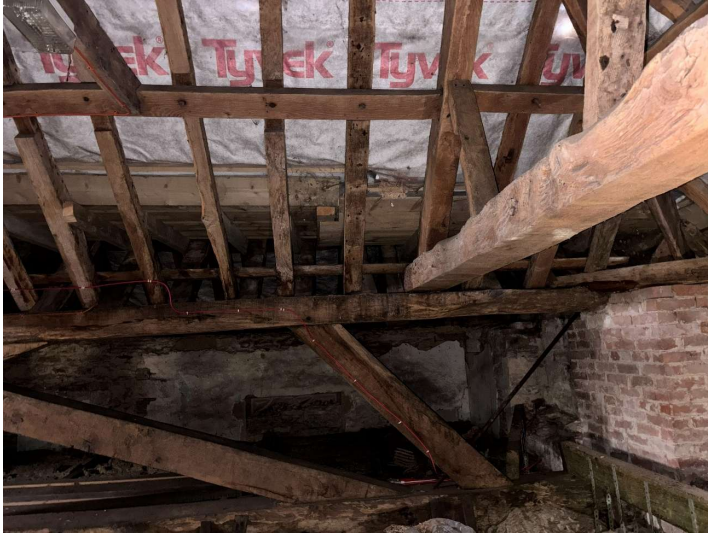
End of girder truss showing arrangement of struts and tension rod

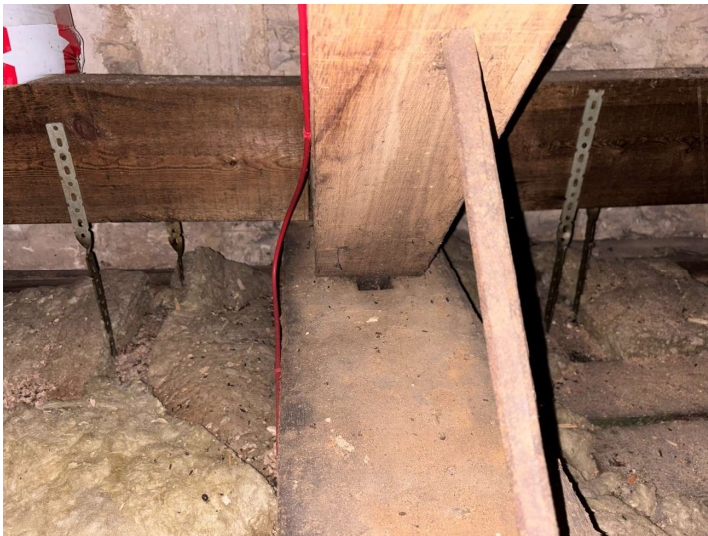
Tension rod through the strut

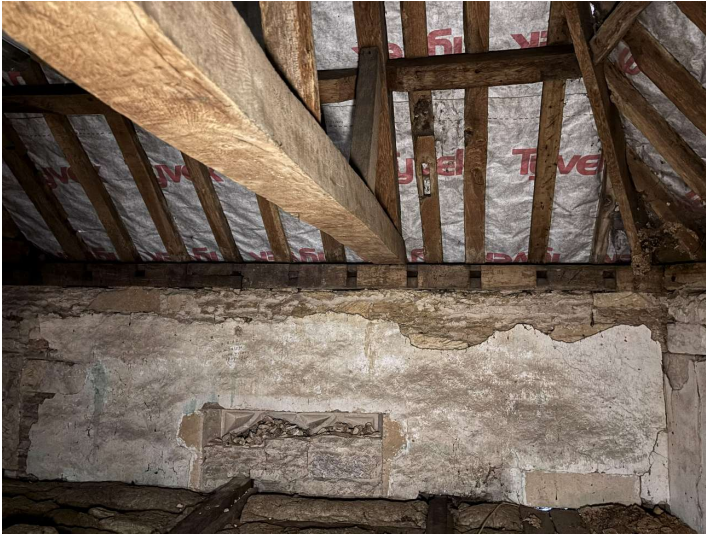
The In general the principal roof truss members appeared to be in a reasonable condition. There were indications of historic alterations to the structure, and possibly that there had originally been different floor / ceiling levels within the area, with vacant pockets in the external masonry walls. It was unclear whether the roof timbers had been reused from the original scheme and integrated into the later trussed valley system.

Internal face of eastern wall showing redundant pockets in wall plate – suggesting possible previous ceiling level.

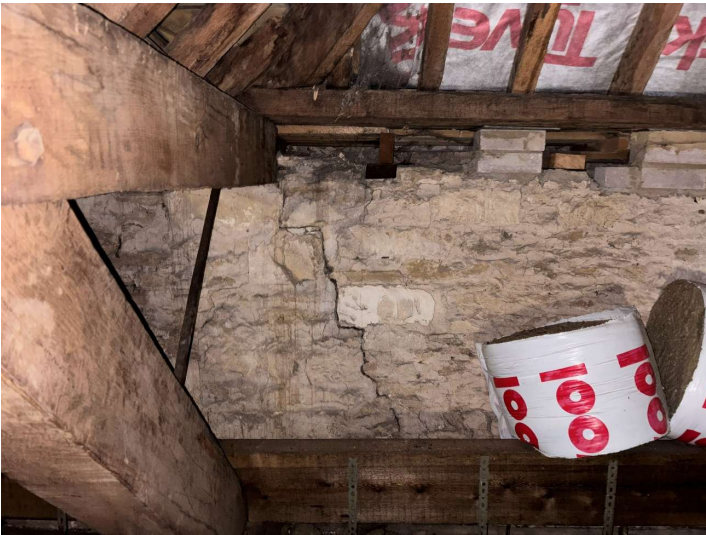
Northern wall with cracking beneath bearing of girder truss.

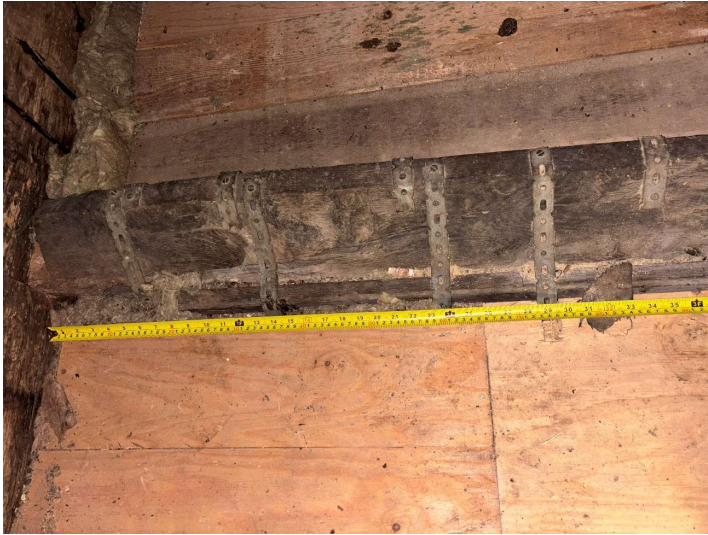
Historic strapping repair to failed secondary ceiling beam – see previous report for details.
