**Botanic Garden Glasshouse  
Lacock Abbey  
Lacock  
Wiltshire**

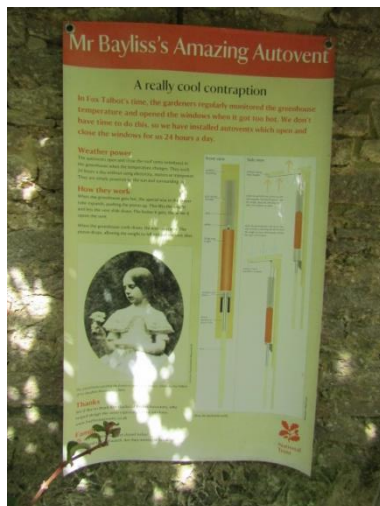
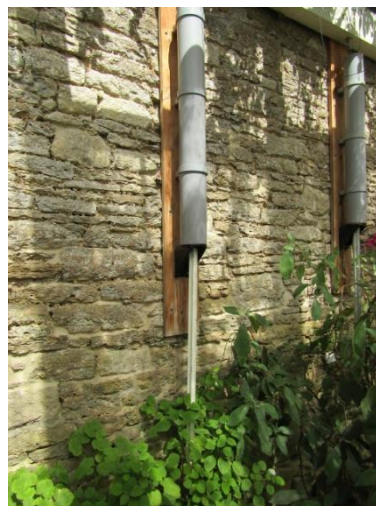
The upper opening sashes are controlled by a bespoke autovent system and where this has failed sandbags are being utilised.

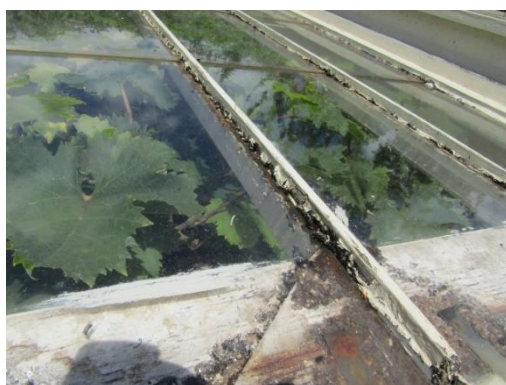
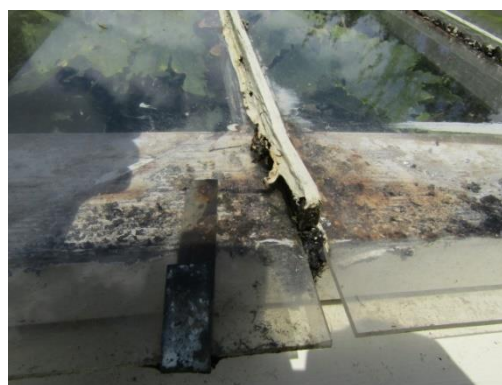
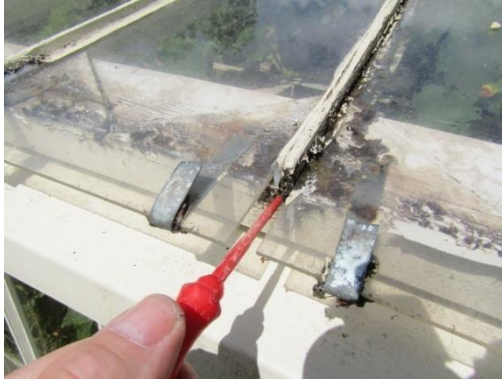
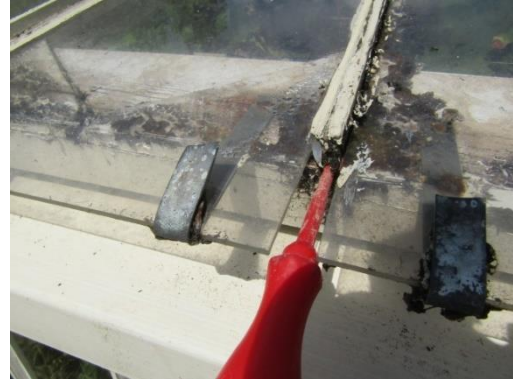
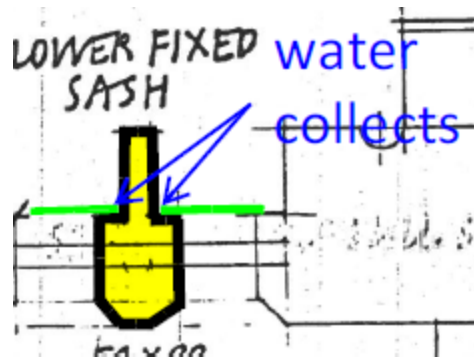
The first issue is the condition of the glazing bars which is set so that the glass sits on top and then held with a small tack. The edge is not properly sealed and therefore water is collecting at the side of the glass and tracking down to the lower section and collecting at the end. Therefore the glazing bars are showing distinct rot and thus the glass panels are loose.

One of the main issues is the water run off and the junction of the glazing to the glazing bar. Where a sash requires replacement then the glazed section could be replaced utilising a hardwood frame but using a glazing system such as that produced by the patent glazing company. They produce an aluminium glazing bar and restraint system and therefore the rotting of the timber glazing bar would be eliminated. The appearance will be similar but the sashes would have to be re-detailed so they still function with the top opening sash which may be problematic due to the height of the upstand cover strip.

The most appropriate option is to repair the existing but upgrading the materials. The front frame has already been replaced with Sepele and a similar procedure could be introduced with the repairs. The sashes can be replaced and rebuilt but in a stable hardwood and if a high quality paint system is also utilised then that will provide a degree of protection against the poor original detailing. The sashes can be designed so that the joints are protected and will not collect as much water into the end grain and so again reducing the risk of long term damage. Without a complete redesign of the glasshouse in terms of the detailing or the material as set out in options 1 and 2 then the proposal is to reduce the impact of the issues. A similar approach can be taken with the rafter ends to ensure these are more durable. The opening sash system with the brass wheel on a brass runner plate is functional as long as the gap is maintained and regularly cleaned and this should work with the sashes rebuilt. This option will allow a more piecemeal approach to the repairs as it can be carried out in Bays. This work also includes the top flashing to ensure the existing wall coping is intact as well as the lead. The condition of the bays are recorded with the repairs required in the appended document.

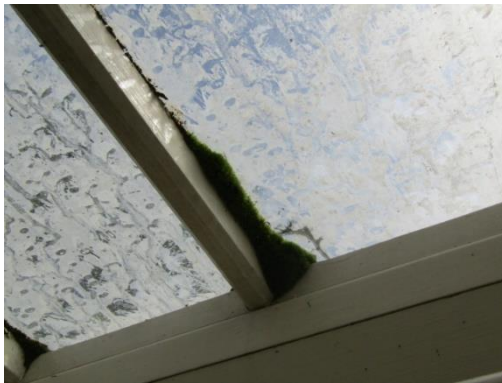
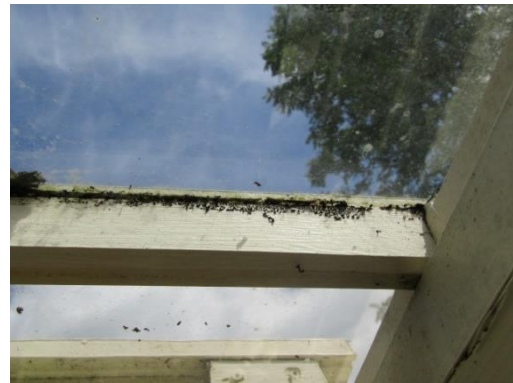
Internally the damp issues around the glazing bars are clearly evident as there is moss growth evident.

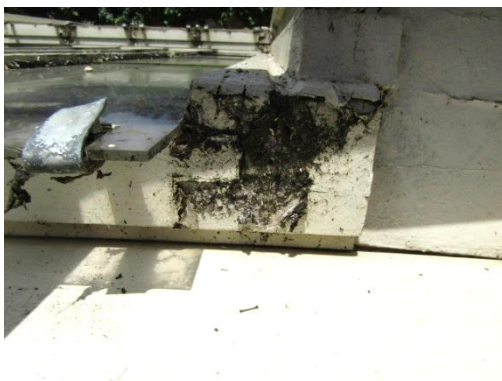
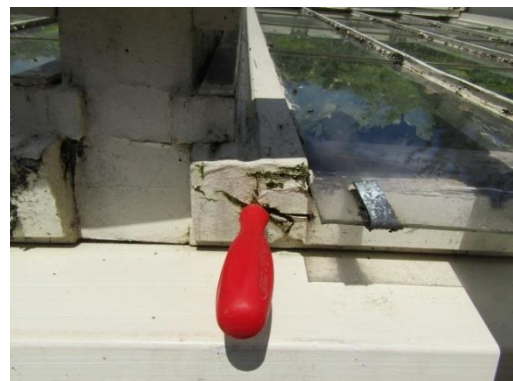
The second issue is the condition of the lower sashes where the water is discharging off the glass and then into the end grain of the softwood. Therefore where the sashes are jointed the timber is suffering from wet rot as indicated by the moss growth.

The recommendation would be to systematically replace the sashes with a stable and durable hardwood. All the issues with the original design can not be eliminated without significant intervention but the impact can be greatly reduced. This involves regular redecoration and close co-ordination of the sash jointing details with a high quality joiner and/or architect.

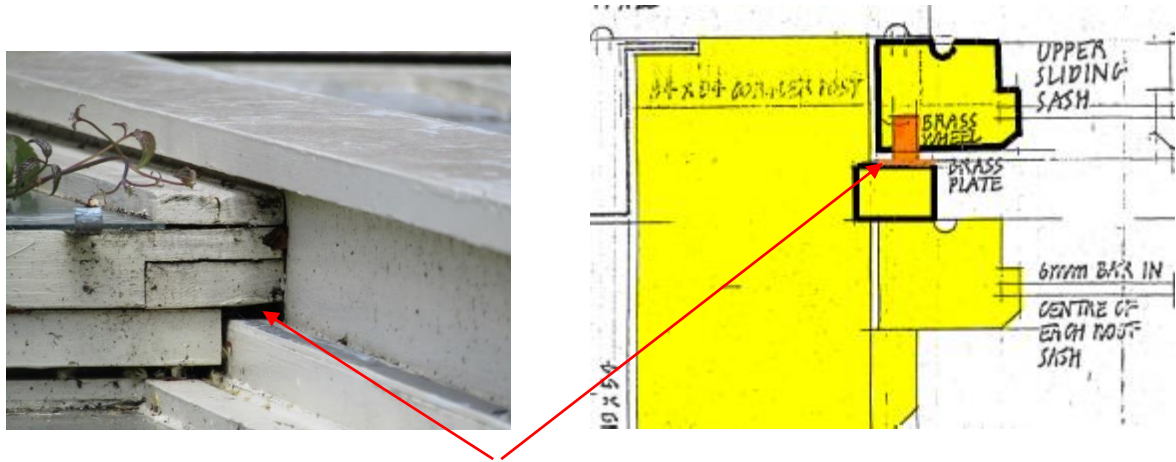
Sashes work when the timber is intact and there is a clear gap

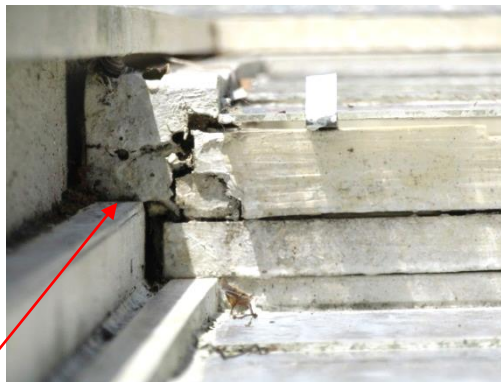
Sashes fail when the timber is rotted and there is no gap for the runner
