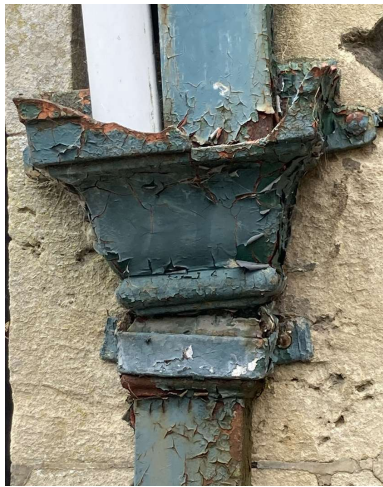
Existing gutters and downpipes to the east elevation of the ambulance station. The existing cast iron has degraded and broken off beyond repair and will need to be replaced along with the upvc for Heritage cast aluminium half round profile to the gutter and a square downpipe and hopper to match the existing as closely as possible.

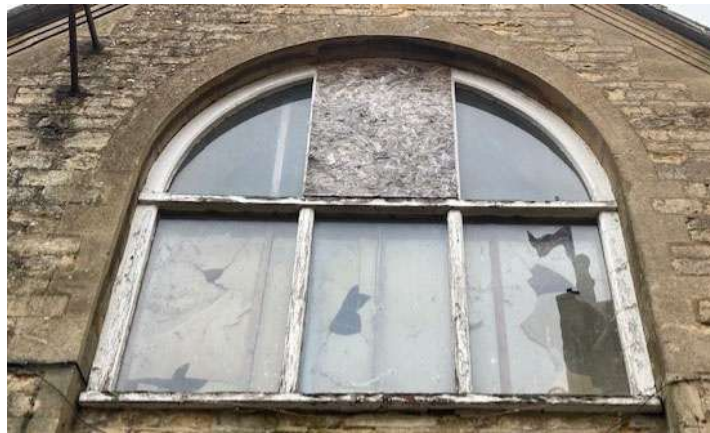
Existing large arched window to the first floor of the east elevation. Timber to be sanded back. New hardwood timber sill required. The rest of the timber to the window to be repaired with resin as necessary. All to be primed and painted to match the existing.

Existing louvre panel to the top centre to be replaced with single glazing to match the surrounding glazing.

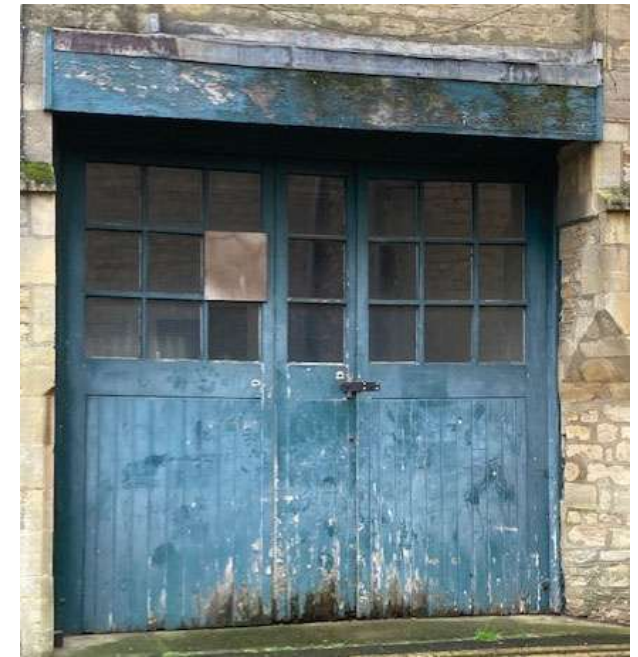
Existing main doors to the fire station. Doors to be sanded back. The timber to the bottom edge of the doors is rotten. This will need to be cut out and new timber scarfed in. Missing glazing to be replaced with new panes of single glazing to match the existing. Timber panel above the doors to be replaced with new. Lead flashing to be carefully removed and replaced with new. Prime and paint to match the existing. New hardware required.

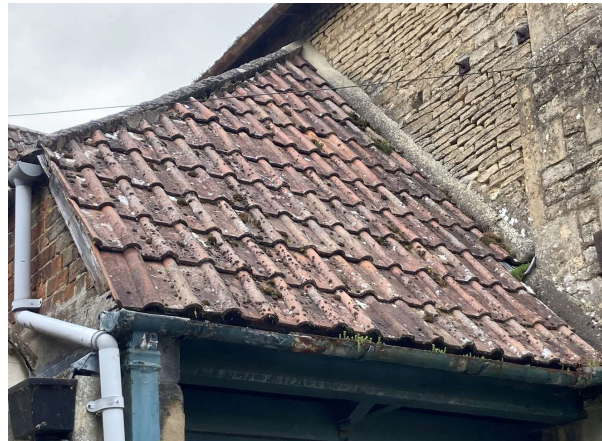
Existing front sloping roof to the ambulance station. Existing double Roman pantiles to be set aside for reuse. Mortar hip fillet and mortar fillet to wall abutment to be replaced with new lime mortar. Existing timber to verge to be replaced with new timber to match the existing.

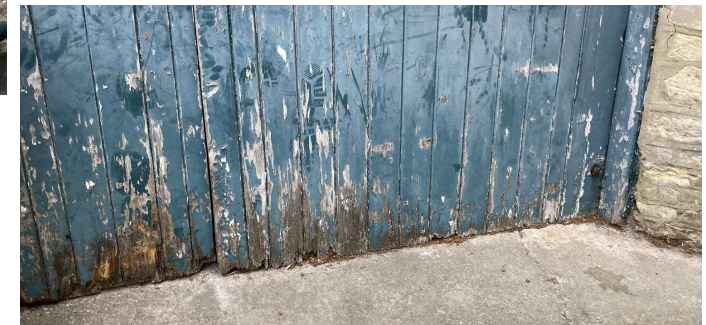
Existing ambulance station doors to be sanded back, repaired if necessary, primed and repainted to match the existing. New hardware
