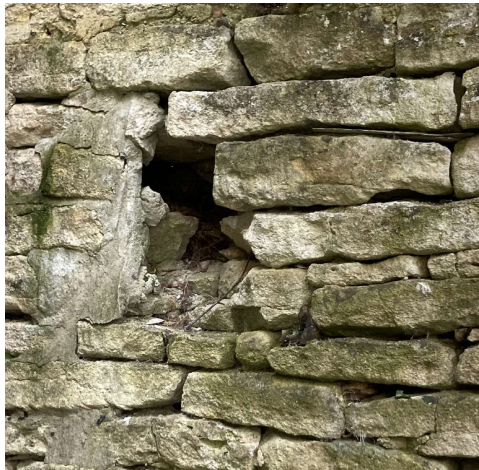
To the north elevation there are large holes where stones are missing or worn back. New replacement stones used for repairs to be reclaimed or locally quarried similar stone

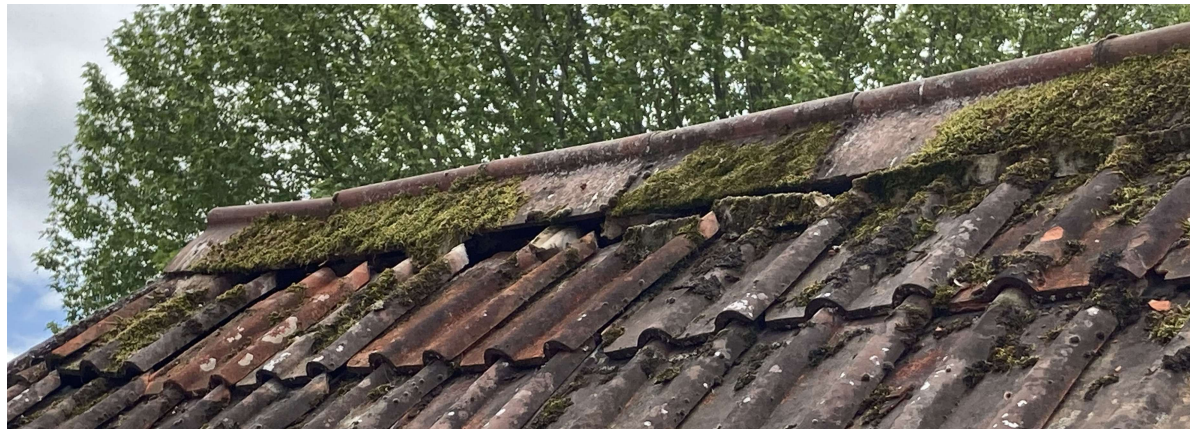
The existing roll top ridge is heavily covered in moss and the tiles are loose with the mortar bedding missing or loose.  
The existing roof is in poor condition with numerous slipped tiles especially to the north elevation, cracked and broken tiles are also evident across the roof across the roof slopes. There is also decay evident to some of the roof timbers although most look to be in adequate condition. These are to be inspected by a structural engineer
