# Crack Investigation at Salisbury Guildhall

Salisbury City Council

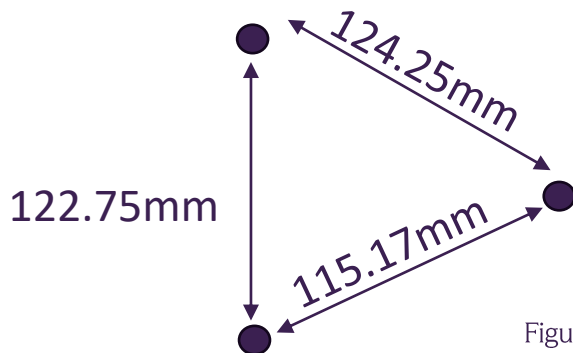
Figure 3: Tell-tales recording in ceiling void

The tapered nature of the crack suggests differential movement rather than uniform shrinkage. Crack monitoring fixings were present at the time of inspection, confirming that this defect has been previously identified and is currently subject to previous monitoring, assumedly via the estates team. Measurements taken during the inspection are recorded in Figure 3.

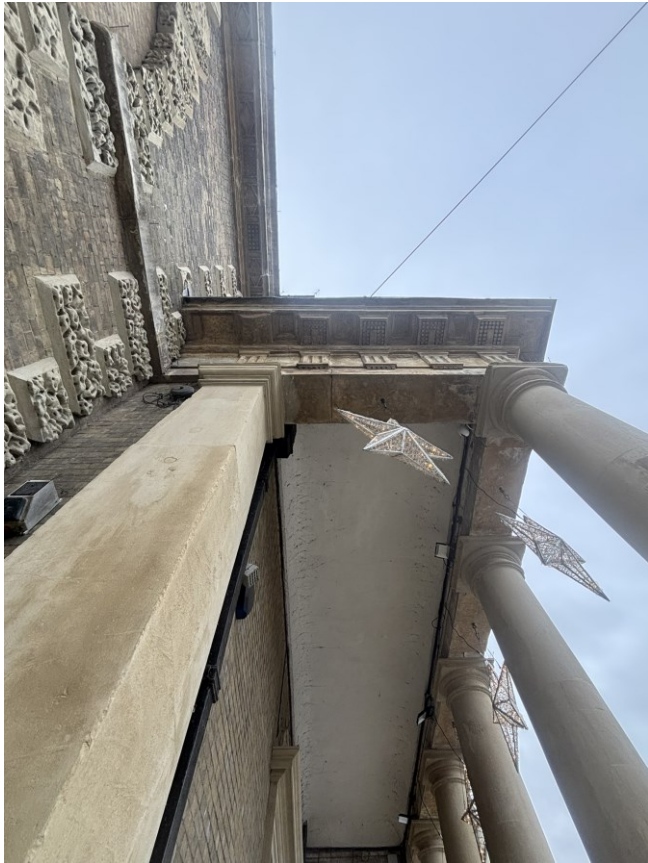
The soffit exhibited general age related cracking but no signs of instability (refer to image P1).

P1 - Crack can be seen Portico.

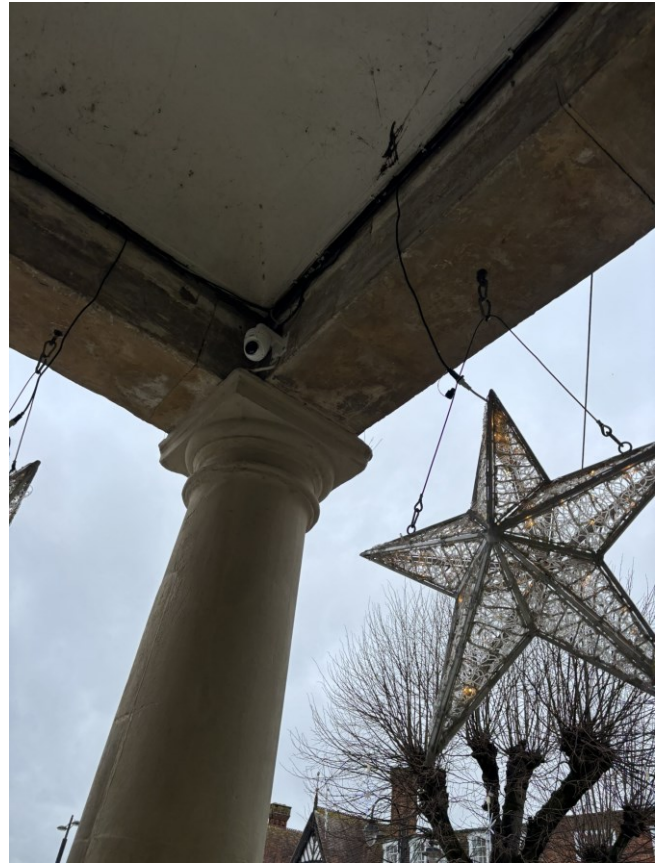
A structural crack identified within a stone block to the east elevation of the portico, measuring approximately 4 mm in width, being approx 400mm totalling in length. The crack passes through the face of the stone and appears to extend through the section of the block rather than being limited to surface weathering (refer to image P2-P4).

The cracked stone block appears to be L-shaped, with the base of the L portion positioned directly beneath the limestone column. This configuration may be susceptible to stress concentration where vertical loads from the column are transferred through the stonework.

P2 - Corner of L shaped stone under entablature.

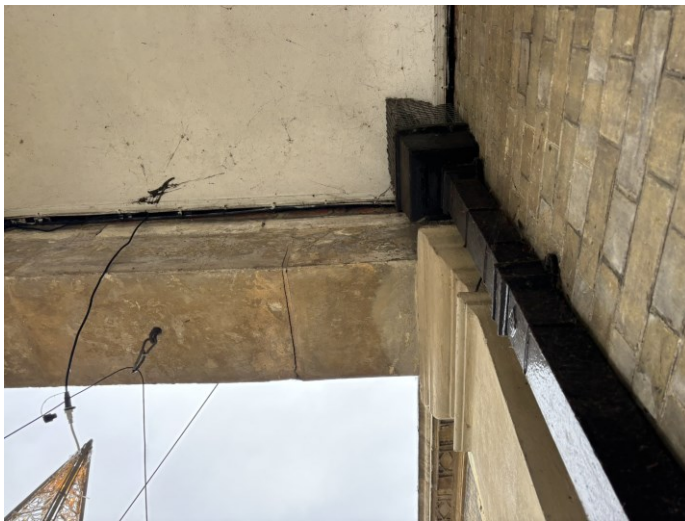
The most probable cause is long term compressive loading from the entablature above, coupled with consolidation of the ground below. The consequential compressive loads from above, coupled with restraint at the corners could introduce localised stress within the masonry, resulting in the separation. However, the precise cause of the cracking cannot be confirmed from visual inspection alone, and this assessment should not be taken as definitive.

P3 - Close up of compressive crack in Portico.

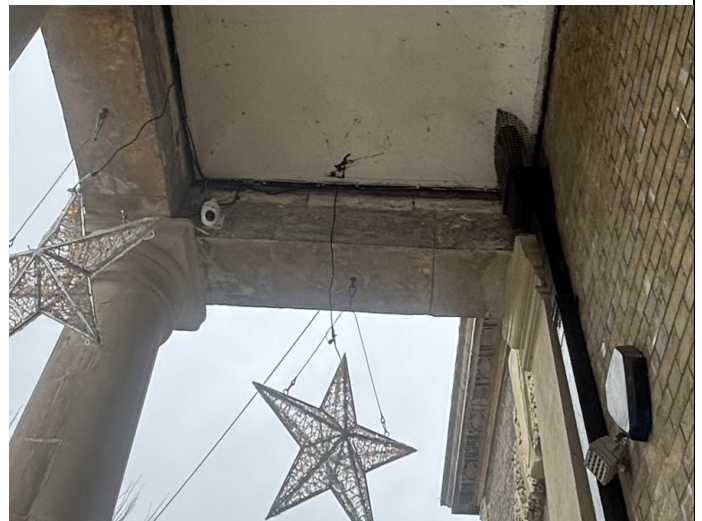
P4 - Overview of crack from under Portico.

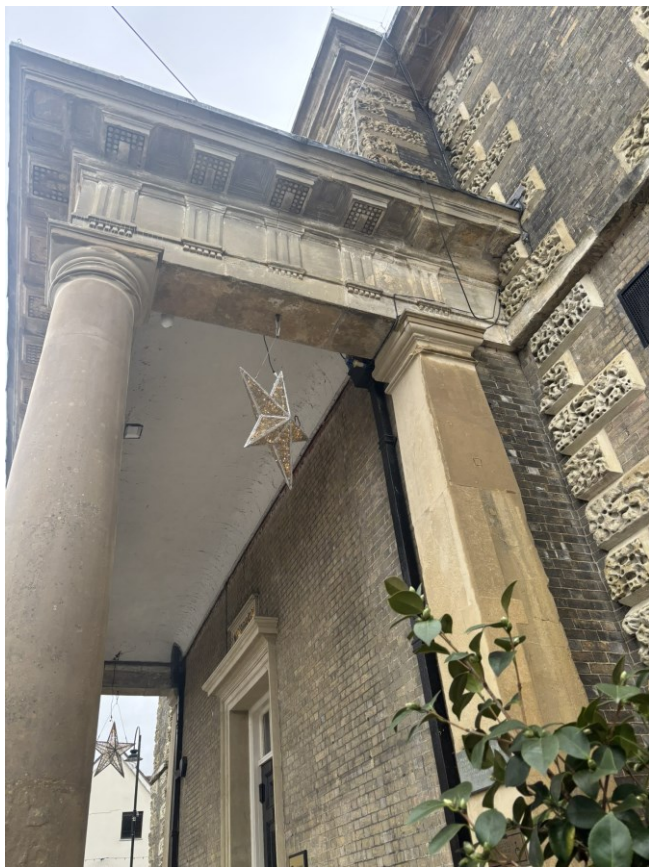
A corresponding crack was observed on the opposite elevation of the portico, within a stone block of similar form and location. This crack has previously been repaired using a lime putty joint, which is generally appropriate for historic masonry. The presence of a matching defect on both elevations suggests that the same issue has arisen on the opposite previously of the portico (refer to images P7-P8).

P7 – Crack on opposing side filled in with a putty.

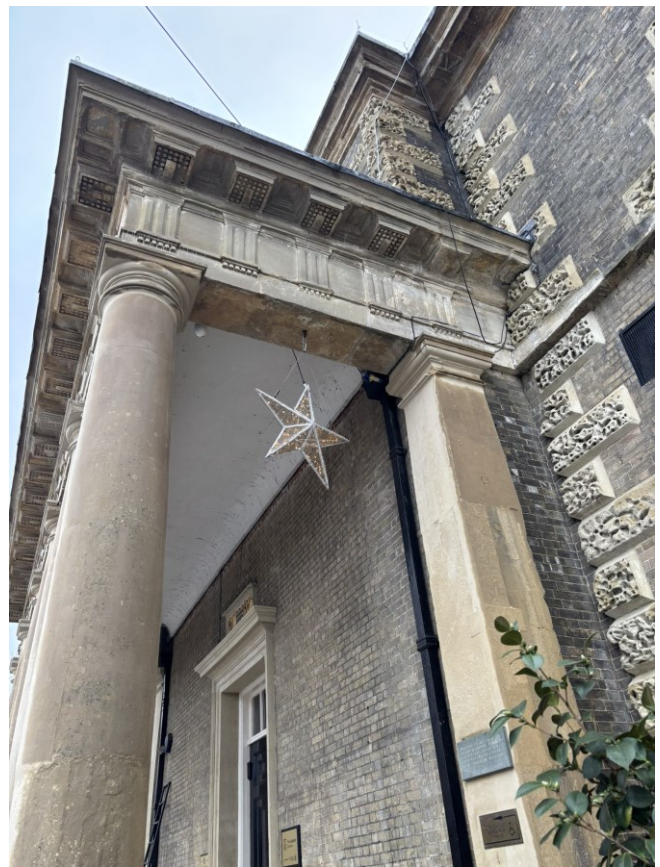
P8 - Crack on opposing entablature side filled in with a lime putty.

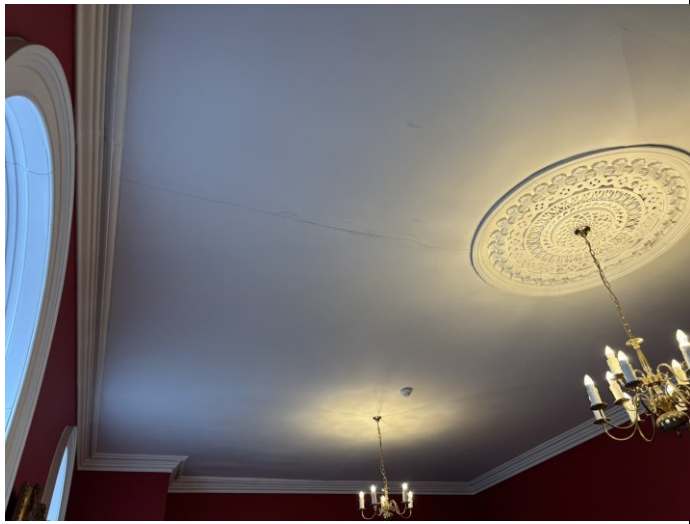
P9 – Hairline cracking in ceiling going to decorative rose.

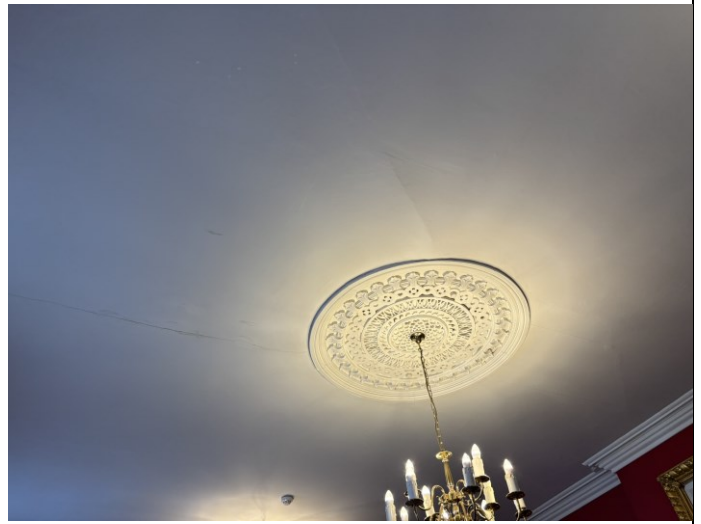
P10 – Hairline cracking in ceiling going to decorative rose.

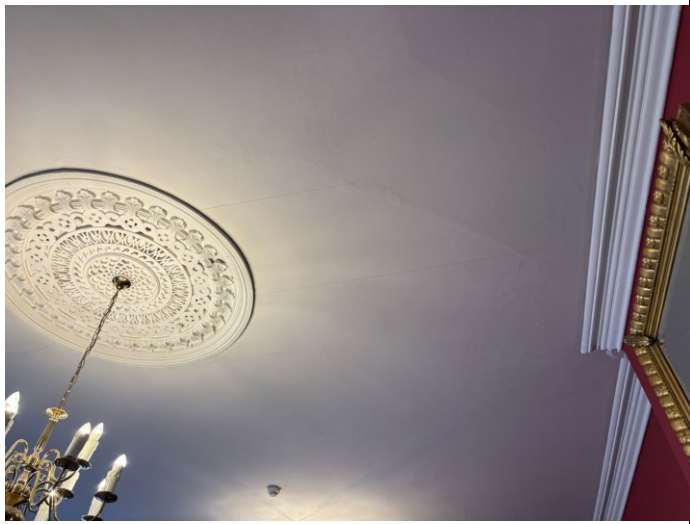
P11 – Hairline crack extends through rose to the other side of the room in a horizontal line.

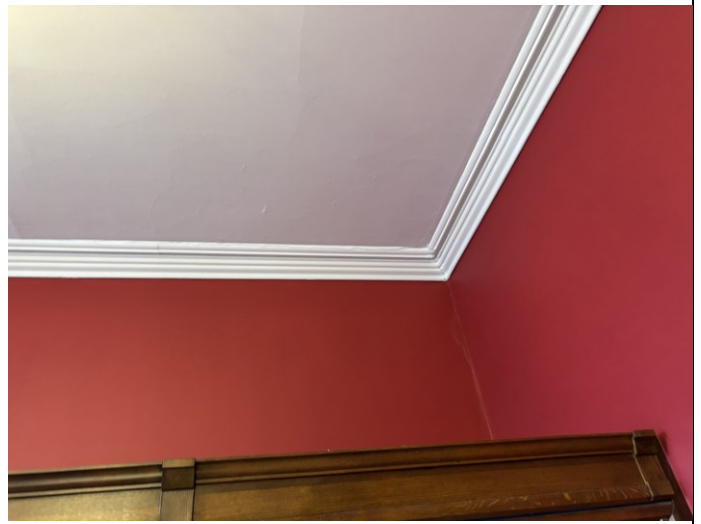
P12 – Further cracking in NE corner of Grand Jury Room.

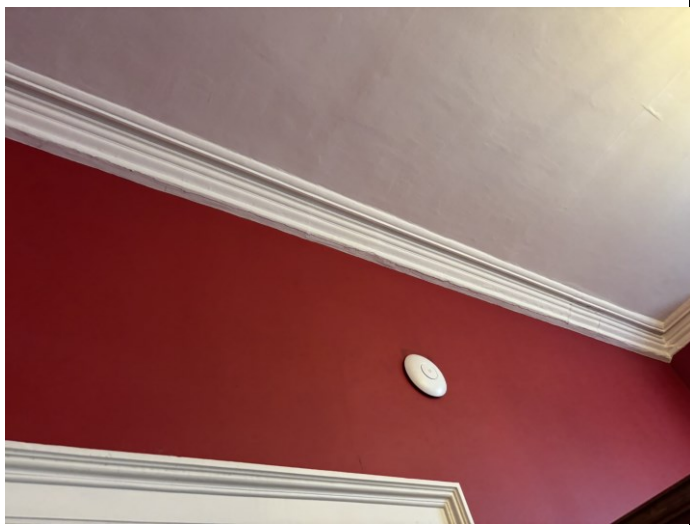
Isolated areas of minor staining were identified on the ceiling surface, considered likely to relate to historic water ingress (refer to image P13).

P13 – Grand Jury Rooms cornices appear to have some hairline cracking within as well.

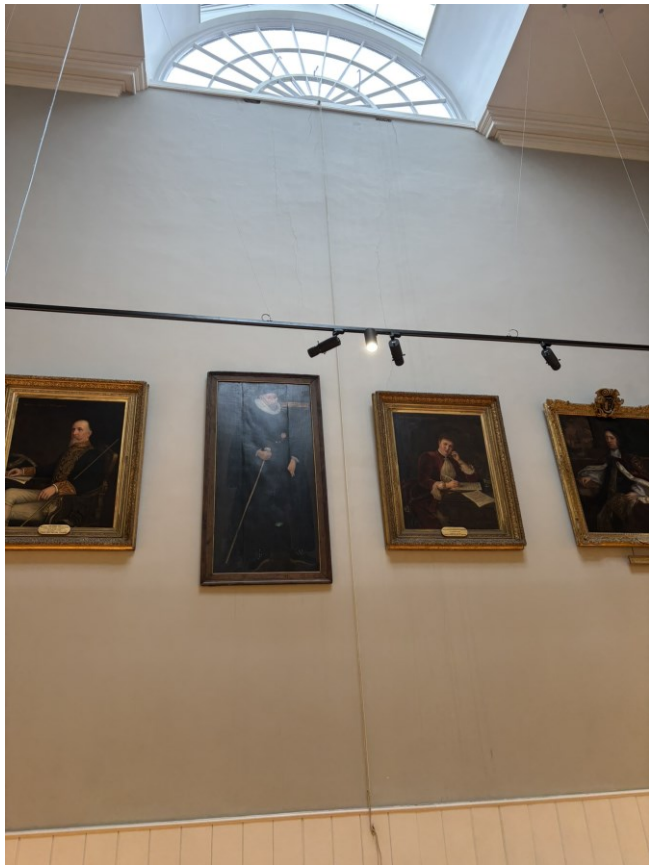
P15 – Various hairline cracks on West wall.

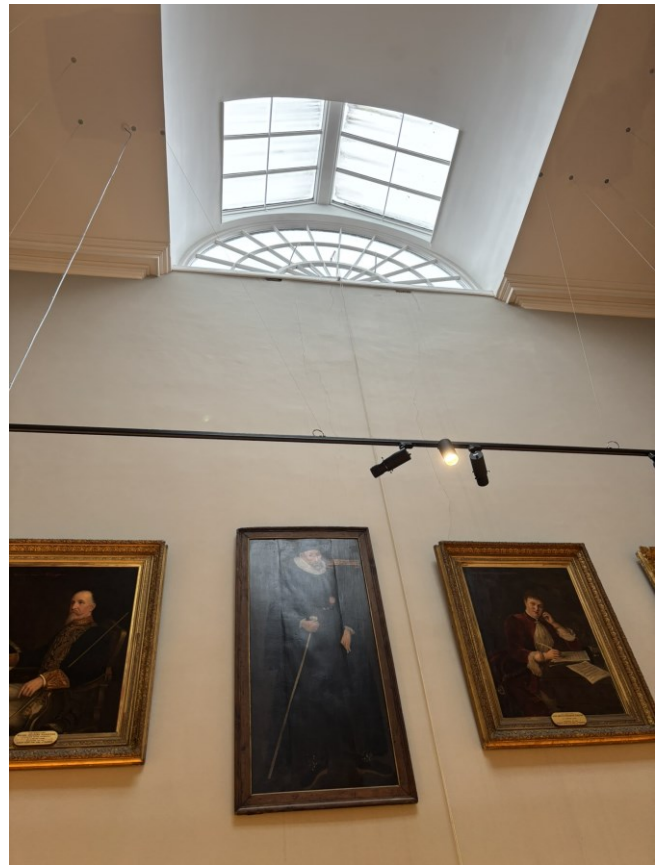
The hairline cracking observed on the west wall appears to not exhibit characteristics consistent with structural movement, however it is seen on both sides of the wall, suggesting the cause is similar to the crack on the opposing

wall. The cracks are narrow, discontinuous and show no evidence of displacement, widening, or progression into the underlying masonry. There is no cause for structural concern at this time, however monitoring is required (refer to image P16).

P16 – Non-structural cracks on West wall.

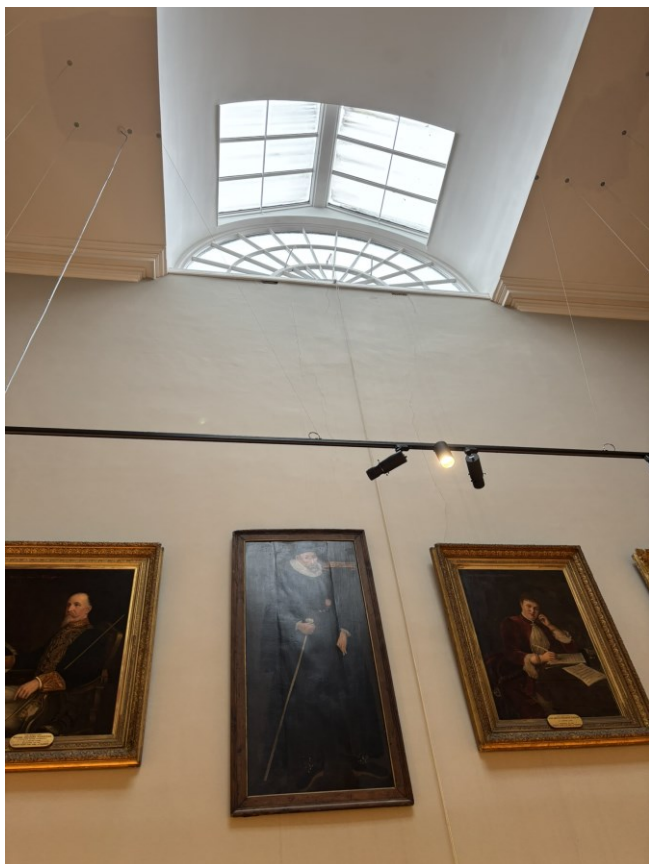
P17 – Longest crack here extends approx 7.7M

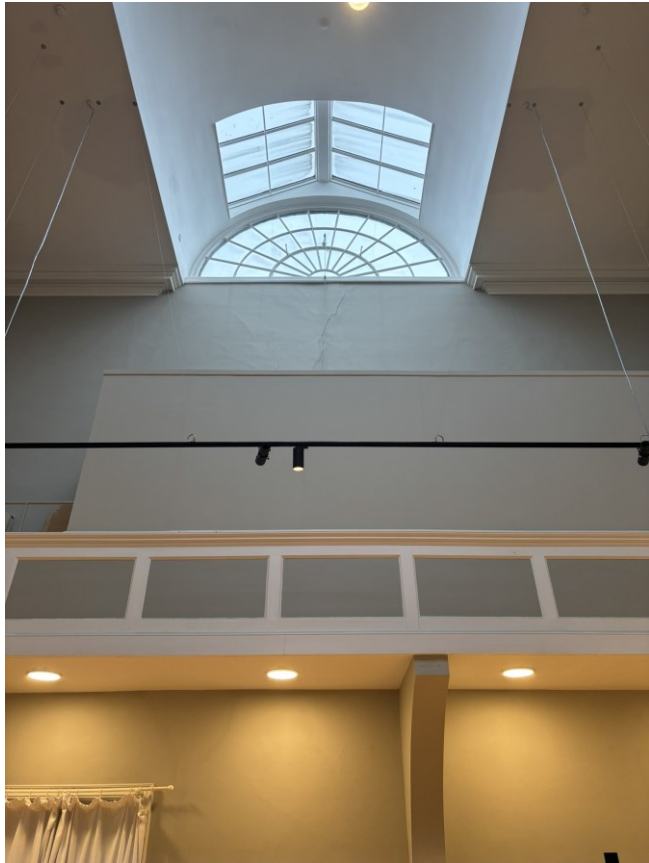
The principal structural crack was identified on the east wall of the Crown Court. This crack is predominantly vertical and extends from high level below the clerestory window above the mezzanine through the wall face and descends to an approximate height of five metres (refer to images P18-P21).

The vertical alignment and consistent location of the crack suggest that it is associated with long-term movement within the masonry wall rather than isolated failure of internal finishes (refer to images P19).

P19 – Structural Crack as seen on East wall.

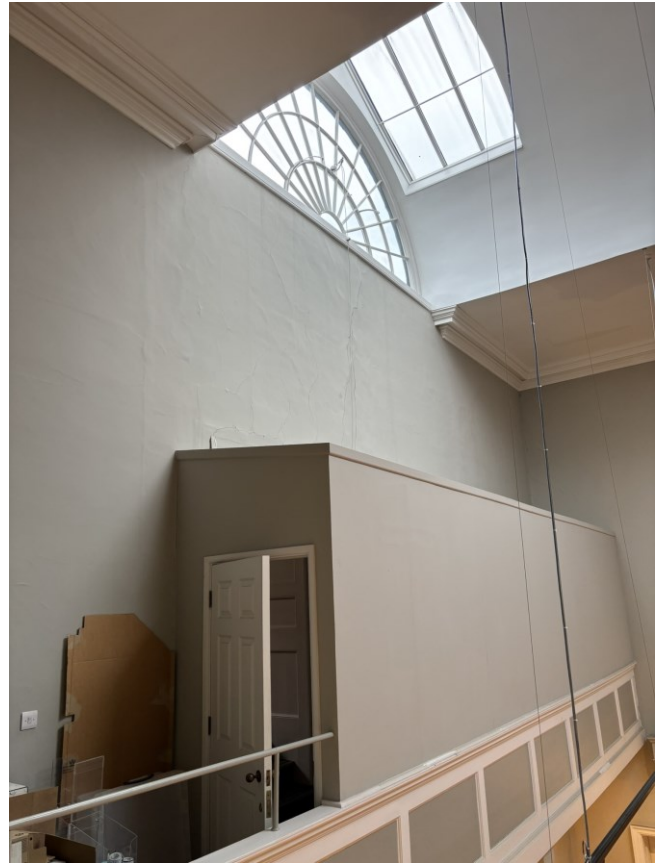
P20 – High level view of the Crown Court east wall showing vertical cracking extending down from the arched rooflight, consistent with the principal crack line observed through multiple levels of the building.

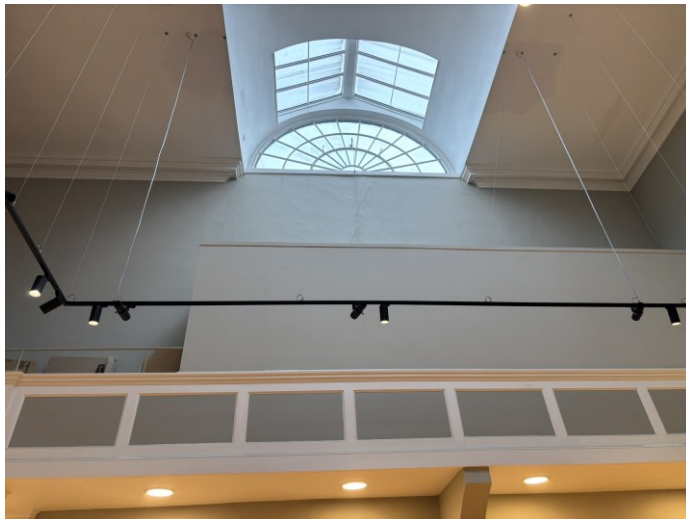
P21 – Principle crack as seen from ground floor.

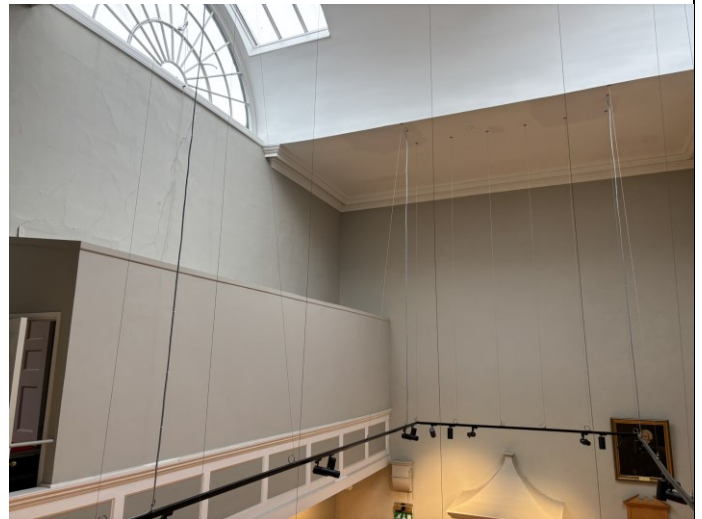
P22 – Principle cracks are restricted to underneath the arched window and extend below.

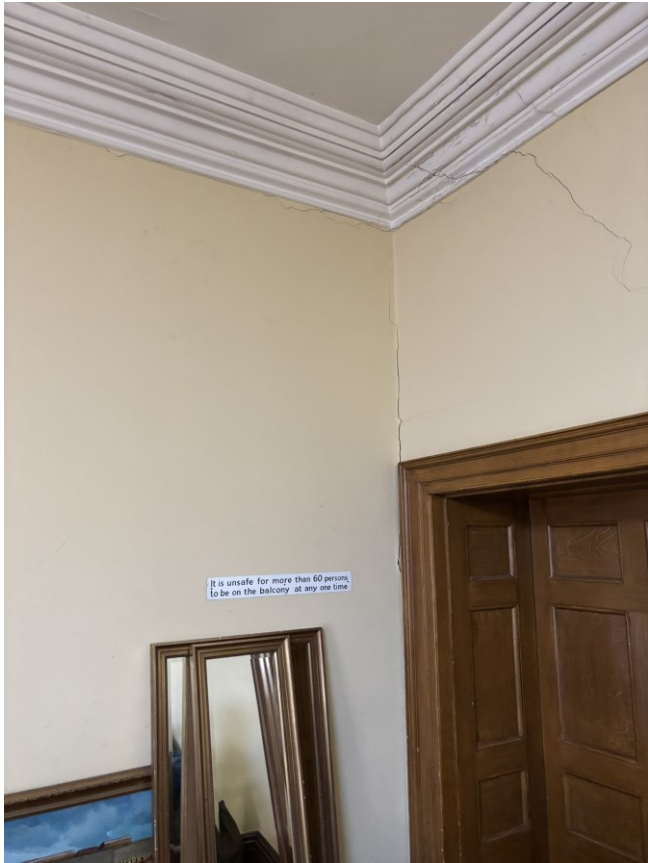
P23 – Principle crack observed in NW corner of room.

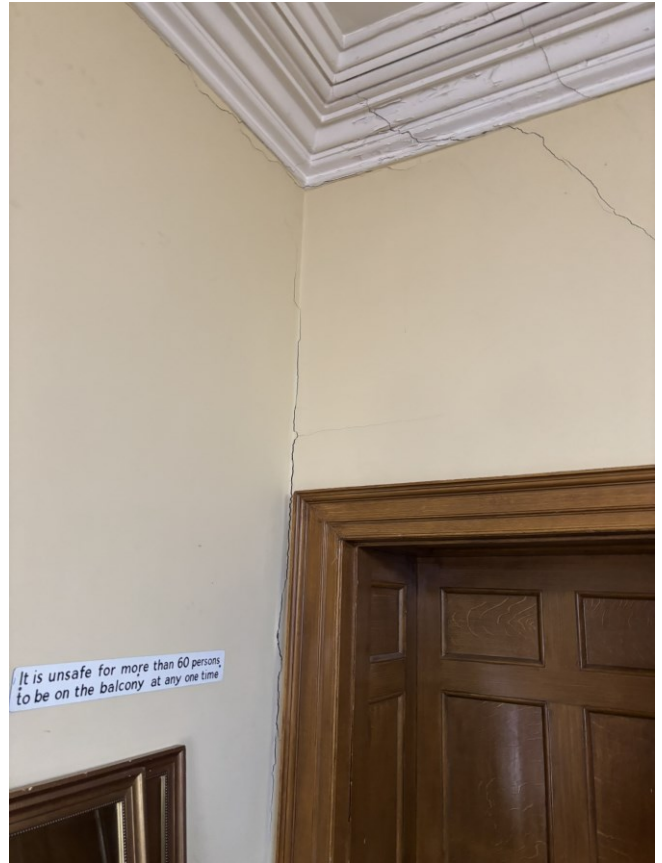
P24 – Evidence of door dropped due to structural crack.

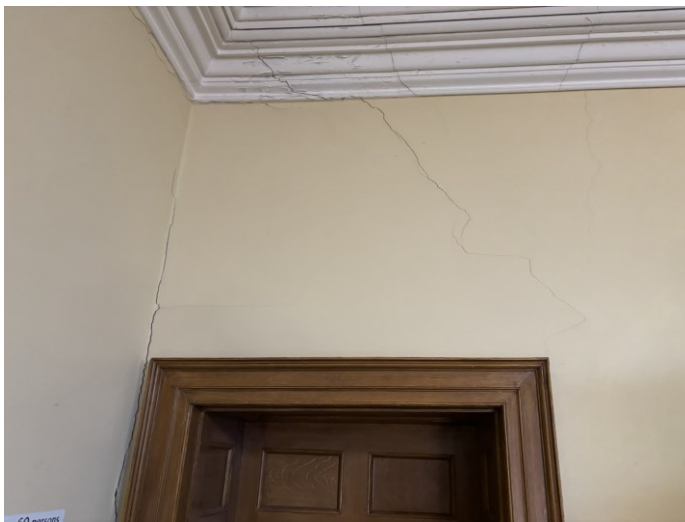
P25 – Overview of principle crack visible.

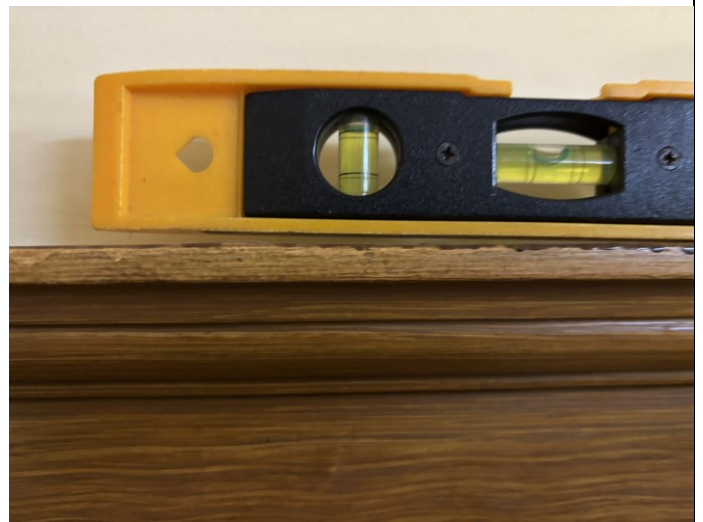
P26 – Evidence of door dropped.

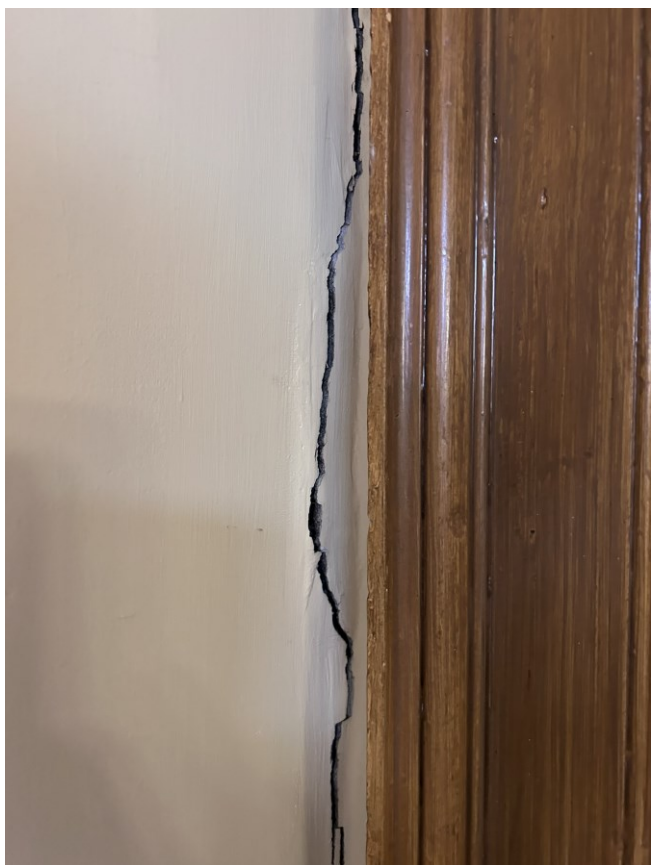
P27 – Close up of structural crack behind door frame.

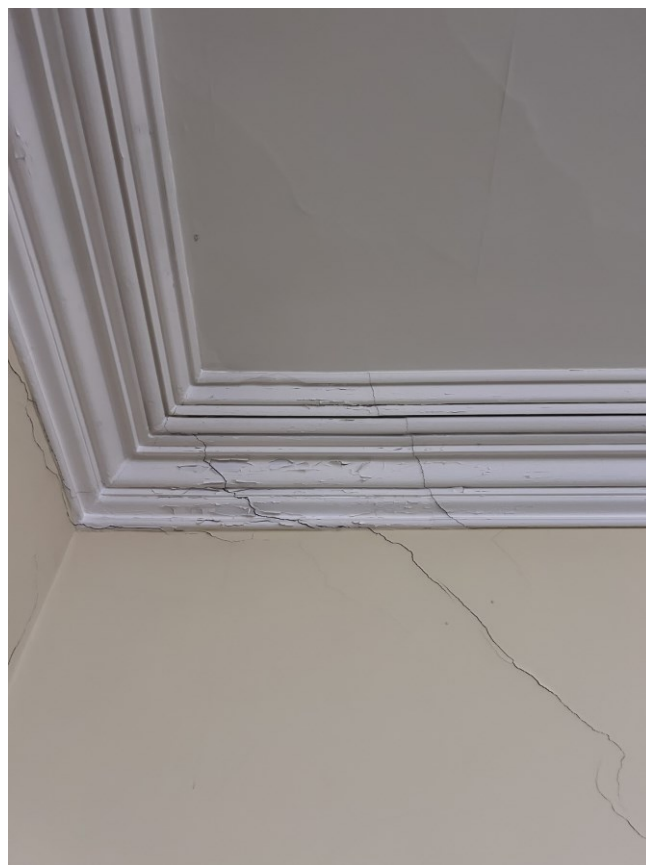
P28 – Hairline cracking coming off of principle crack.

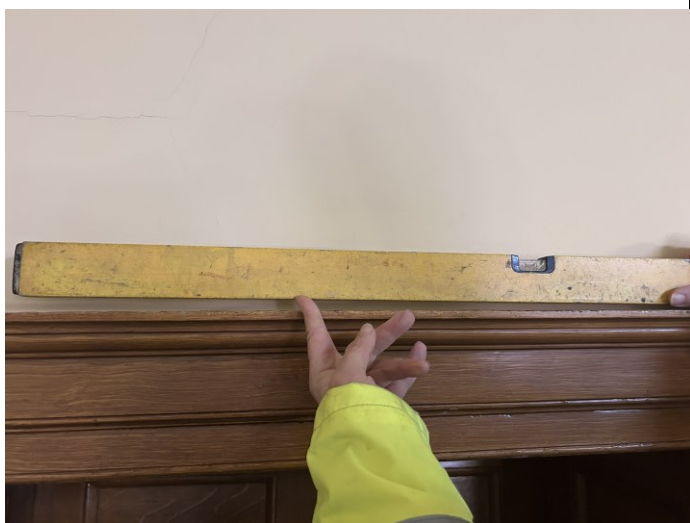
P29 – Door frame has dropped approx 30mm.

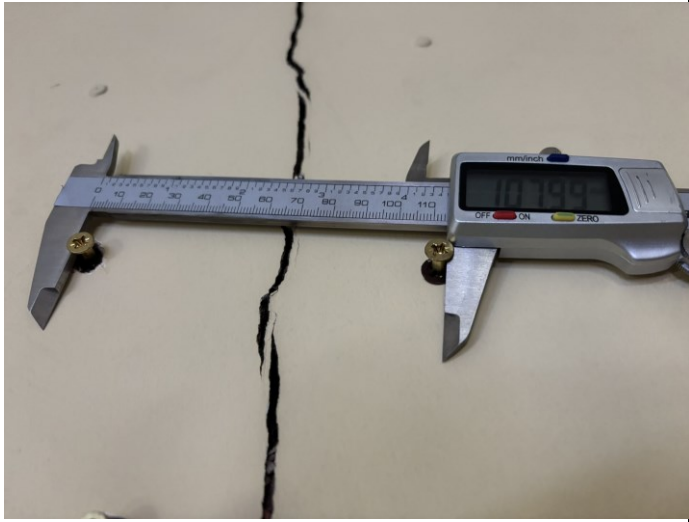
P31 – Digital callipers used to record crack width on North wall.

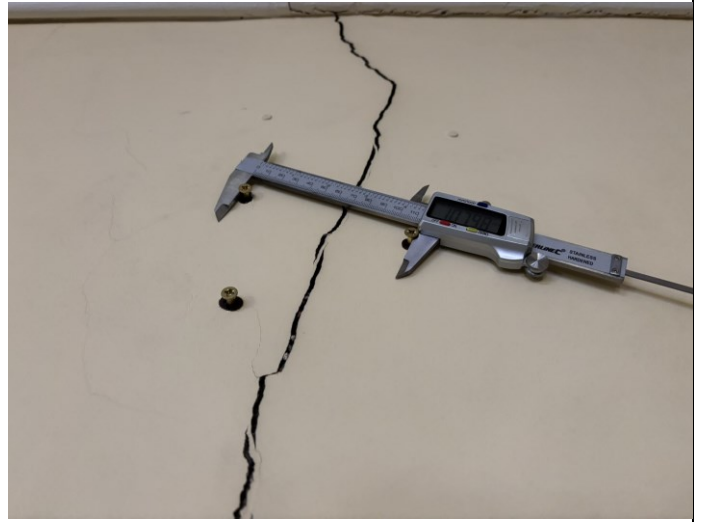
P32 – Digital callipers used to record crack width on North wall.

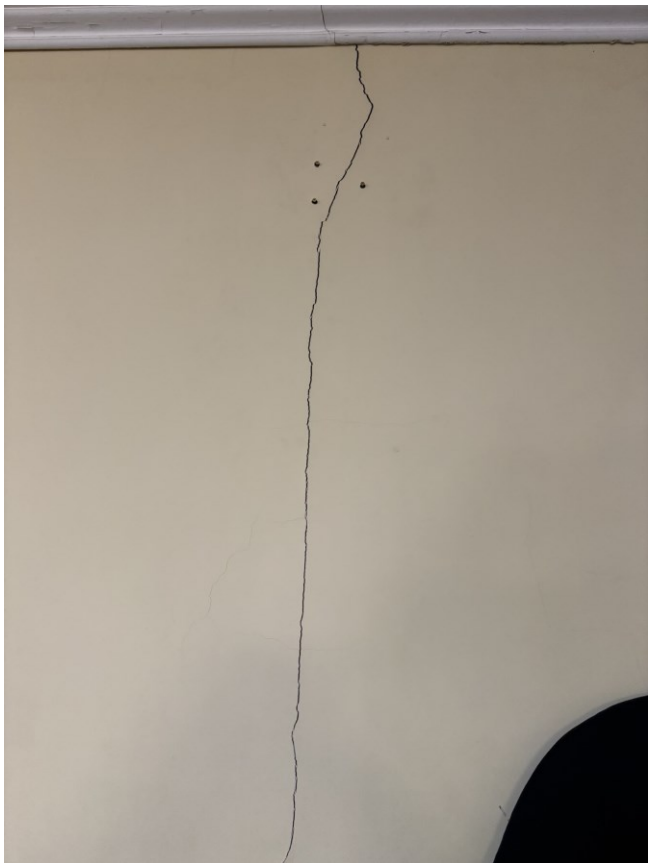
P33 - Overview of principle crack on North wall.

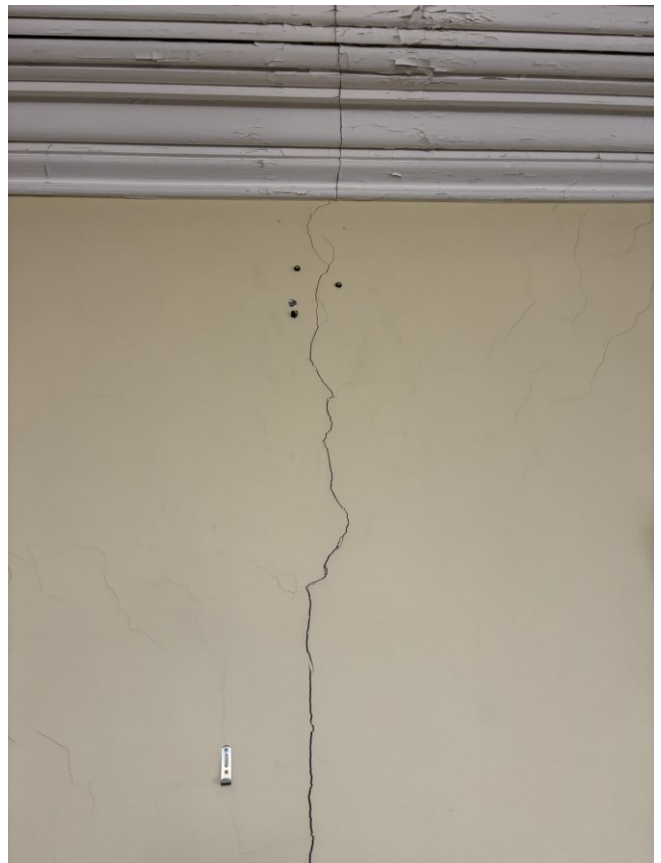
P34 - Overview of principle crack on East wall.

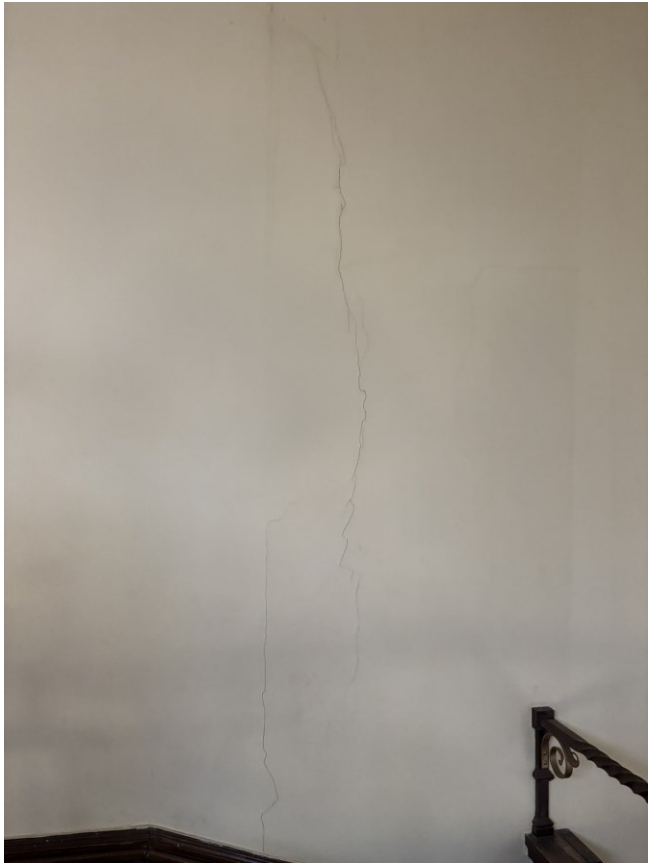
P35 – Hairline cracking observed on South wall.

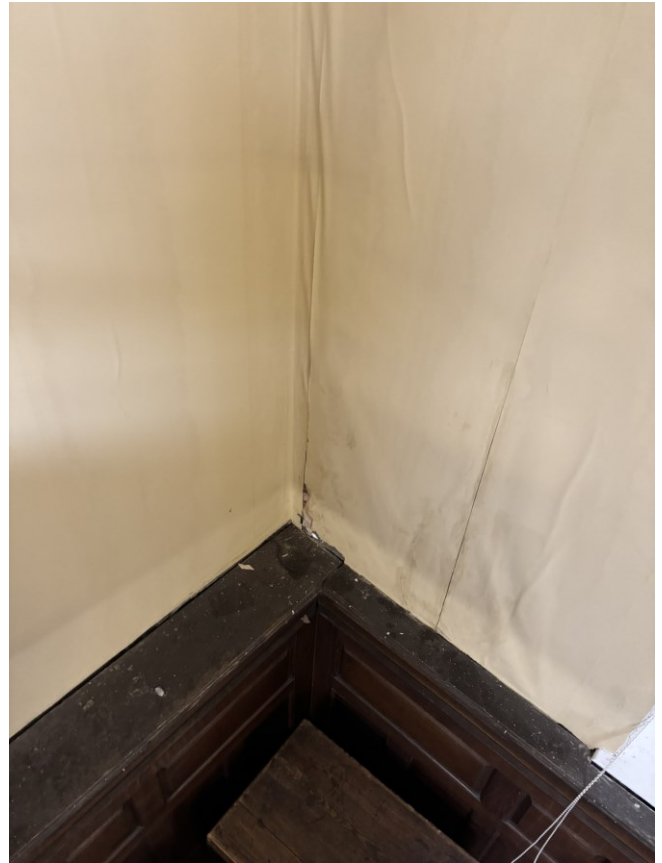
P36 – Signs of previous water ingress on South wall of Oak Court.

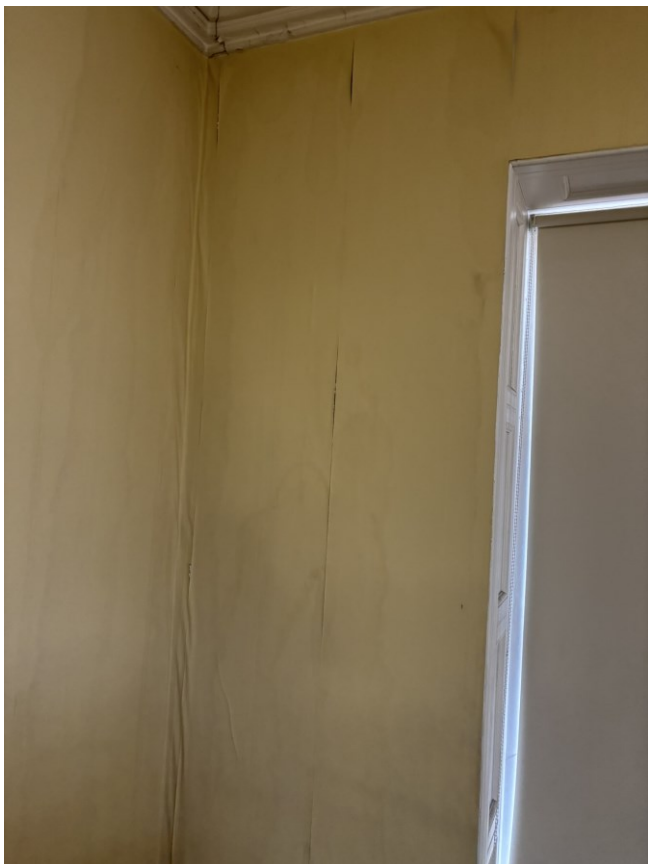
P37 – Signs of previous water ingress on South wall of Oak Court.

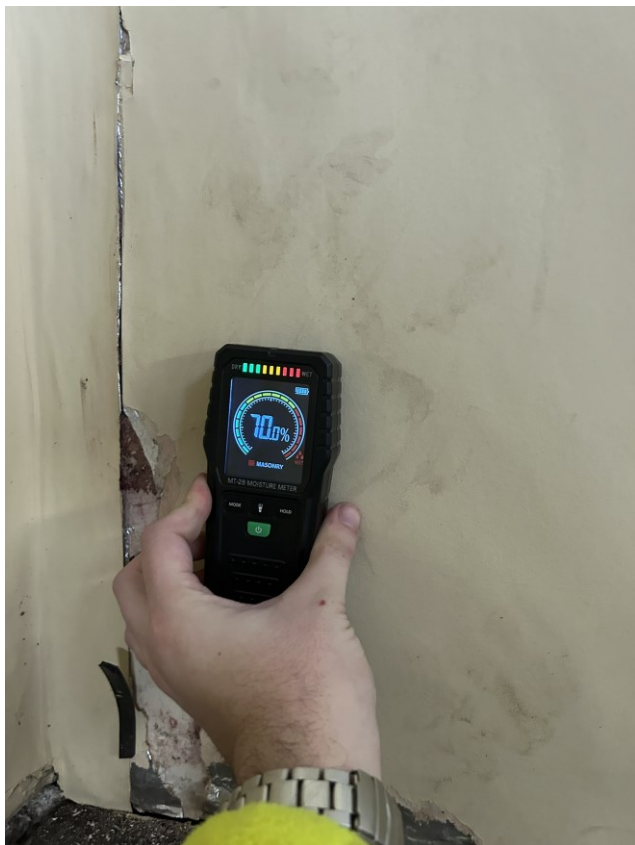
P39 – High readings of moisture however results not accurate due to foil behind paper.

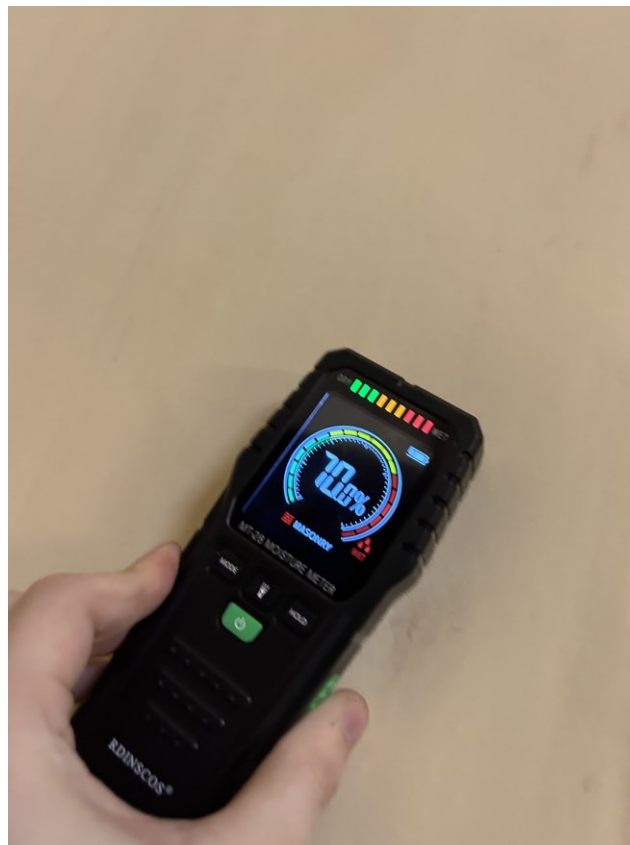
P40 – High readings of moisture however results not accurate due to foil behind paper.

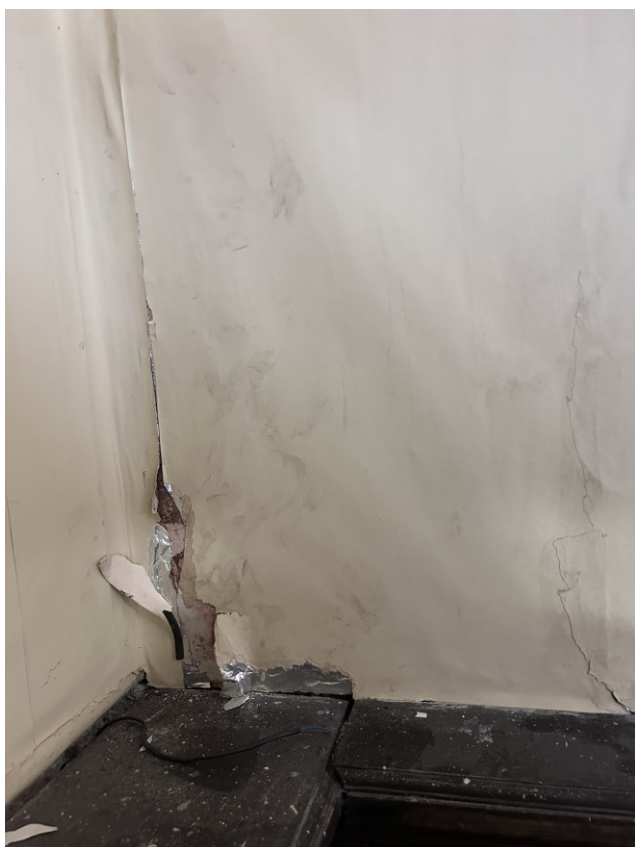
P41 – Paper physically feels fine and no deterioration noted suggesting that the water ingress has been repaired.

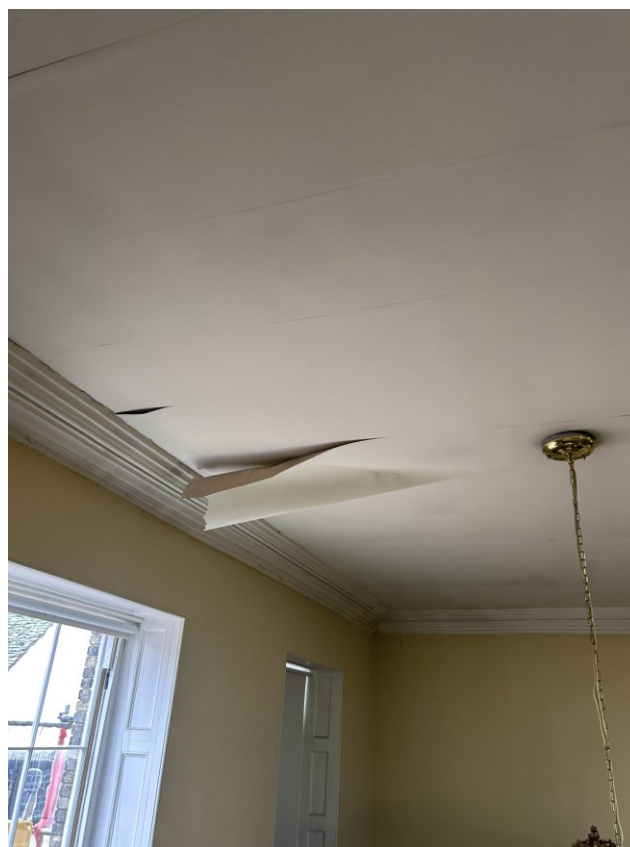
P42 – Paper sheets on ceiling loose.

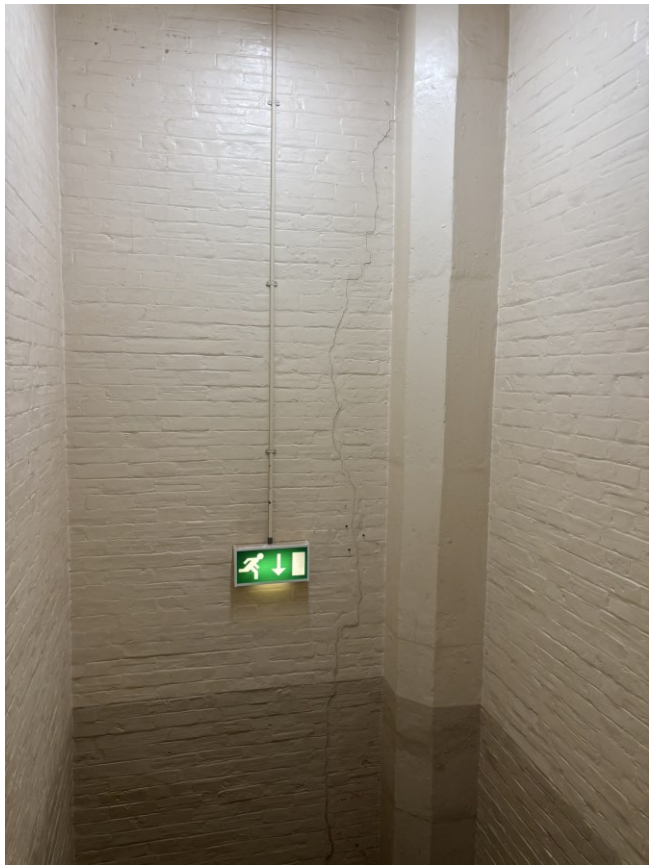
P43 – Overview of crack in staircase.

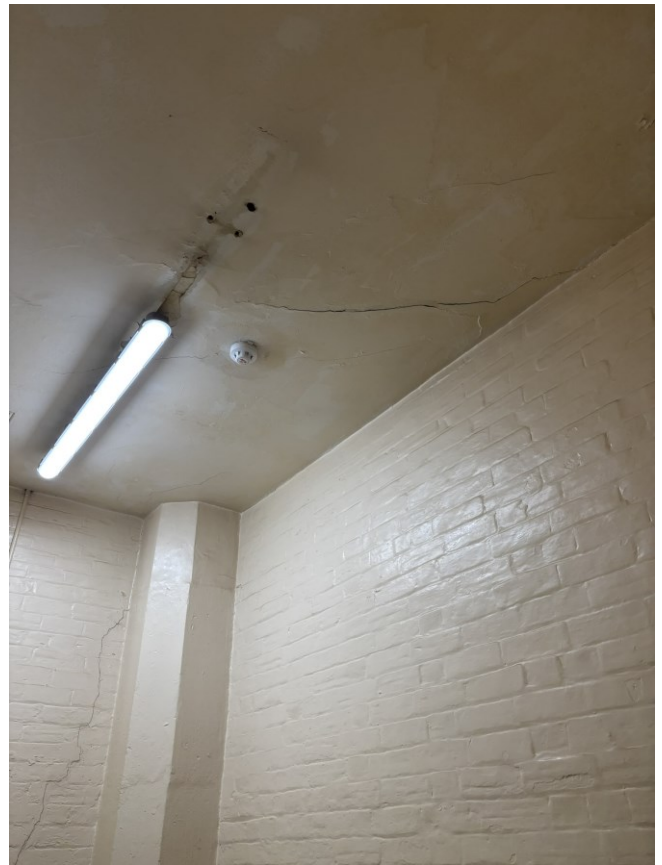
P44 – Evidence of cracking in ceiling as well.

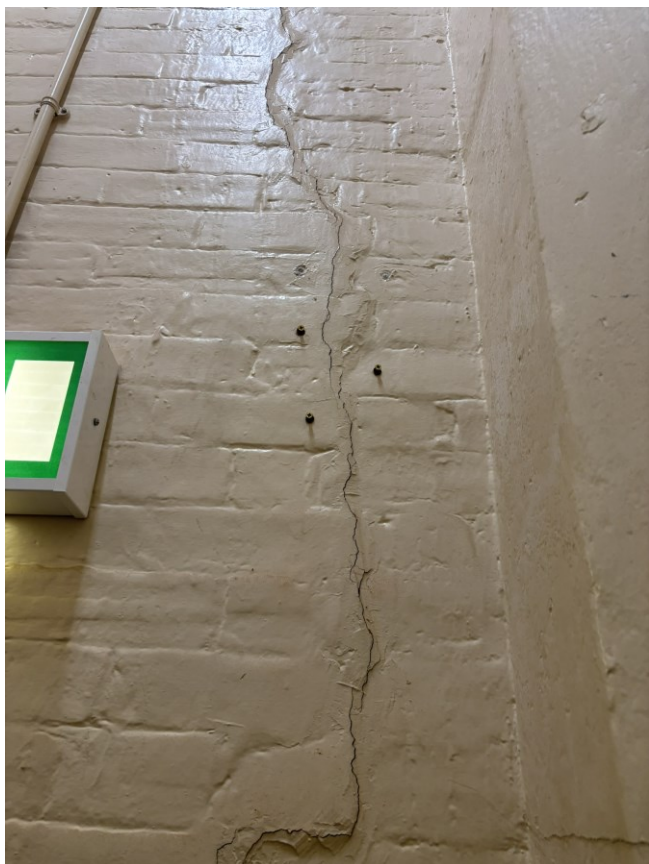
P45 – Crack gauges under monitoring.

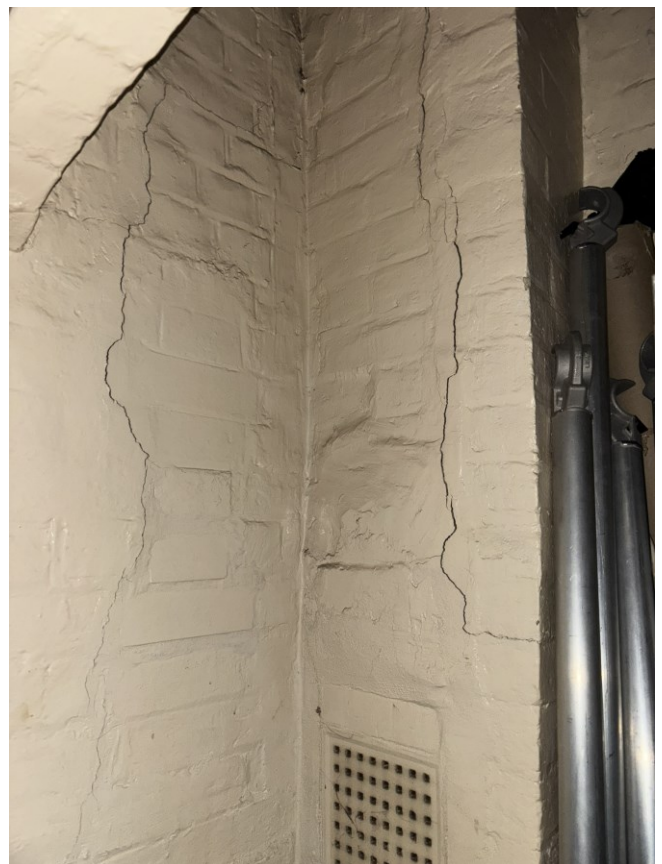
P46 – Cracking extending beneath staircase and further on flue.

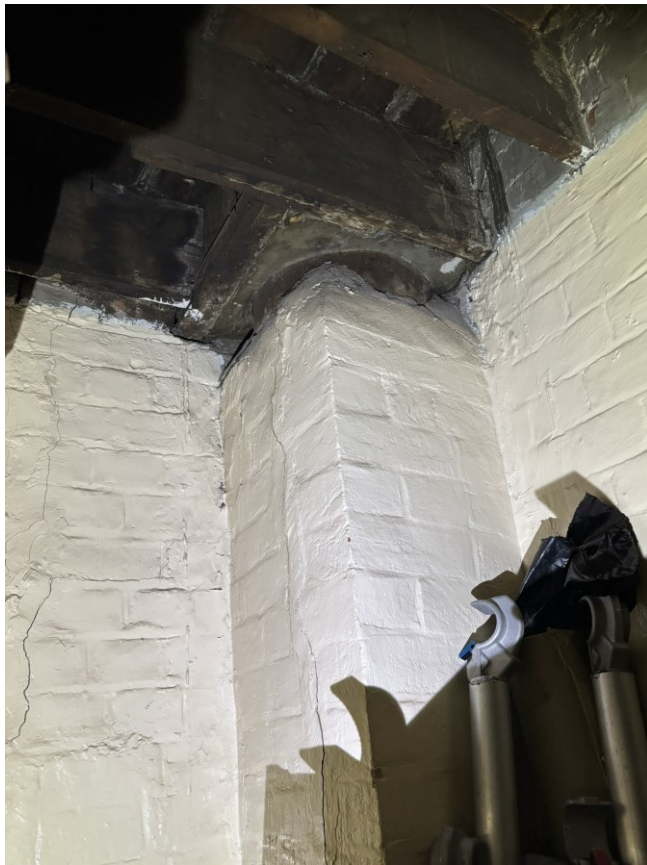
Cracking associated with the basement flue is considered to be driven by a combination of moisture related deterioration, corrosion of the flue, and localised pressure on surrounding brickwork, exacerbated by raised external ground levels and the presence of hygroscopic salts.

P47 – Evidence of corrosion on flue.

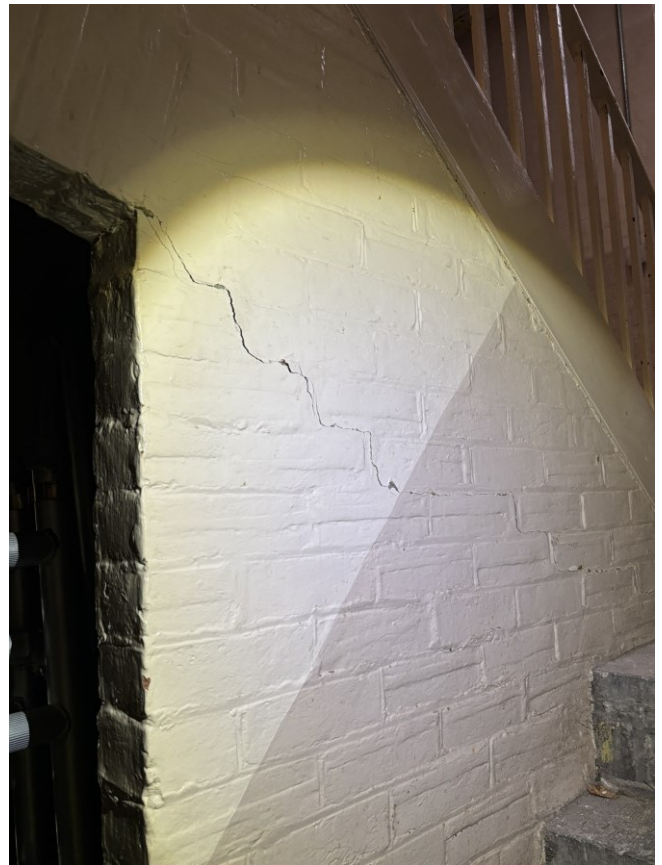
P48 – Stepped crack through course under staircase.

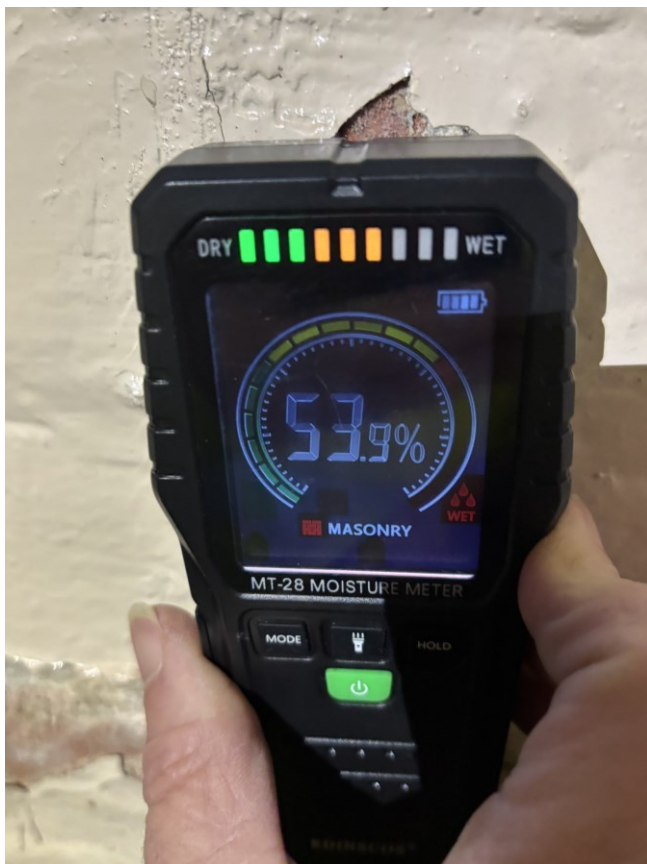
P49 – Elevated readings of moisture levels around flue.
