# Crack Investigation at Salisbury Guildhall

Salisbury City Council

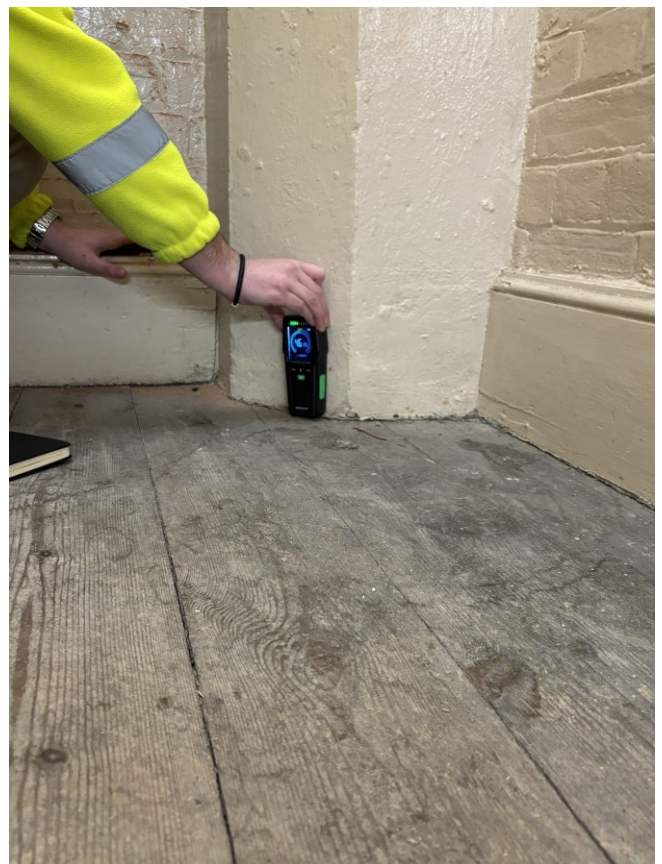
P50 – Elevated readings of moisture levels around flue.

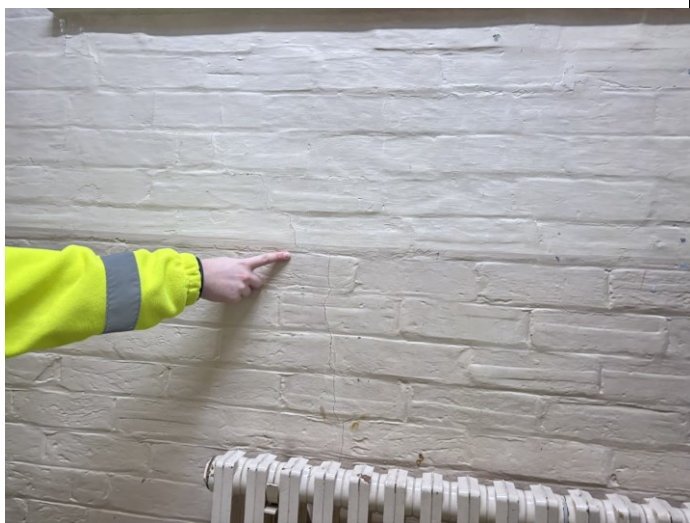
P51 – Crack through course and brickwork underneath Crittle windows.

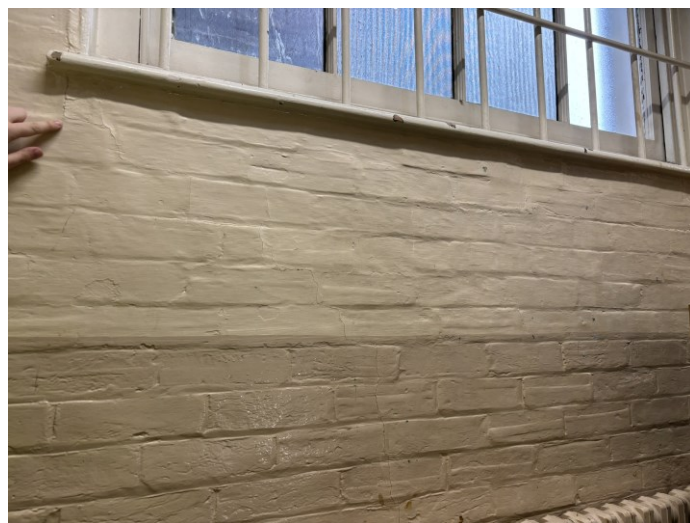
P52 – Crack through course and brickwork underneath Crittle windows.

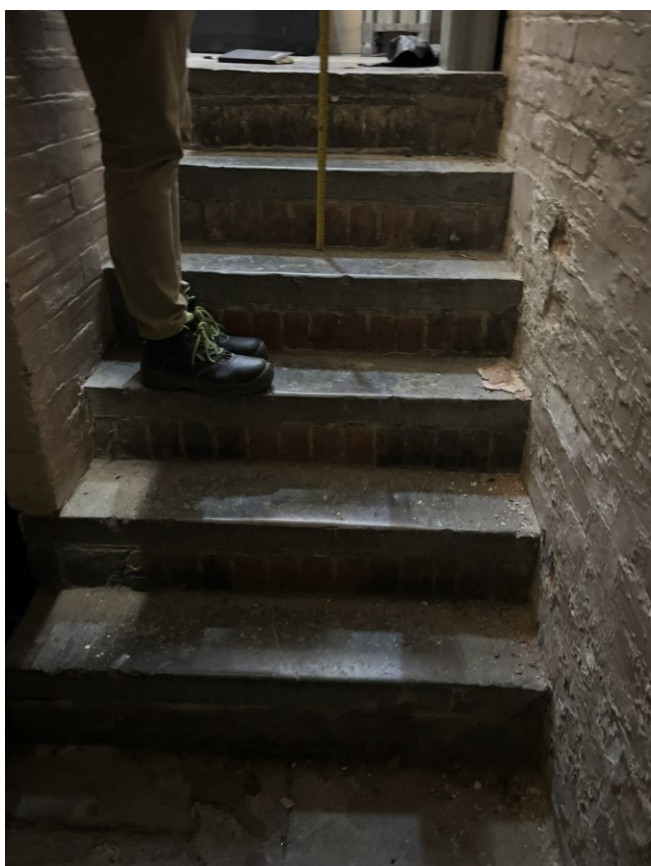
P53 – Bottom of tape measure is actual ground level.

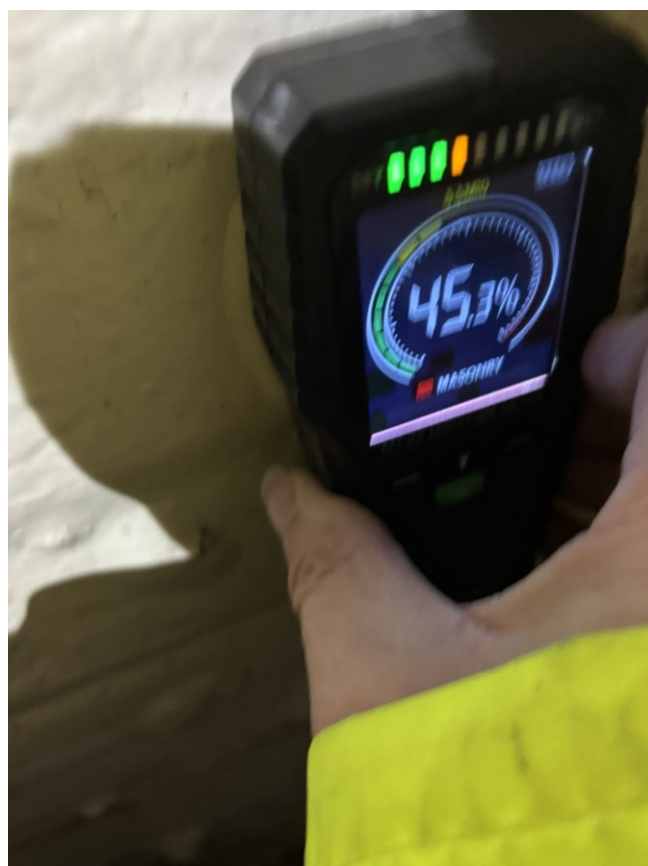
P54 – Elevated readings of moisture levels around flue.

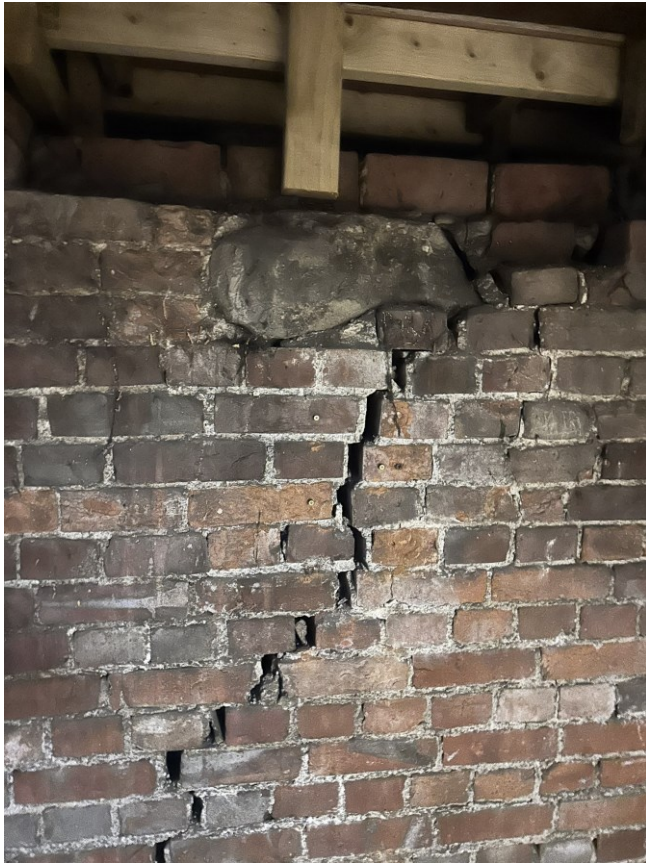
P55 – Crack through brickwork likely caused due to stress from roof.

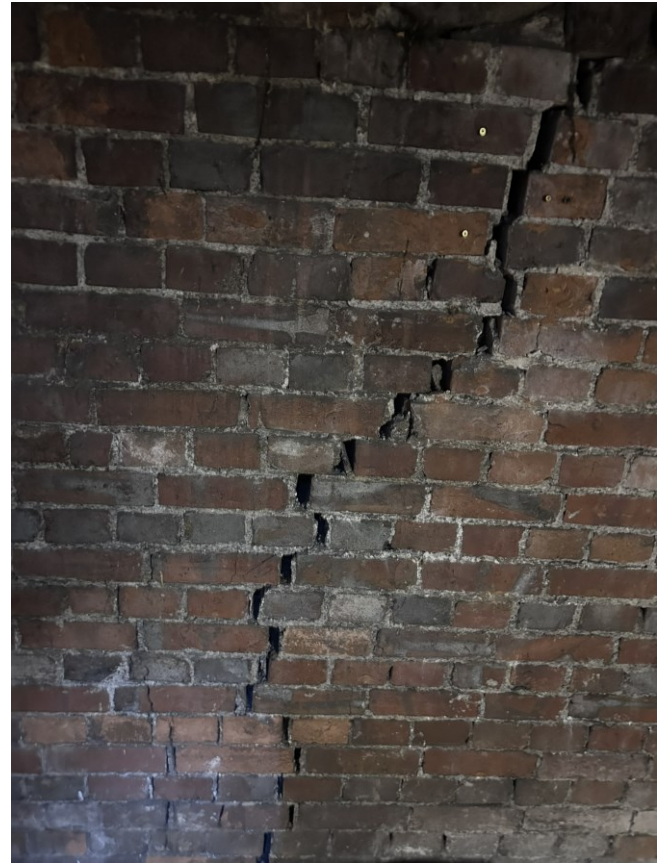
P56 – Crack through brickwork likely caused due to stress from roof.

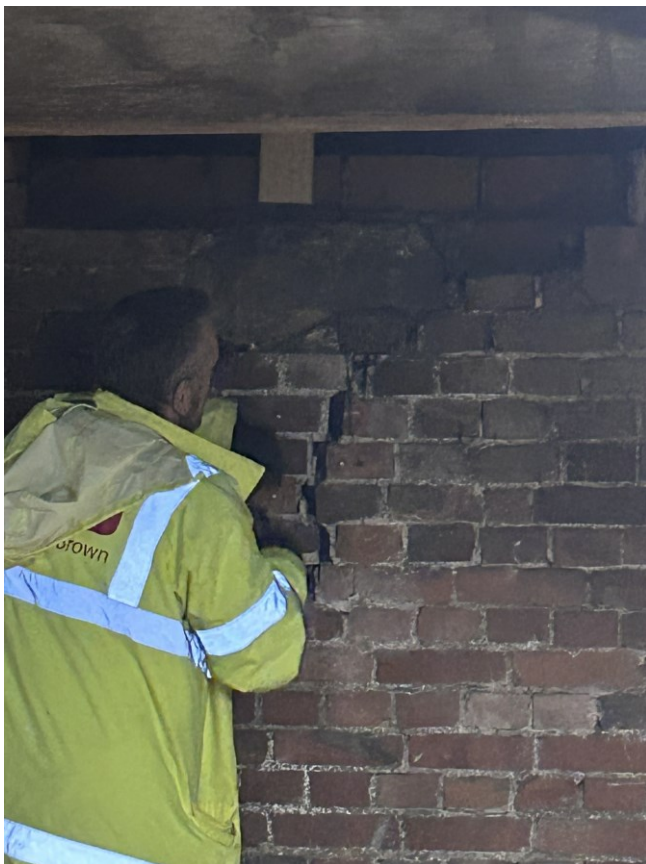
P57 – Crack width is 35mm at widest point.

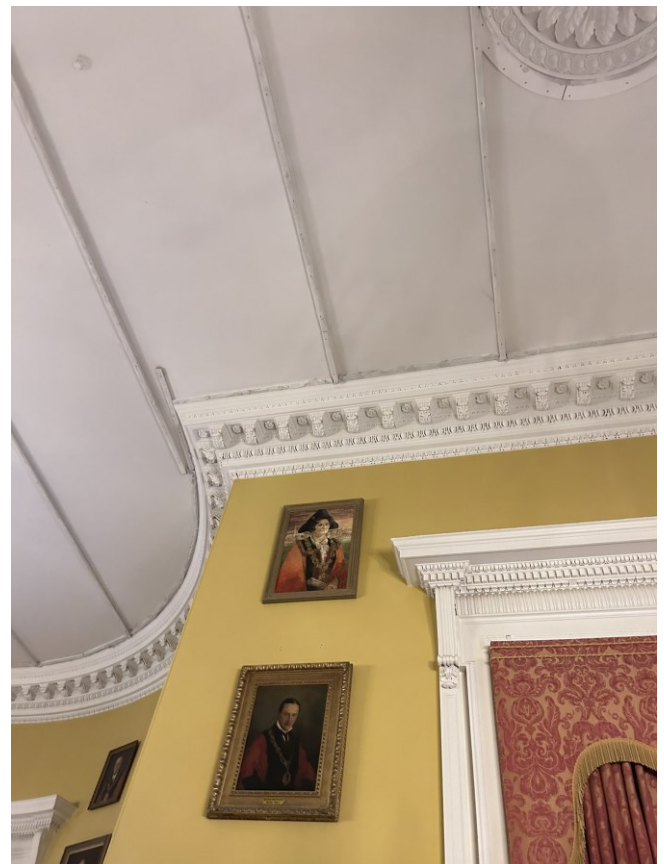
Importantly, the crack was observed to terminate within the roof void and does not continue down through the external wall or on the ceiling beneath into the Banqueting Hall (as seen in image P58).

P58 – No evidence of the crack extending beneath into Banquet Hall.
