## TREE SURVEY & SITE REPORT

Woodland, Trowbridge

17/05/2026

Nurture Group Ltd

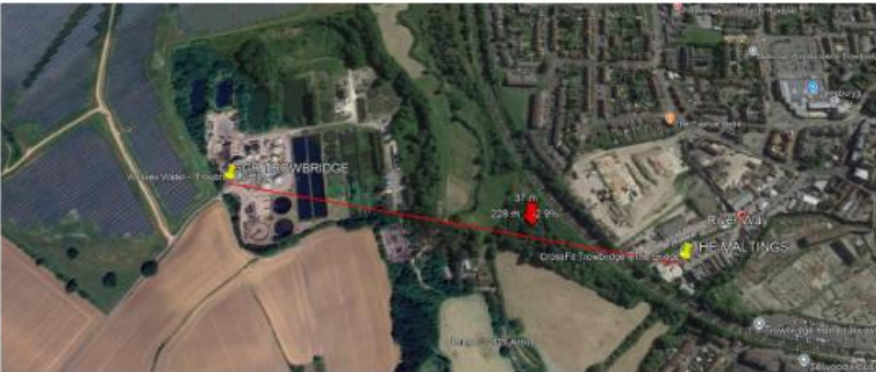
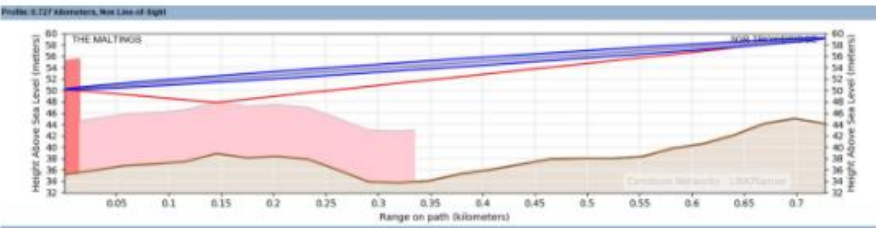
LOS checked by climbing team and drone survey to confirm. LOS is blocked by multiple trees in the first 500m from the B END, some tree's growing alongside the railway line and others further back towards site. It has not been possible to provide specific locations due to the nature of the area and also the fact that several tree's would need cutting most of which are on land we cannot access.

Link profile shown below.

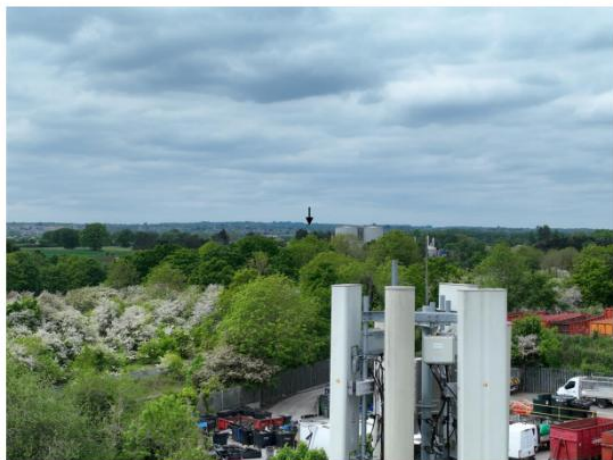
Image from +5 meters above dish, this would be the highest possible mounting point for a dish raise. Far end is now in view but the LOS is still blocked by several tree's in the foreground.

Re route or lease line to A END site would be the best option as there are too many tree's in difficult locations which I cannot identify. Dish raise does not look viable as even at the max possible height the LOS was still compromised. TXN team to provide feedback on which option is best suited.

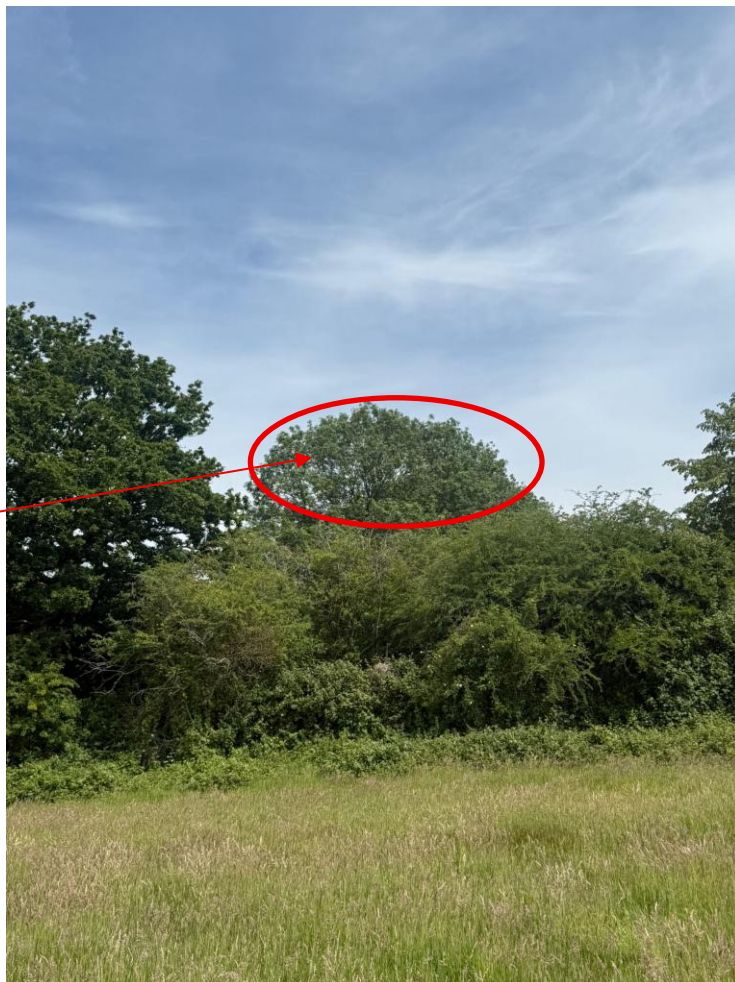
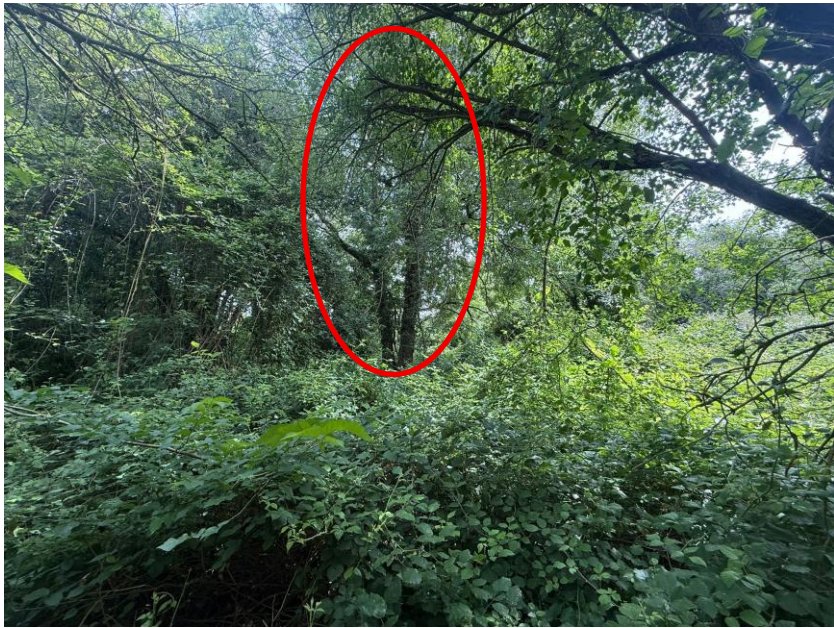
During the inspection, several trees within the woodland were found to have the potential to interfere with the signal path. However, it was determined that a mature Ash tree is the primary contributor to the obstruction due to its size, crown spread and position relative to the signal line.

Ash tree causing obstruction

It is recommended that the mature Ash tree undergoes a **4 -metre crown reduction**, focused on the sections of the canopy affecting the signal path. The works should be completed in accordance with **BS3998:2010 – Tree Work – Recommendations**, ensuring the tree retains an appropriate natural form while restoring and maintaining the required line of sight.

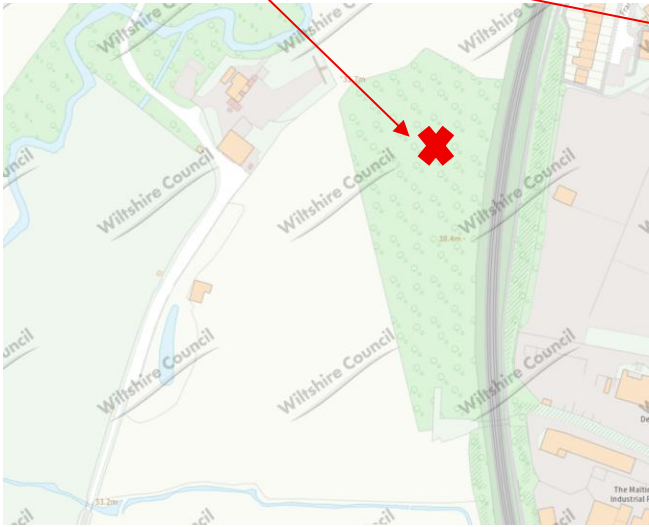
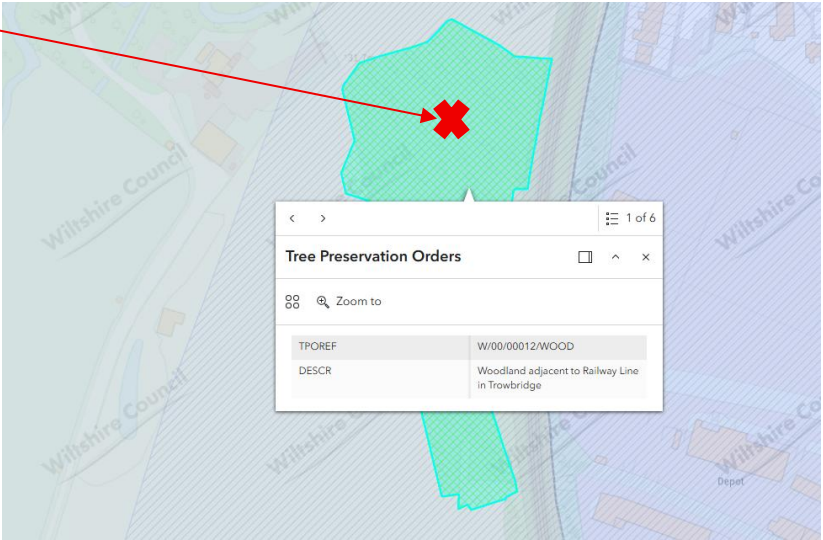
Ash tree location within woodland TPO

The woodland is protected by a **Tree Preservation Order (TPO)**, and as such, no pruning or tree works may be undertaken without obtaining prior written consent from the Local Planning Authority (LPA), unless exemptions apply under current legislation. It is therefore recommended that a formal TPO application is submitted detailing the proposed **5-metre crown reduction** to the identified Ash tree, together with the arboricultural justification relating to the restoration of the required line of sight. No works should commence until the necessary consent has been granted.
