# RIBA STAGE 3 - STATEMENT OF SIGNIFICANCE FOR LISTED BUILDING CONSENT APPLICATION

Window renovations  
16 Cross Keys, Corsham SN13 0DT  
Revision (-) Issued June 2026

TABLE 1: CONDITION SURVEY

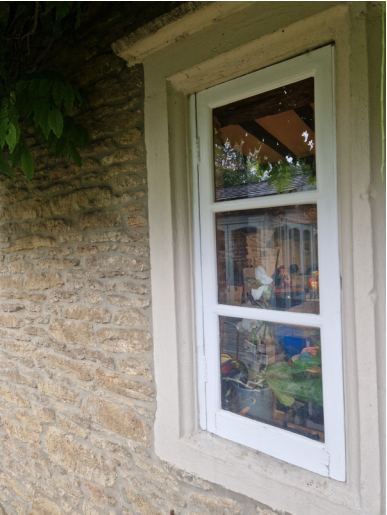
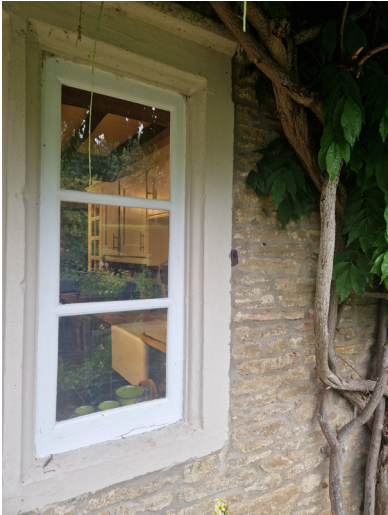
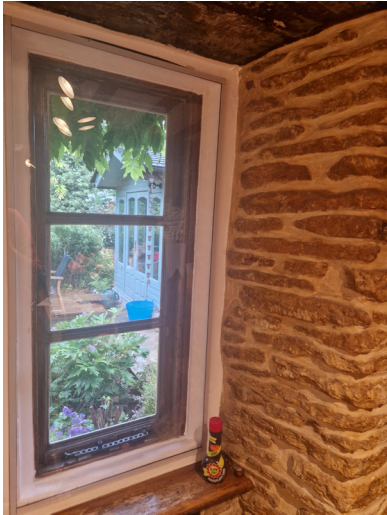
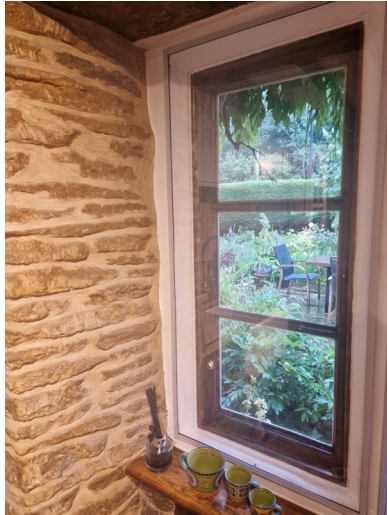
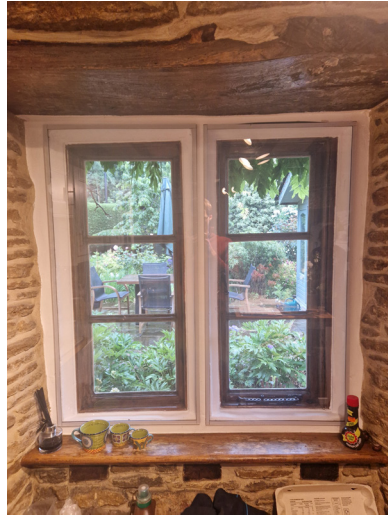
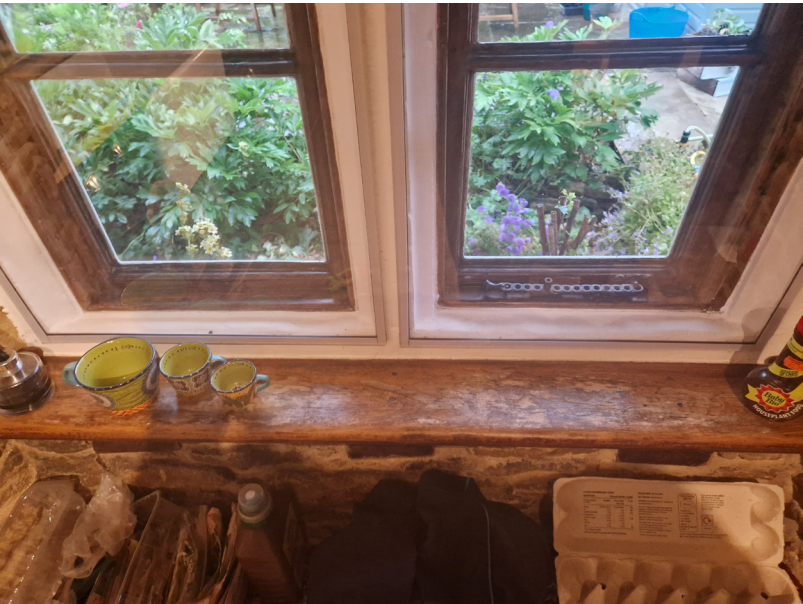
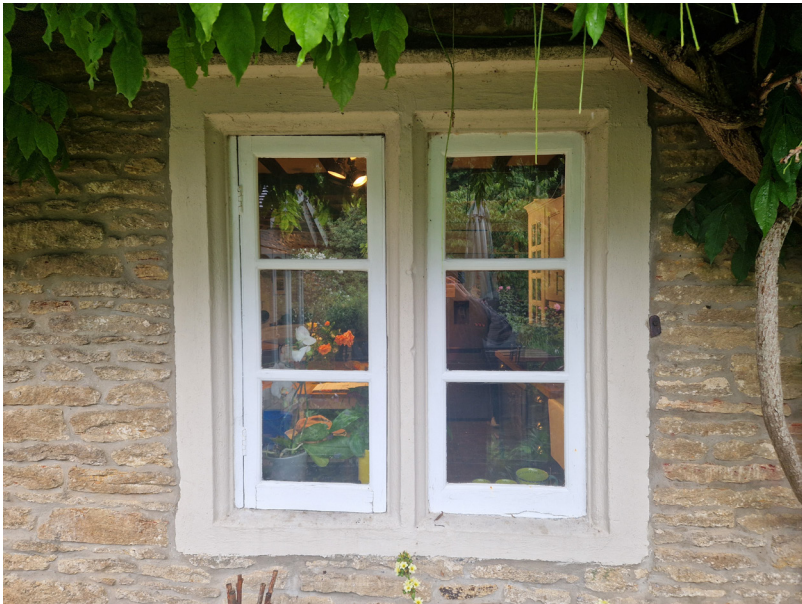
**WINDOW IDENT: WG01**

| Window Ident | Location | Action needed to the frames | Action needed to the Sashes |
|---|---|---|---|
| WG01 | South-East elevation | Casements very poor. Lower half of stiles, bottom rail and glazing bars rotten and beyond repair, will need to be remade | Frame very poor, Cill and Jambs beyond repair. Frame will need to be remade |

Frames and casements to be repaired in accordance with the noted actions in Table 1. Where appropriate, historic fabric shall be retained wherever possible, with localised, rotted sections of frames to be carefully removed with new paint-quality hardwood frames scarfed / spliced in.

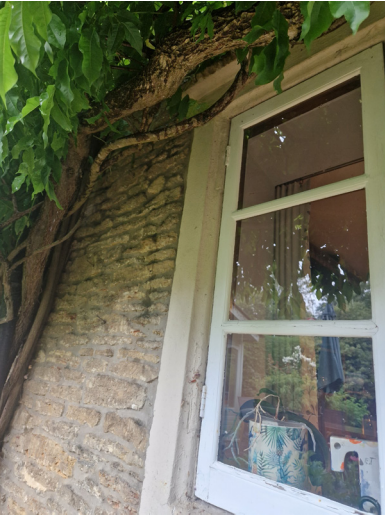
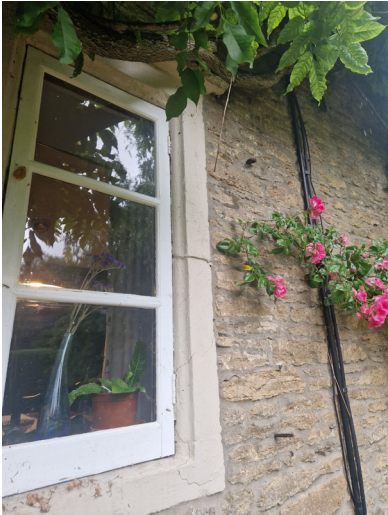
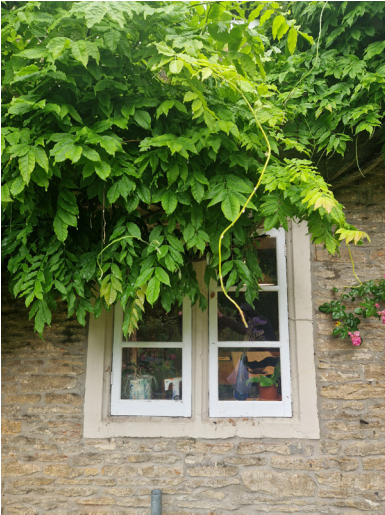
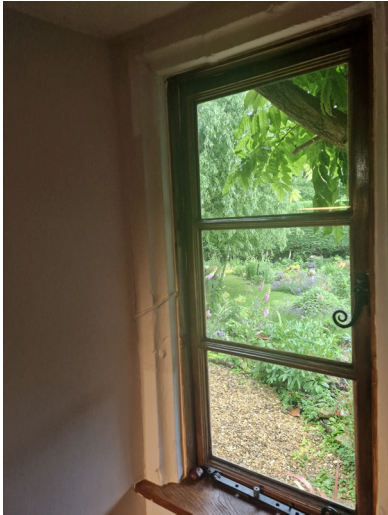
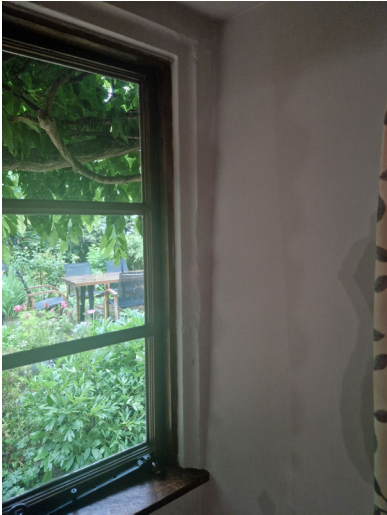
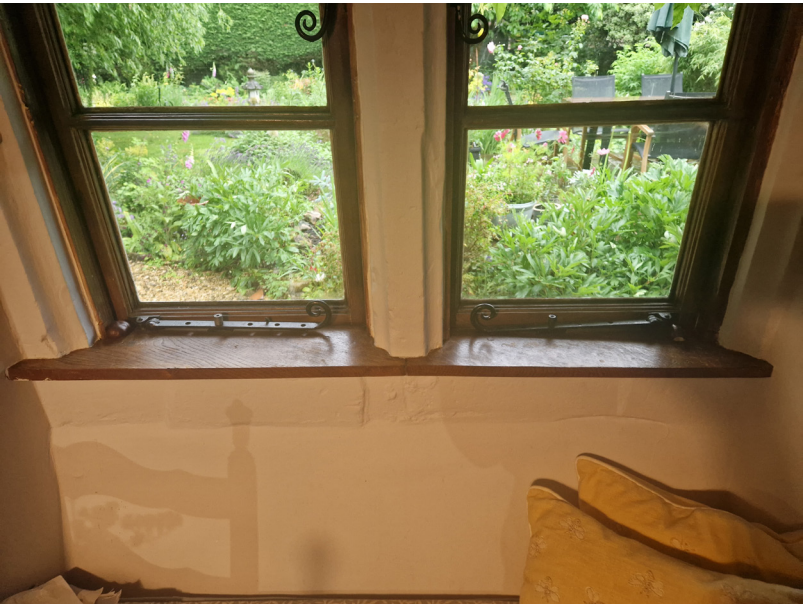
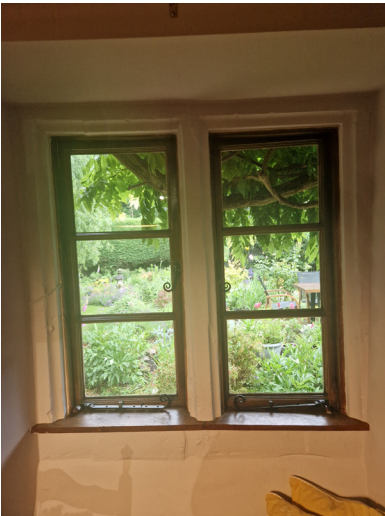
**WINDOW IDENT: WG02**

| Window Ident | Location | Action needed to the frames | Action needed to the Sashes |
|---|---|---|---|
| WG02 | South-East elevation | Casements very poor. Lower half of stiles, bottom rail and glazing bars rotten and beyond repair, will need to be remade | Frame very poor, Cill and Jambs beyond repair. Frame will need to be remade |

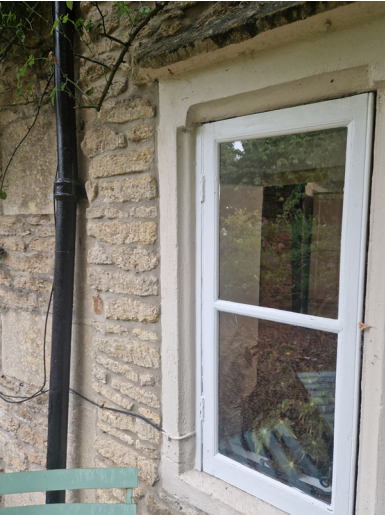
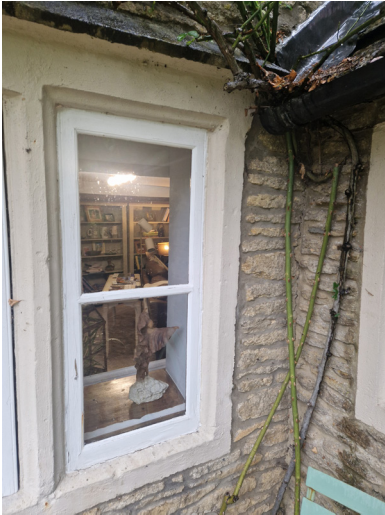
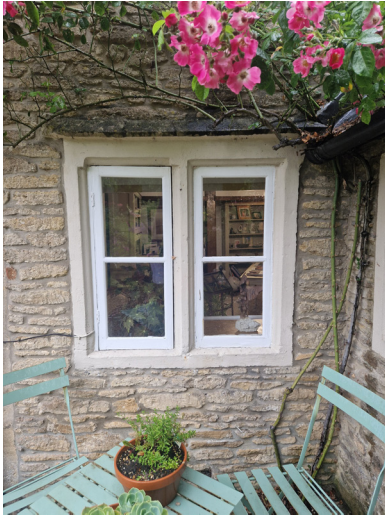
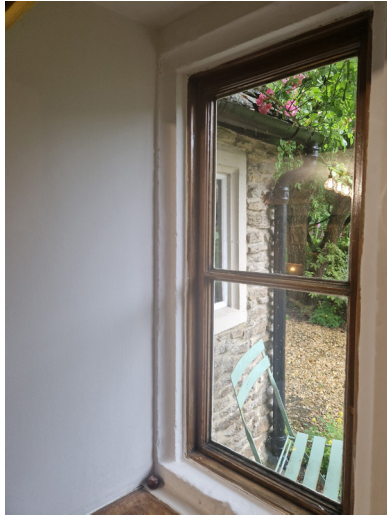
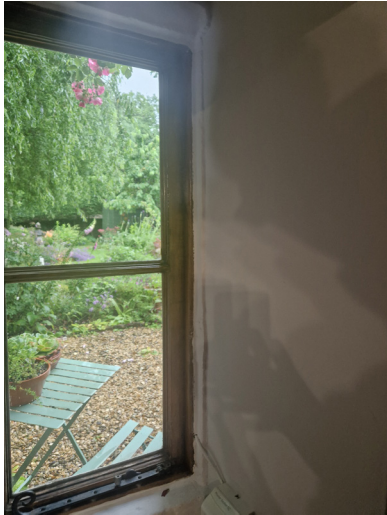
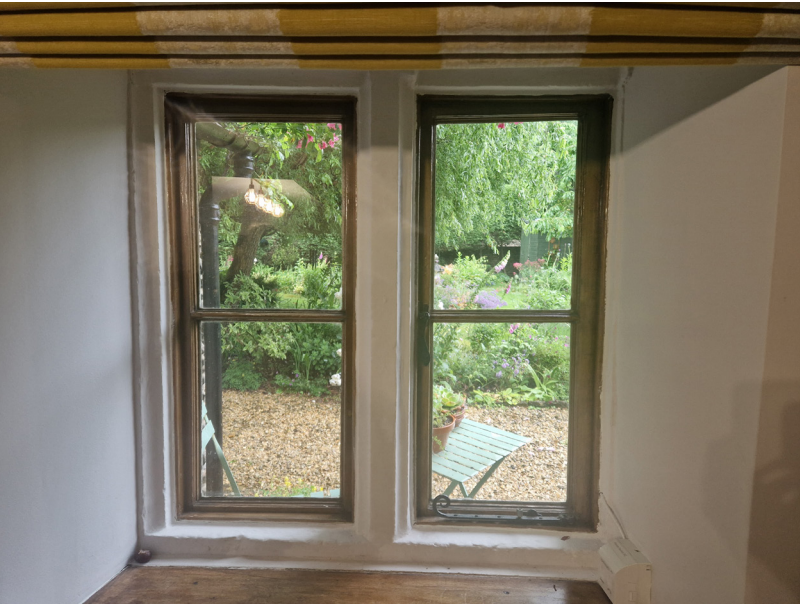
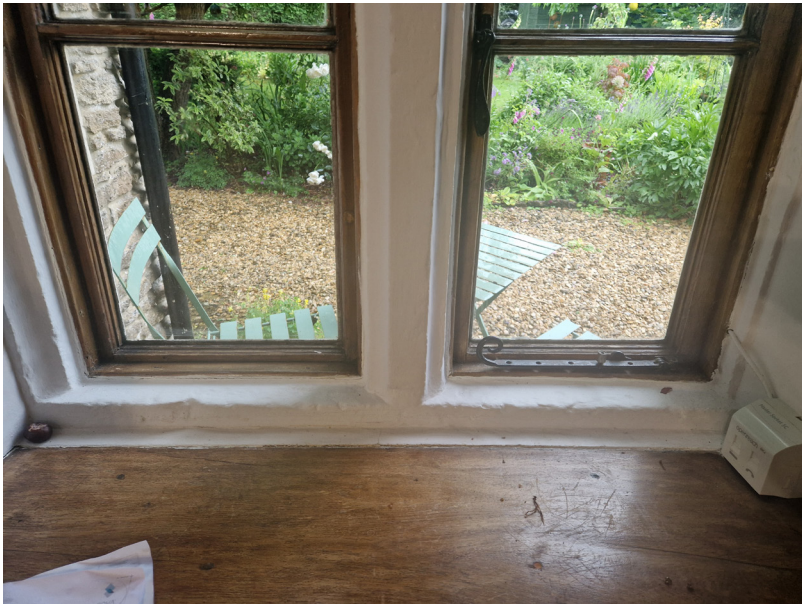
**WINDOW IDENT: WG03**

| Window Ident | Location | Action needed to the frames | Action needed to the Sashes |
|---|---|---|---|
| WG03 | South-East elevation | Casements very poor. Lower half of stiles, bottom rail and glazing bars rotten and beyond repair, will need to be remade | Frame very poor, Cill and Jambs beyond repair. Frame will need to be remade |

Frames and casements to be repaired in accordance with the noted actions in Table 1. Where appropriate, historic fabric shall be retained wherever possible, with localised, rotted sections of frames to be carefully removed with new paint-quality hardwood frames scarfed / spliced in.

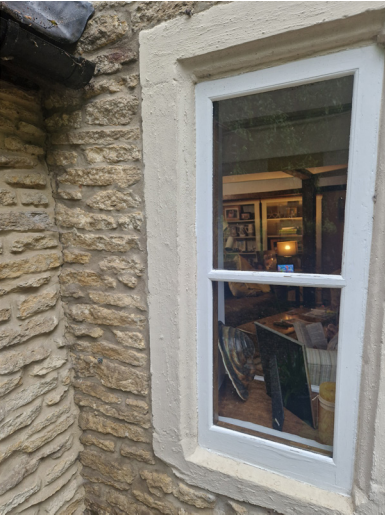
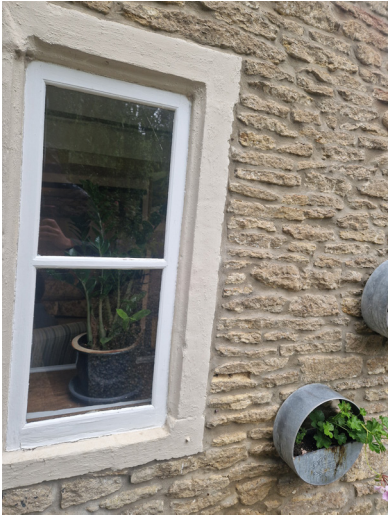
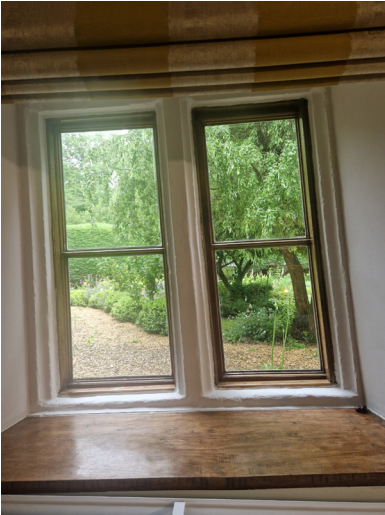
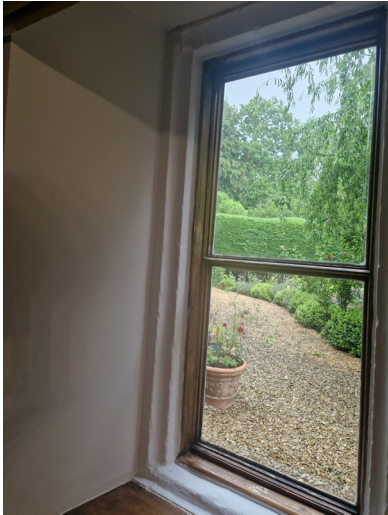
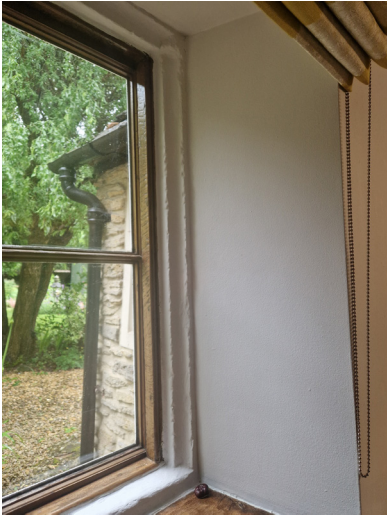
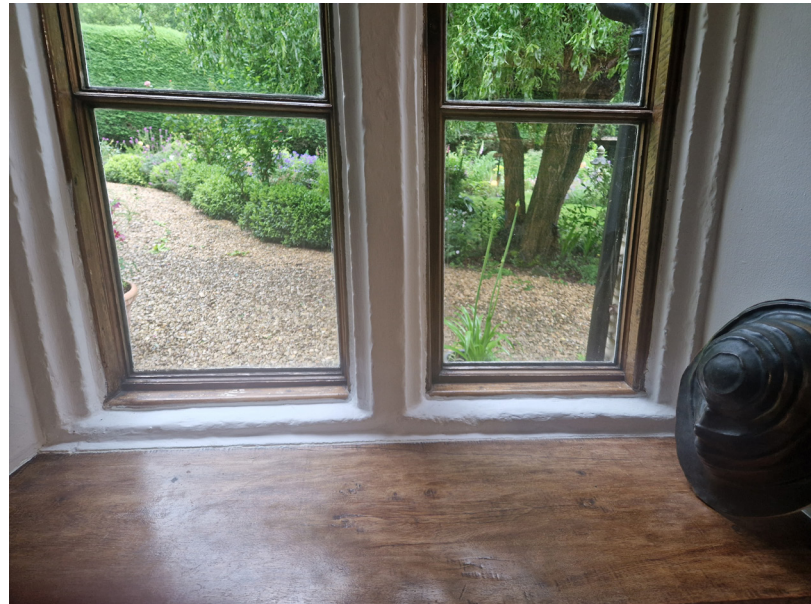
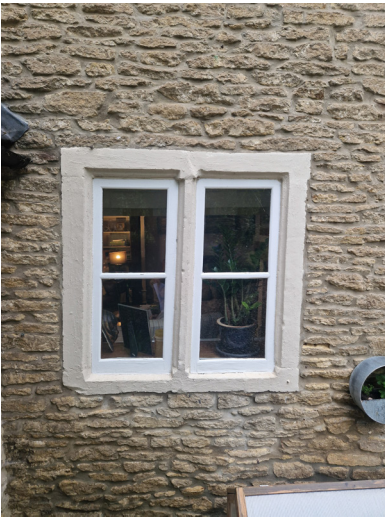
**WINDOW IDENT: WG04**

| Window Ident | Location | Action needed to the frames | Action needed to the Sashes |
|---|---|---|---|
| WG04 | South-East elevation | Casements very poor. Lower half of stiles, bottom rail and glazing bars rotten and beyond repair, will need to be remade | Frame very poor, Cill and Jambs beyond repair. Frame will need to be remade |

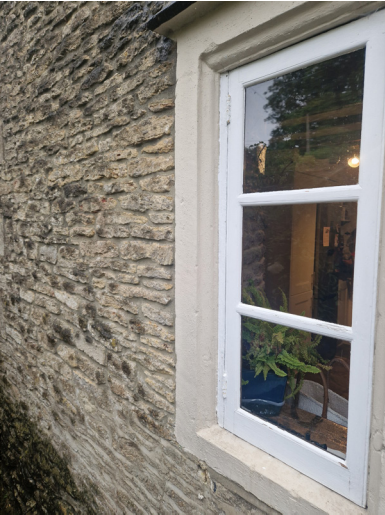
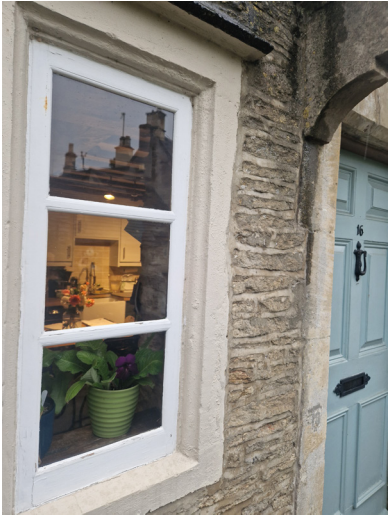
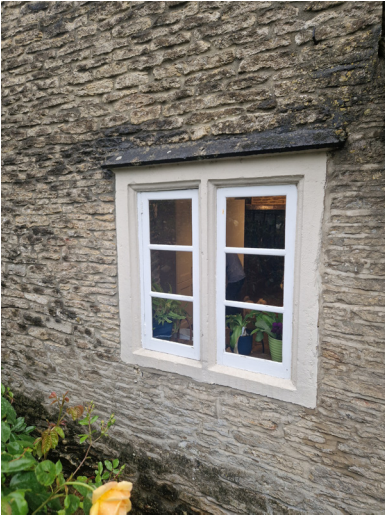
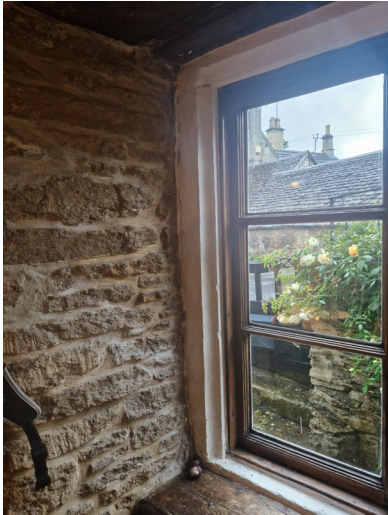
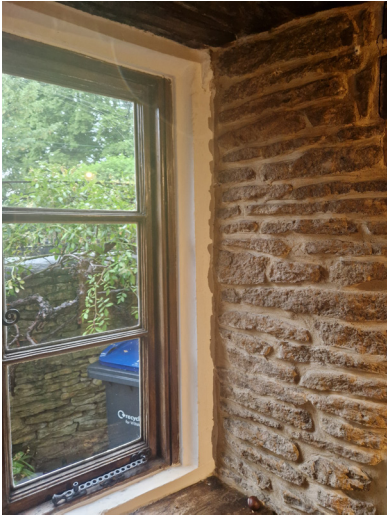
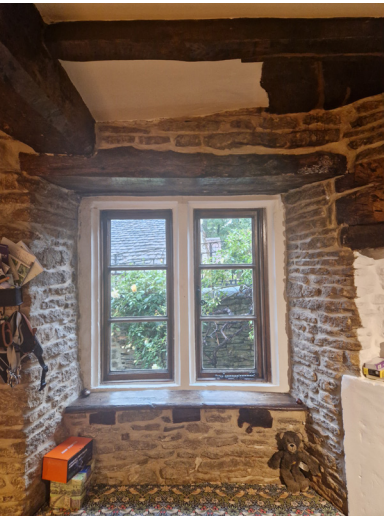
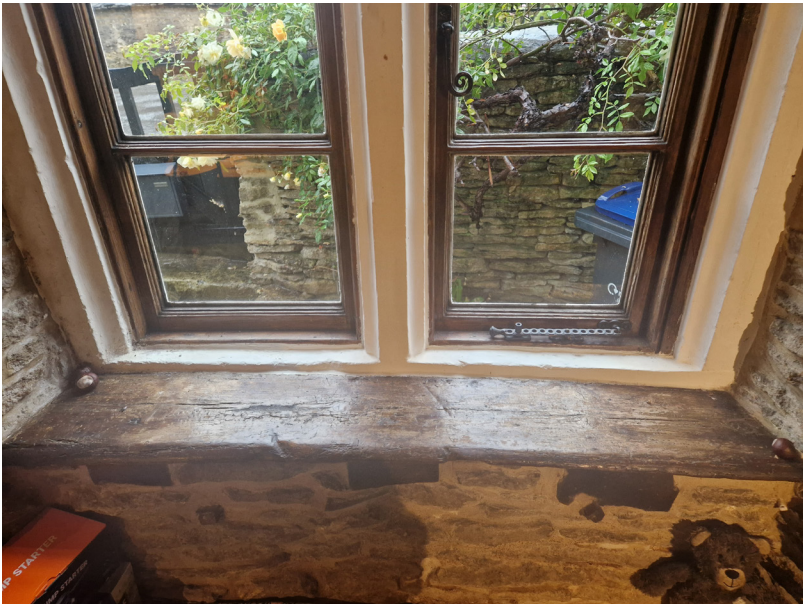
**WINDOW IDENT: WG05**

| Window Ident | Location | Action needed to the frames | Action needed to the Sashes |
|---|---|---|---|
| WG05 | South-West elevation | Casements very poor. Lower half of stiles, bottom rail and glazing bars rotten and beyond repair, will need to be remade | Frame very poor, Cill and Jambs beyond repair. Frame will need to be remade |

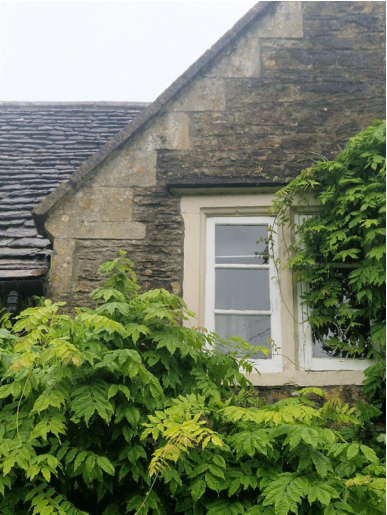
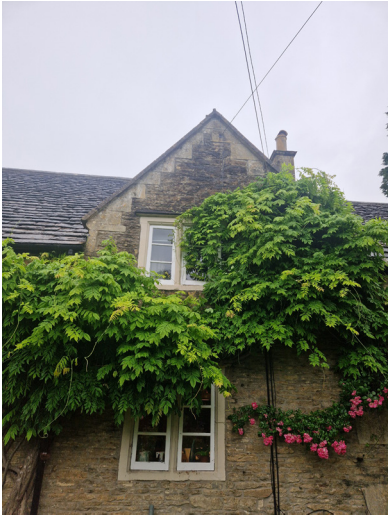
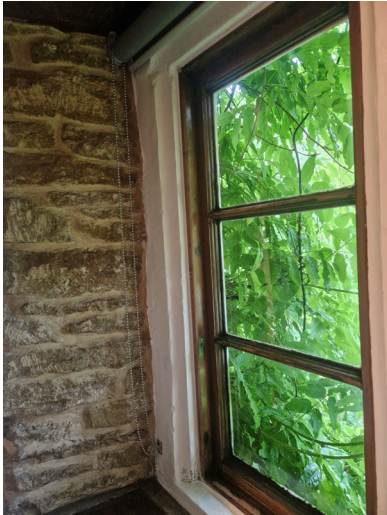
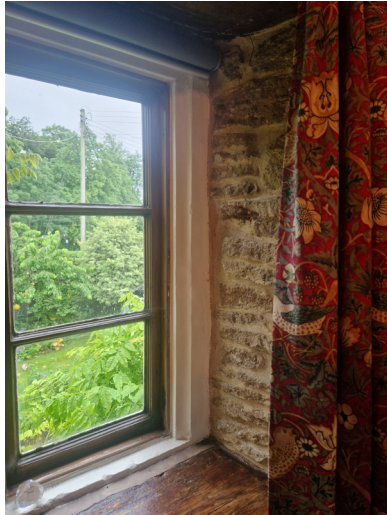
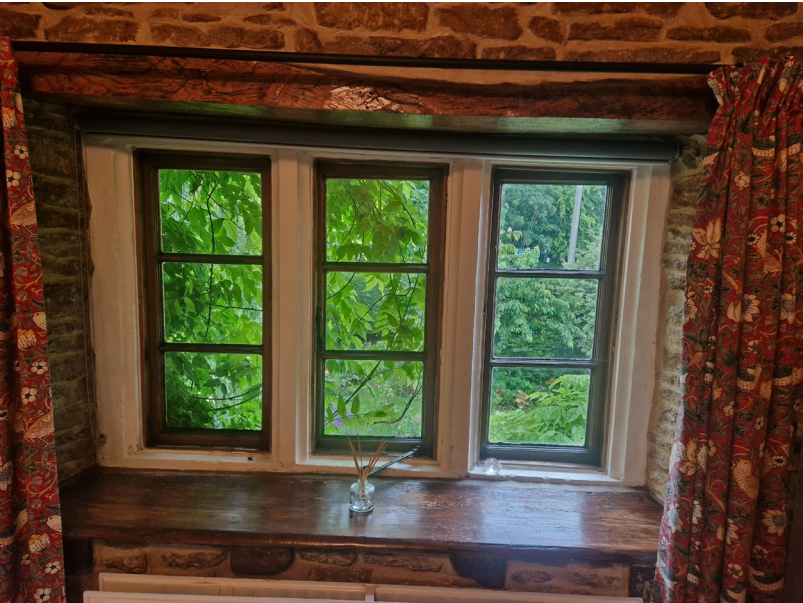
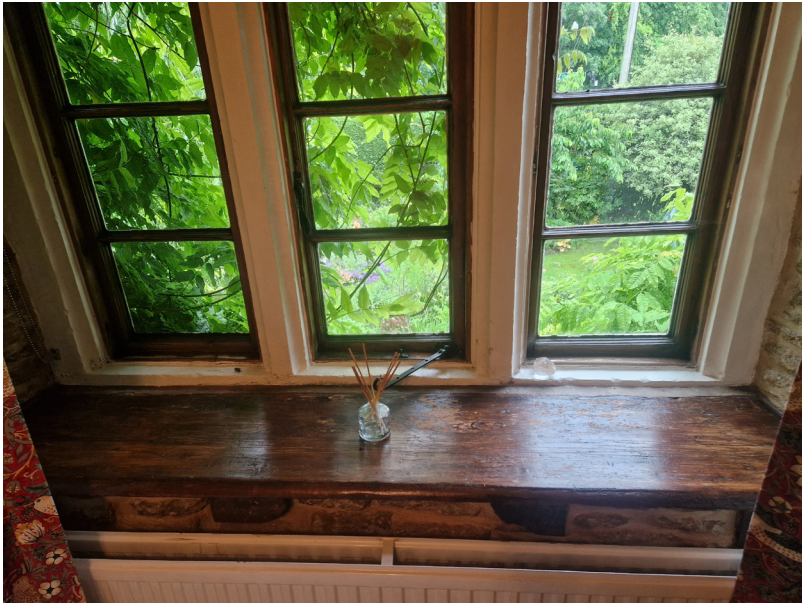
**WINDOW IDENT: WF01**

| Window Ident | Location | Action needed to the frames | Action needed to the Sashes |
|---|---|---|---|
| WF01 | South-East elevation | Casements completely rotten. Casements will need to be remade. | Frame completely rotten. Frame will need to be remade |

Frames and casements to be repaired in accordance with the noted actions in Table 1. Where appropriate, historic fabric shall be retained wherever possible, with localised, rotted sections of frames to be carefully removed with new paint-quality hardwood frames scarfed / spliced in.

New glazing bars to be paint-quality hardwood with 18mm ovolo profiles. New slim line double glazed' panes to be set into three 3 panes casements.

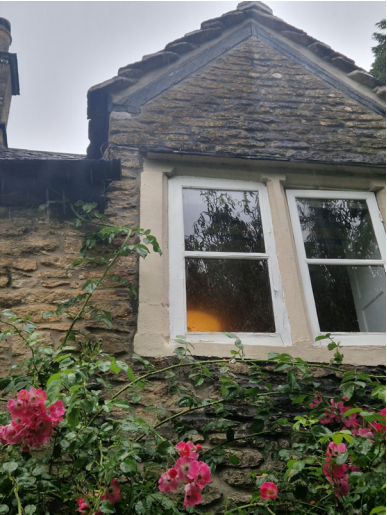
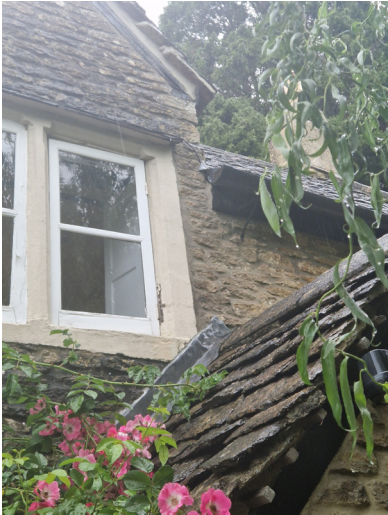
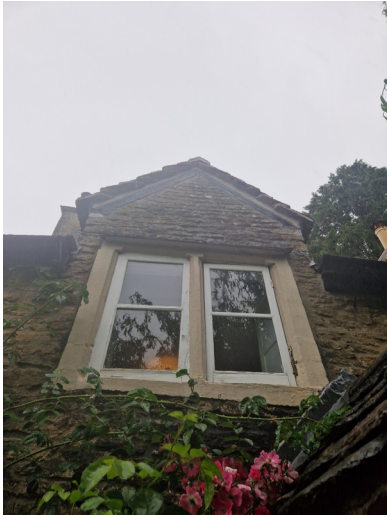
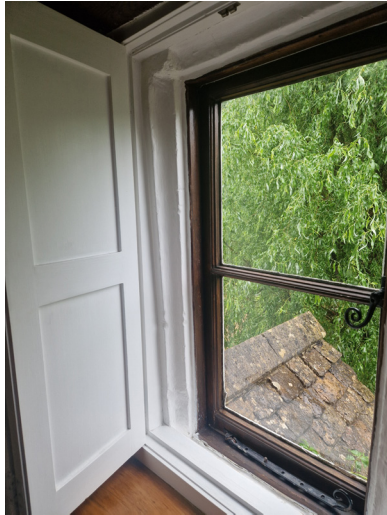
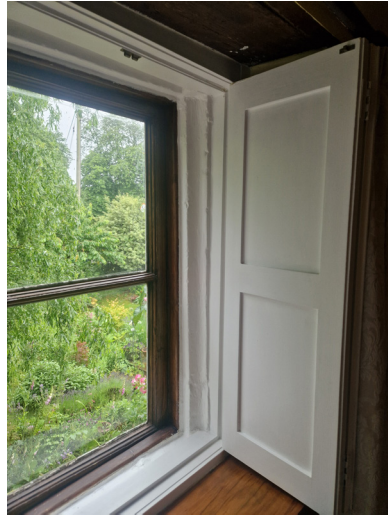
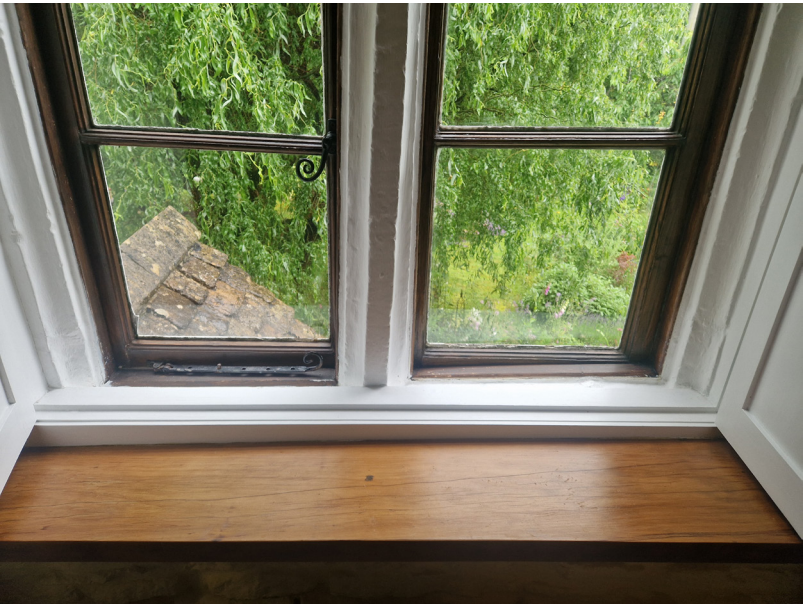
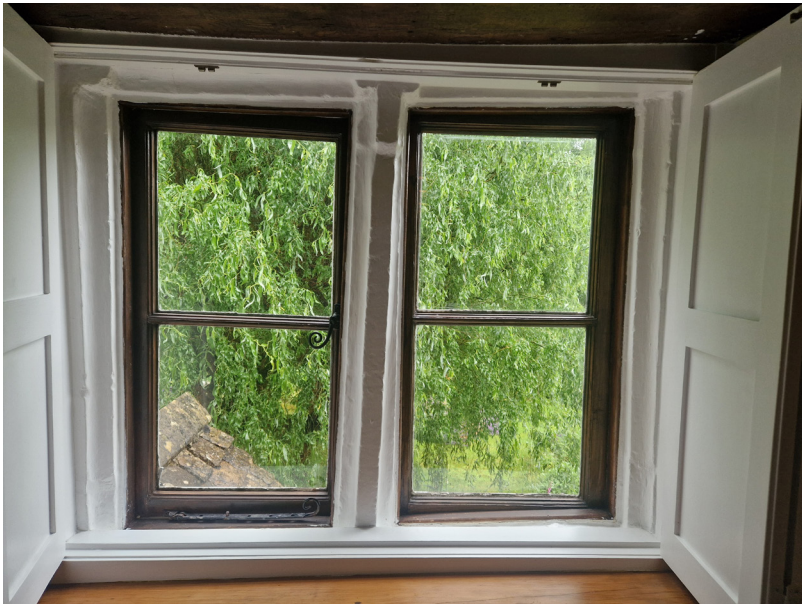
**WINDOW IDENT: WF02**

| Window Ident | Location | Action needed to the frames | Action needed to the Sashes |
|---|---|---|---|
| WF02 | South-East elevation | Casements completely rotten. Casements will need to be remade. | Frame completely rotten. Frame will need to be remade |

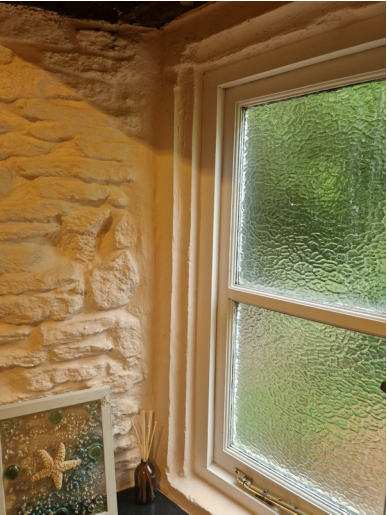
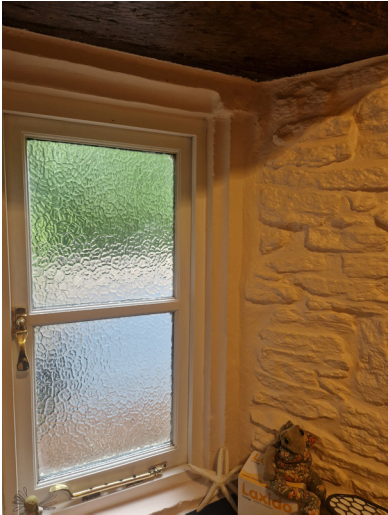
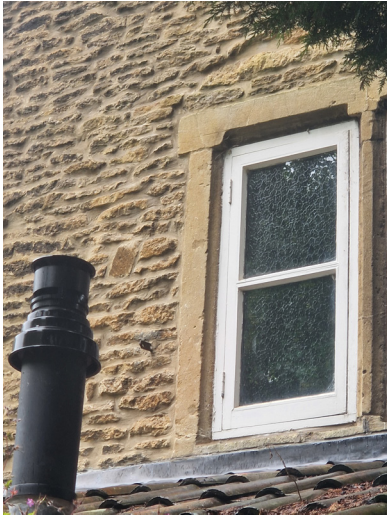
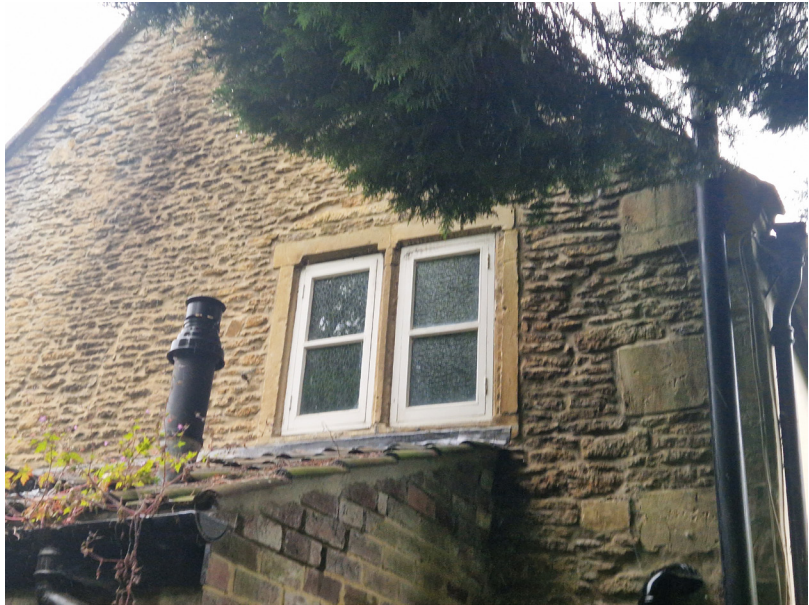
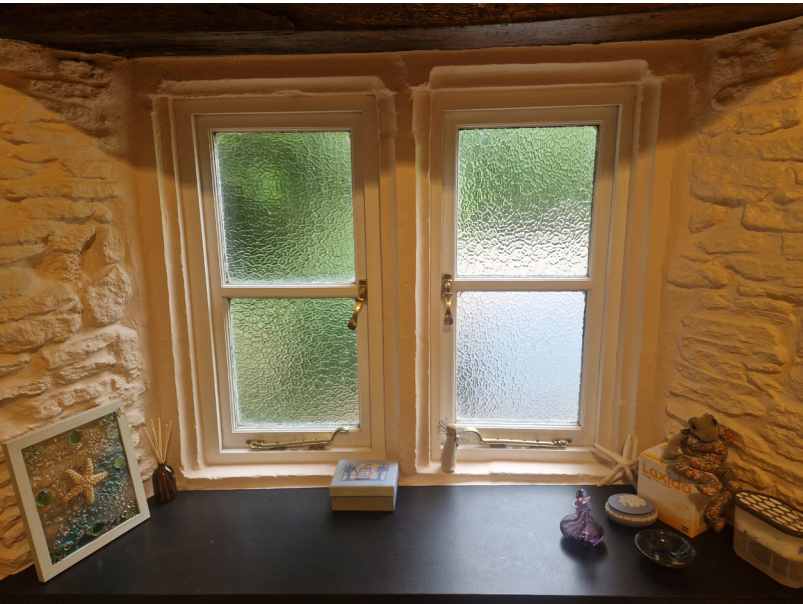
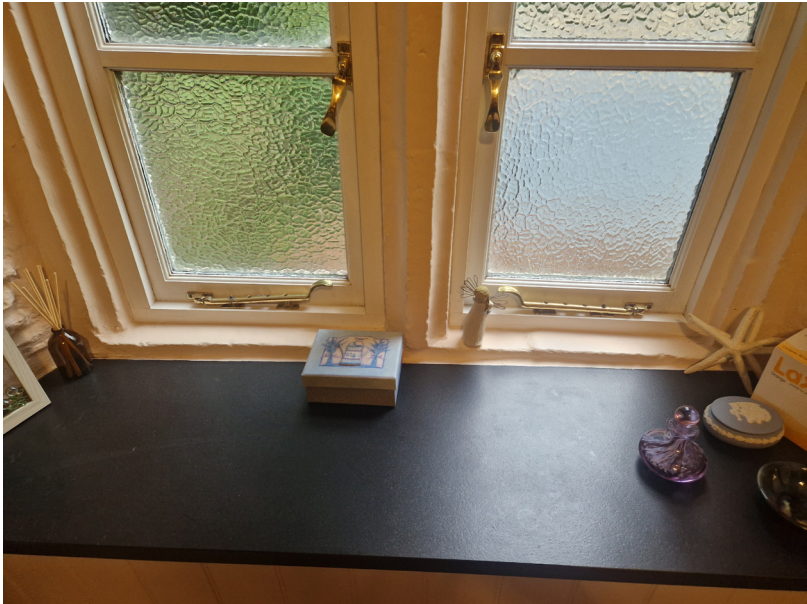
**WINDOW IDENT: WF03**

| Window Ident | Location | Action needed to the frames | Action needed to the Sashes |
|---|---|---|---|
| WF03 | North-East elevation | Casements very poor. Lower half of stiles, bottom rail and glazing bars rotten and beyond repair, will need to be remade | Frame very poor, Cill and Jambs beyond repair. Frame will need to be remade |

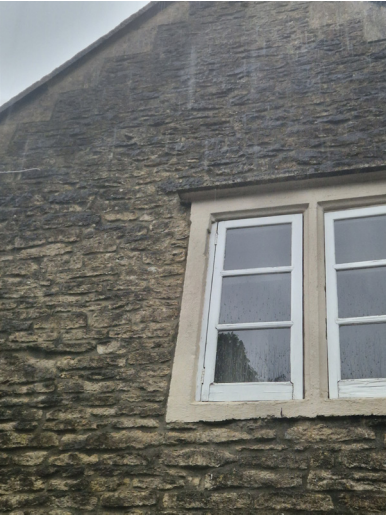
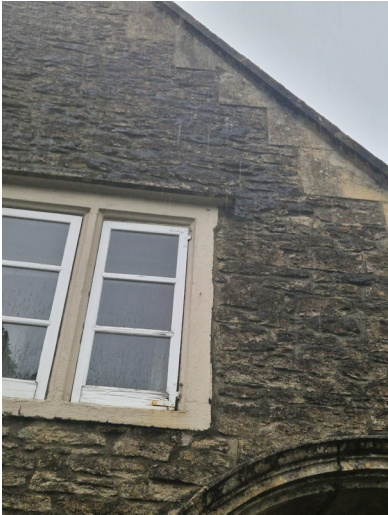
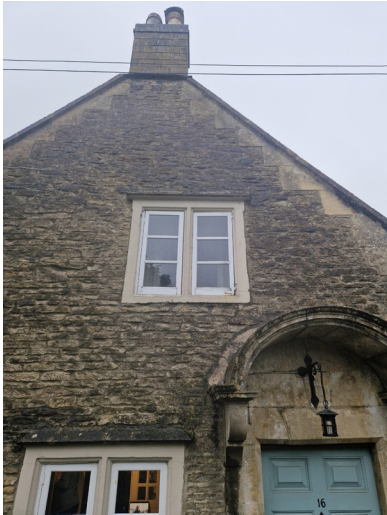
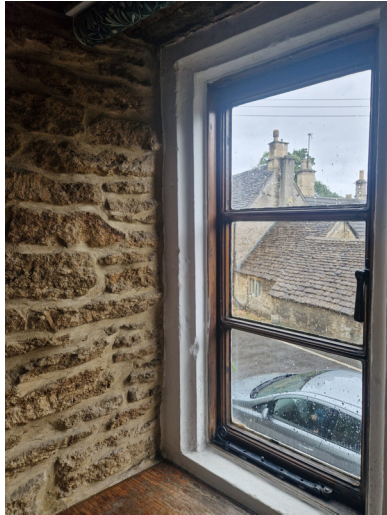
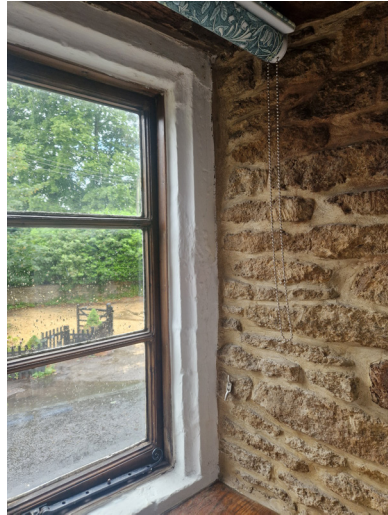
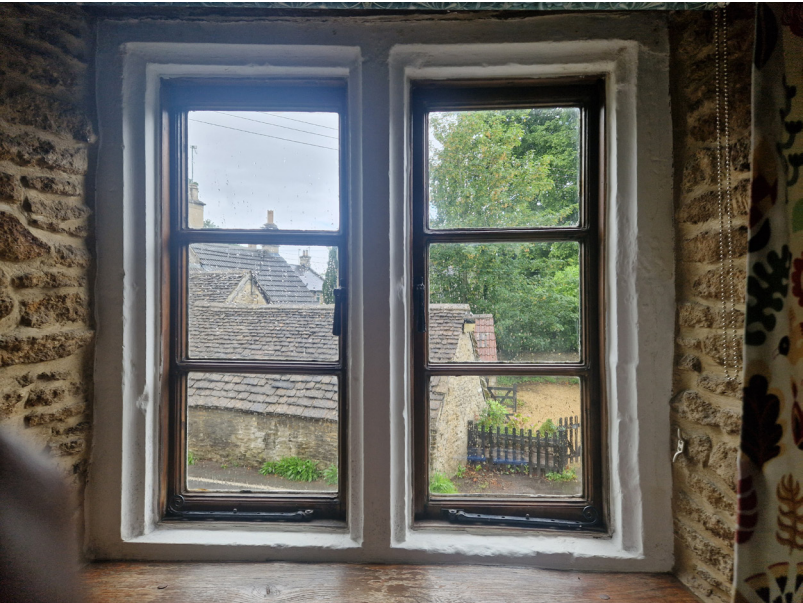
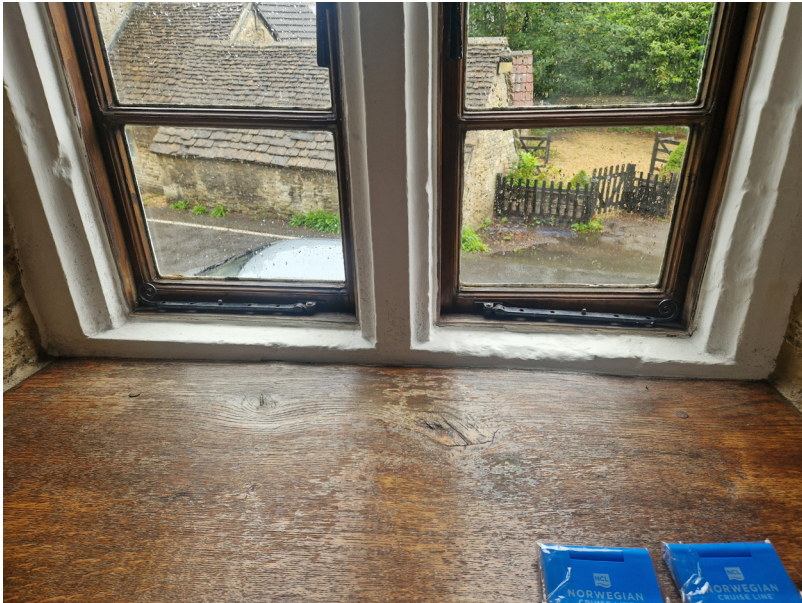
**WINDOW IDENT: WF04**

| Window Ident | Location | Action needed to the frames | Action needed to the Sashes |
|---|---|---|---|
| WF04 | South-West elevation | Casements very poor. Lower half of stiles, bottom rail and glazing bars rotten and beyond repair, will need to be remade | Frame very poor, Cill and Jambs beyond repair. Frame will need to be remade |
