PRELIMINARY ROOST APPRAISAL

CLEEVE COTTAGE, FOVANT, WILTSHIRE

stark ecology<sup>ltd</sup>

JUNE 2026

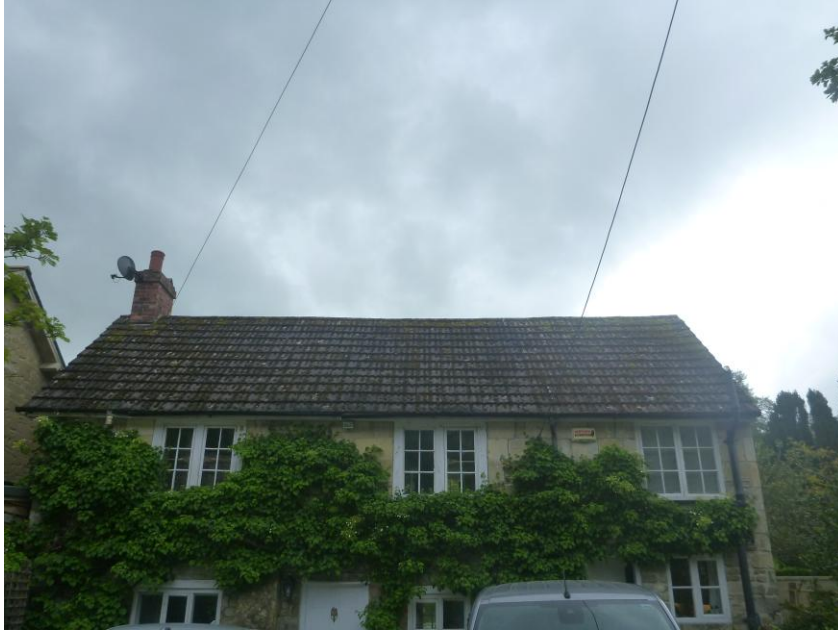
**Fig 2:** Cleeve Cottage, Fovant.

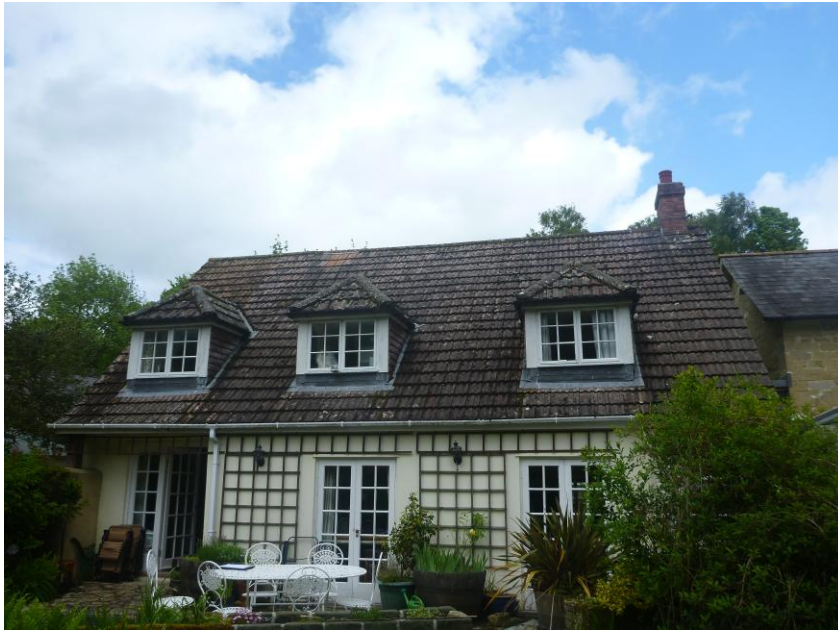
**Fig 3:** There is a catslide roof incorporating three dormer windows to the rear of Cleeve Cottage.

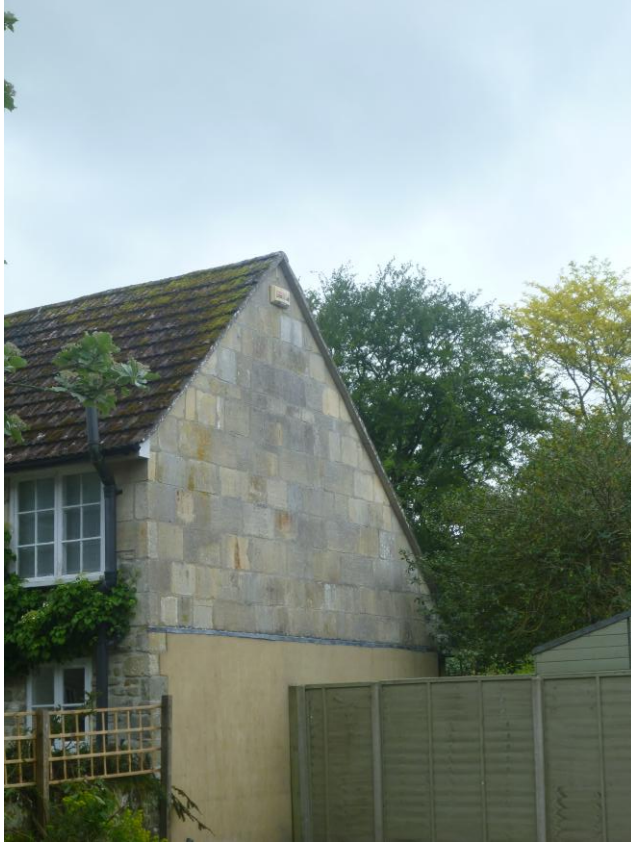
The mortar along the full length of the ridge and at the roof verges was found to be in good condition with only one small crevice identified at the southern end of the property, close to the chimney.

**Fig 4:** The mortar at the roof verges is in a good state of repair with none noted to be missing or damaged.

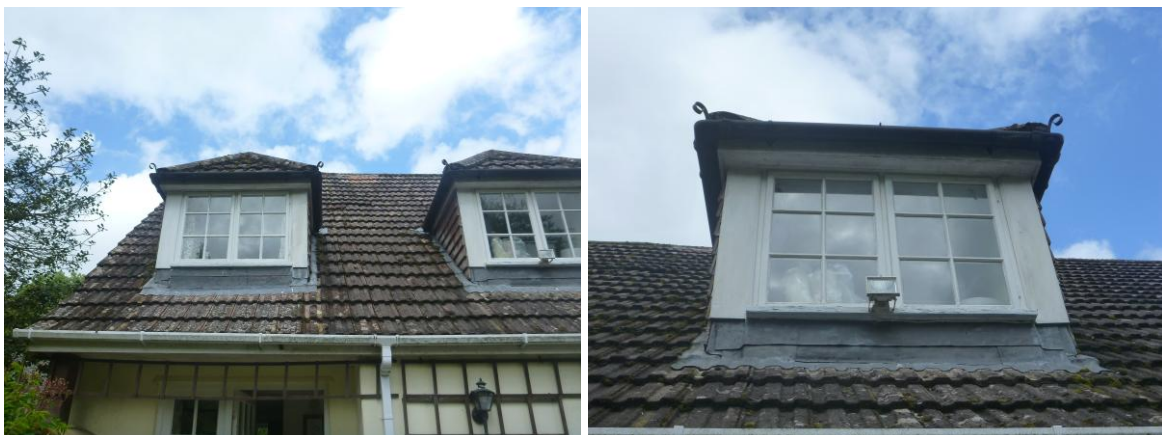
The three dormer windows to the rear of the property were also found to be well sealed with the interlocking cement tiles, mortar and flat cement tiles covering the cheeks of the dormers all well sealed. The lead flashing which seals the dormer windows to the roof was not lifted in any area.

**Fig 5:** The dormer windows to the rear of the property are well sealed.

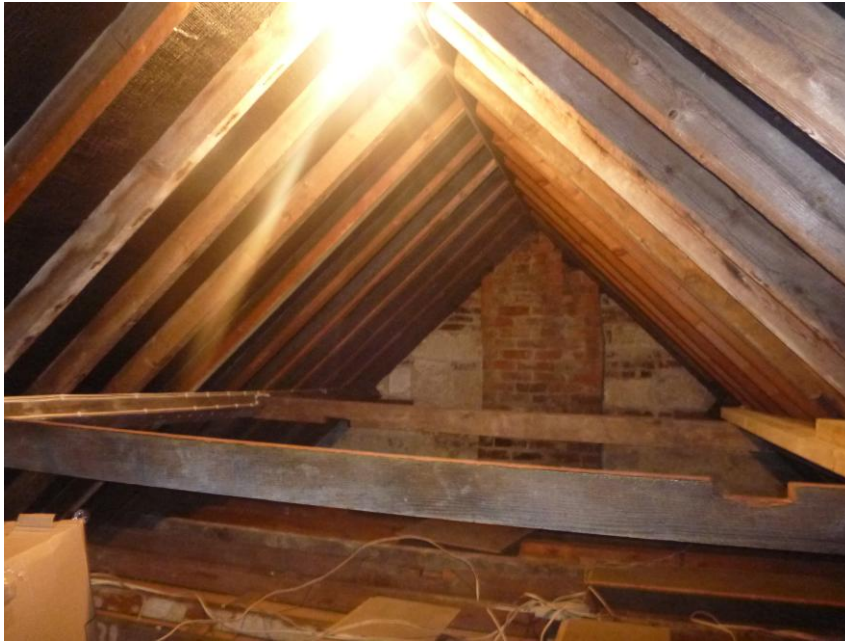
There is a single loft space which runs the length of the property and is c.1.2m high to the ridge. The roof is lined with bitumen felt and the loft space is insulated with fibreglass material, some of which had been removed before the survey was carried out. All areas (including the small areas of loft space above the dormer windows) were accessible to the surveyor.

**Fig 6:** The roof is lined with bitumen felt and all areas of the loft space were accessible.

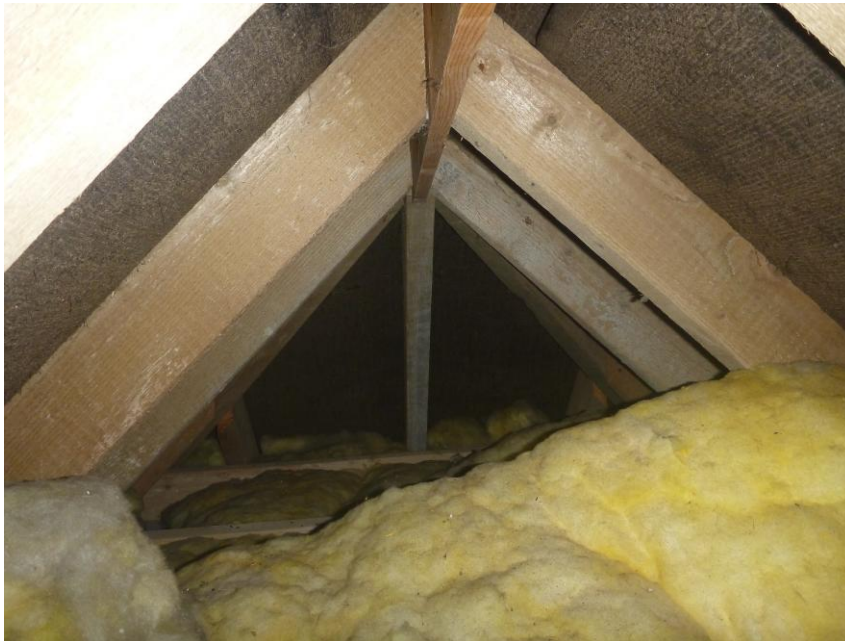
**Fig 7:** The small areas of loft space above the dormer windows were accessible.
