# Structural Investigation of Salisbury Guildhall Ceiling in the Banqueting Hall

Salisbury City Council

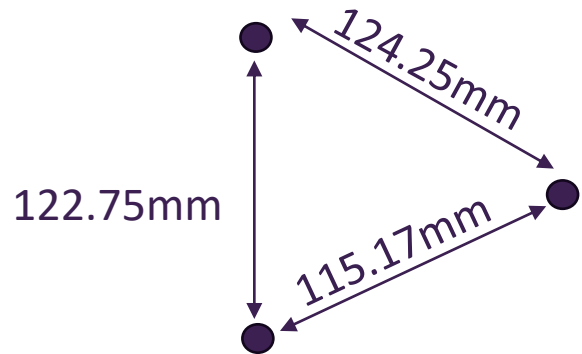
Figure 1: Crack Monitoring Measurements taken as of 09/01/26

In addition, a significant vertical tapered crack was identified within the masonry wall in the roof space. The crack extends approximately 1.8m in height, running through multiple brick courses and exhibiting clear displacement of individual bricks, indicating structural movement rather than superficial shrinkage. The crack varies in width, measuring approximately **14 mm at its narrowest point** and up to **35 mm at its widest**, suggesting progressive movement over time. Crack monitoring fixings have already been installed and were noted during the inspection, confirming that this defect is under observation, measurements taken at the time of survey can be seen on Figure 1. While the crack raises concerns regarding the stability of the supporting wall and its ability to transfer roof loads, there is no indication that it currently impacts the stability of the ceiling finish. Further investigation is recommended to determine its cause and potential implications for the wider structure (refer to image 24-25)

- Implement 6 monthly monitoring using existing crack monitoring tell-tales and maintain accurate records of any changes in width or displacement.

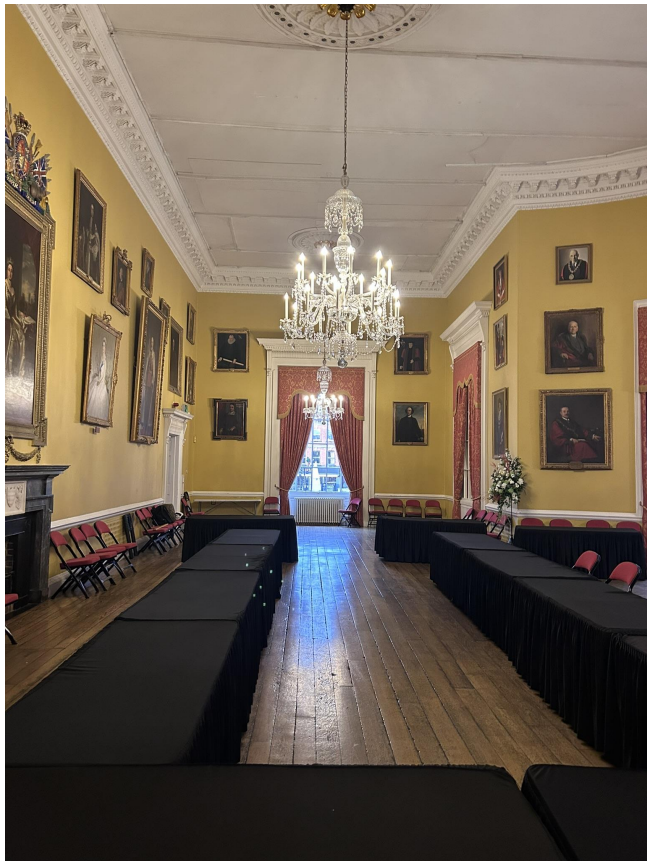
01 Overview of the Banquet Hall.

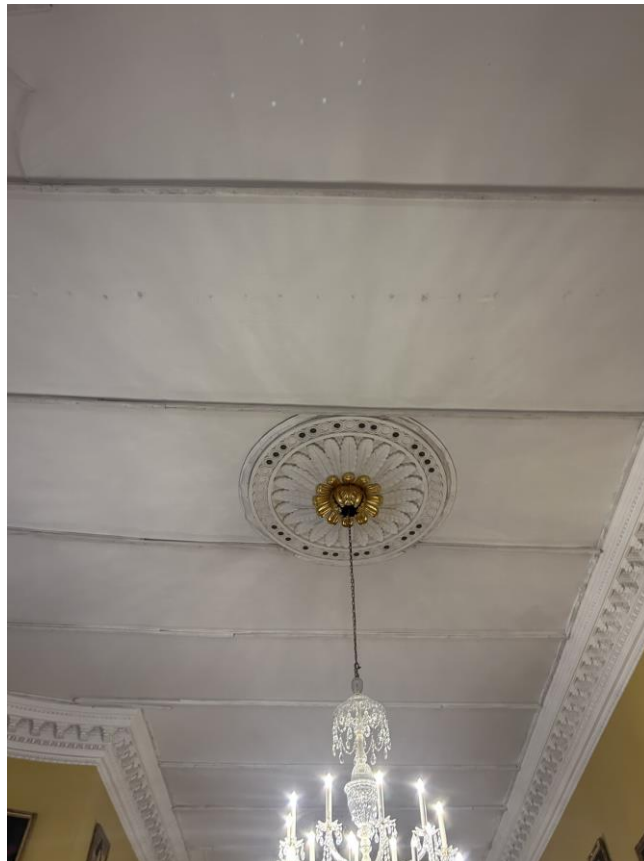
02 Detailed roses and cornice detailing.

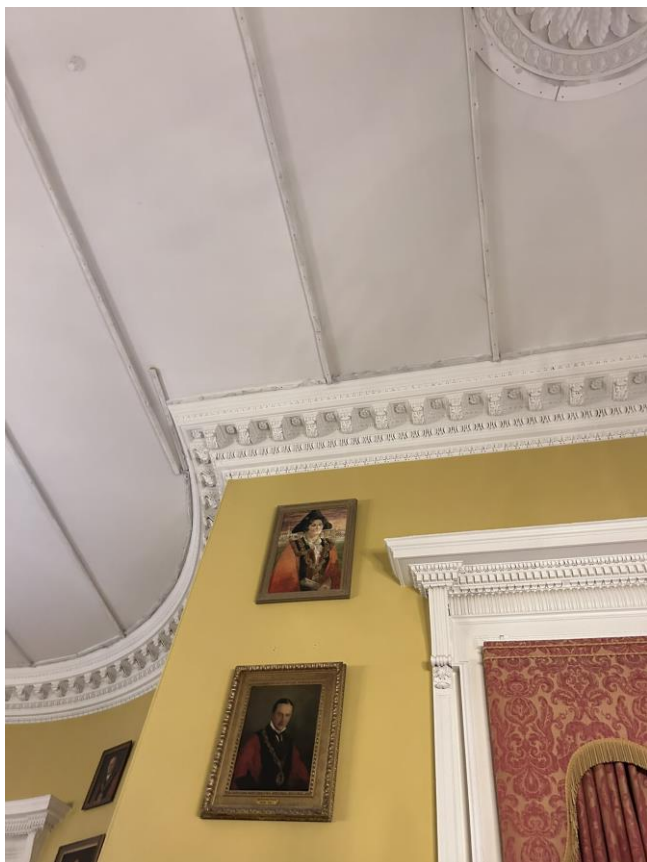
03 Area identified beneath crack in roof, no signs of cracking in the room below.

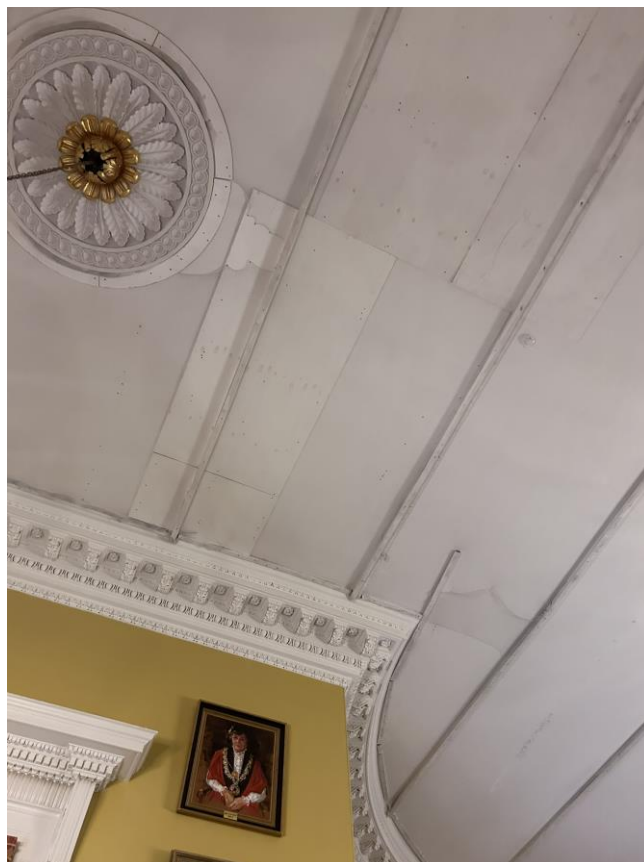
04 Area which has been previously repaired using ply boarding and netting with fixings from below appears to be well secure.

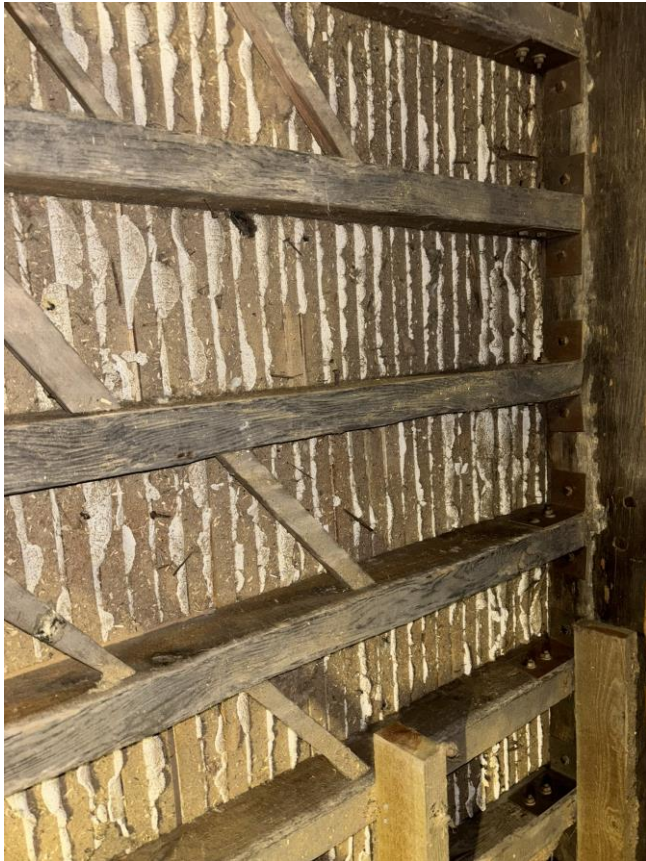
05 High risk zone identified, where key is more degraded than other areas, with ply backing been installed.

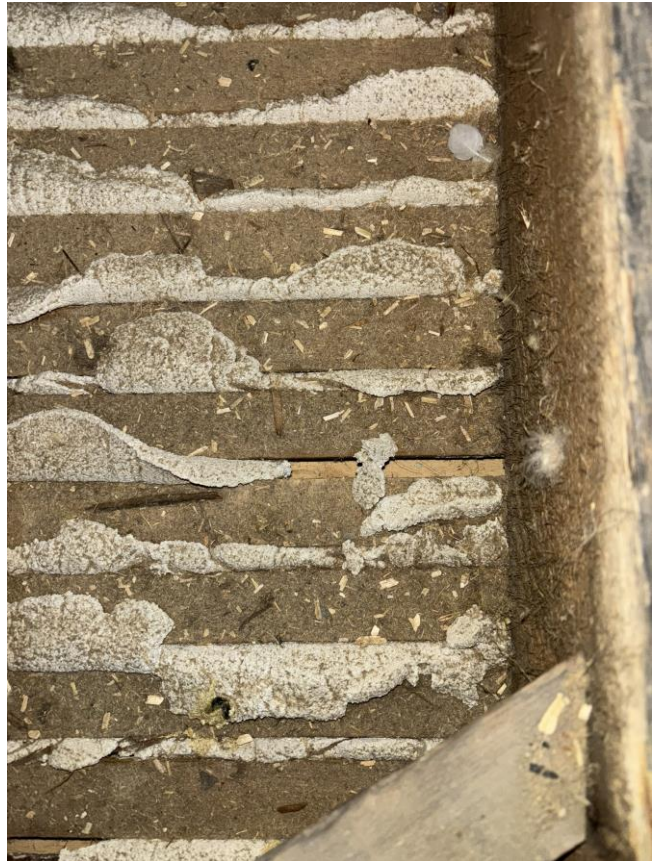
06 Evidence of ply backing has slight flex in areas however seems quite secure.

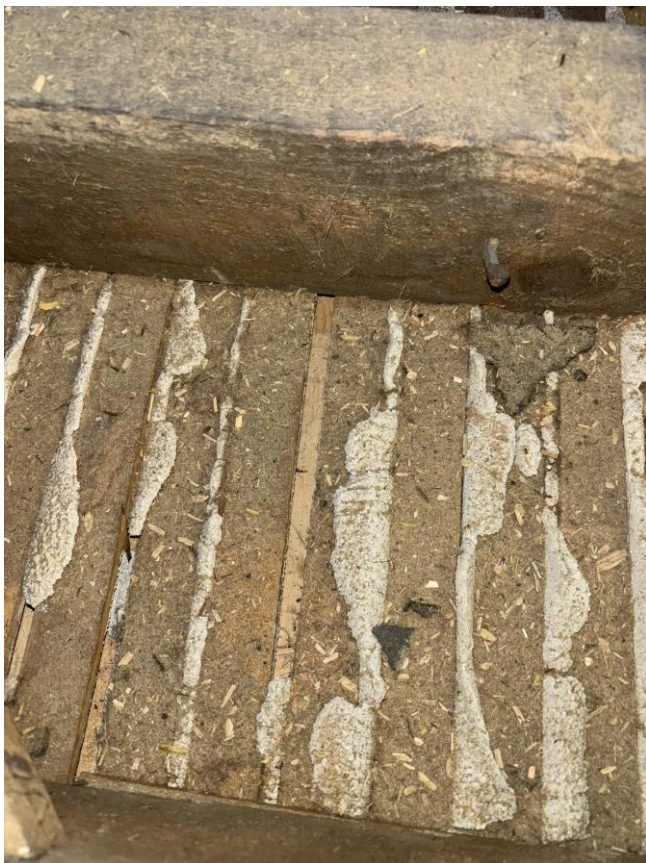
07 Area in high risk zone with loss of key (doesn't seem to have worsened).

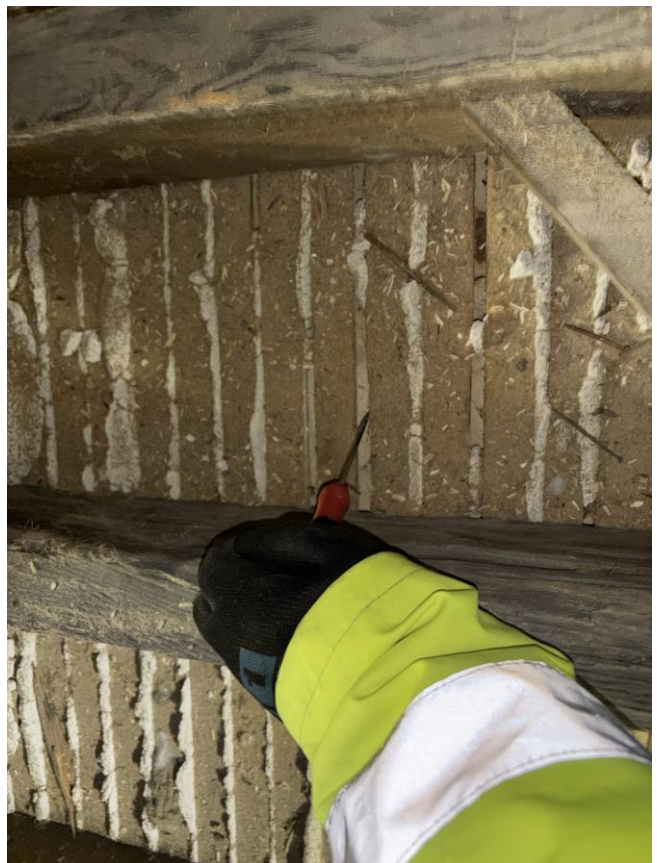
08 Slight flex in ply however fixings seem to be secure.

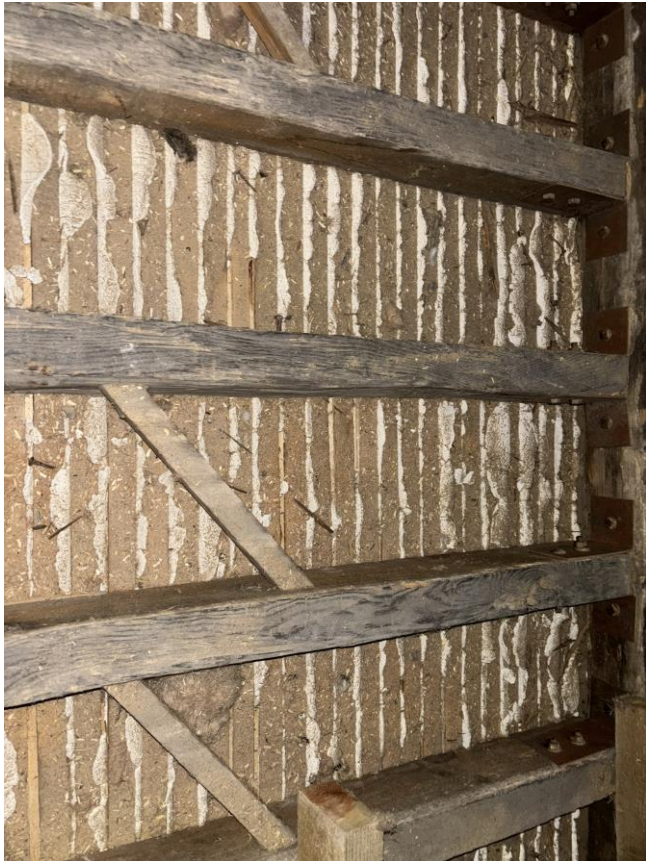
009 Medium risk zone, with no ply backing, some areas have a slight loss of key but this is in small, localised areas, with the plaster being still secure.

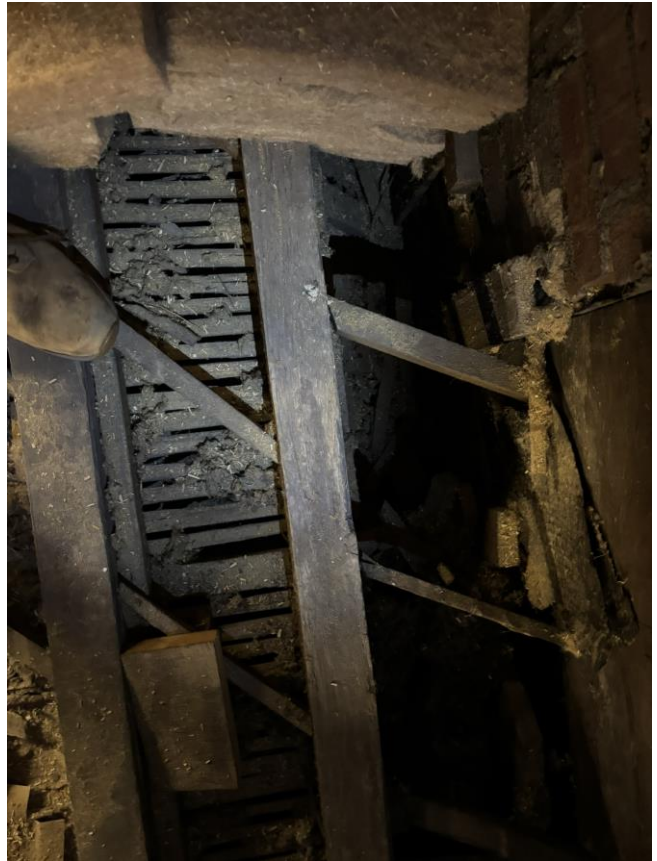
010 Area behind cornice detailing. Darkening area of timber would suggest historic soot/smoke damage.

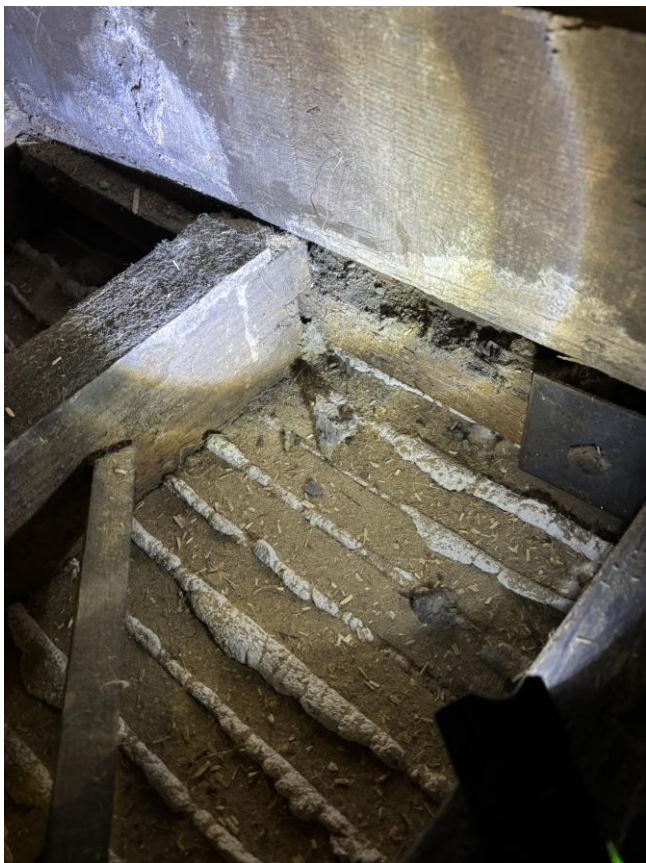
011 Key here is well covered in medium risk area.

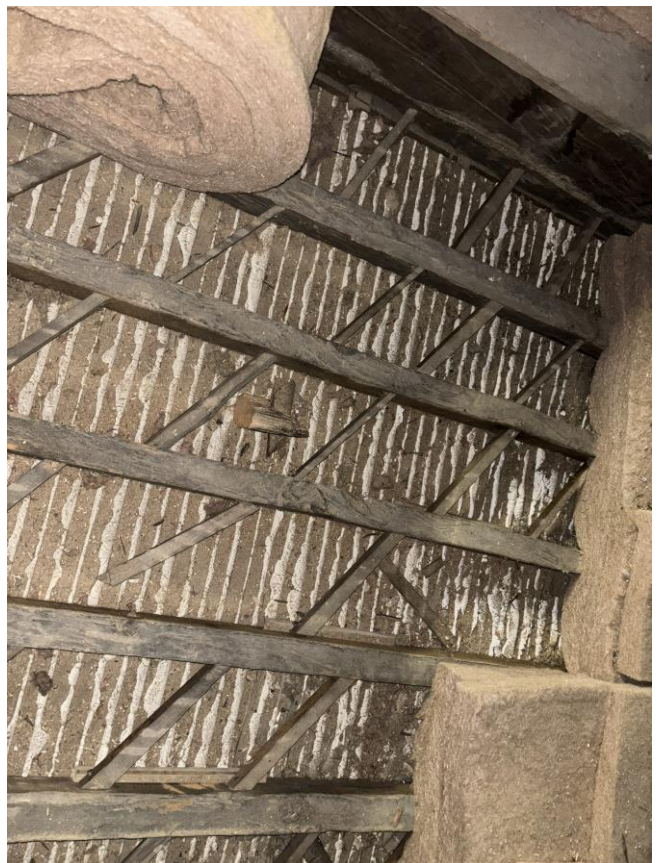
012 Some diagonal bracing/strutting is not attached in all areas which is designed to resist torsion of joists.

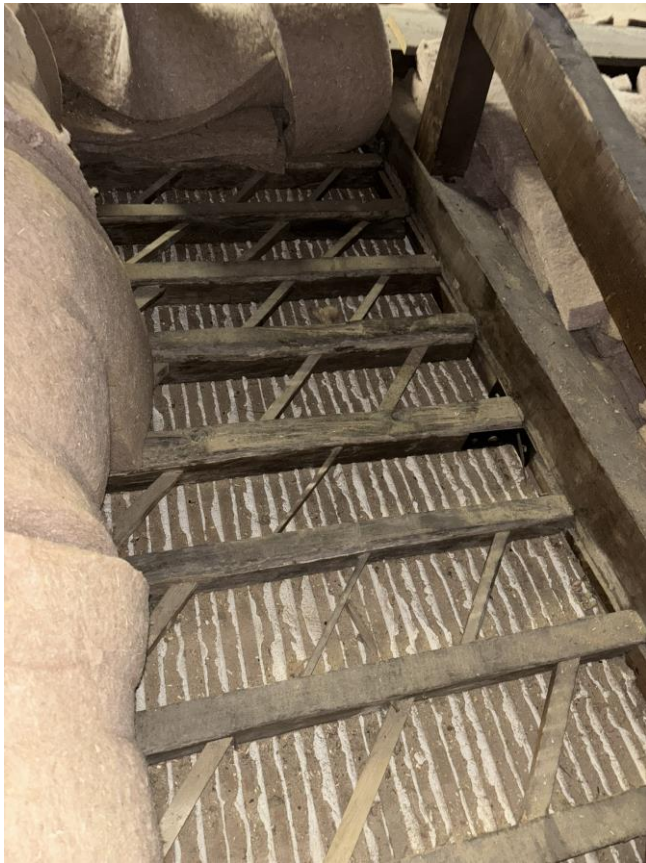
013 Area of medium risk area is all well keyed and seems secure.

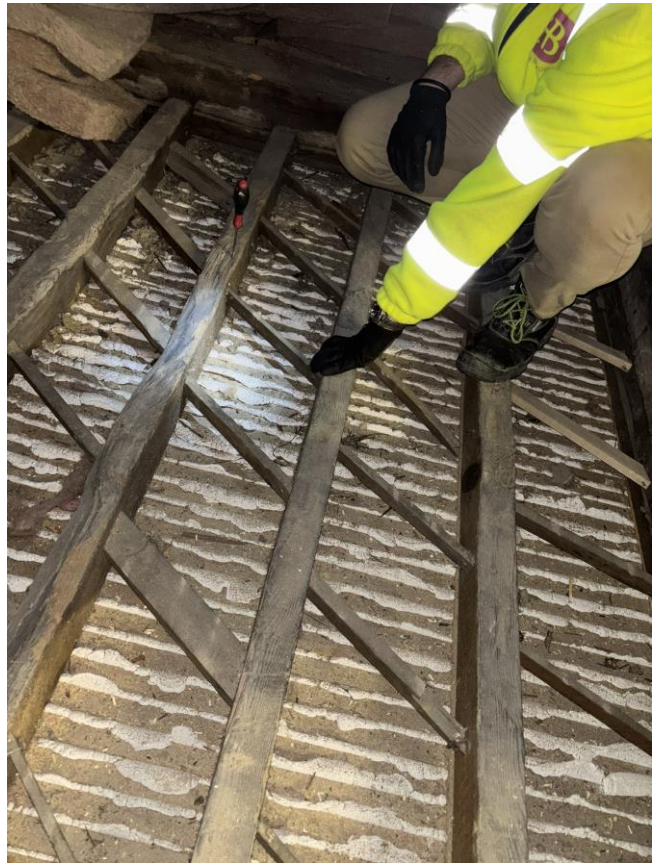
014 Evidence of some repairs to diagonal bracing, medium

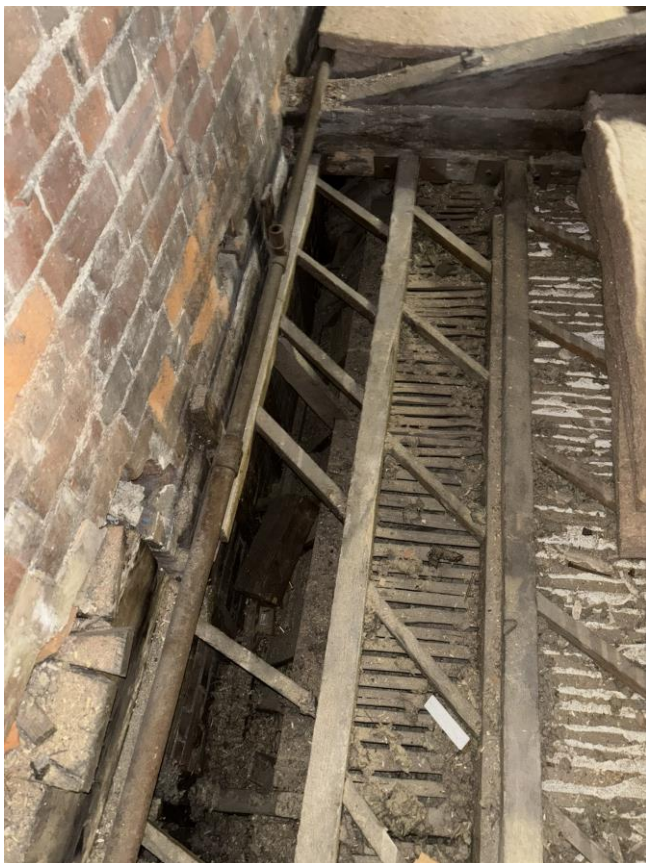
015 Another area behind corner area has some debris inside however not substantial.

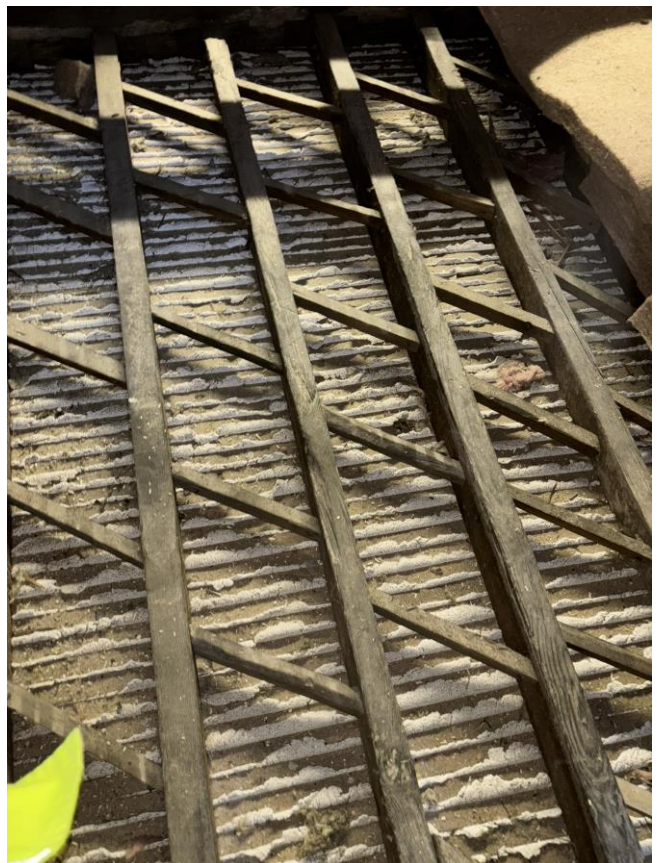
016 Previously identified medium risk area is well secured.

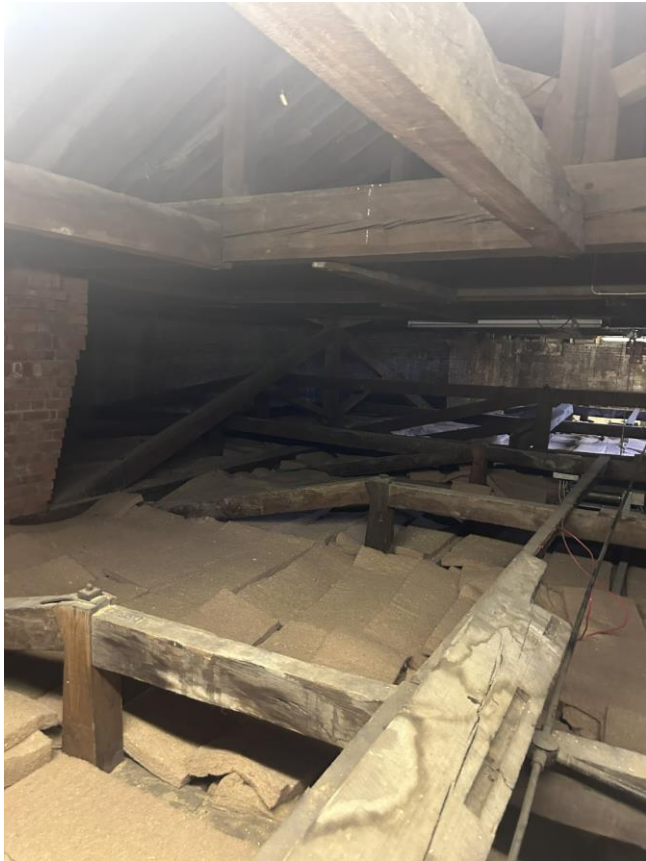
017 Overview of loft space.

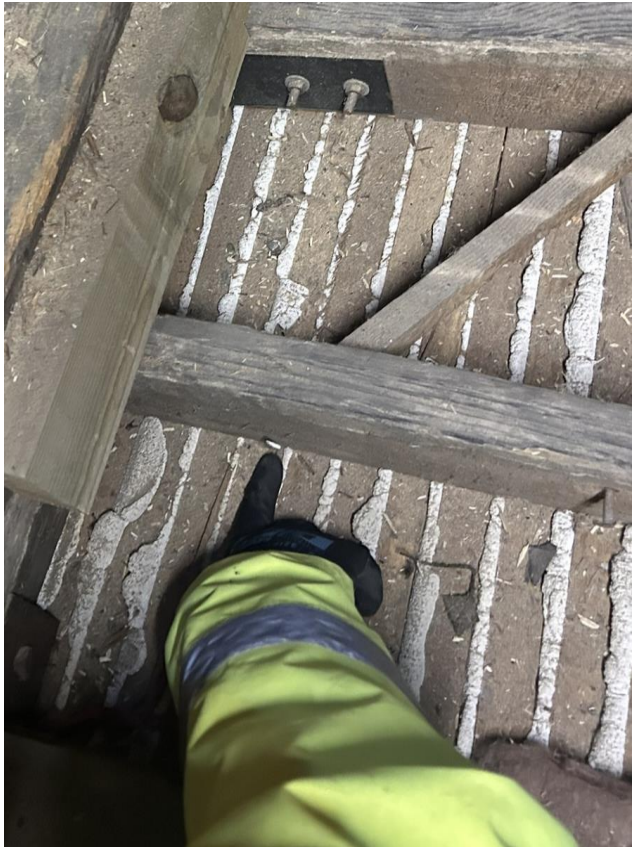
018 Approx 100mm fixings securing battens to underside of ceiling which in this case has missed joist.

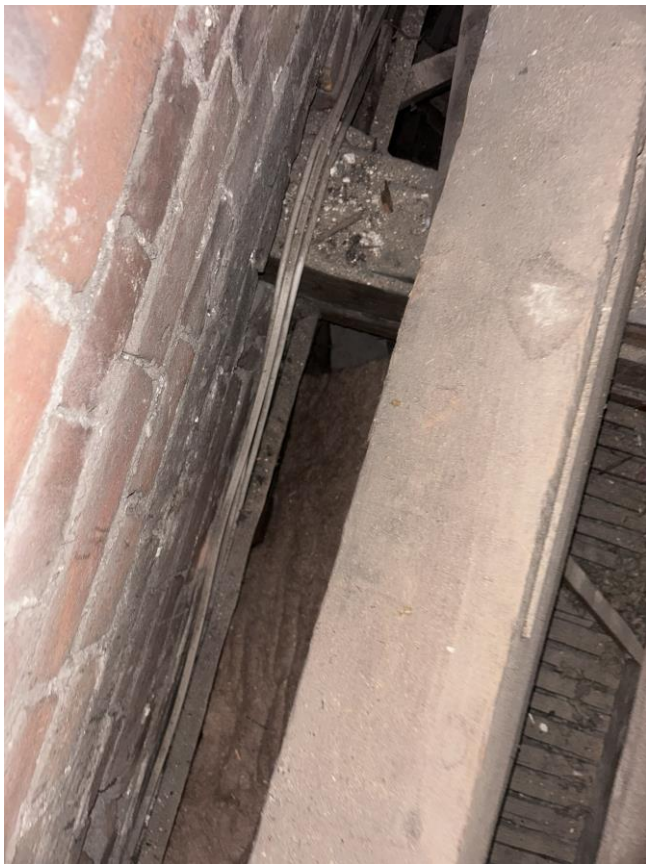
019 Area behind cornices evidence of insulation.

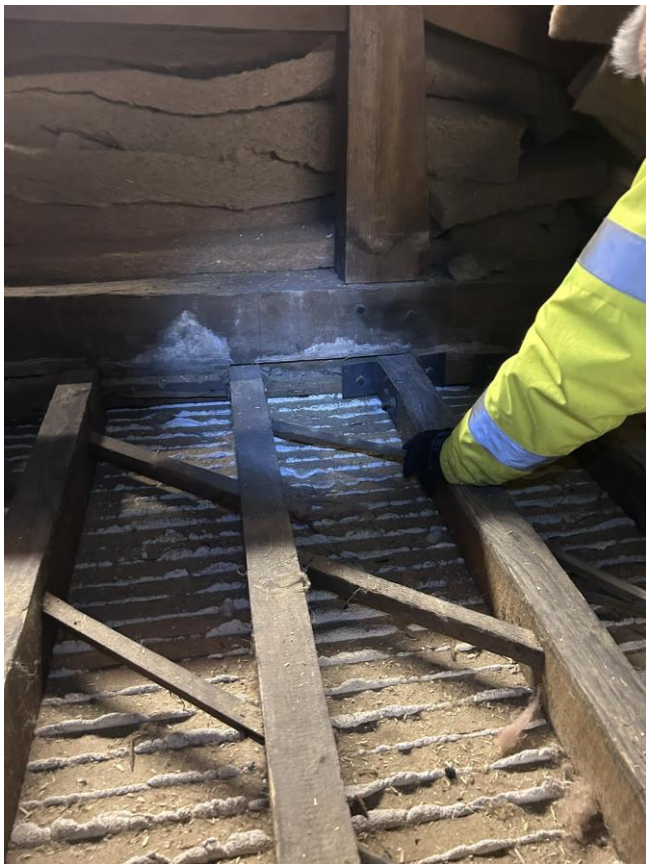
020 Low risk area appears to be well keyed and intact and secure.

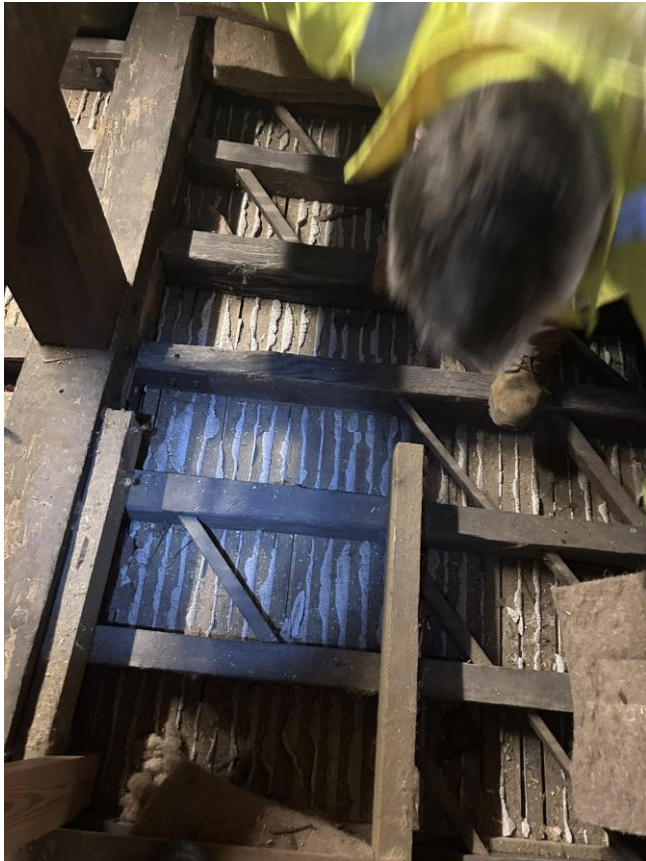
021 Area of medium risk appears to have some missing areas of key; however plaster still seems quite secure in arched part of ceiling void.

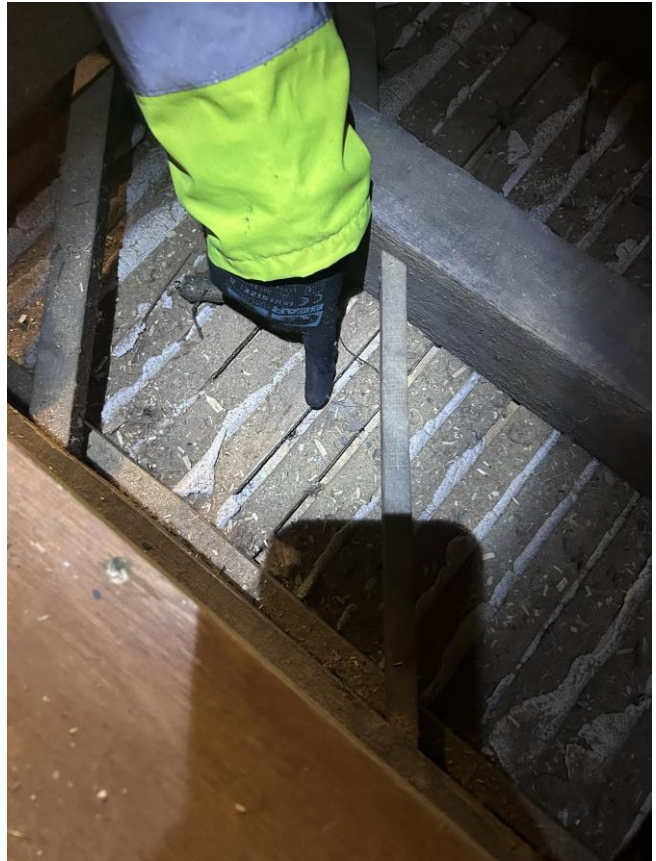
022 High risk area of ply over boarding, repairs seem well carried out.

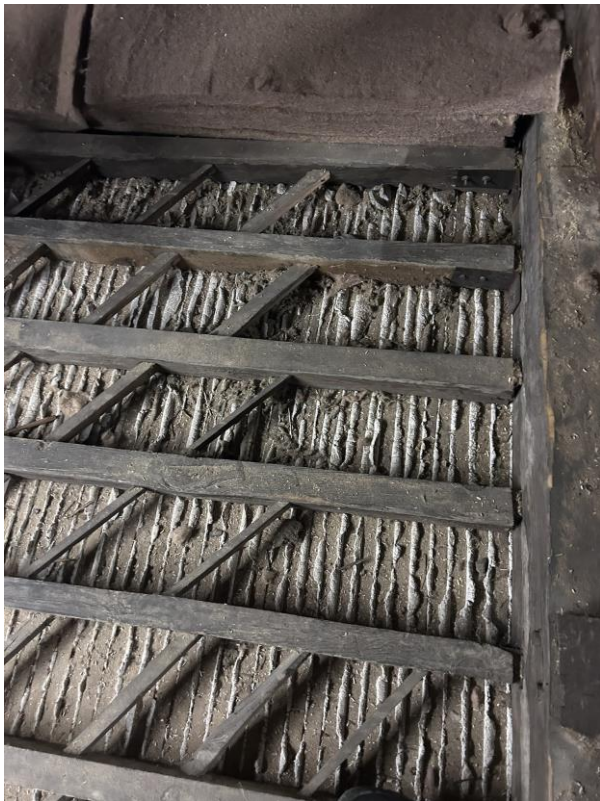
023 Low risk area key is well covered, the joists in some areas could do with some extra fixings as seemed to flex slightly while walking across them.

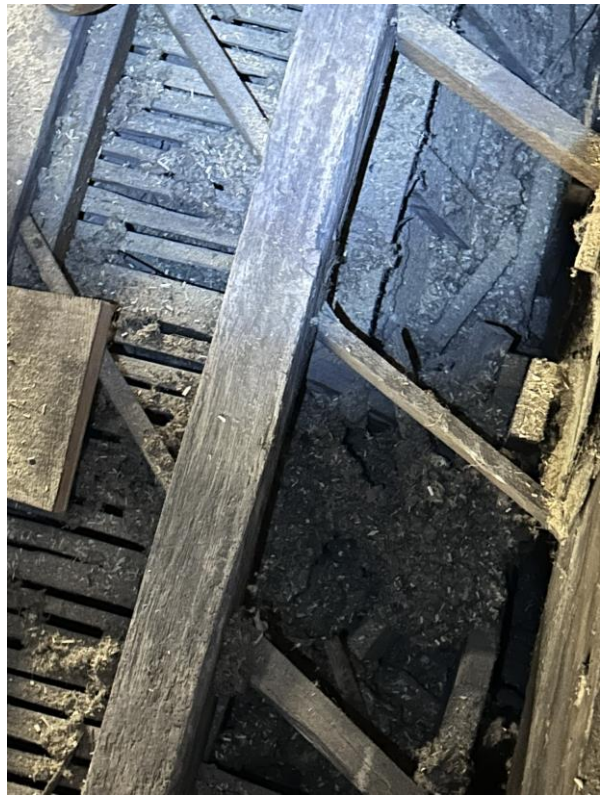
024 Area behind cornice detailing evidence of debris from timber shavings.

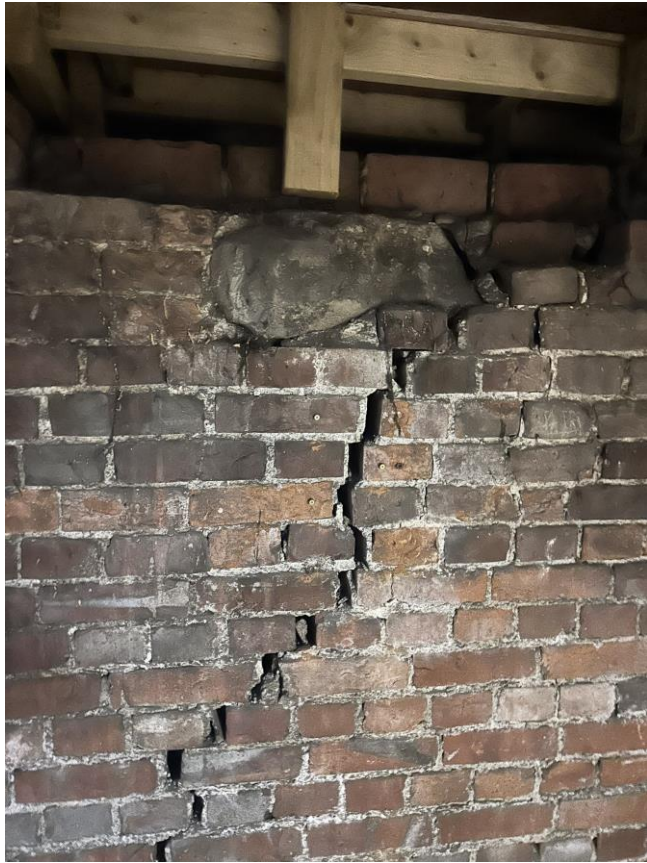
025 Large vertical crack on East elevation about 1.8m in length and the widest part being approx 35mm.

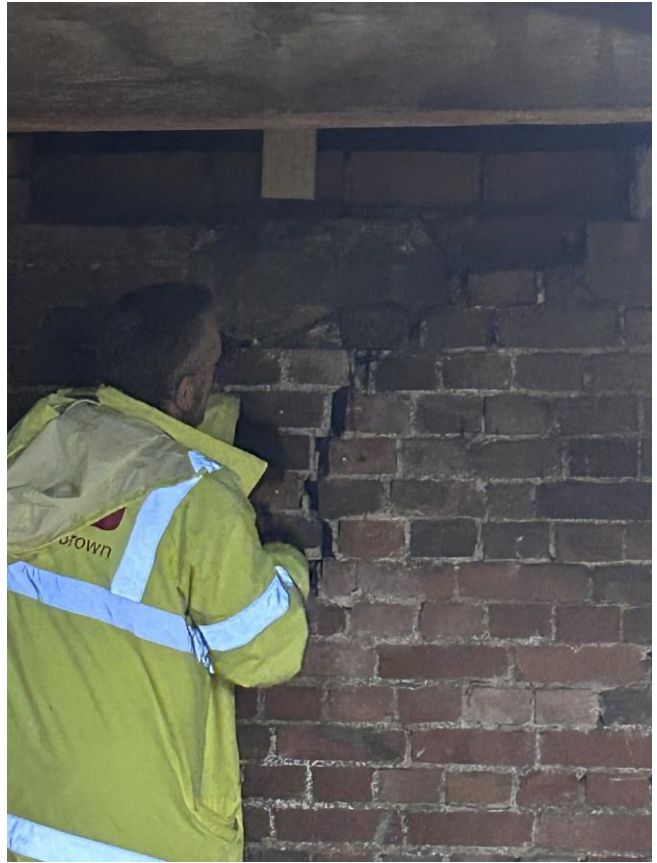
026 Taking measurements of existing tell-tales/crack monitoring on established fracture in brickwork.
