# Site Visit Report

Project: Folly Cottage, Former Stable,  
Rudloe

Report No: **12927/0551**

Date of visit: 15<sup>th</sup> October 2025 / 4<sup>th</sup> November 2025

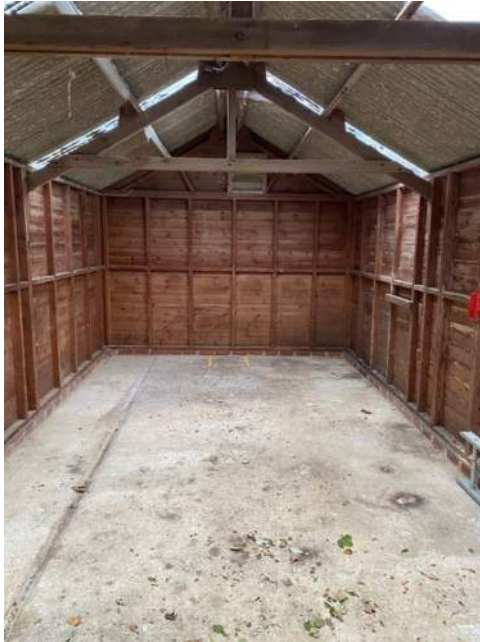
The structural elements of the stable building are exposed (Photos 1 and 2) and confirmed as insufficiently robust to support heavier slate roof finishes / brittle ceiling finishes. The walling studs are insubstantial and unsuitable for supporting additional roof loads or new brittle wall finishes. Wall studs are of insufficient depth to accommodate a suitable depth of insulation. The southern wing of the stable block (Photo 2) is particularly ad hoc in its construction with a number of reclaimed telegraph poles used as columns and roofing purlins.

Photo 1 – Structural elements with exposed interior, main wing looking south.

It was agreed in discussion with the building owner and their consultants that from a structural perspective, the appropriate course of action would be to design a replacement structure with the volume and footprint matching existing; aside for the planned extended wing at the north end. This approach will enable design of a suitably robust and durable structure, with structural elements compliant with current building regulations.

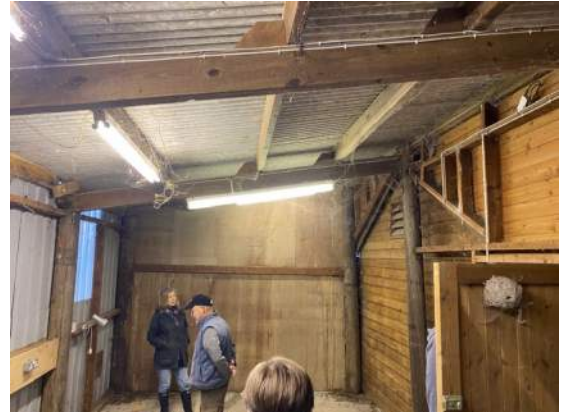
Photo 2 – Structural elements with exposed interior, south wing

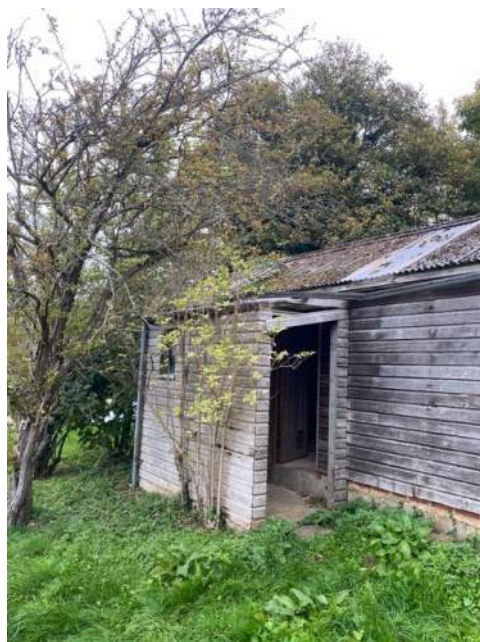
Photo 3 – Main West Elevation, North End

The existing stable building is principally a lightweight timber framed structure, with walls clad in timber boarding and the roof clad in a lightweight corrugated cement-based board. The external elevations of the building are shown in Photos 3 to 6 below.
