## Off Mains Drainage Survey Report Prepared For:

20, 21, 22 & 23  
Kingston Deverill,  
BA12 7HE.

**Date of Survey:** 07/04/2025  
**Engineer:** Paul Stewart

## Drainage Survey Standard Report:

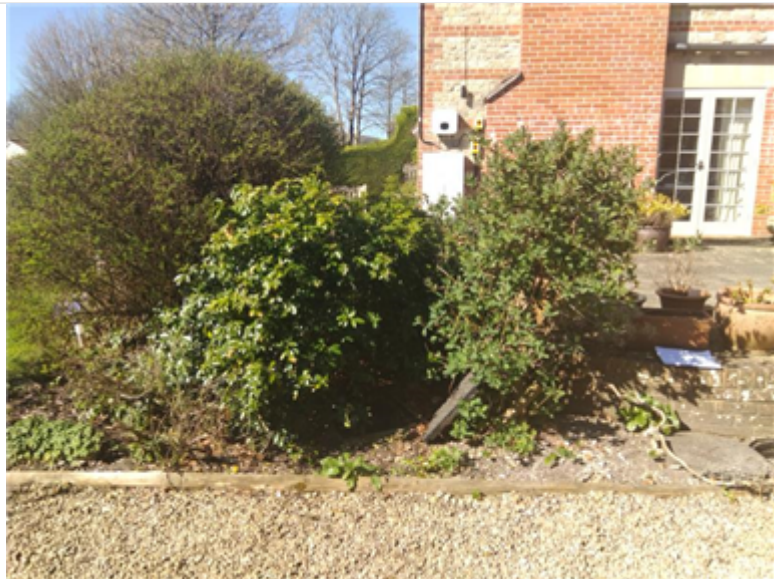
Photograph of the general area of the tank:

| <b>Overall condition of the tank:</b> | Satisfactory |
| <b>Was there any damage observed to the tank during the inspection?</b> | No |
| <b>Was the outlet pipework accessible from the tank in order to conduct a CCTV survey?</b> | No<br>Outlet pipework is protected by the internal baffle. |
| <b>Is the existing discharge functioning correctly?</b> | No<br>Tank was sitting 200mm above the correct operating level, which indicates the discharge in place is not functioning correctly. |

Install a new 21 population sewage treatment plant with pumped outlet. Inlet 800mm. Numerous small trees to be taken up and re-planted on completion.

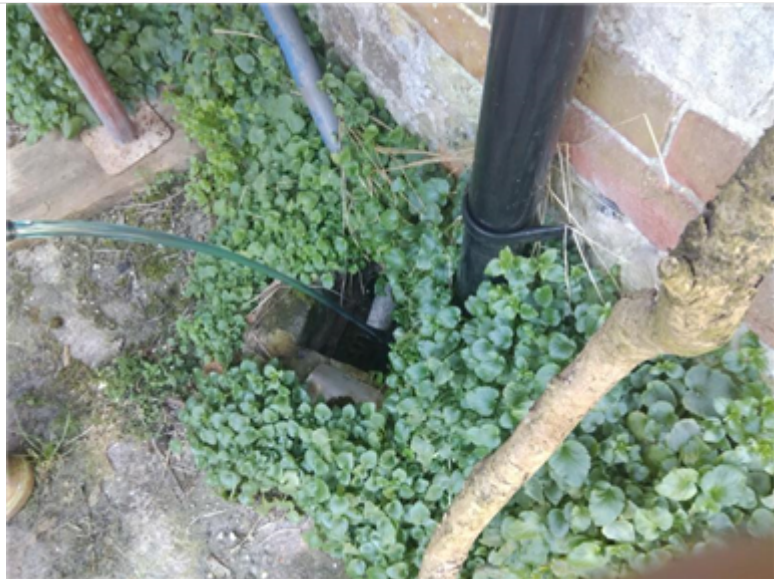
Photograph of dye test undertaken

Yes

RWWG1 to front of No.21  
RWWG2 to front of No.22

Rainwater discharging to an off mains system is not best practice, during periods of heavy or persistent rainfall the tank will become hydraulically overloaded. This can lead to the quality of the discharged effluent being compromised.

At RWWG1 + 2 - remove downpipes from main roof and reroute of existing guttering to fall and discharge to existing RWG1 on the property of No.23. install 2 X rainwater butts to the front of properties 21 + 22 to take minimal rainwater from very small pitched roofs.
