# The Goat Barn Marridge Hill Ramsbury

## Structural Inspection

Job Number: 13181

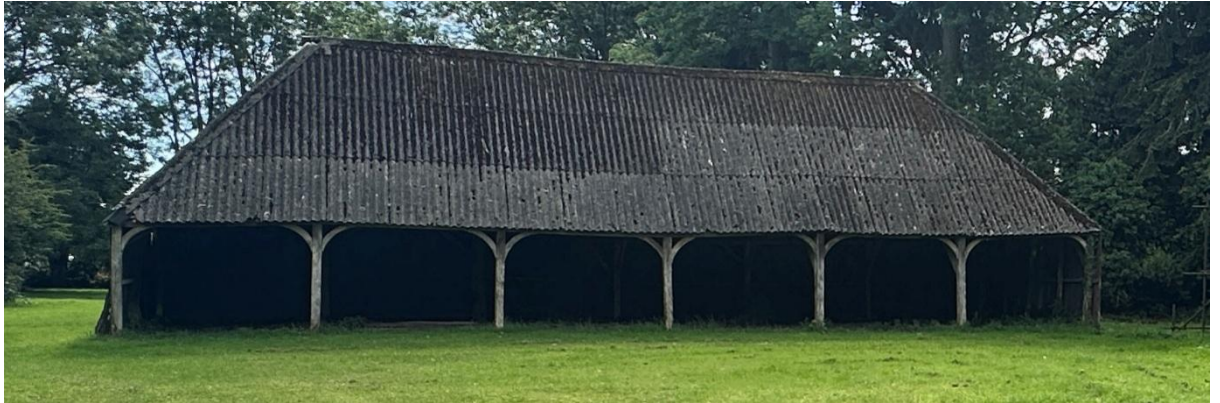
- 2.01 The west elevation of the Goat Barn is shown in the image below. The barn is formed of 6 equal timber framed bays, with arch braced columns to the open west elevation. The roof is finished with relatively modern corrugated sheet material, which has provided efficient weather protection in recent years. As an open structure with good weather protection the general condition of the structural timbers is considered good.

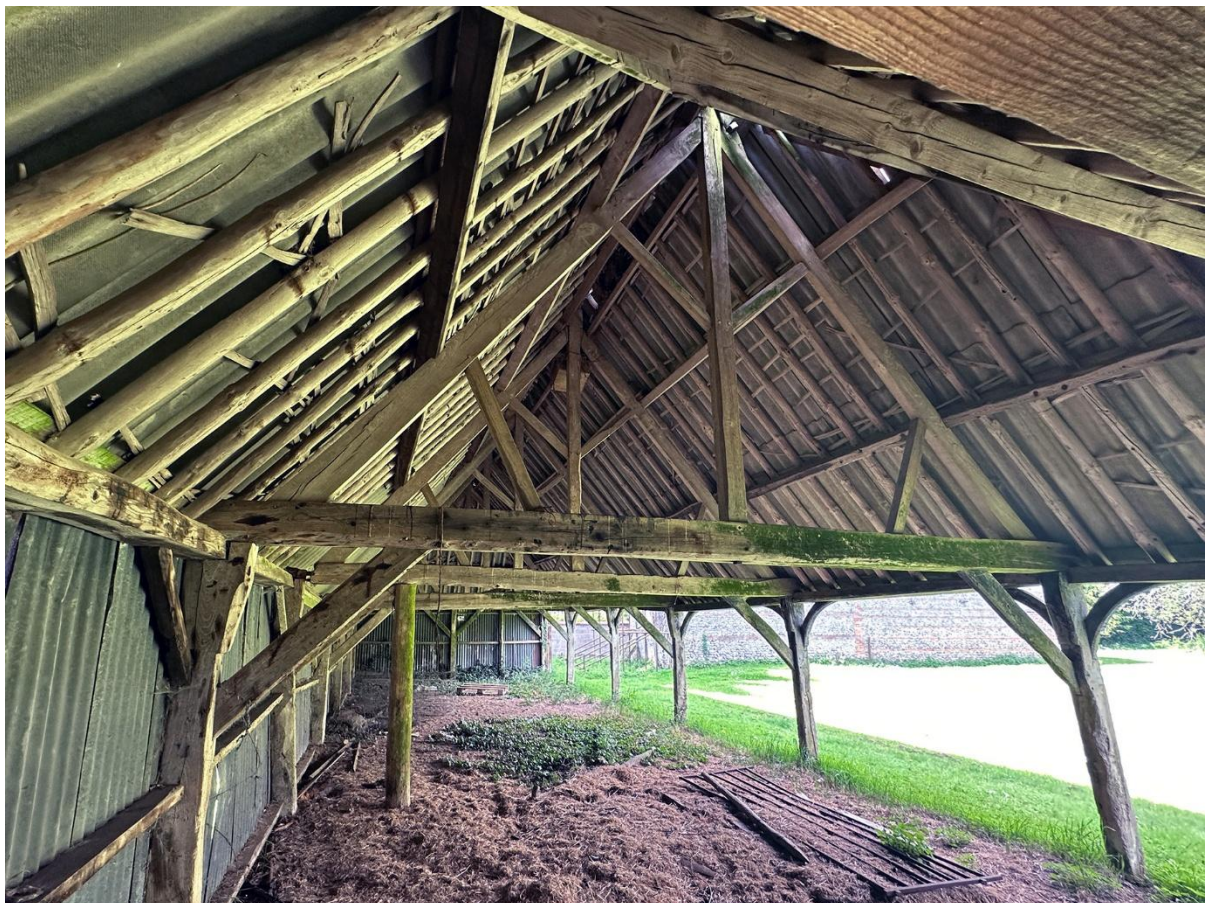
- 2.02 The image below shows the internal configuration of the barn, looking south. The timber roof trusses clear span east-west and are supported on timber posts. The posts appear to bear onto stone plinths and all appear in reasonable condition where visible. Some local base decay may be expected to base of posts, but this can be easily remedied with a simple local splice repair.

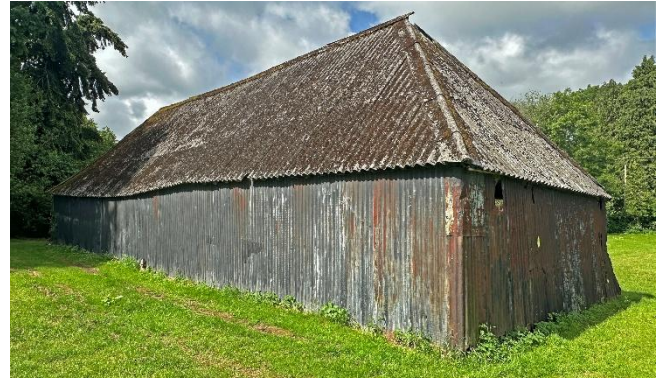
- 2.03 The north east corner of the Goat Barn is shown in the image opposite with corrugated sheet cladding to elevations providing effective external weather protection, while internally the timbers remain generally exposed and well ventilated providing good environmental conditions.

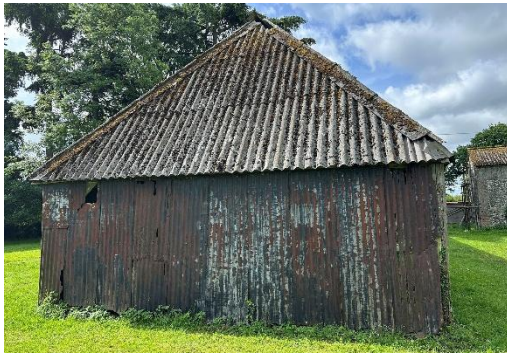
2.04

The north elevation of the Goat Barn is shown in the image opposite. Some minor penetrations to the corrugated cladding was observed, however this is not resulting in any significant risk to the structure.

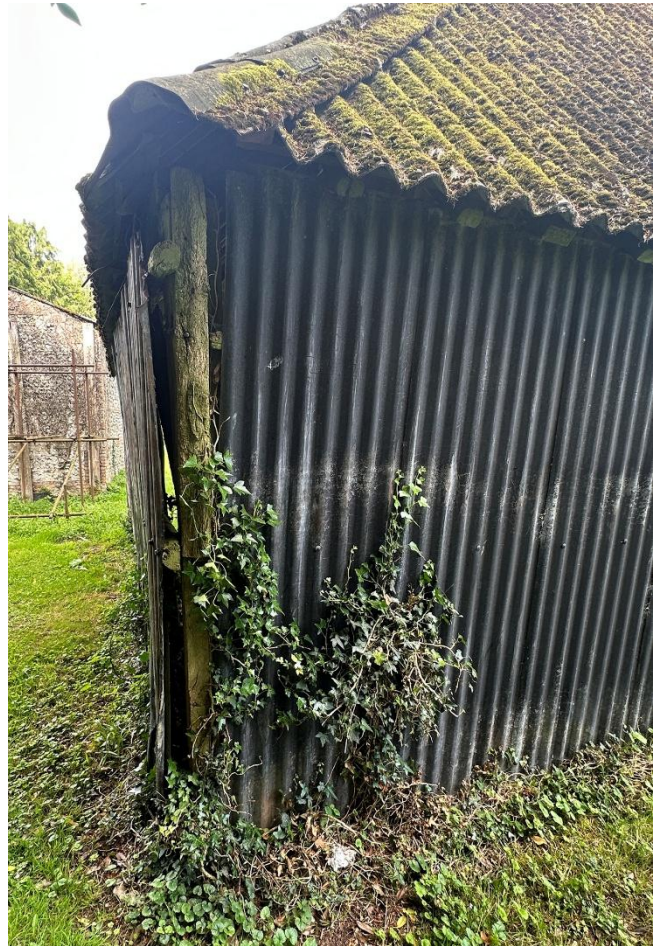
- 2.05 The image opposite shows the south east corner of the building. The cladding in this location has separated, exposing the corner timber post and allowing water ingress. Some localised timber decay is evident and the intersecting timbers at this location are poorly secured. Localised repairs to reinstate continuity of intersecting timber members should be allowed for and adjustments to cladding to ensure building remains watertight.

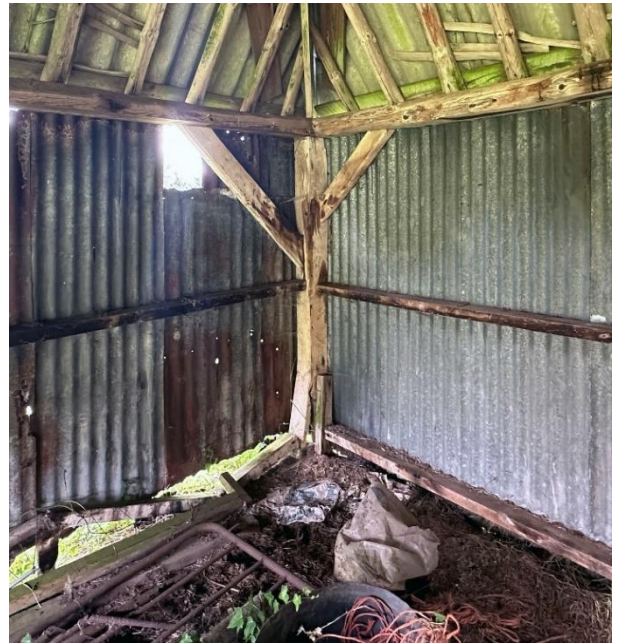
- 2.06 The internal view of the southeast corner is shown in the image opposite. The timber frame elements are all in place, but have been locally displaced or affected by water ingress.

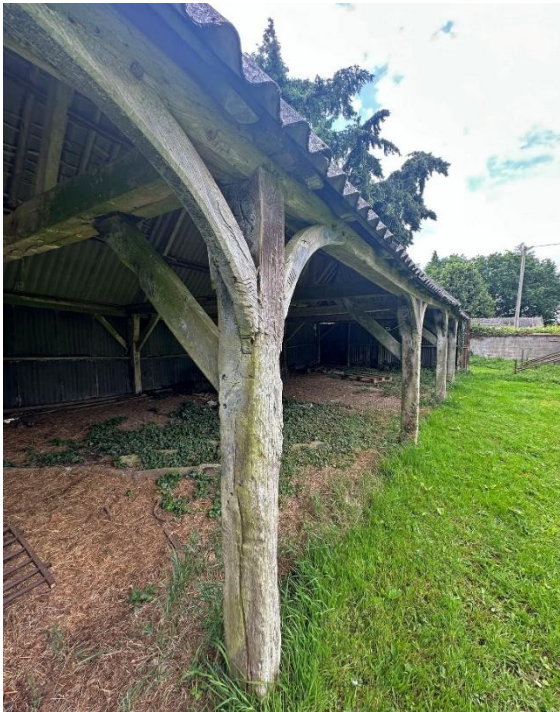
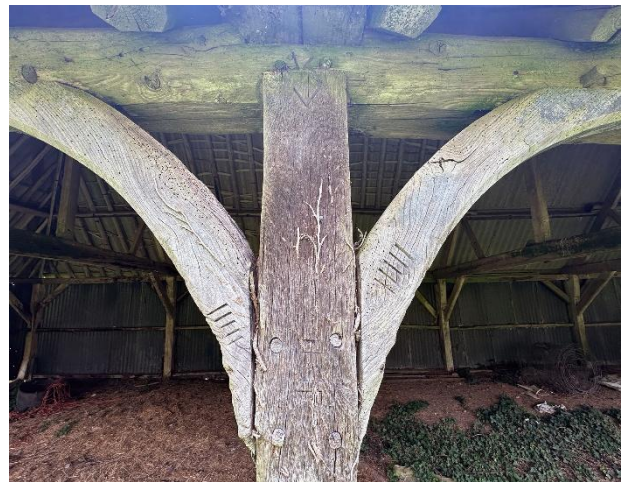
2.07

The image opposite and below shows the configuration of supporting timbers and bracing along the open west elevation. The posts all continue to effectively support the eaves line and good stability is apparent.

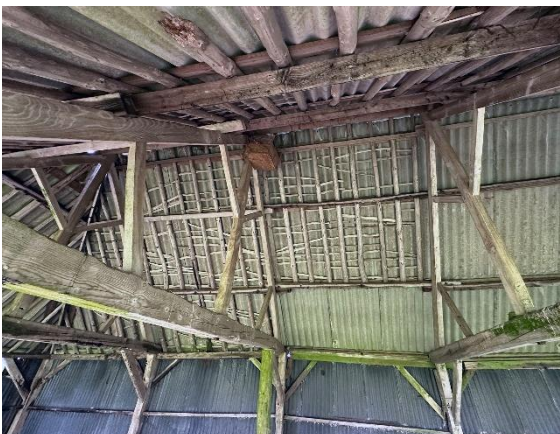
2.08

The roof structure was originally configured with a series of purlins to each pitch with pole timber common rafters and battens over. These remain in some areas but are missing in others with the corrugated sheet spanning between purlins and not relying upon any rafters. Some repairs, strengthening or supplementing of timbers may be anticipated in a conversion, although the existing structure would likely be retained.

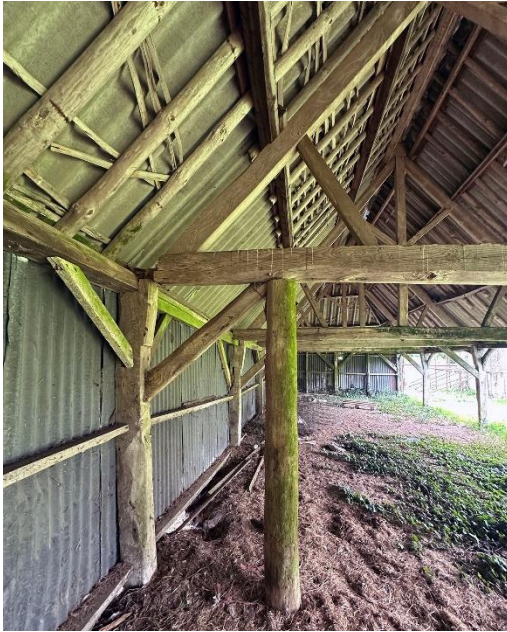
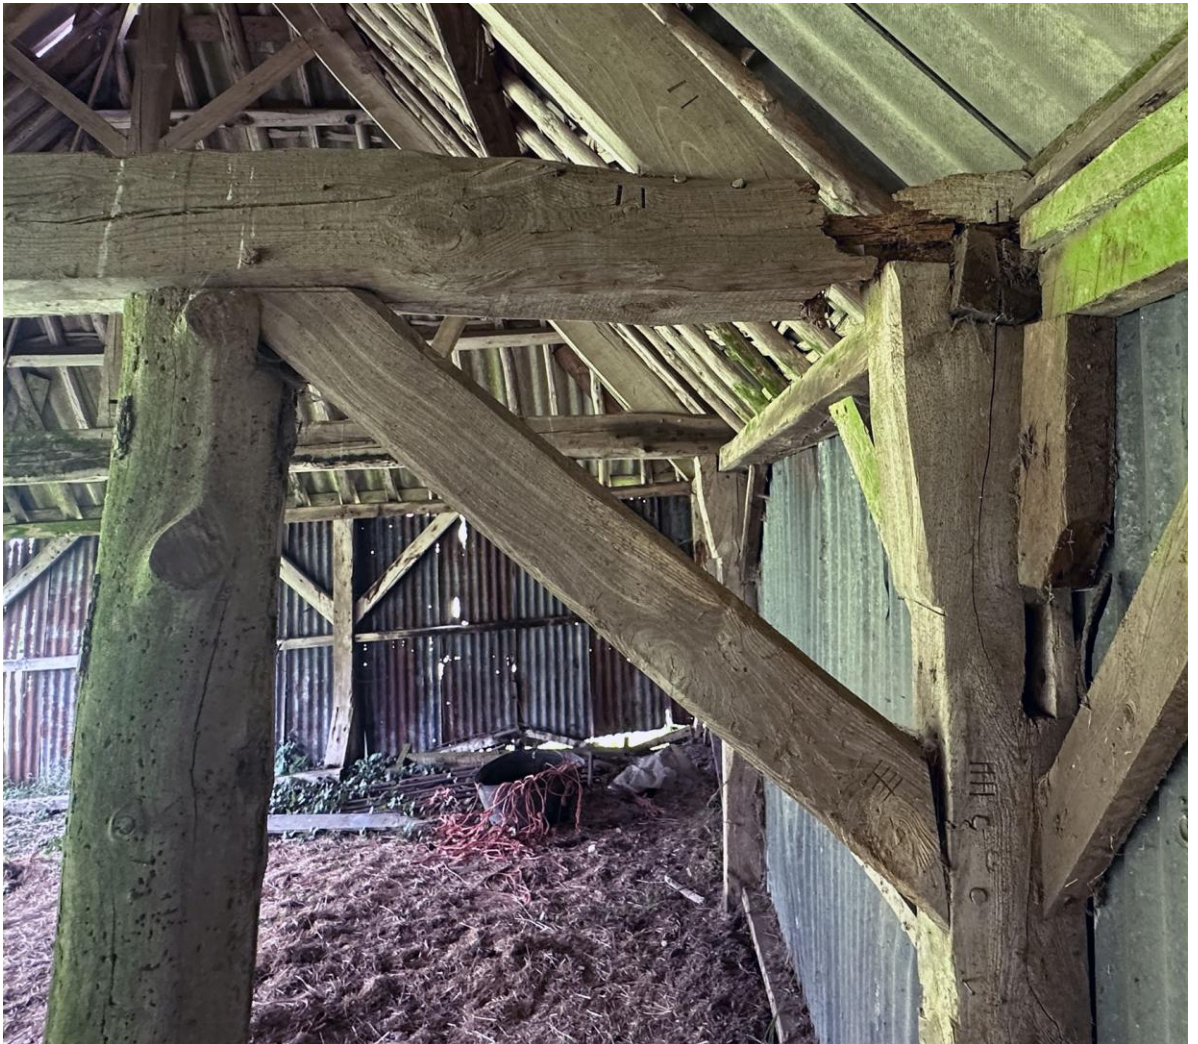
2.09

The image opposite shows the east bearing end to the truss/frame on grid line 'C'. A circular timber post (telegraph pole?) has been inserted to provide remedial support to the truss and prevent failure. The image below shows a closeup detail and shows the extent of detail to bearing end. The decay and subsequent repair post is long standing and assumed to relate to an historical roof leak. None of the other trusses exhibit similar decay. To remove the post a traditional spliced repair can be carried out to enable the majority of the truss and support post to be retained.
