# Statement of Remedial Works

Outline of Proposed External Repair  
Works Affecting Historic Fabric for  
Cathedral Hotel

| PROJECT NAME | Cathedral Hotel |
| DOCUMENT NO. | 23007 - 8302 |

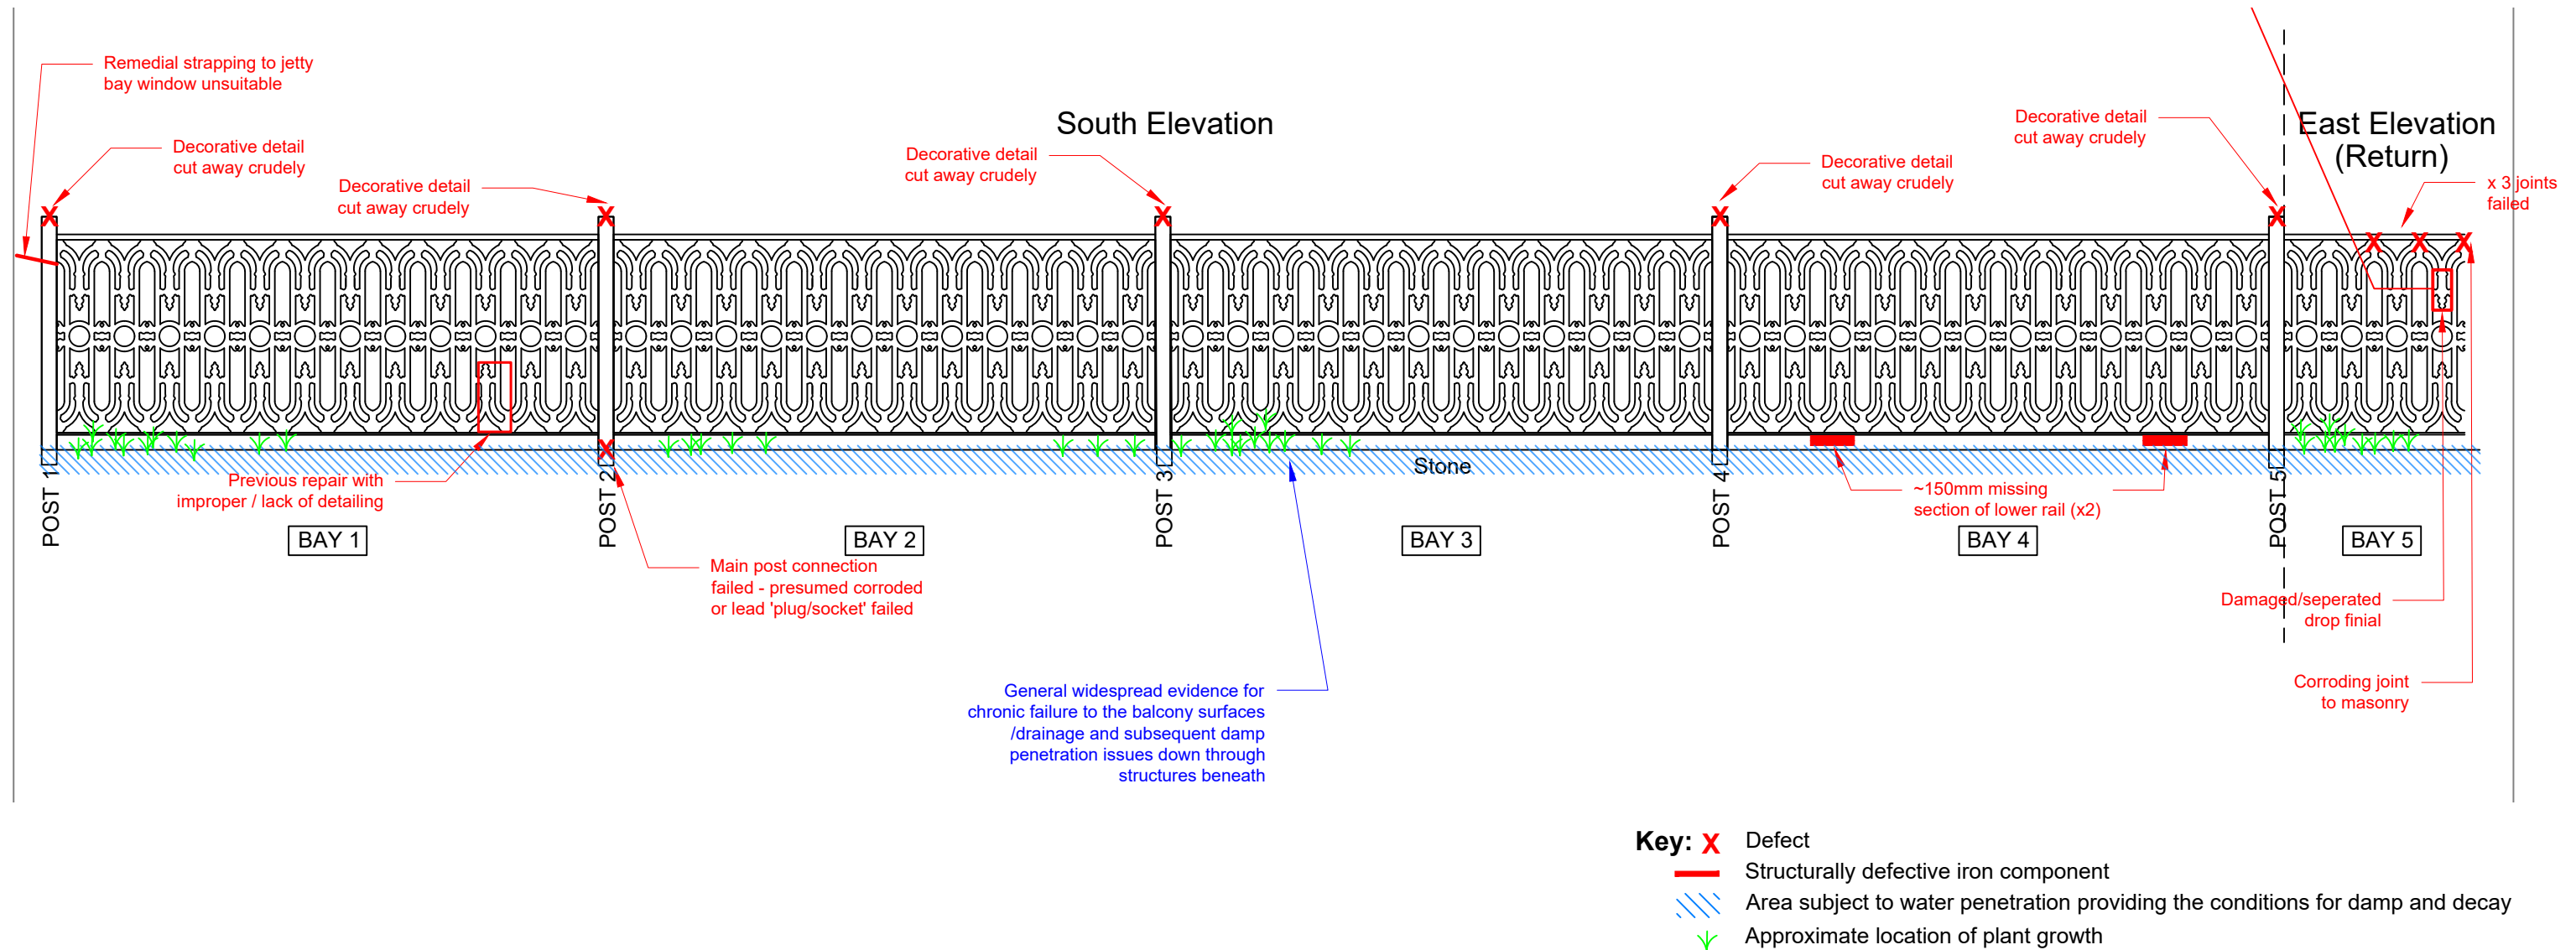
## Appendix B: South Facade - Iron Railings Condition Investigation

Previous remedial works involving cementitious encasement around the base of one of the posts were likely intended to strengthen a weakened connection; however, this approach is liable to trap moisture and accelerate corrosion. Evidence was observed of corroded and partially failed junctions, damaged finials, and poor-quality historic repairs lacking the original three-dimensional modelling and detailing. These issues will require appropriate remedial treatment.

Overall, the decorative wrought ironwork remains substantially intact in form, although there are multiple localised failures together with a broader pattern of moisture-related deterioration associated with waterproofing failure and inappropriate historic repairs. The defects are identified on an elevation, where missing sections, failed joints, damaged finials and defective post connections are annotated. (Appendix B)

The base of the railings will require exposure through the removal of the asphalt membrane to allow inspection of all post feet. Defective post bases will be reinstated using traditional lead socket fixings where required. The railings will remain in situ throughout the works, and all repairs will therefore be carried out on site without removal from the hotel.

Localised failures, including missing sections of the bottom rail, will be carefully cut out and replaced with accurately profiled wrought iron sections to match the existing work. Damaged drop finials will be reinstated and failed welded or forged joints repaired using appropriate conservation-led forging and welding techniques. Galvanising and modern arc-welding methods will be avoided in favour of traditional forge-welding repairs using compatible materials, including salvaged wrought iron or mild steel where appropriate. Any elements identified as cast iron will be repaired in an appropriate technique as it cannot be repaired using the same forge-welding techniques, due to the likelihood of fracturing under sudden stress or heat. Instead, any cast iron will require techniques like cold metal stitching or bronze brazing for joining smaller pieces of cast iron.

A historic repair within Bay 1 has been identified as substandard and inconsistent with the original detailing and three-dimensional modelling of the ironwork. This section will be removed and replaced with a correctly modelled replica section matching the original profile, depth, and detailing. The remnants of the former canopy support posts currently project above the railing line and will be carefully reduced and finished flush with the height of the surrounding railings.

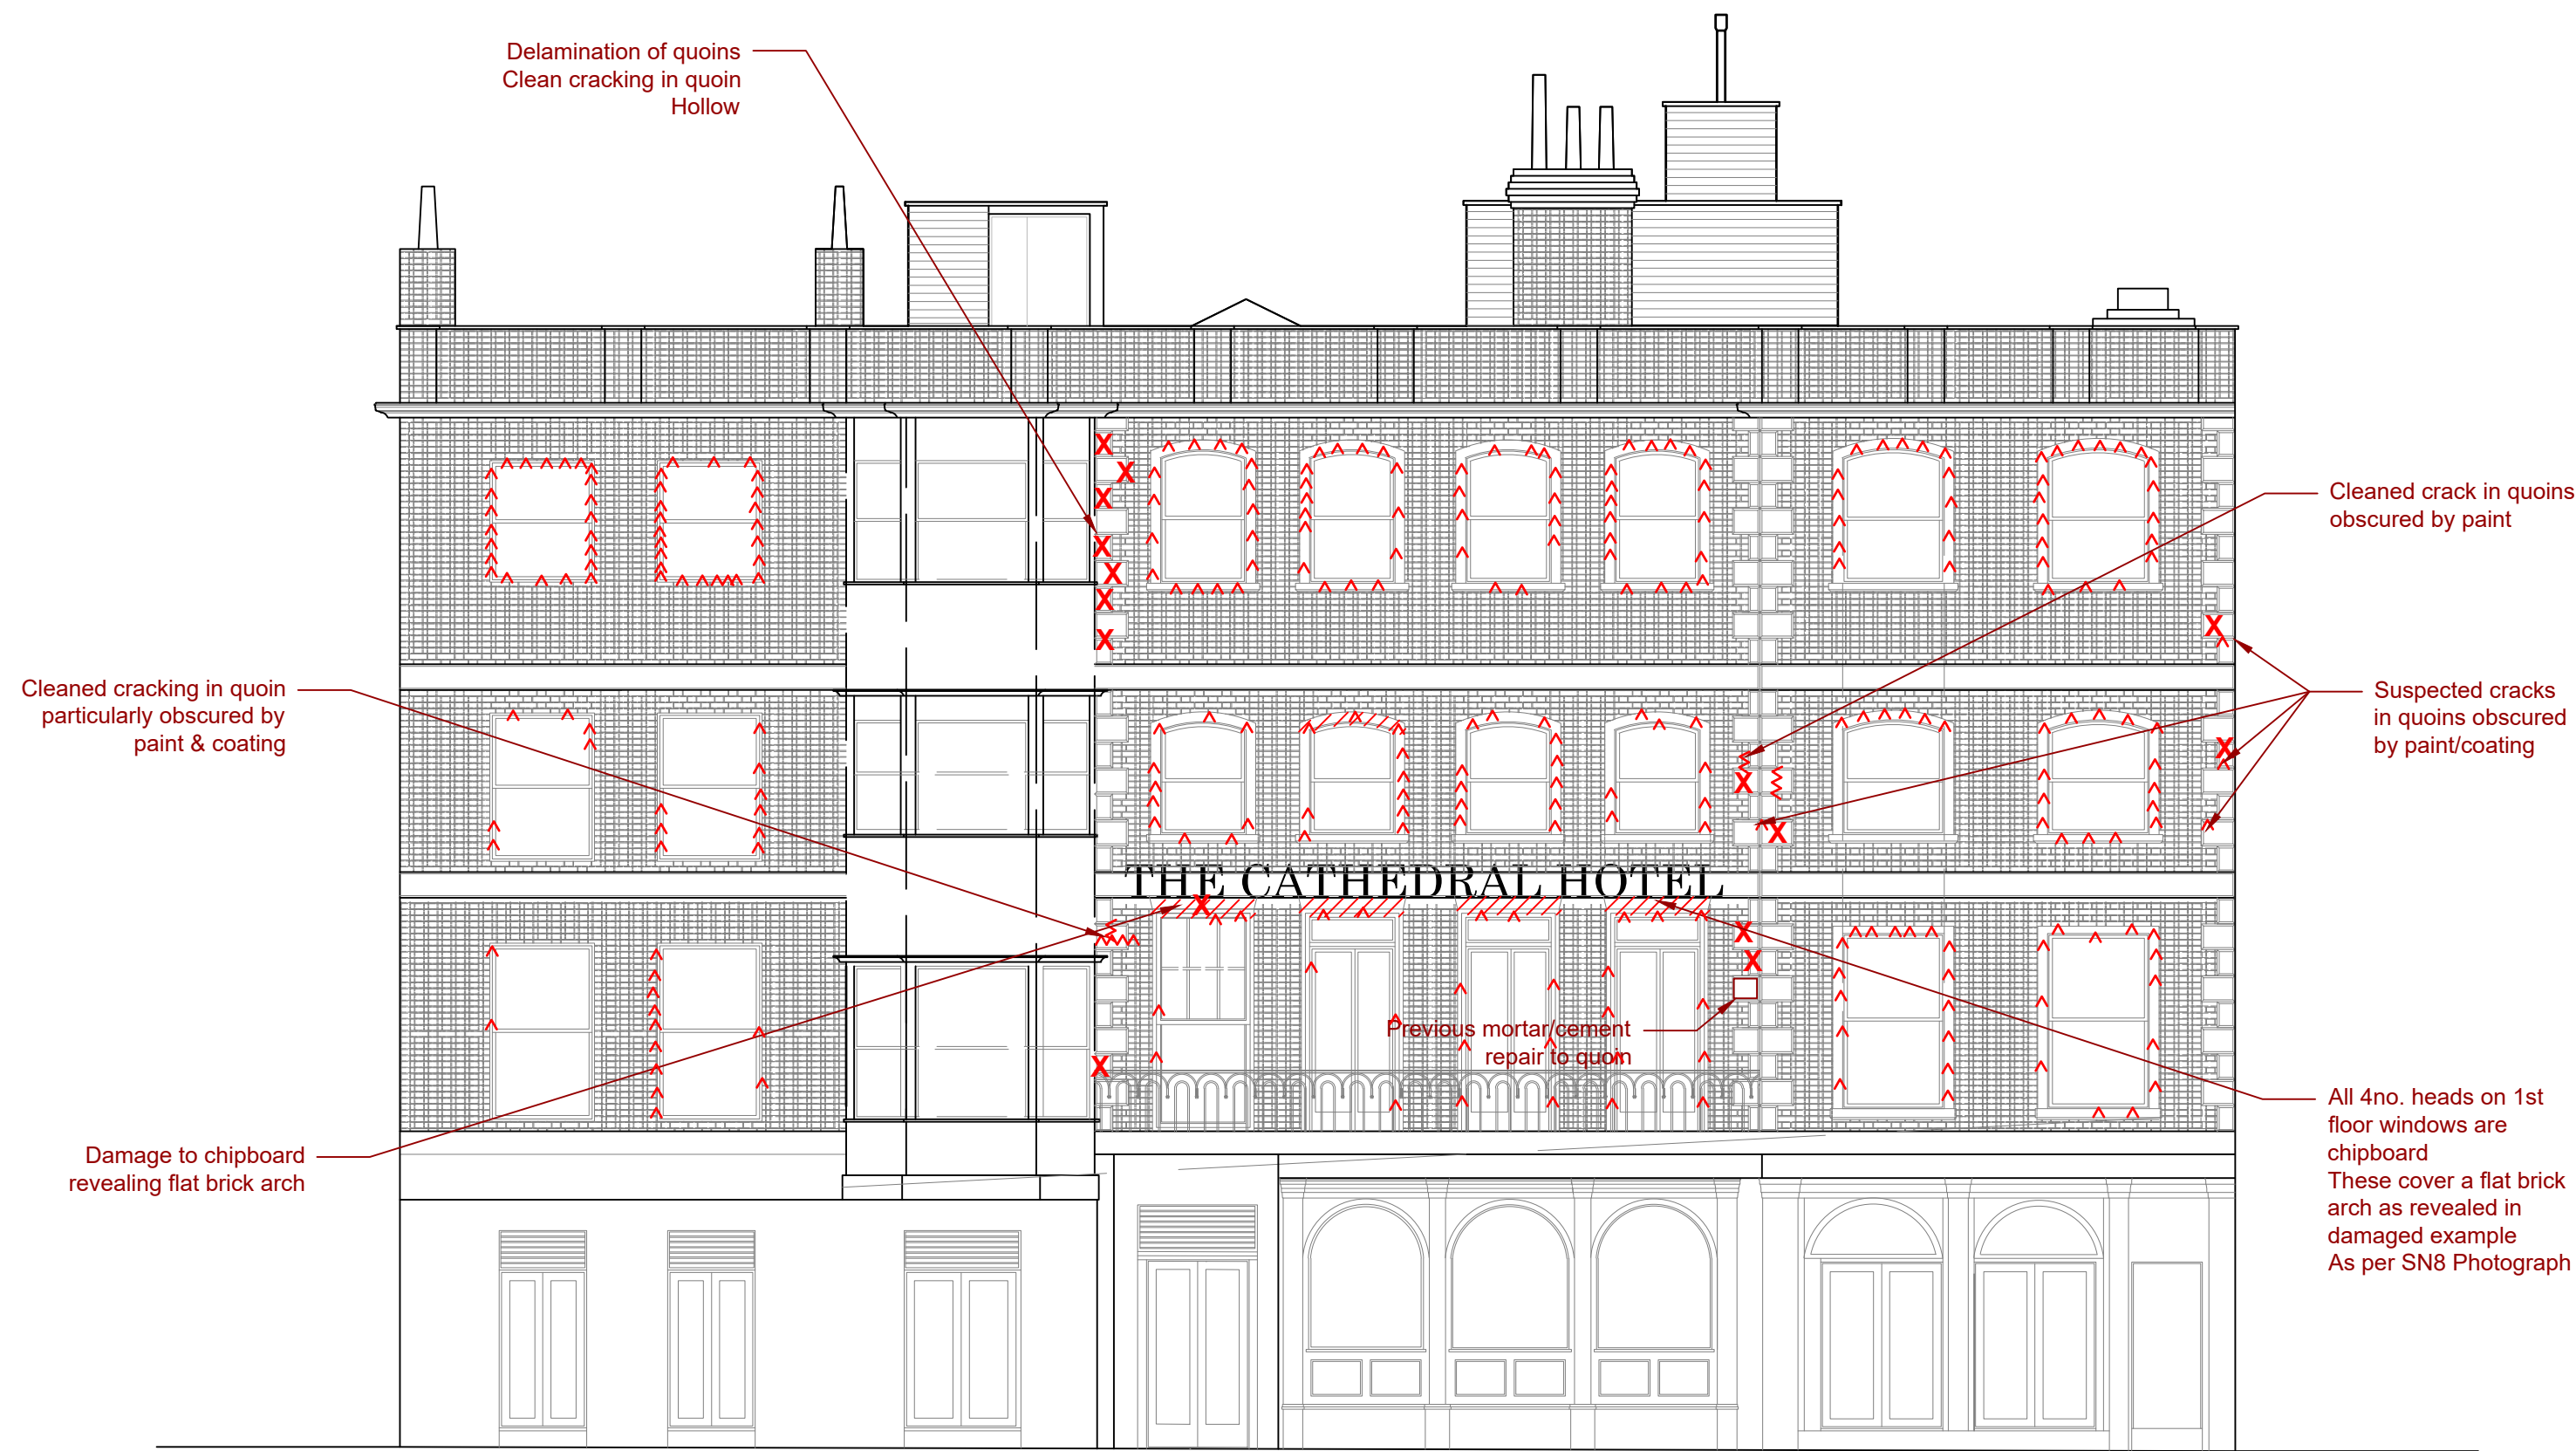
Appendix C: South Facade - Architectural Details Investigation: Window Surrounds

The rendered window surrounds do not currently display active detachment; however, widespread surface cracking is evident throughout, indicative of material movement and long-term environmental exposure. The rendered arch panels above the second-floor openings show evidence of partial separation, while timber chipboard panels installed at upper-storey window heads exhibit decay and localised detachment.

At the time of H&R's inspection of the principal façade, no significant detachment of the quoins was observed. However, areas of cracking and isolated hollow sections were identified within the rendered surfaces. As with the other architectural elements, the quoins are coated in a thick layer of impermeable masonry paint, which restricts vapour permeability and contributes to moisture retention within the fabric. Although the overall rendered form remains intact, there is evidence of localised surface weathering and deterioration.

Following the removal of masonry paint from the window surrounds and cills, the condition of the underlying substrate can be assessed. At the time of H&R's inspection, no loose or hollow areas were identified; however, widespread cracking within the render and evidence of debonding at cill locations indicate the need for practical conservation repairs. Minor cracks will be injected using compatible lime-based grout, while larger fractures will be repaired using lime-based mortars.

The quoins, once stripped of paint, may be repaired using similar conservation methods to those proposed for the window surrounds and cills. Fine cracks will be filled using lime-based grout, while areas where render or mortar has lost cohesion will be repaired using compatible lime-based mortar to fill voids and reinstate original profiles.

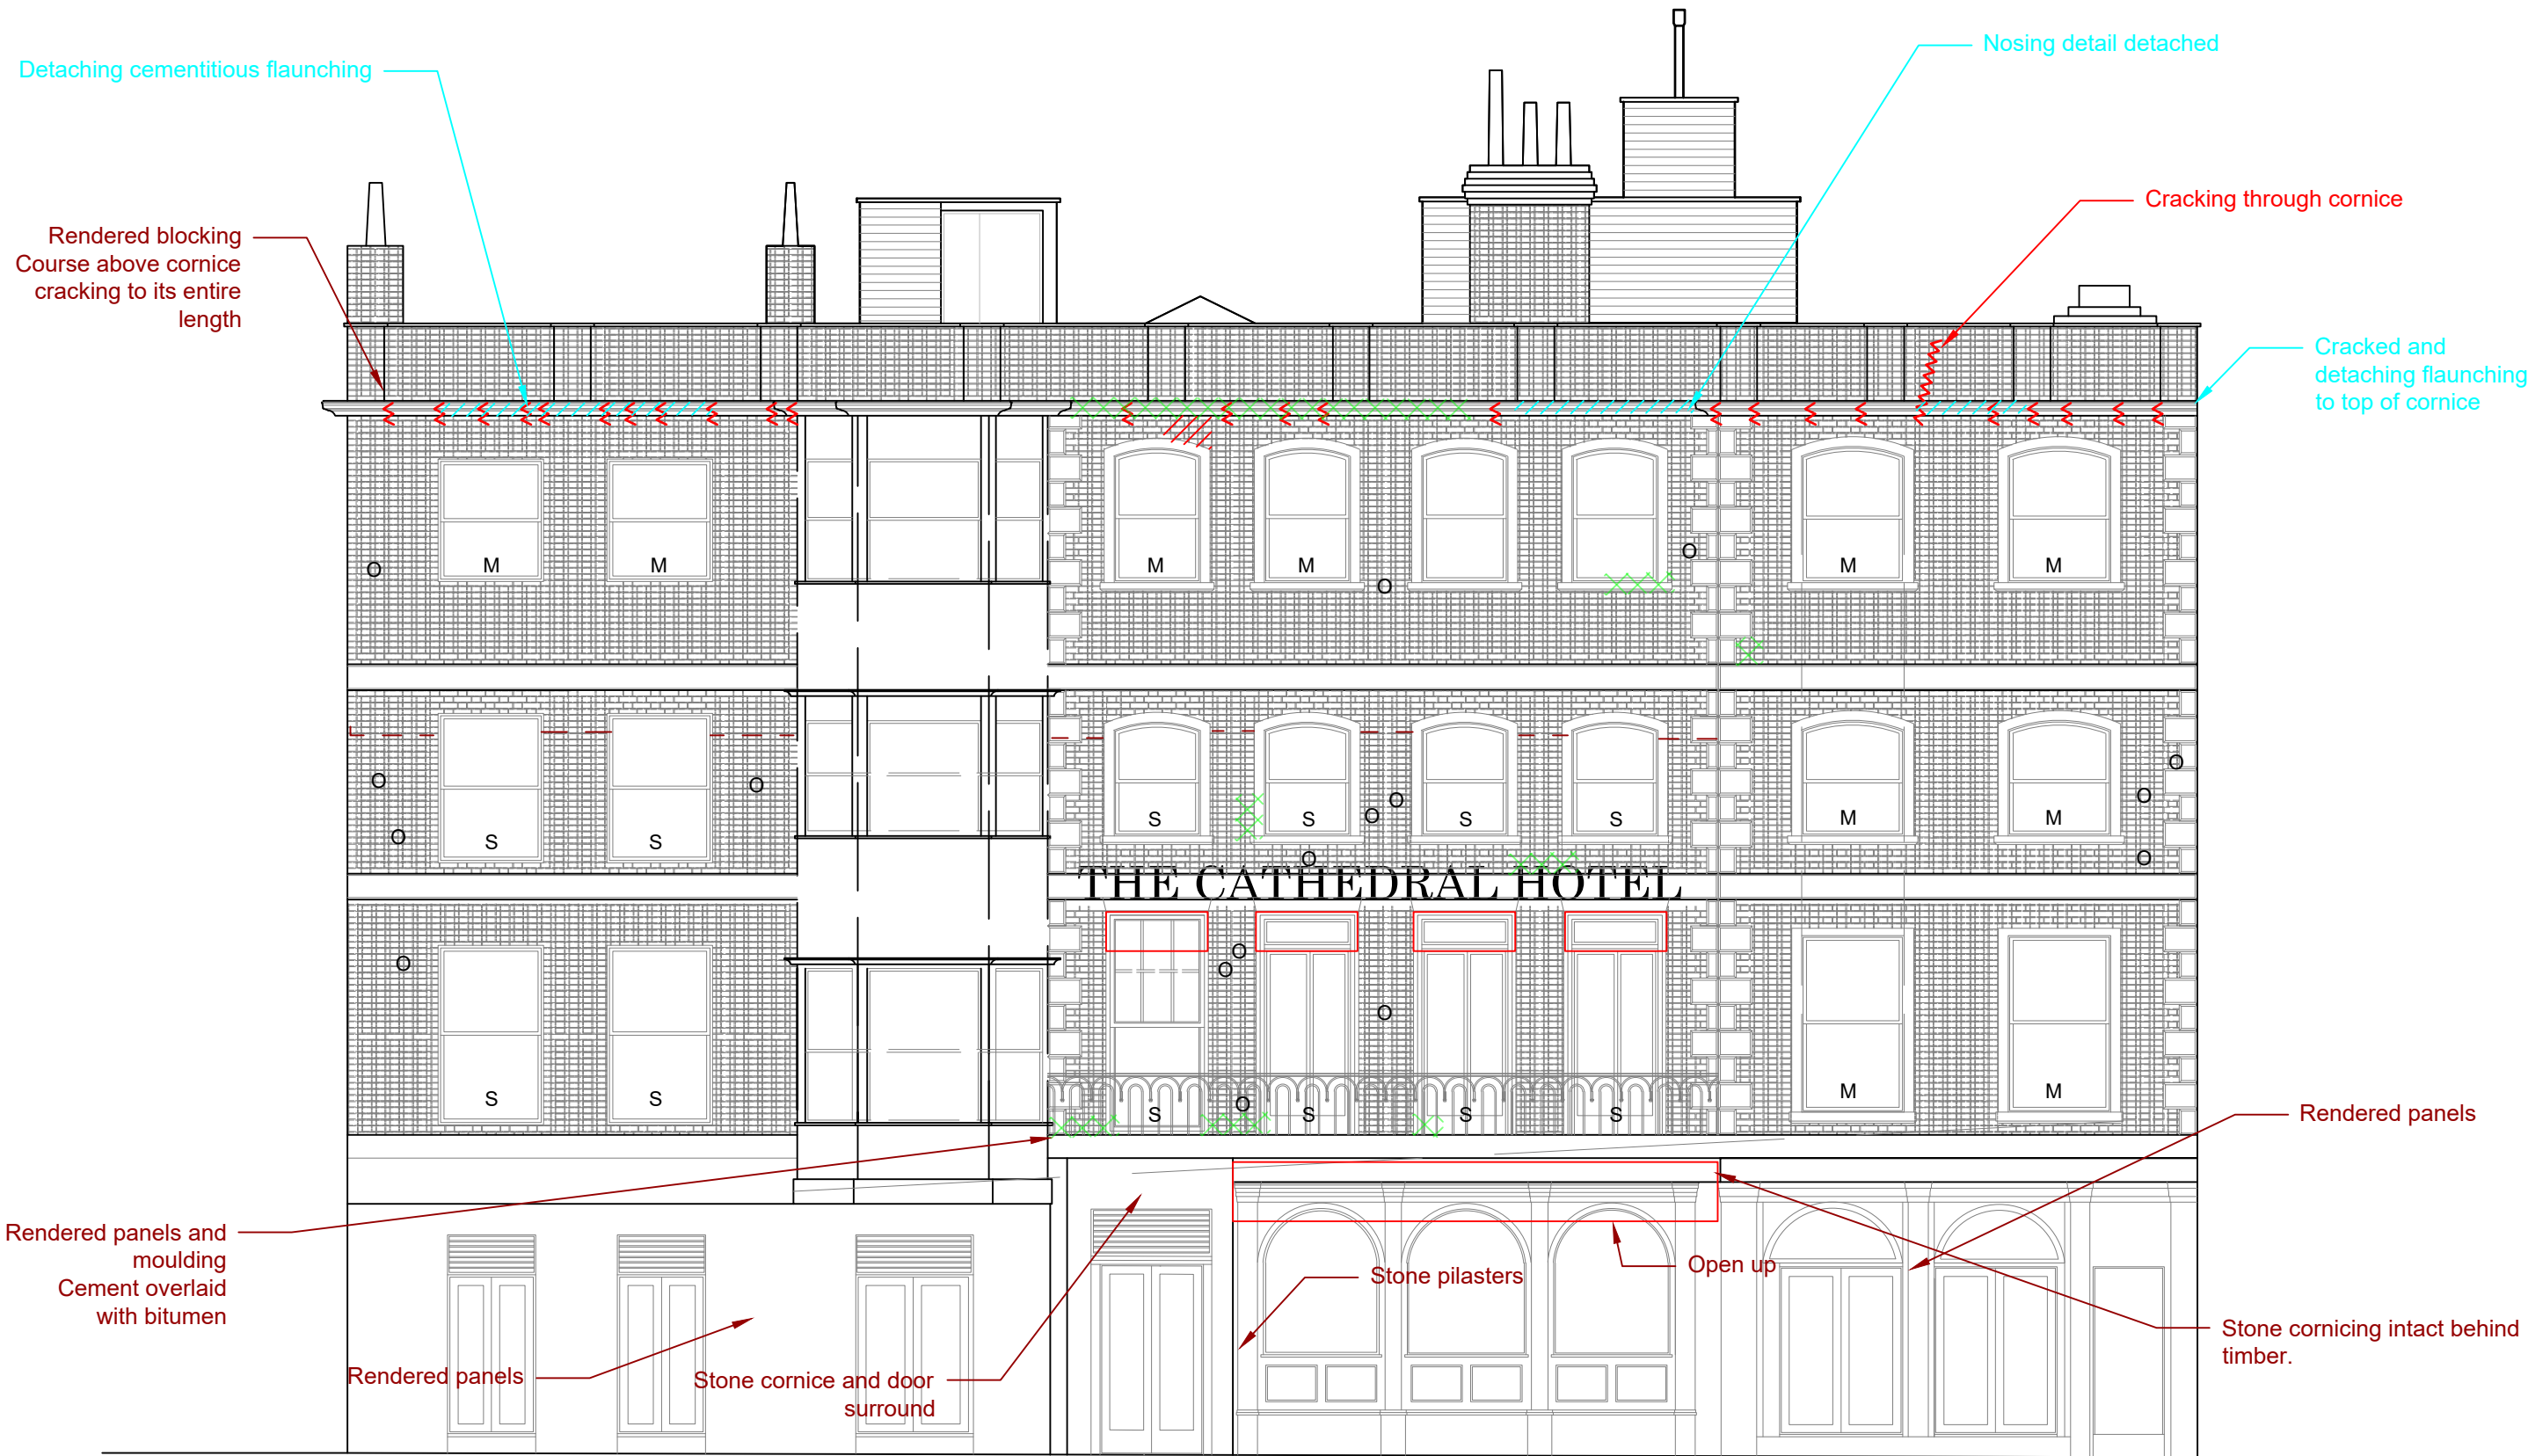
Appendix C: South Facade - Architectural Details Investigation: Stone Details

Defective areas are identified on the front elevation drawings found in appendix B. The upper cornice exhibits areas of detachment and deterioration to the upper flaunching, together with widespread cracking, shrinkage, and debonding. These defects are likely associated with moisture ingress and the application of impermeable masonry paint coatings.

A detached section of cornice moulding, approximately 1.2 metres in length, is present within the central section of the building. The flaunching above the upper cornice is extensively fractured, allowing water penetration into the cornice structure.

The ground-floor cornice, while largely intact, displays evidence of surface deterioration, moisture retention, salt efflorescence, and corrosion of embedded ferrous fixings. Multiple historic applications of masonry paint, in places reaching approximately 4mm in thickness, are also present. Much of the cornice at ground floor is currently concealed behind timber construction, limiting visibility of the underlying stonework. The string course exhibits continuous longitudinal cracking along its length. The stone pilasters at the principal entrance show signs of moisture-related deterioration and salt crystallisation concentrated at their bases.

All defective flaunching at the head of the upper cornice should be carefully dismantled to allow full inspection of the underlying build-up and its bond to the façade. This investigation will enable assessment of the relationship between the later cementitious render layers and the underlying oolitic limestone core, which is assumed to provide the principal structural stability and connection to the façade.

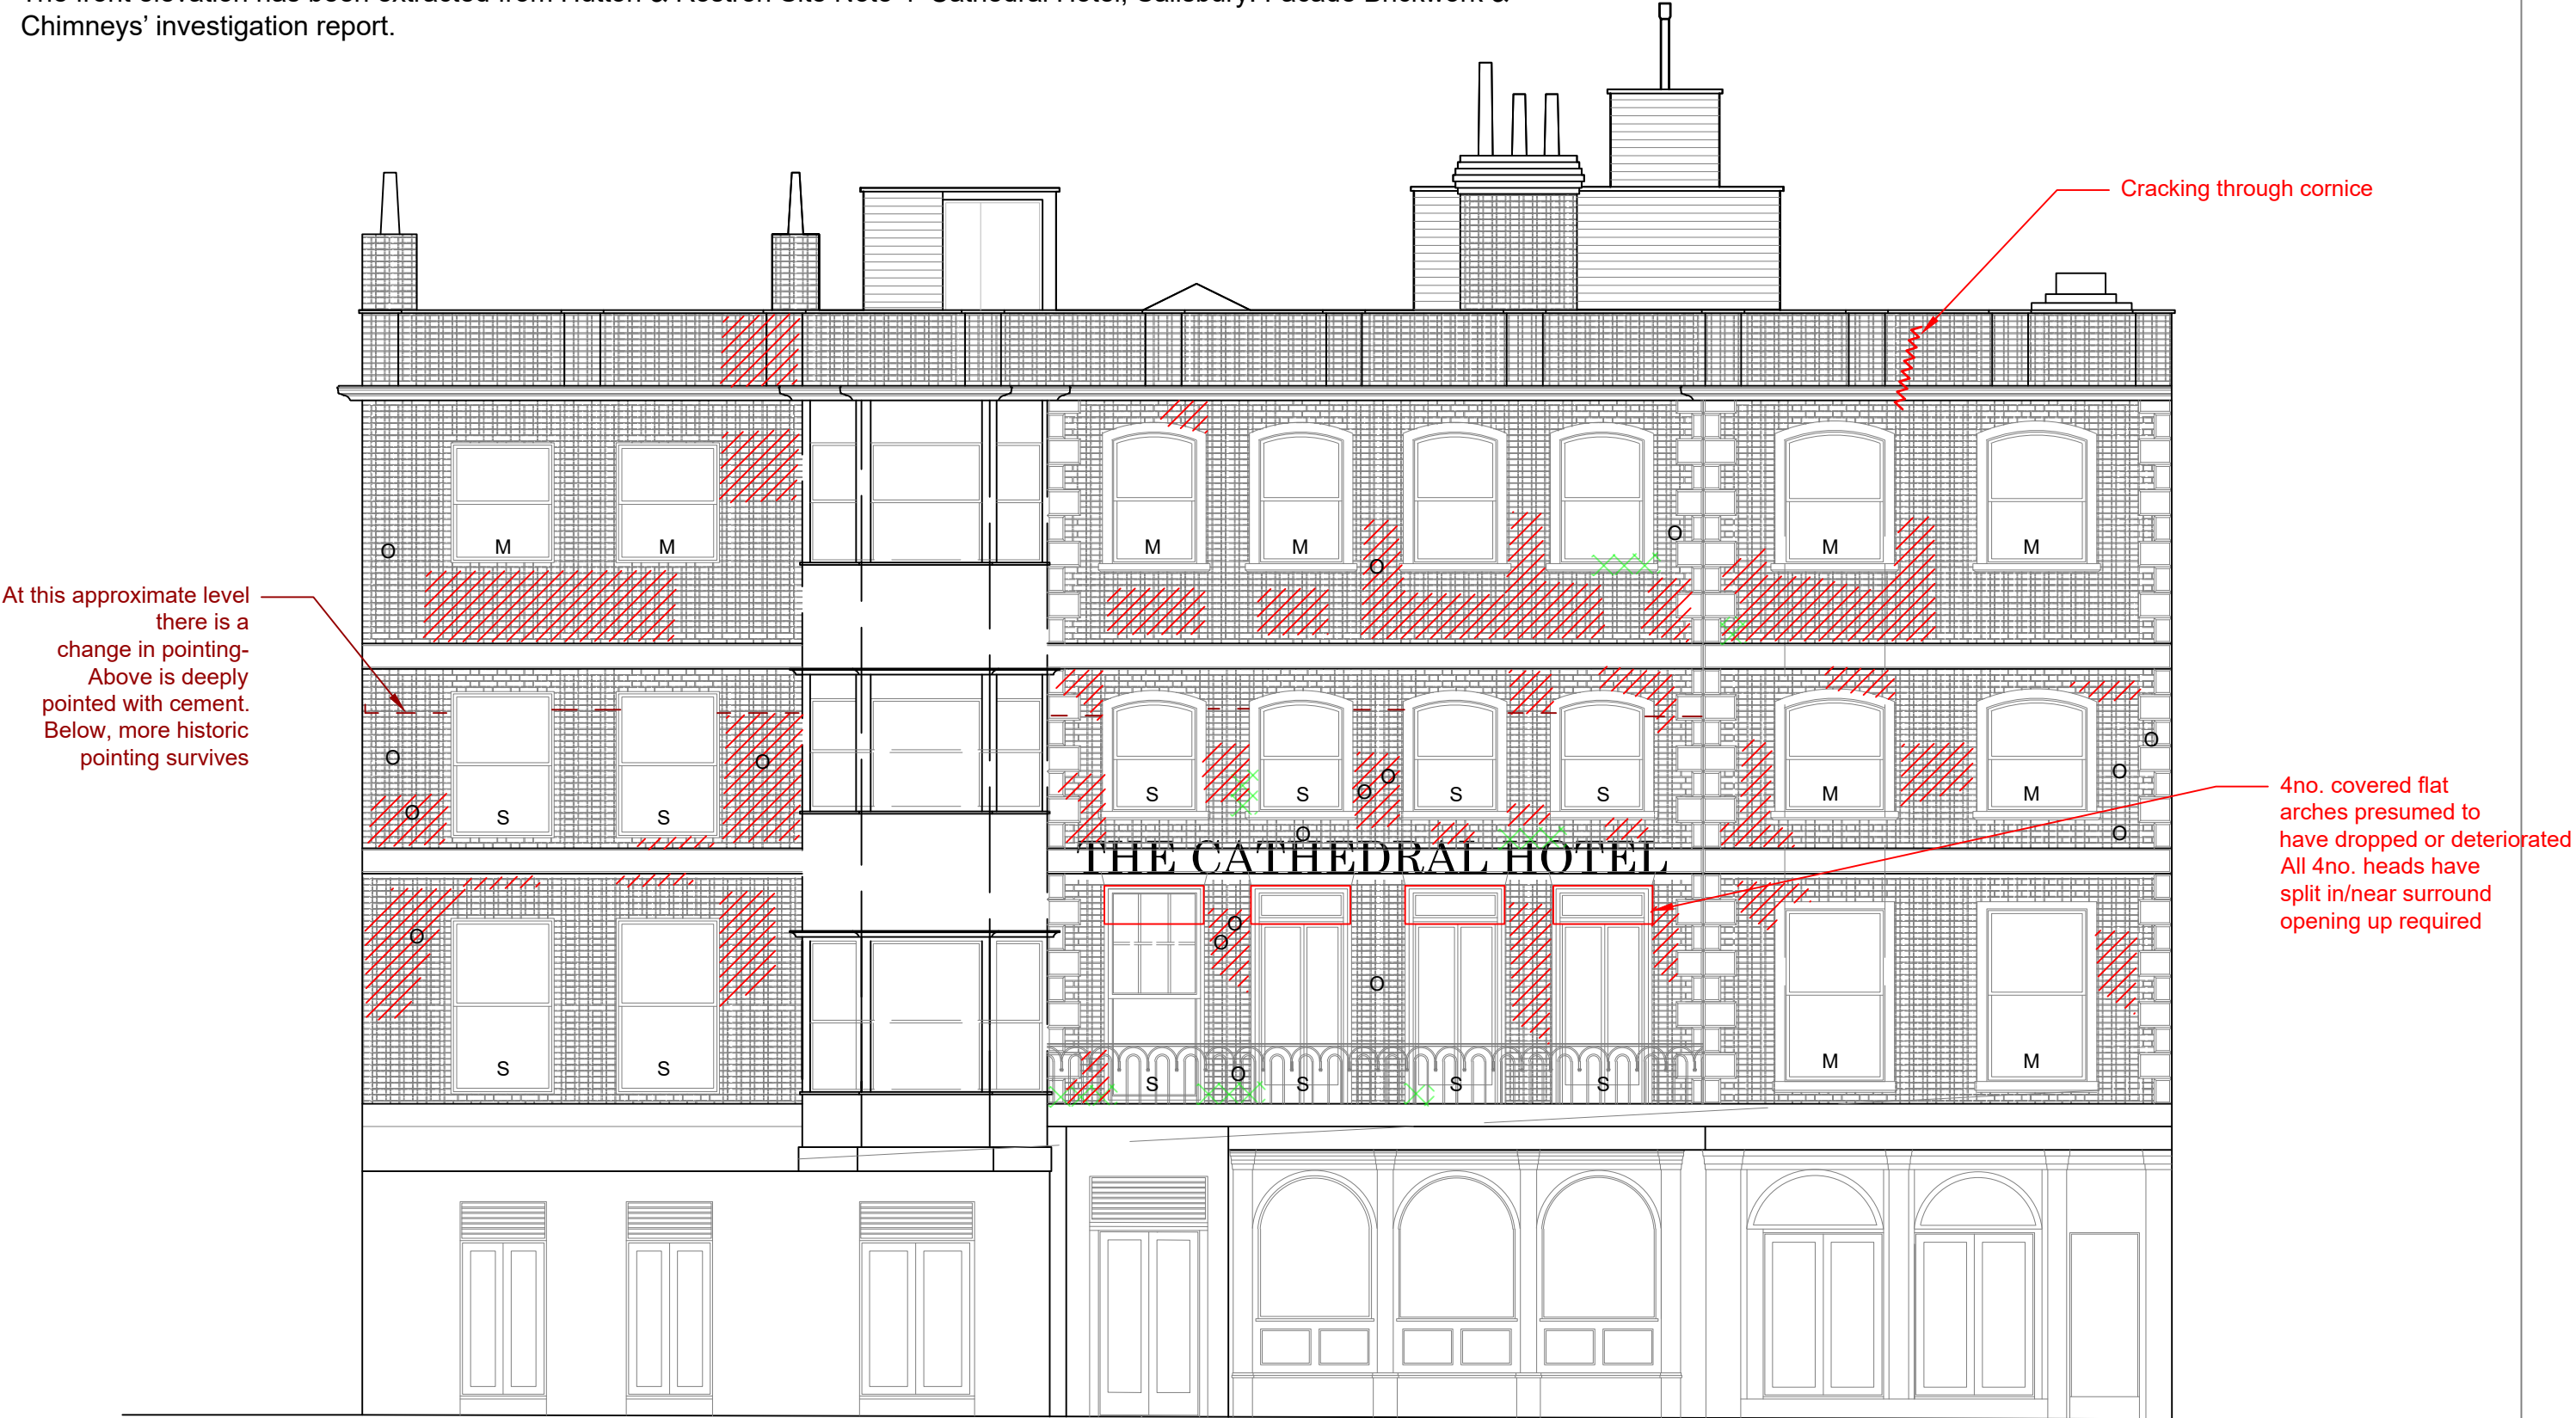
Appendix D: South Facade - Brickwork & Chimneys Investigation: Pointing Condition

The principal façade exhibits several localised areas of deterioration and alteration. Approximately 30% of the pointing above first-floor level is defective, with open joints and localised mortar loss evident throughout. A total of 25 spalled bricks were identified across the front elevation, together with 15 embedded redundant fixings associated with previous installations. Four isolated areas of cracking are present to the eastern side of the façade at parapet level and immediately below, likely indicative of differential movement at high level.

Dense grey cementitious mortar has been applied as a thin over-pointing to earlier lime mortar joints across the principal façade as part of previous repair works. This treatment has altered the permeability of the masonry, increasing the potential for moisture retention within the brickwork and contributing to surface deterioration due to the disparity in porosity between the mortar and surrounding brick.

There is widespread evidence of debonding and failure of the cementitious over-pointing in numerous locations.

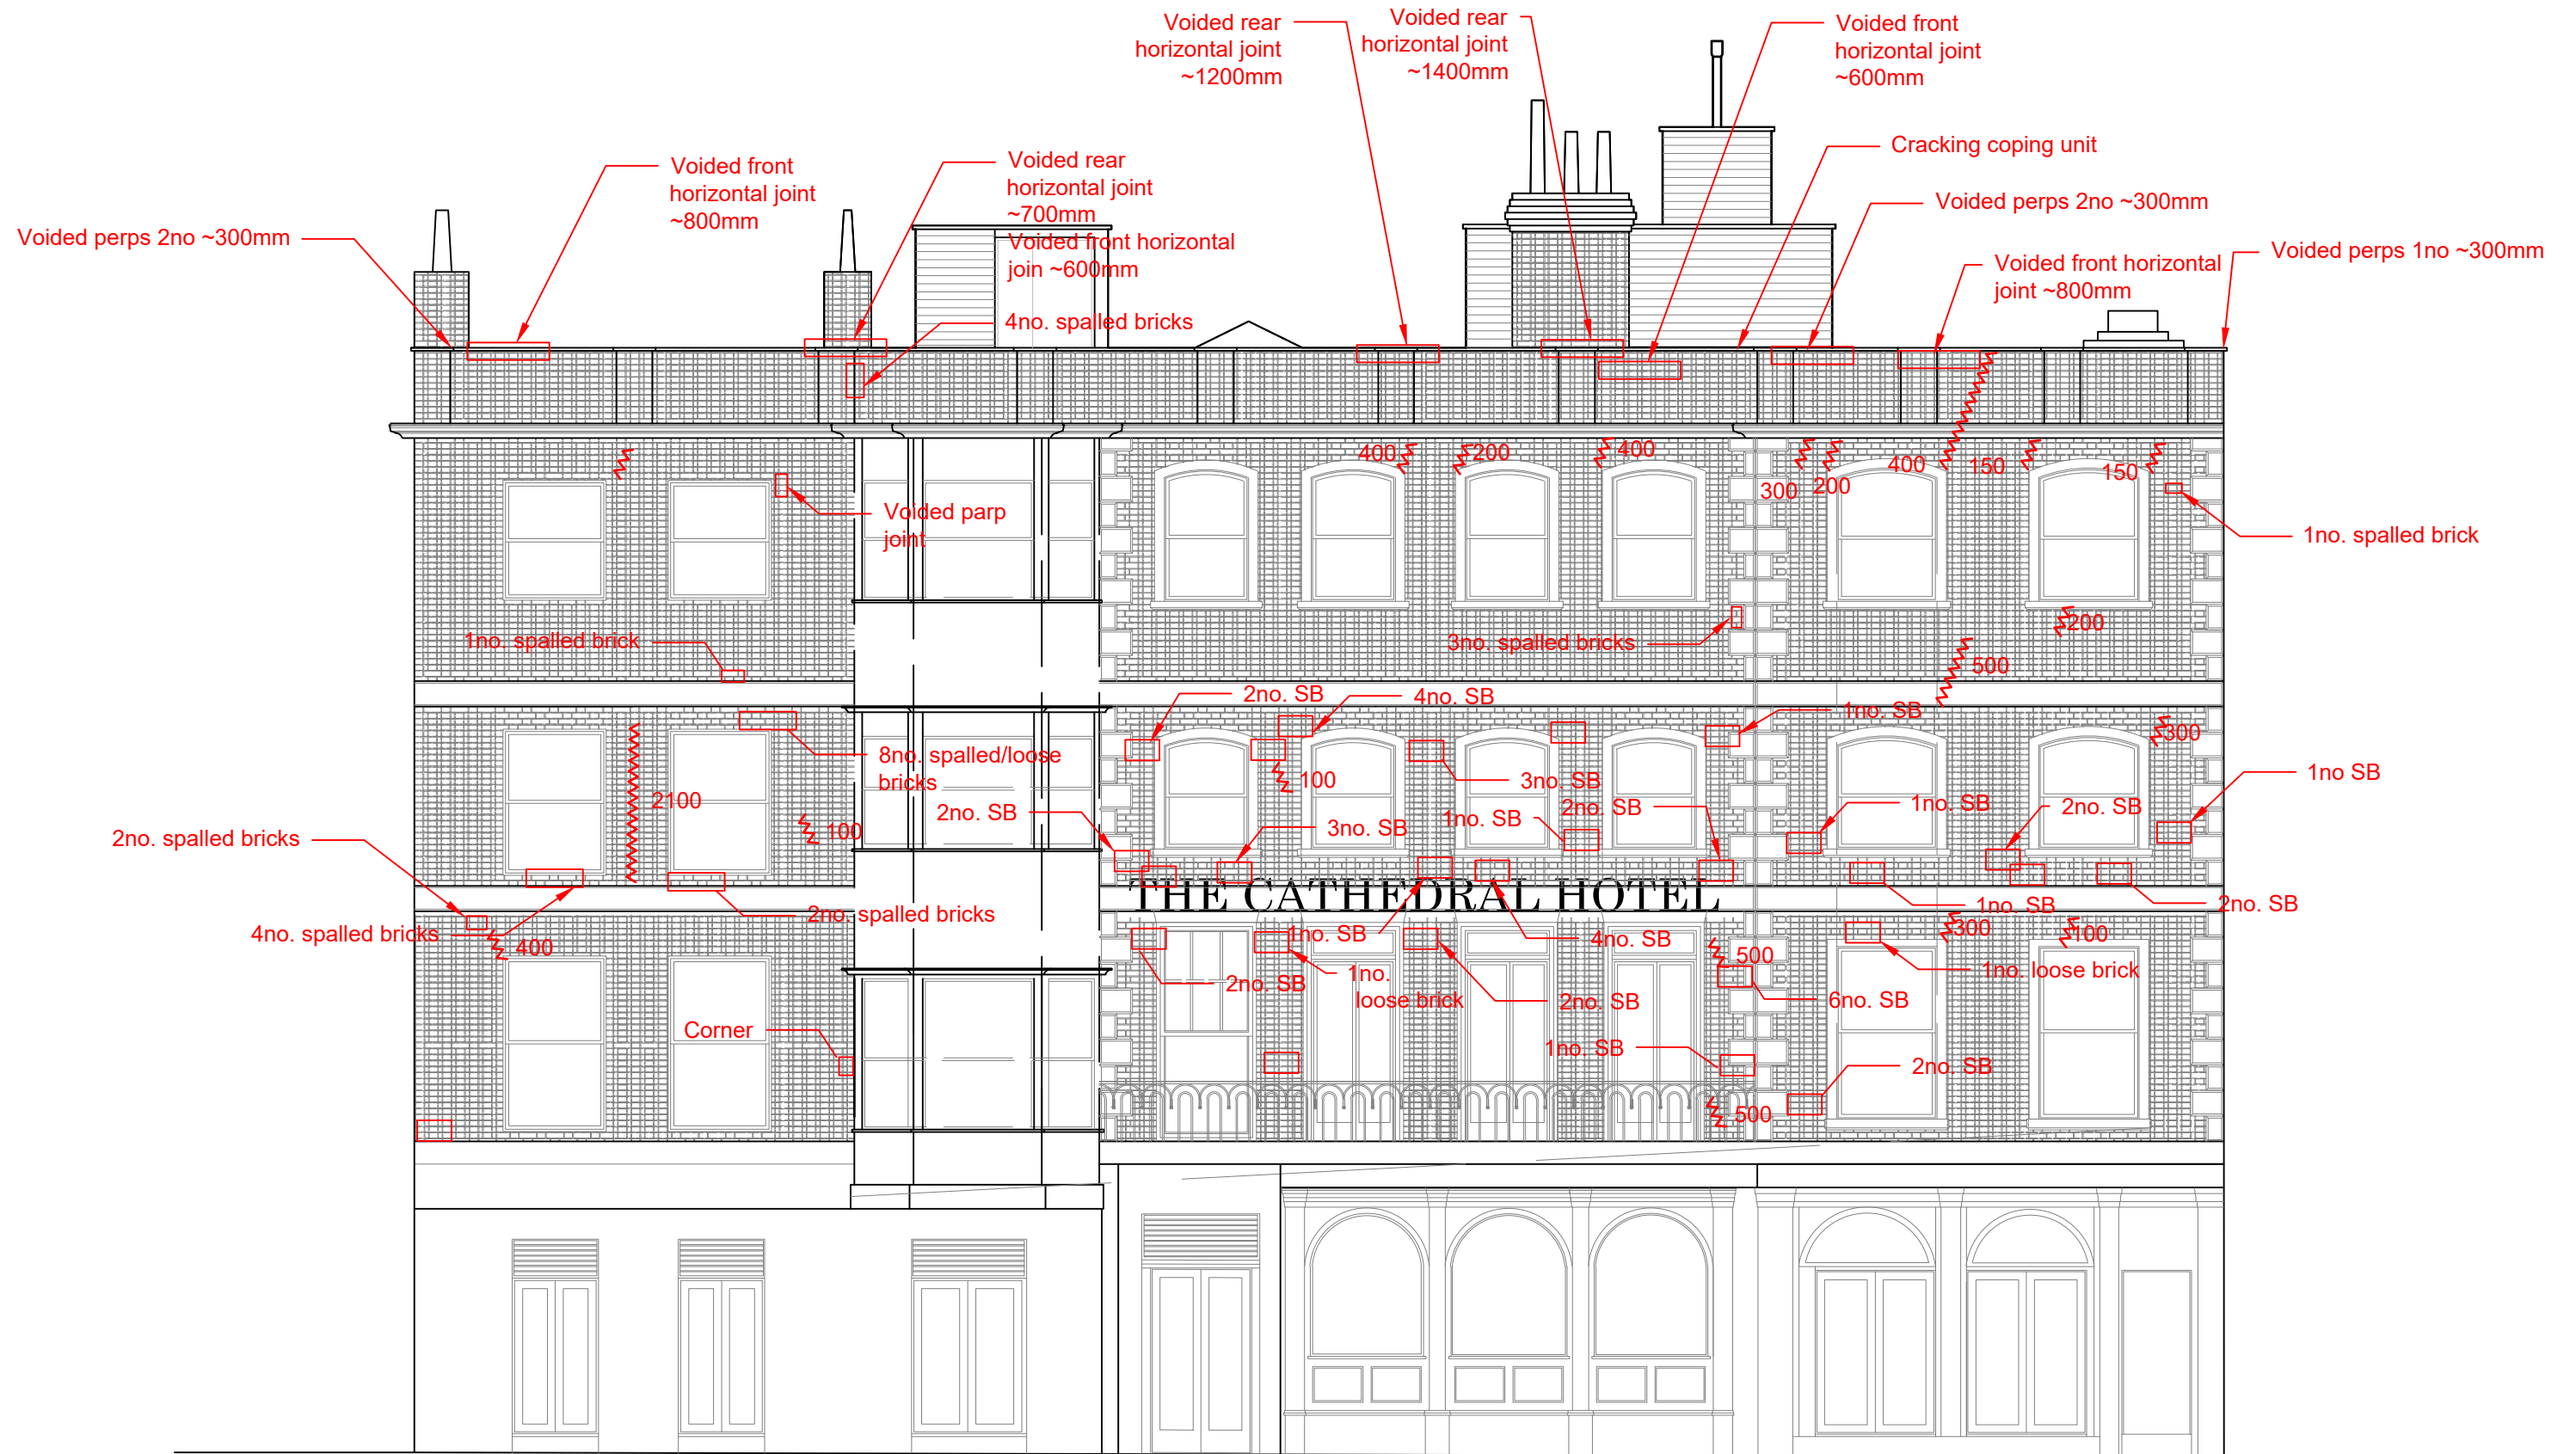
## Appendix D: South Facade - Brickwork & Chimneys Investigation: Brickwork Condition

The first-floor window heads within the central section are also formed in gauged brickwork with oolitic limestone keystones. Three of these openings have been concealed with timber boarding, while the westernmost opening remains exposed, revealing surface deterioration to the limestone keystone. This deterioration is considered to result from prolonged moisture retention behind the timber boards and associated salt migration.

The parapet copings exhibit widespread joint failure, including approximately 4 metres of voided horizontal bed joints and 12 open perpendicular joints. The copings appear to have been reset over a continuous damp-proof membrane layer, reducing frictional restraint and increasing susceptibility to movement. Consequently, there is widespread loss of bedding cohesion and localised displacement between coping units.

Spalled bricks will be replaced using 'Heritage Handmade Dark Blend' laid in lime mortar to maintain both structural performance and visual continuity.

Cracked and displaced gauged brick arches, particularly the dropped arch at second-floor level within the western section and the first-floor window heads within the central section, will be carefully stabilised. Existing limestone keystones will be retained and repaired using minimal intervention techniques in accordance with conservation best practice.
