# Statement of Remedial Works

Outline of Proposed External Repair  
Works Affecting Historic Fabric for  
Cathedral Hotel

| PROJECT NAME | Cathedral Hotel |
| DOCUMENT NO. | 23007 - 8302 |

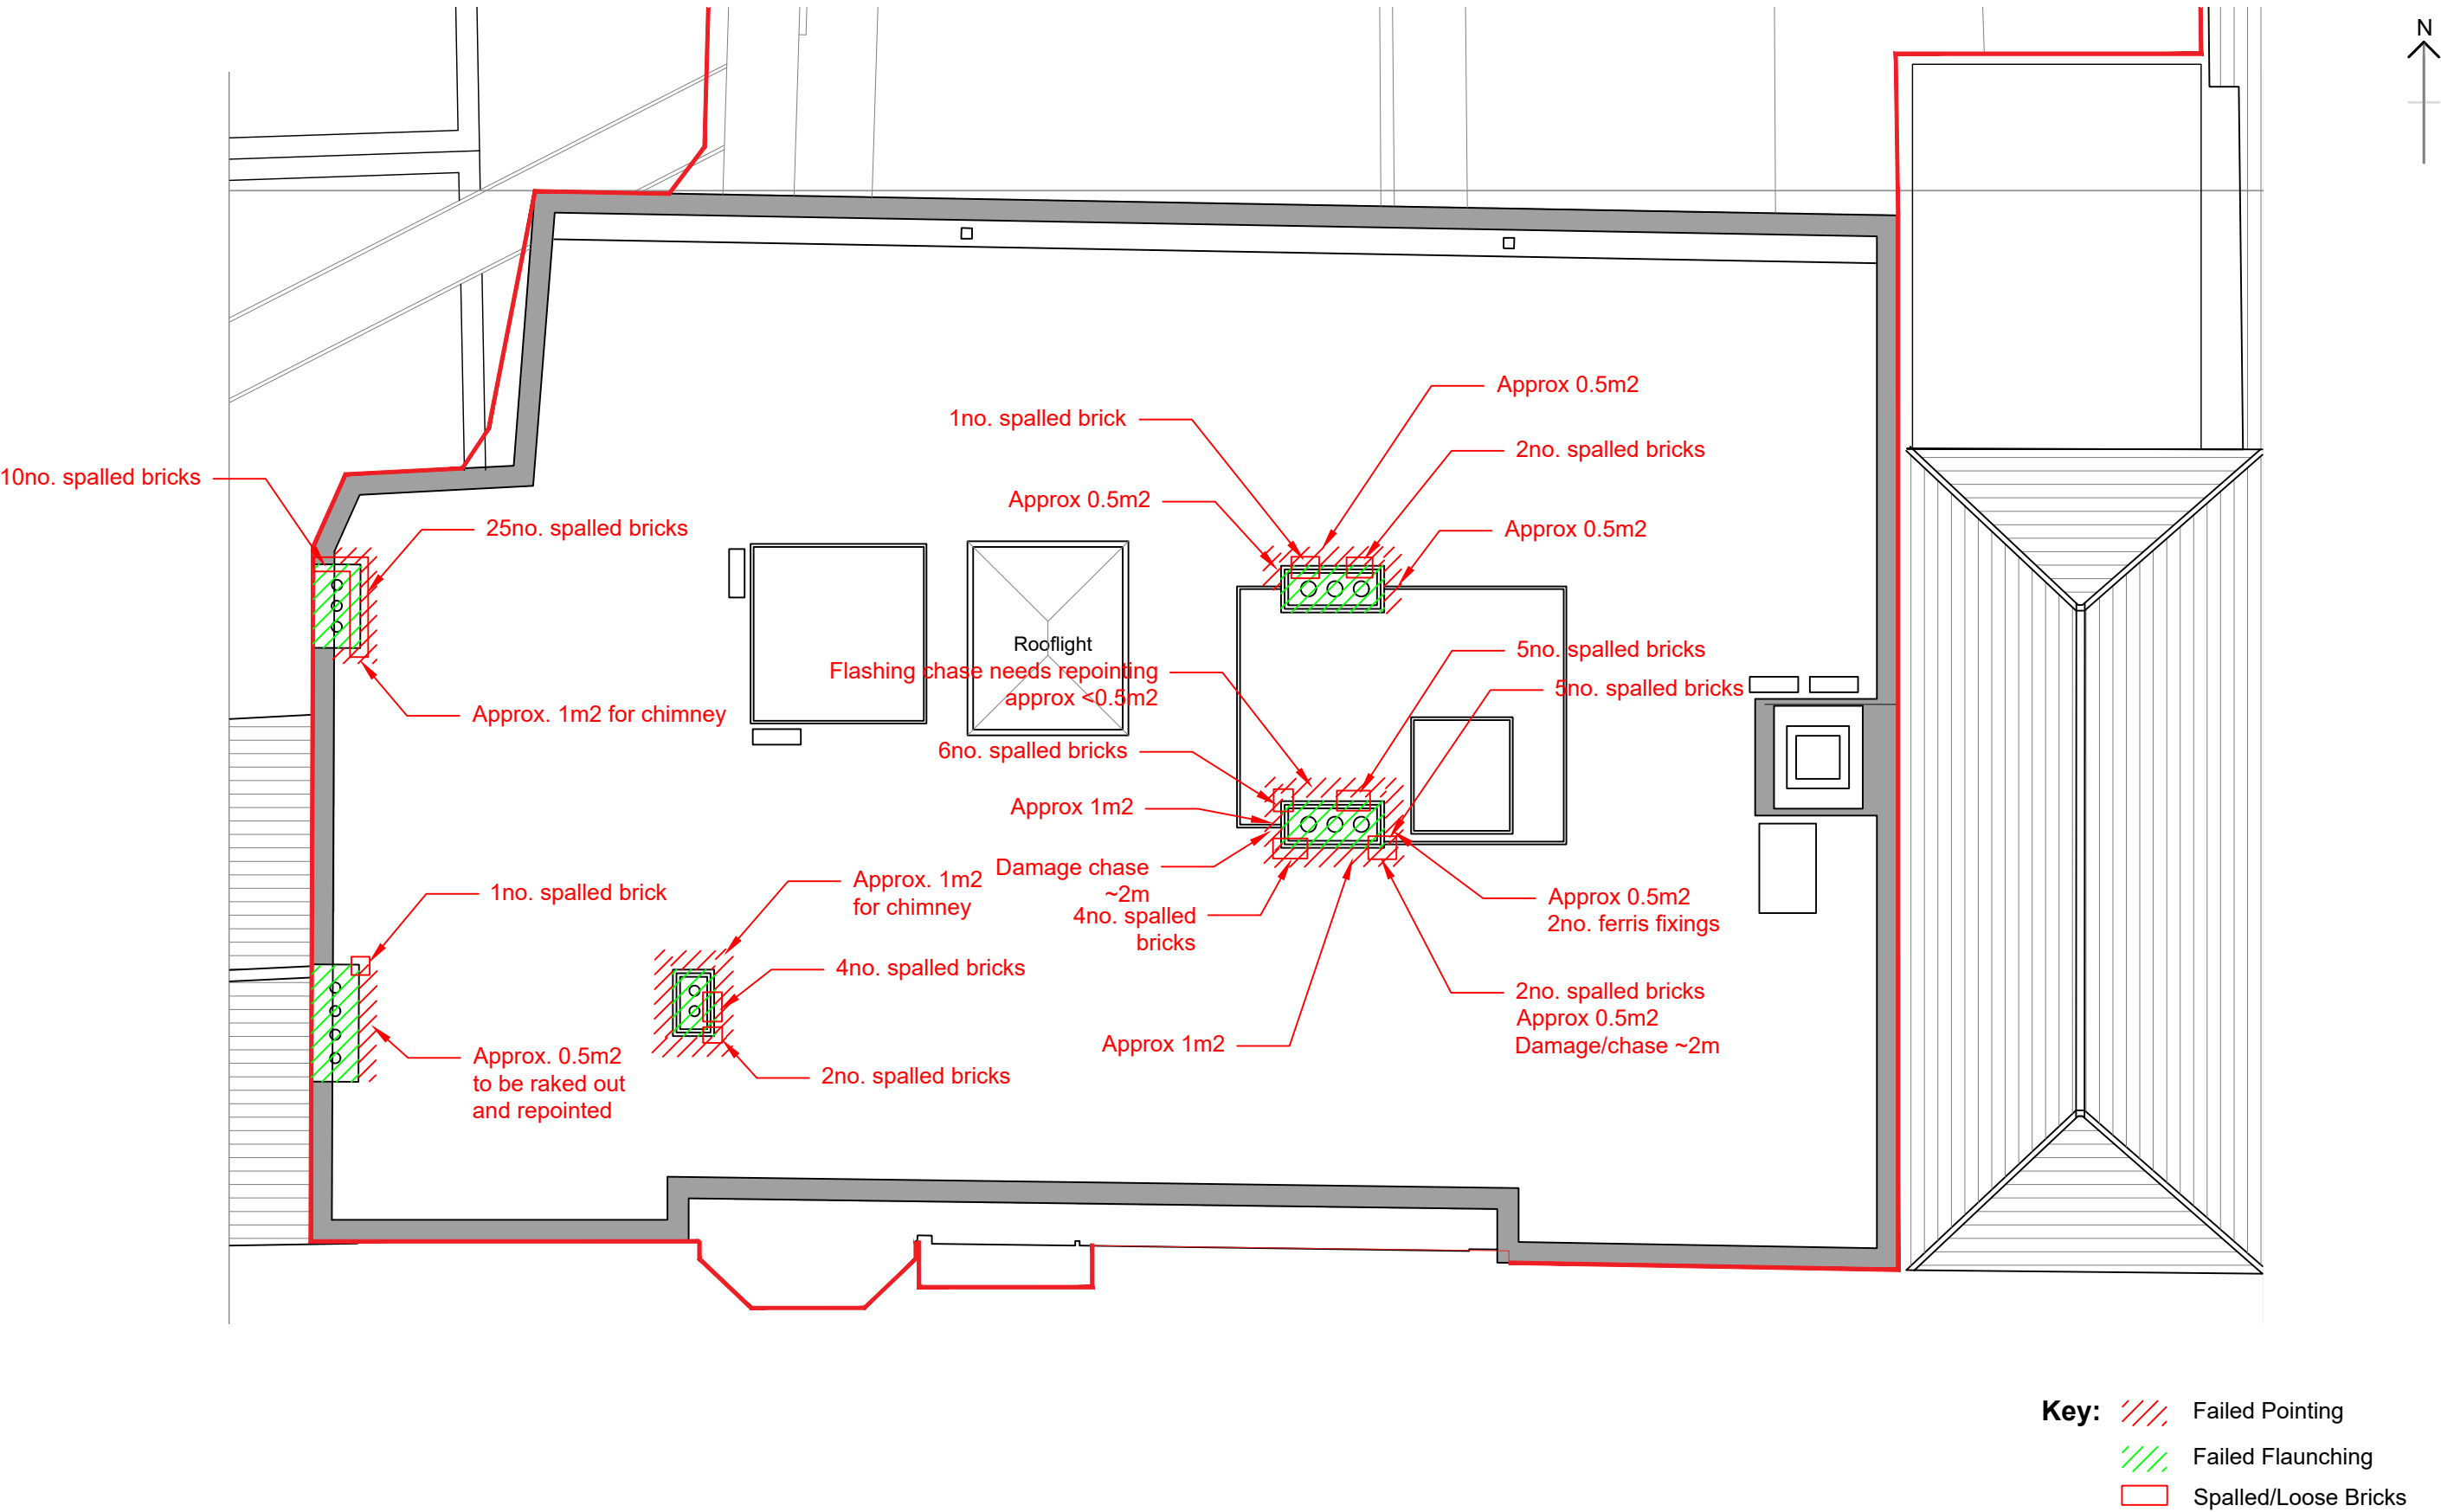
Appendix D: South Facade - Brickwork & Chimneys Investigation: Chimneys Condition

All chimney stacks display evidence of weathering and progressive masonry deterioration, most notably at high level and adjacent to flashing details. Defects are generally consistent across all stacks and include spalled brickwork, recessed and failed pointing, defective cementitious flashing, and redundant fixings and flashing chases cut into the masonry.

Minor brick spalling is evident across several elevations of each stack, ranging from isolated damaged units to more concentrated areas of decay. Mortar joints are widely eroded or open, with localised areas exhibiting more significant loss. The corbelled brickwork also shows early signs of movement associated with mortar recession and prolonged weather exposure.

The cementitious flashing to the chimney heads is generally cracked and debonded, allowing water ingress around the chimney pots and into the masonry core. Redundant lead chases, embedded ferrous fixings, and poorly executed repairs are evident in several locations, contributing to localised cracking and increasing the potential routes for moisture penetration.

All defective pointing and failed mortar joints to the chimneys will be carefully cut out and repointed using a lime-based mortar. Failed flaunching to the remaining chimney stacks will also be repaired or replaced as required.

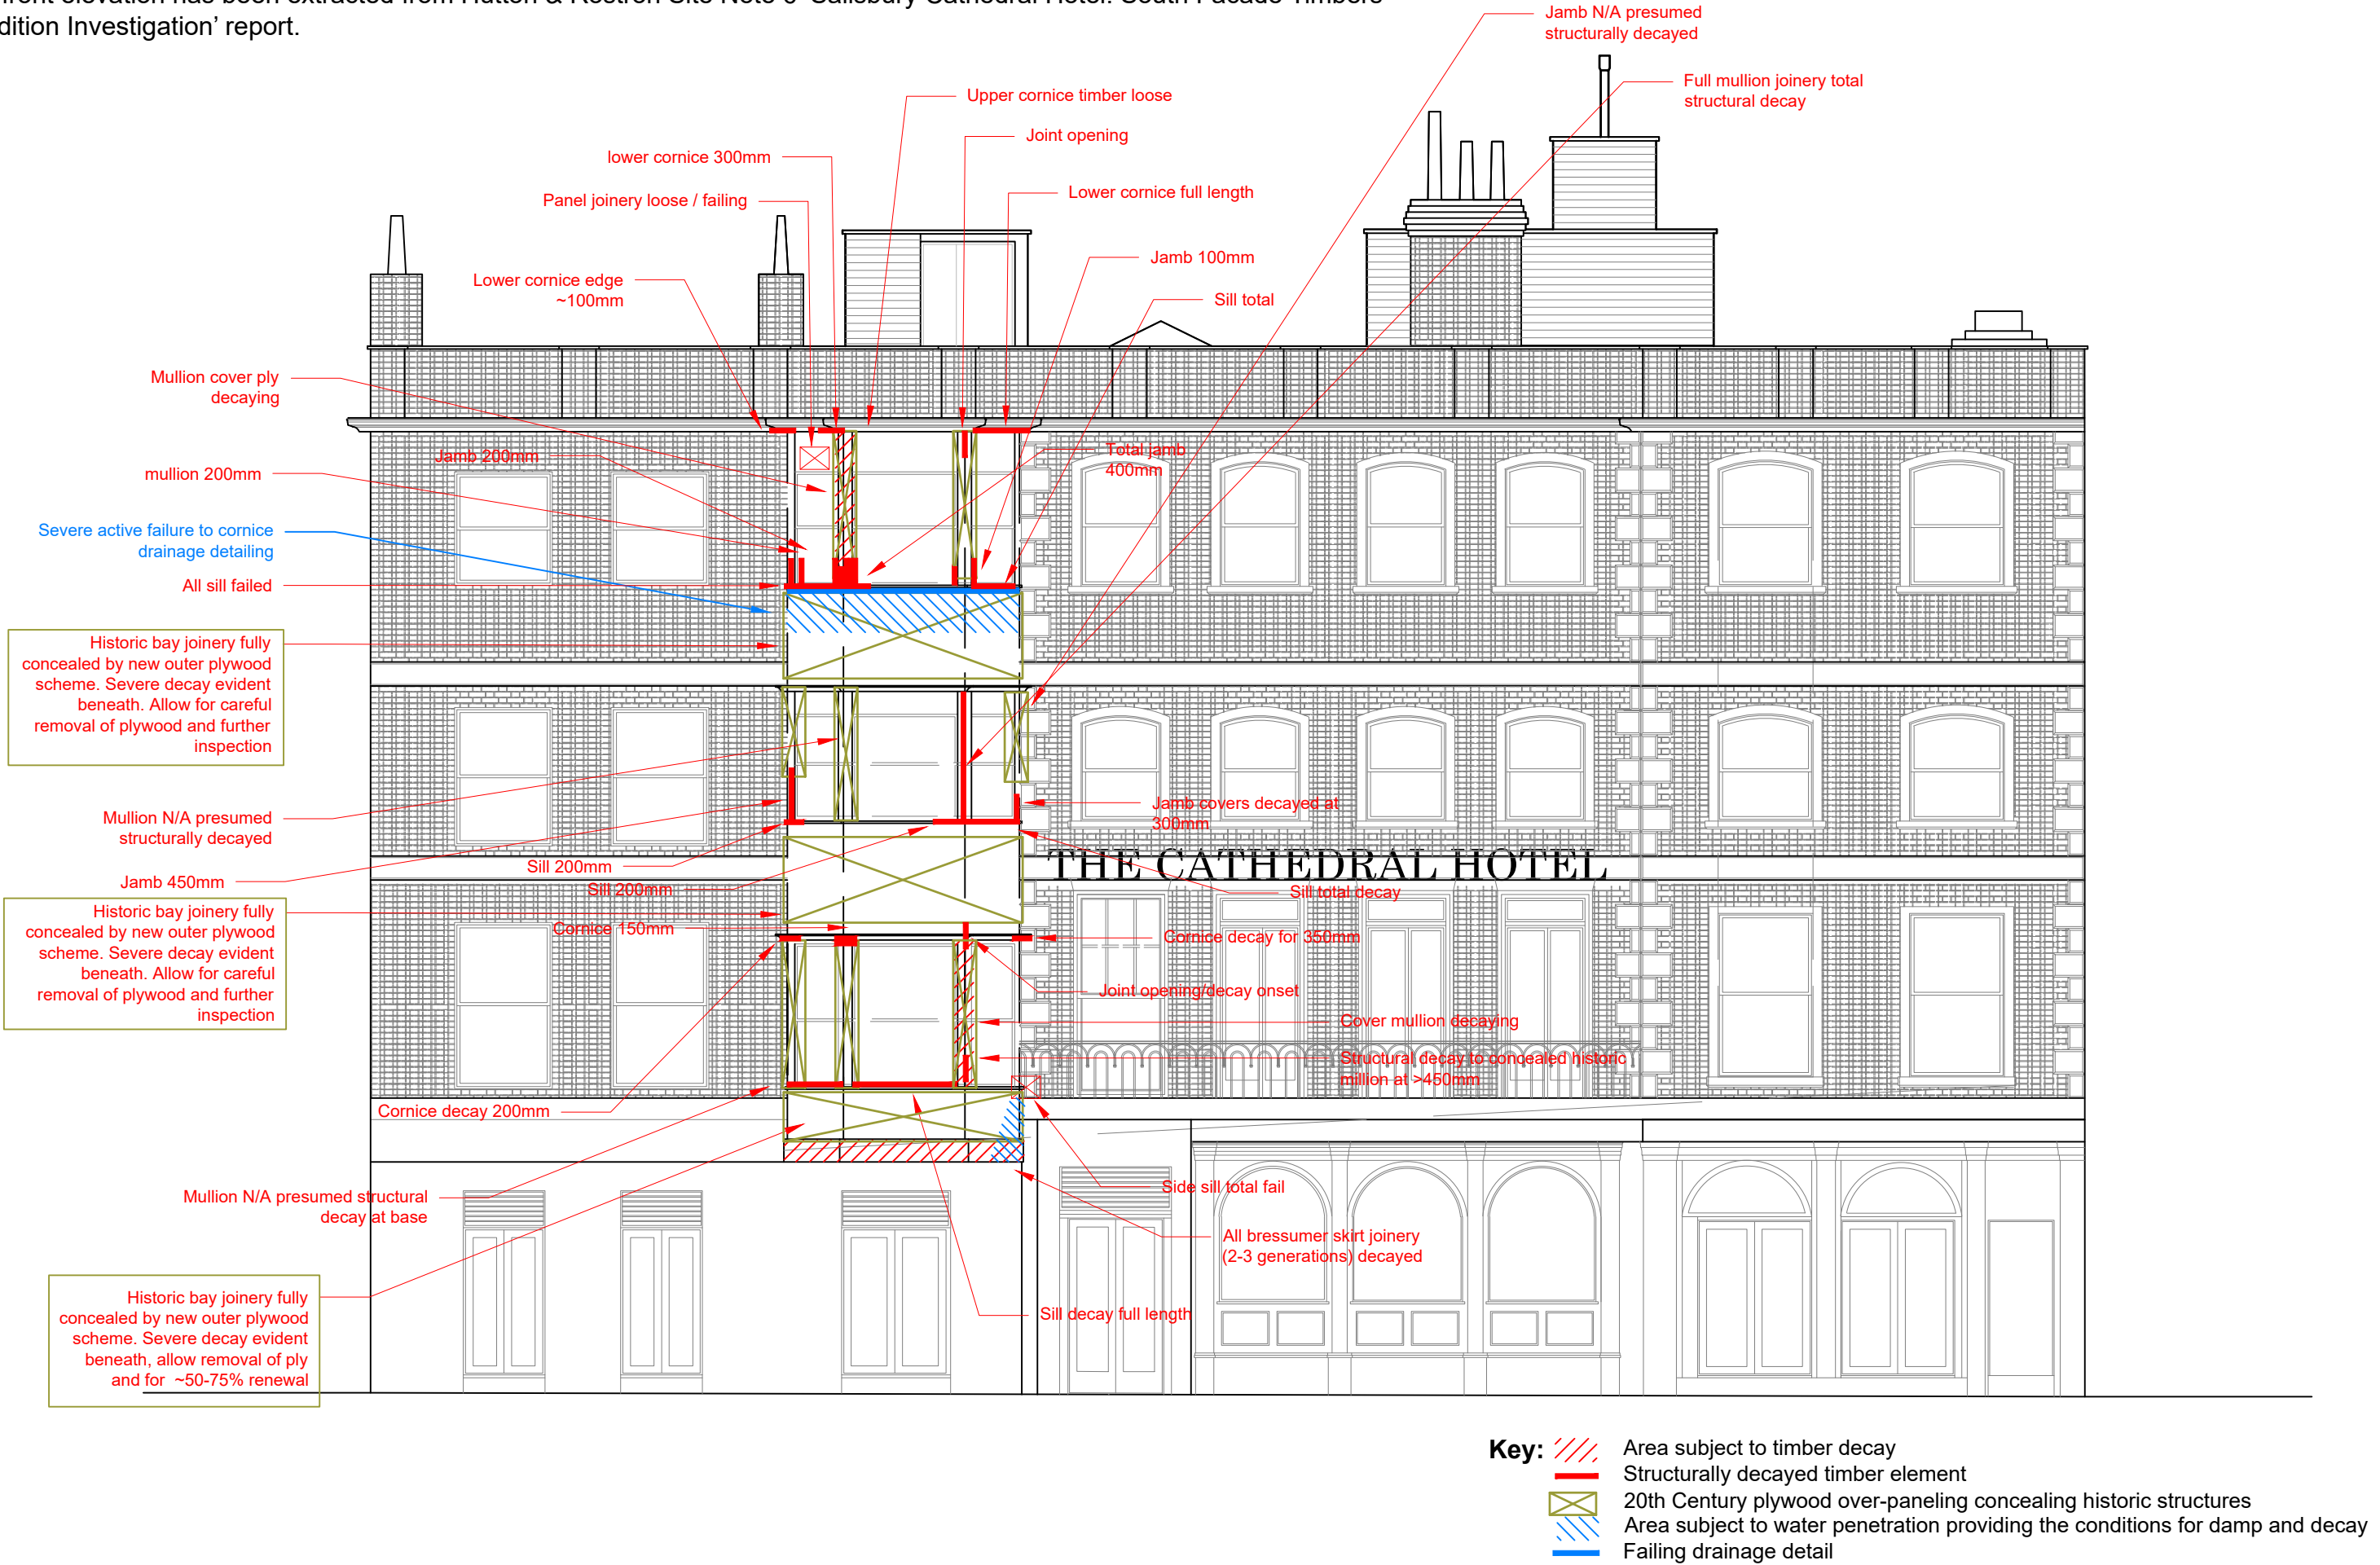
# Appendix E: South Facade - Timbers Investigation: Bay Window

All three levels of the bay window exhibit evidence of extensive and advanced structural decay. The combined effects of prolonged moisture ingress, impermeable over-cladding, and the use of small-section timber construction have led to a substantial loss of structural integrity.

Mitred cornice joints were found to be open and locally unstable, particularly at corner junctions, creating vulnerable points for the penetration of wind-driven rain. Cornice drainage detailing at the upper levels was observed to be defective, likely because of stress fracturing and inadequate historic repairs. Lead flashings had been poorly patched in several locations, with these failures actively permitting water ingress into the bay structures. Low-level but ongoing decay was identified within the cornice timbers, typically originating from exposed end grain at inadequately sealed mitre joints.
